HAINES 2015

FACILITY PLANNING REPORT

Haines Borough | Project Facilitation & Management

McCool Carlson Green | Architect

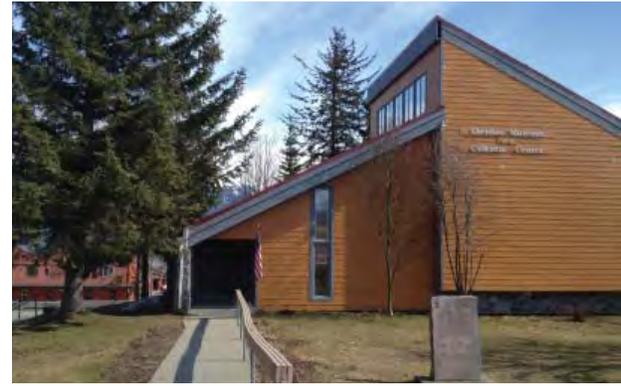
EXTERIOR - MAIN ENTRY

Structurally, there are signs of water-infiltration and potential stress on the exterior walls, which may be caused by wind pressure on the roof. Due to the date of construction and visual observation of suspicious materials, this facility may contain hazardous materials. This, along with water issues, also raise questions about air quality.

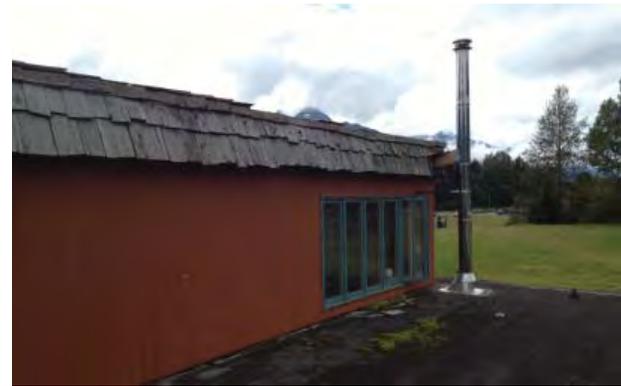
EXTERIOR - ROOF

- New roofing
- Minor Sheetrock work
- New poured front and rear concrete walkways
- New rear stairs.
- New rear doors.
- Minor paint and trim touch-up
- Window replacement
- Minor caulking in rest room
- New gasket on boiler side-arm

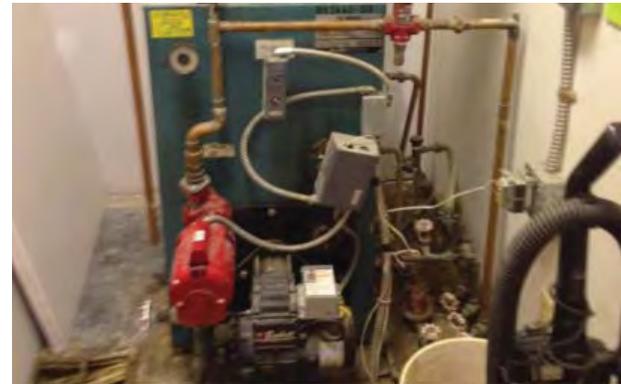
INTERIOR - BOILER

- New boiler
- Repair rotted rim joists
- Rotten logs repair
- Paint Rest rooms
- Ventilate crawl spaces
- Repair rotten wood at front wall of building
