Haines Borough Pool Condition Survey Haines, Alaska

June 2007

EXECUTIVE SUMMARY

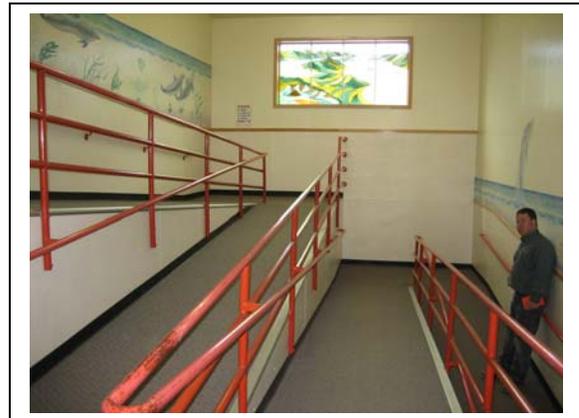
- 1. Handrails:** The handrails at the entry ramps and the stairs to the viewing balcony are set at approximately 32" above the walking surface. The current code requires handrails to be set between 34" and 38" above the walking surface.

Recommendation: *The handrails should be replaced.*

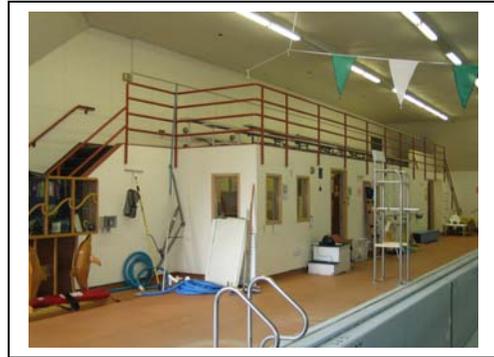
2. **Guardrails:** Guard rails are required on the open side of the ramps that are more than 30" above the adjacent ramp and at the edge of the viewing balcony. The rails need to be at least 42" above the floor and have intermediate rails or panels that prevent a 4" sphere to pass through the rail. The existing ramp and balcony rails do not meet this requirement.

Recommendation: *The existing rails should be replaced or modified.*

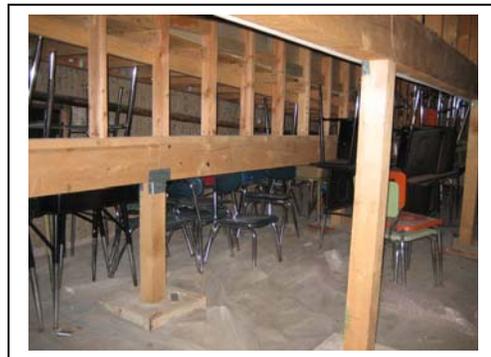
3. **Use of space under pool deck:** The space under the pool deck is used for storage, an exercise room and for pool equipment. Storage needs to be accomplished in a manner that does not interfere with the sprinkler coverage.

Recommendation: *The exercise room needs to meet the requirements for an occupied space, which means adequate exits, lighting, heating and ventilation.*

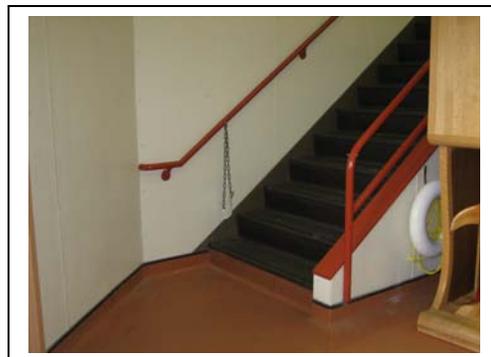
4. **Stairs to balcony:** The stairs to the viewing balcony have a riser height of approximately 7 ½" and a tread width of approximately 10." The current code requires stairs to have a maximum riser height of 7" and a minimum tread width of 11."

Recommendation: *It is reasonable to retain these stairs as they probably met the Code when designed.*

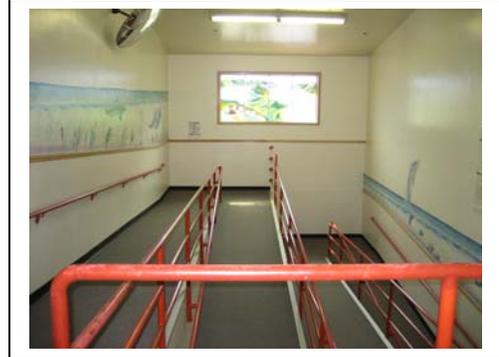
- 1. Ramps at Entry:** The slope of the entry ramps, the ramp widths, and the dimensions of the landings meet the standard. However, the rails do not. The handrails are 32 inches above the ramps. They need to be between 34 and 38 inches above the ramps. There are two intermediate rails below the top rail leaving a space approximately 10 inches between rails. The bottom rail needs to be set to provide no more than 4 inches between the rail and the surface of the ramp. There are additional building code requirements related to the rails.

Recommendation: *The rails should be replaced if the ramp system is retained.*

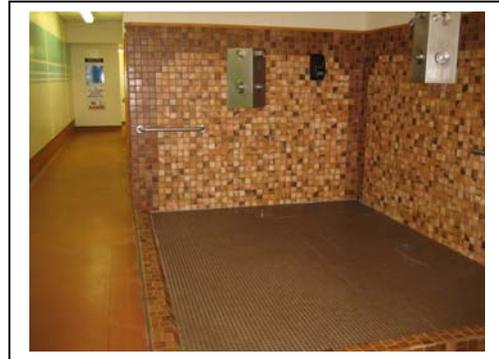
- 2. Access to showers:** Both showers have a large gang shower area. In addition the Women's Locker has 2 private showers. The showers all have a curb surrounding the area. The dimensions of the private showers do not meet the requirements of the standard for making them accessible.

Recommendation: *A portion of the curb around the gang showers needs to be removed to allow wheelchair access to the shower area. In addition a fold-down seat needs to be installed in each area. An alternate, and a preferred option, to this change is to construct a separate accessible shower in each locker room which would provide privacy for disabled users.*

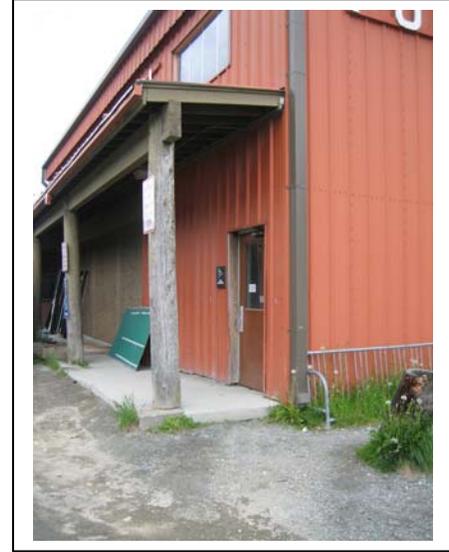
- 1. Building Entry:** The entry to the building is not inviting. The single door leading to a narrow corridor and a series of ramps does not present a positive approach to the facility. The current entry requires all users to traverse the long series of ramps. Even though this system makes the facility accessible it is cumbersome for both the able bodied and disabled users.

Recommendation: *Improve the entry by constructing a common entry vestibule with the High School, removing the ramps and installing an elevator and a stair to the pool level creating a high entry area which could be enhanced by providing additional natural light to the space. This would help provide an arctic entry to the facility to prevent unwanted gusts of wind and make the entry more pleasant and efficient. It could also provide an opportunity for large artwork to enhance the entry.*

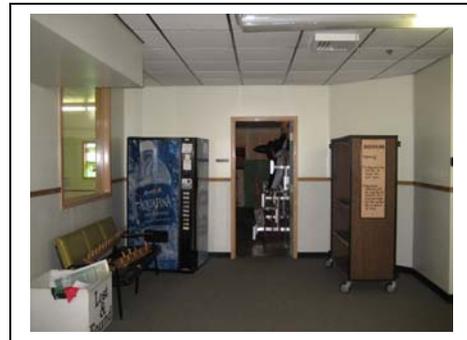
- 2. Pool Lobby:** The pool lobby is small and provides limited opportunity for parents or spectators to view the activities in the pool.

Recommendation: *Improve this area in conjunction with improvements to the entry.*

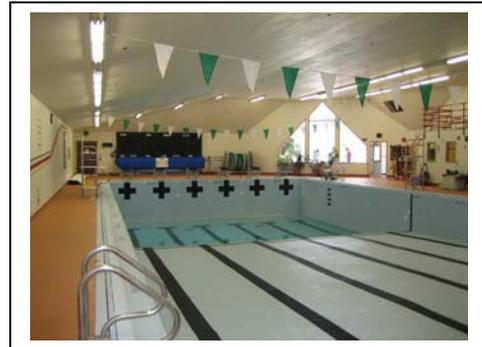
- 3. Acoustics:** The Entry, the Pool Lobby the Pool Room all have hard surfaced walls and ceilings which reflect sound making the spaces very noisy.

Recommendation: *Consideration should be given to applying sound absorbent materials on these surfaces to make them more pleasant to occupy.*

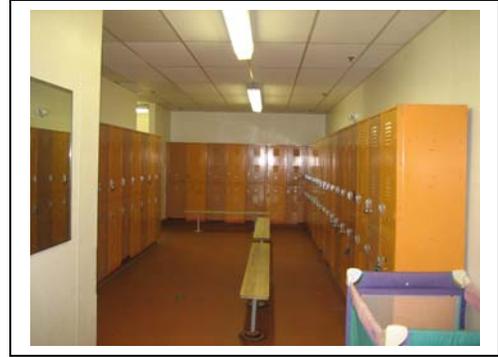
4. **Locker Room Ceilings:** The use of a suspended acoustical ceiling in the locker rooms helps absorb sound making them less noisy, but the suspended ceiling is not a durable or a secure ceiling for this type of space. Noise can transmit between locker rooms, moisture has damaged the panels and supporting grid system and access from the locker rooms into the ceiling space is possible.

Recommendation: *Installing either a painted gypsum board ceiling or a moisture resistant suspended ceiling with secured panels should be considered.*

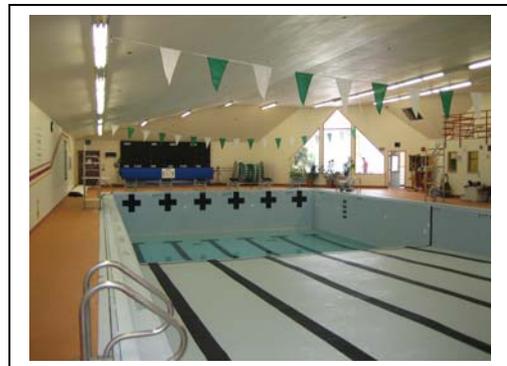
6. **Lighting:** The lighting, especially in the Pool Room is inappropriate for the environment. The quality of light from the strip fluorescent fixtures is harsh and the older style tubes are inefficient. In the Pool Room it causes glare on the water surface.

Recommendation: *Replace existing fixtures in Pool Room to provide more efficient and appropriate lighting to the area.*

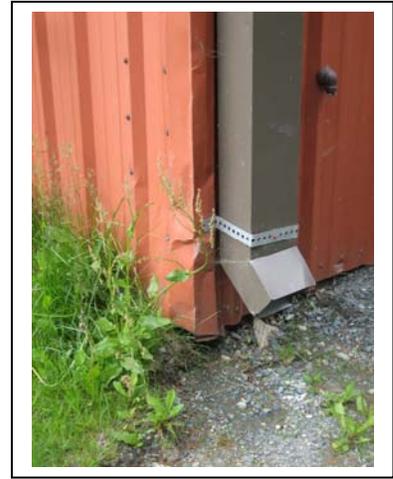
2. **Exterior Walls:** According to the original drawings, the exterior wall system consists of 2x6 and 2x8 studs, plywood exterior sheathing, 2 layers of 2 inch thick foam insulation and metal siding. The interior of the walls are finished with 5/8 inch gypsum board and/or plywood covered with fiberglass panels. The stud cavities are insulated with R-19 batt insulation with a vapor retarder applied to the inside of the studs. The resulting R-value of the walls is approximately R-40. The insulation value is appropriate for current conditions. No evidence of rot or deterioration in the walls was observed. The siding is damaged in several places and the paint coating is weathered.

Recommendation: *The siding should either be replaced or refinished.*

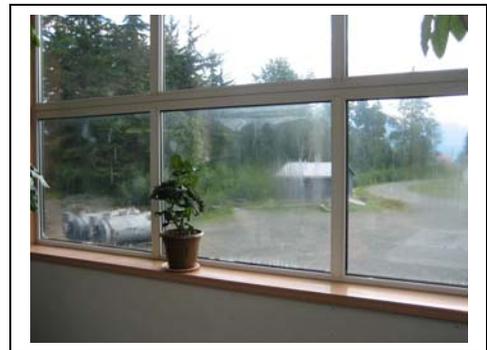
3. **Exterior Doors and Windows:** The exterior doors and frames are painted steel. They are in poor condition. The hardware and weatherstripping should be inspected and replaced as necessary. *The doors and frames should be cleaned and painted or replaced.* Seals on several of the windows in the Pool Lobby have broken and have moisture between the panes of glass. The aluminum window frames appear to be in good condition.

Recommendation: *The glass units with the broken seals should be replaced.*

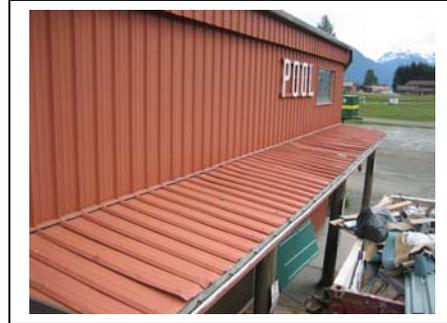
4. **Roofing:** The original metal roofing was replaced in 1999 with a membrane roof system. The membrane is a modified bitumen with a granular top surface. It is in good condition and should last another 15-20 years without significant work. There are several roof penetrations for toilet exhaust fans and attic vents. These penetrations are places that are more prone to leaks. They should be inspected regularly and repaired as needed. The roof over the covered walk between the High School and the Pool entry is the original metal roofing and has been damaged. The attic is insulated with 2 thicknesses of fiberglass batt insulation. The R-value according to the original design was to be R-60, it may not be that high not due to some of the insulation being compressed over time, but the attic is well insulated and does not need improvement.

Recommendation: *Replace roof over covered walk way between the High School and the Pool Entry. Inspect roofing annually and perform minor repairs.*

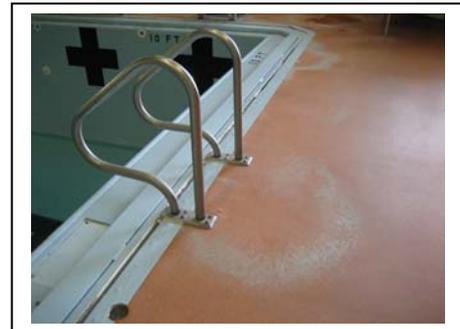
5. **Interior Construction:** The building appears to be well maintained, but due to its age is showing signs of deterioration due to “wear and tear.” The sheet flooring in the locker rooms and on the pool deck is showing wear at high traffic areas and should be monitored. The metal toilet partitions and lockers in the locker rooms are rusted near the floor. The suspended acoustic ceiling system in the locker rooms is deteriorating. There is a joint between the pool deck and the aluminum pool. The joint varied in width from about ½” to 1” and the deck was also ½” to 1” higher than the pool. The pool was empty at the time of the survey. Reportedly the joint width closes somewhat when the pool is full and the tank expands. This joint has been filled with liquid sealant in the past.

Recommendation: *Replace sheet vinyl flooring in locker rooms and pool deck. Clean and paint toilet partitions in locker rooms. Clean and paint or replace lockers. Replace suspended acoustic ceiling in locker rooms. Install a stainless steel or aluminum joint cover across the joint between pool deck and aluminum tank with a rubber membrane to seal water from entering the joint from the pool.*

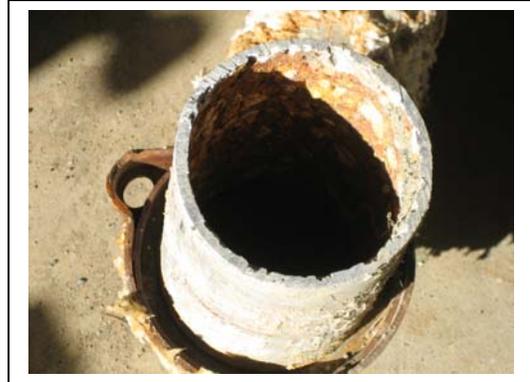
1. Replace the aluminum main drain and inlet piping due to scaling. Scaling is caused by a build-up of calcium carbonate. The pool operator should calculate the Saturation Index, which is a modified version of the Langelier Index for the swimming pool industry. Keeping the index as close to zero as possible will reduce corrosion (of the heater, not piping after it is replaced with PVC) or scaling (of heater and piping). Estimated cost: \$25,000.

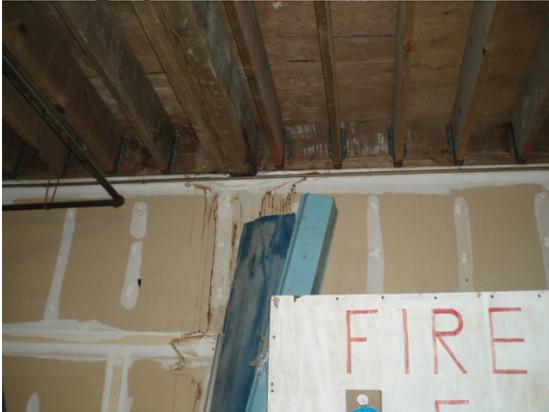
Photo S1 Water marks under second level deck at exterior wall

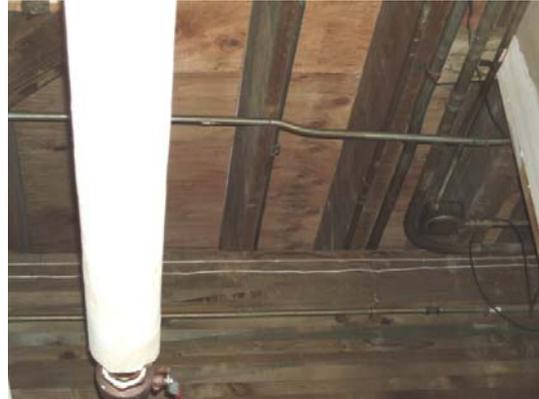
- O4) Second floor framing at the pool deck is in good condition. The only discrepancy is that many joists are not blocked at their bearing points.
- O5) Exterior stud walls appear in good condition, are generally plumb and are with no sign of excessive deflection or deterioration. Some water stains exist on the interior surfaces below the second level deck but these do not appear to be active and there is no sign of fungus or mold growth.

Photo S2 No blocking between 2nd level deck joists at interior beam.

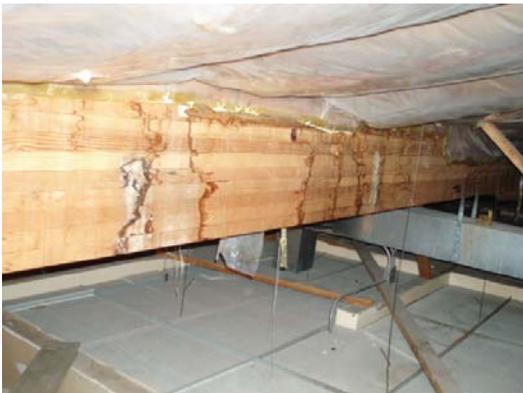
There are water marks at the interior beams above the locker and storage rooms. Maintenance staff indicate that the original roofing leaked and was replaced with a modified bitumastic adhered roof. The beams appear sound at the watermarks. Maintenance staff report that there are no active roof leaks.

Photo S3 Water stains on roof glu lam beam

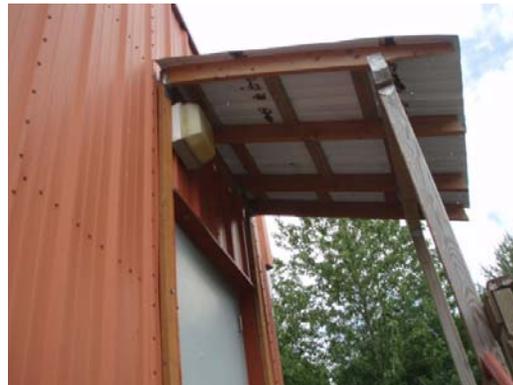
- O8) The exterior stairs and landings appear to be in good condition. However, the roof over the exit landing at the east wall of the building is not well tied to the roof. One roof rafter is broken with a portion missing.

Photo S4 Roof over exit landing east side of building

- R3) Laterally tie the roof over the exit landing on the east side of the building to the building stud walls to adequately resist seismic loads. Replace the broken roof rafter or sister an new rafter to the existing rafter.
- R4) Investigate the soundness of the roof deck at the low roof south of the building, when replacing damaged roofing.

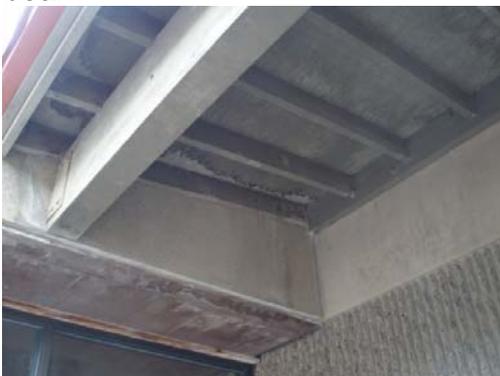
- O9) There are water marks on the underside of the low roof at the south edge of the building, near the west end of the low roof. Metal roofing above the plywood is damaged.

Photo S5 Water marks at underside of low roof along south wall, west end.

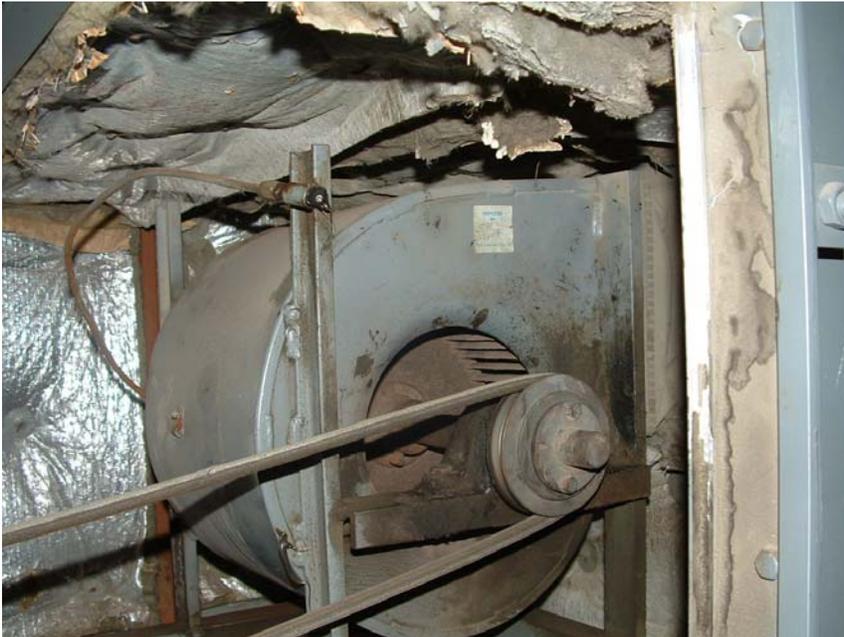
The fans are PACE manufactured internally isolated cabinet fans, good quality fans at the time. Both VU's have a heating coil and filters. Coils were dirty and need cleaning. Interior lining of the cabinet fans is tearing away from the wall in many areas. The interior of the fans are dirty and all three fan scroll wheels are very dirty. Both VU belts are loose and need to be tightened. The exterior insulation has come off the ductwork and there is evidence of condensation dripping onto the floor. A flexible membrane drip pan has been installed under the ductwork but is not effective. The interior dampers are old, caked with dirt and stiff in operation, and do not close totally so bypass leakage is prevalent. See Pictures 1-5 at end of report.

Figure 1; EF-1A Interior, Note Tears in Insulation, Dirty Fan Scroll.

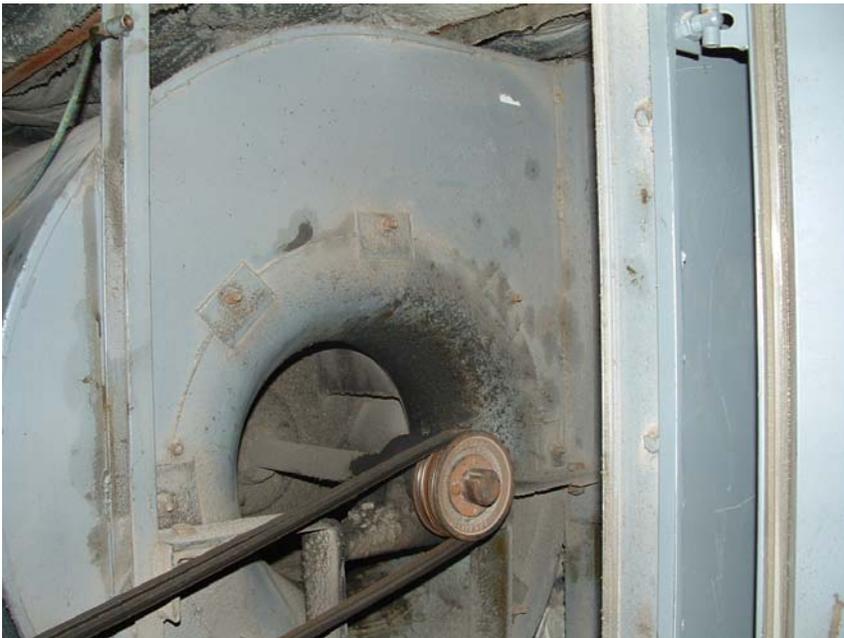
Figure 2; VU-2A Interior, VU-1A similar

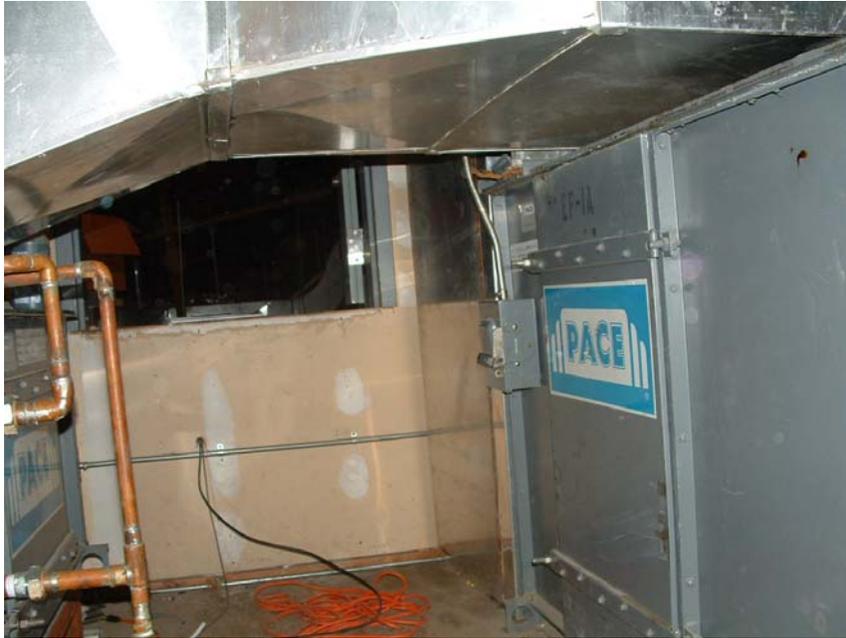
Figure 3; Fan Room Area, Note Poor Access Limiting Regular Monitoring and Maintenance

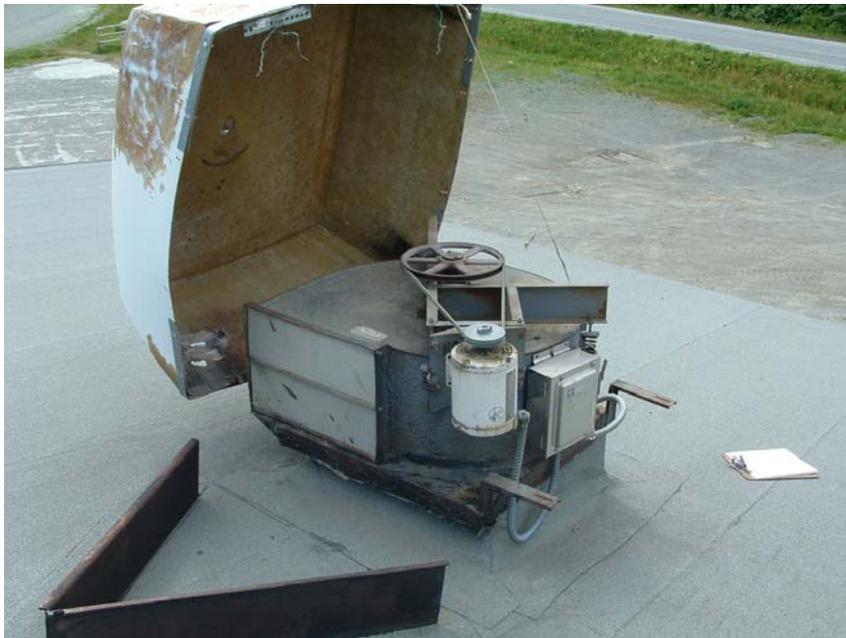
Roof exhaust fan EF-2 exhausts air from the pool toilet room and is in fair condition. Roof exhaust fan EF-3 exhausts from the first floor school locker rooms and is in poor condition. The fans are located on the roof above the pool; both are dirty with fasteners missing. EF-3 fan top is secured with rope and wire. EF-3 was apparently relocated from the previous roof when the pool was built as it had a date code of 1972.

Figure 4; EF-3A on Roof, Fan is over 35 years old.

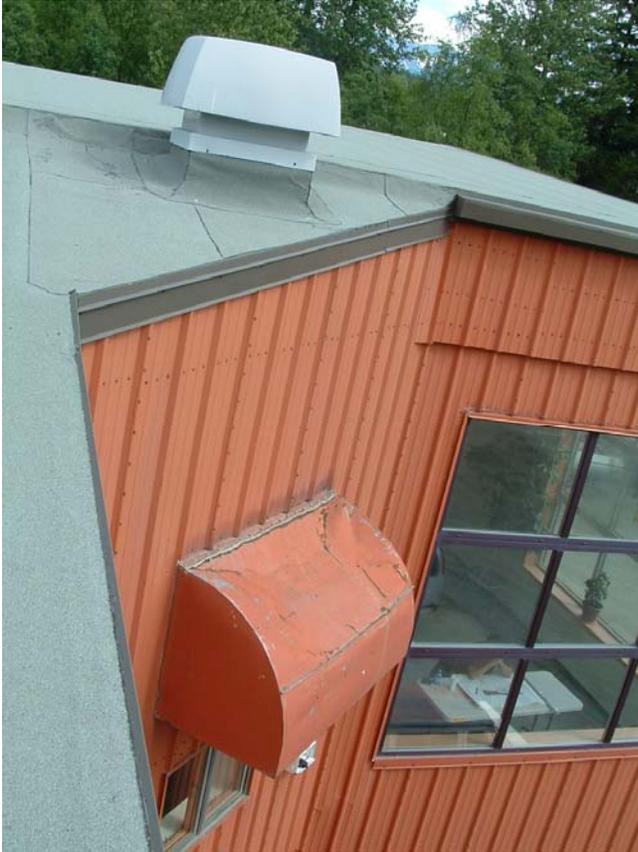
Figure 5; Outside Air Intake Hood (low), Main Exhaust Cap (high). Note damaged intake from snow.

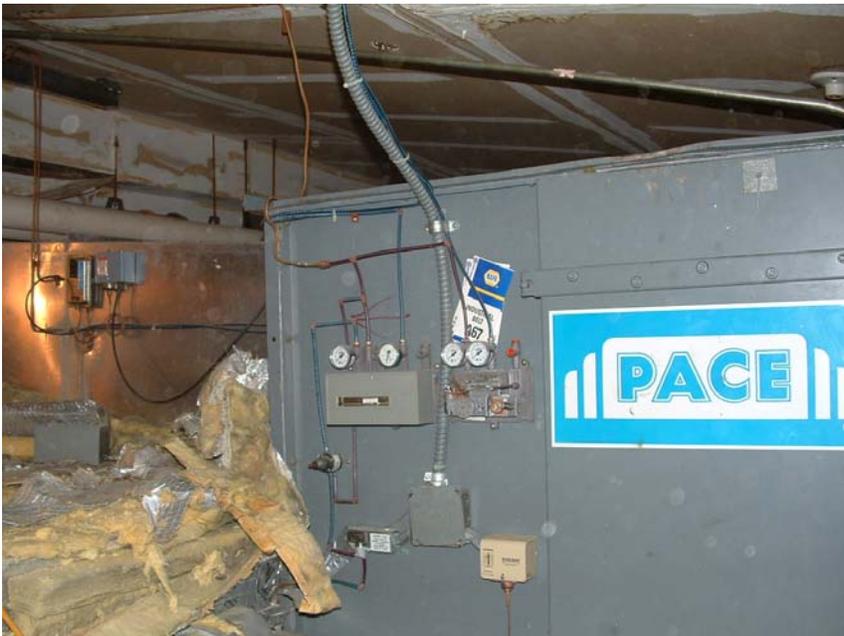
Pneumatic-electric controls operate the ventilation system and electric controls operate the roof top exhaust fans and the various unit heaters. The pneumatic controls are essentially non-functional and the main controllers need to be replaced. Electric controls are in fair to poor condition. See Picture 6. See the January 2007 letter report for more information regarding the ventilation/controls system and scope of work recommended. A pneumatic compressor, located in high School old Boiler Room, supplies the pneumatic air for the pool controls. **Controls systems are in poor condition and need major refurbishment for correct operation of systems.**

Figure 6; Pneumatic-electric Controls for Humidity Control, Non-functioning

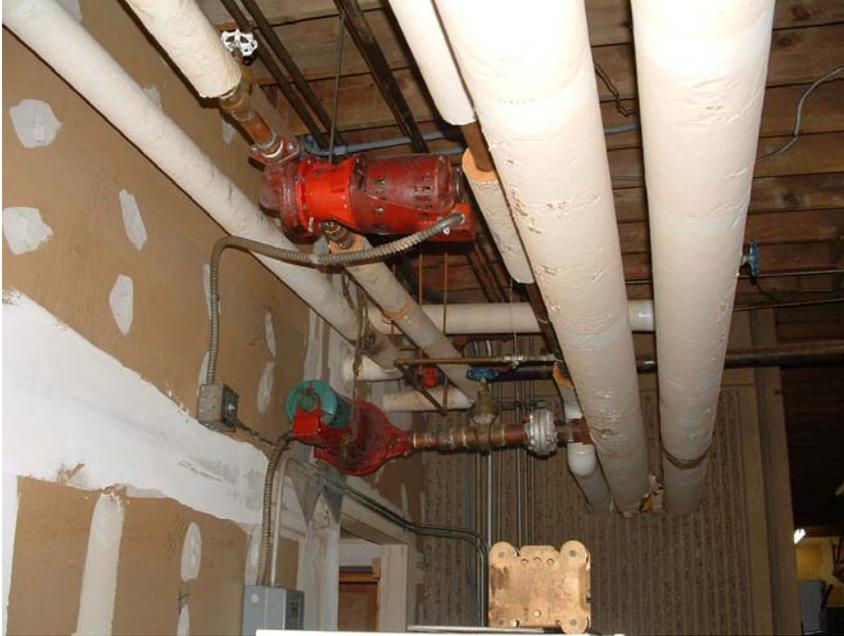
Figure 7; Circulating Pumps P-1A and P-3A. Note replaced parts.

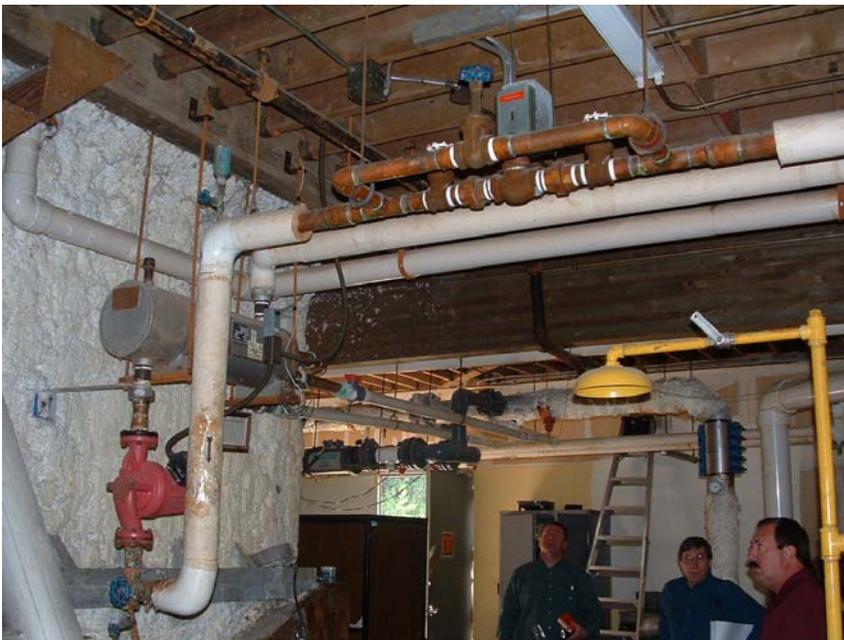
Pump P-1A circulates heating water to the fan unit heating coils. P-1A has had the coupling section replaced in the past. Pump P-3A circulates heating water to the unit heaters that supply heating to storage rooms and mechanical spaces. Pump P-3A has had the motor replaced in the past. See Picture 7. Pump P-4A circulates heating water to the pool heater. P-4A pump has been replaced with a Grundfos type. See picture 8.

Figure 8; Pool Heat Exchanger, Pump P-4A, Heating Automatic Valve for Pool Heat Exchanger

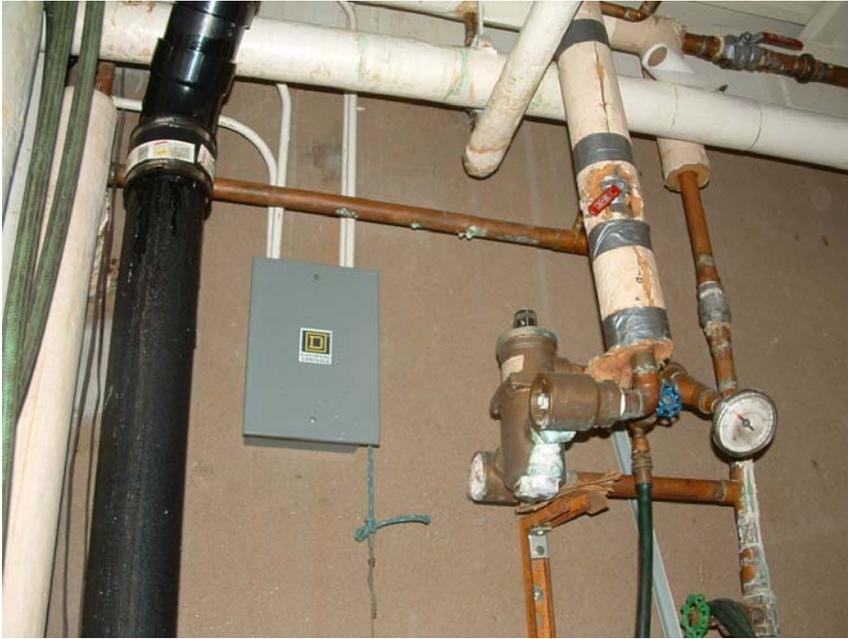
Figure 9 Tempering Valve, Piping Leaks

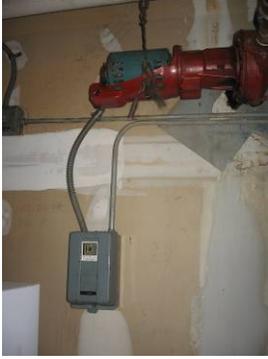
Wrong size OL relays

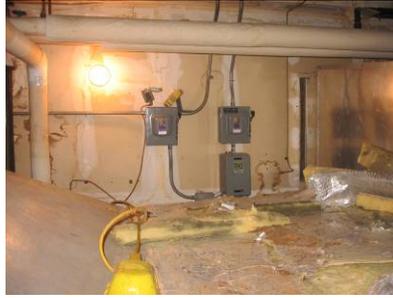
Starters in mech room

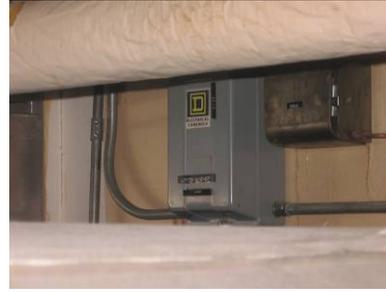
The wiring is in conduit. The receptacles and switches are all original. The starters are also original. This equipment and wiring has also reached it's service life and is in need of replacement. The overload relays were checked in the starter for a circulation pump in the basement. They are sized for a 3.5 amp load, when the motor is rated at 2.4 amps. These should be changed and the remaining overload relays in the building should be checked. The starters and disconnects in the mechanical room above the second floor are located behind equipment. It is very difficult to reach this equipment and the electrician will have to lay on top of the ventilation equipment to do so. This equipment should be relocated where it is accessible.

Starter behind piping

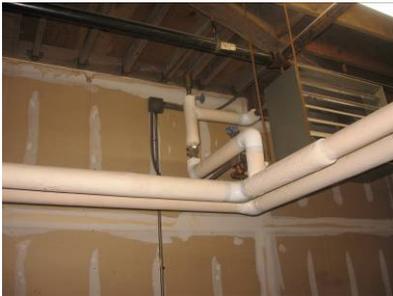
Several unit heaters in the building do not have their own disconnects as required by code. The pool is grounded with a no. 10 bare conductor that is bonded to the structure every 15 to 20 feet. This ground should be checked for current when the pool is filled with water and it's equipment is operating.

Unit Heater w/ no disconnect

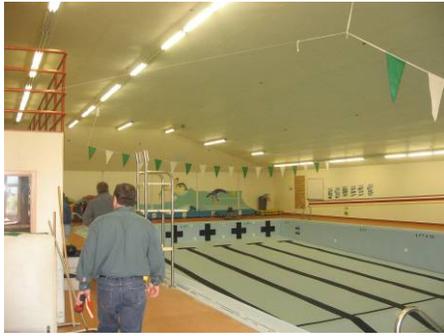
Pool Area strip fluorescents

All of the lighting is original with magnetic ballasts. The ballasts have started to fail. With luminaires this old, the ballasts need to be replaced. The cost to relamp and ballast luminaires with energy efficient ballasts and lamps is very close to the cost of new luminaires that have less glare. This would also solve the lens attachment problem with the existing luminaires. The pool lighting should be replaced based upon the wrong type of lighting in that space alone.

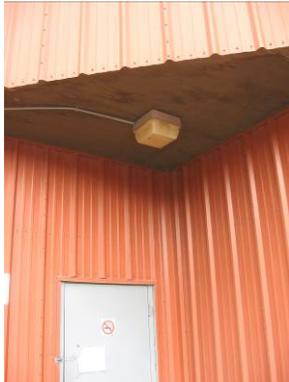
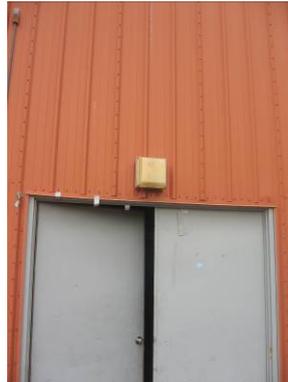
Exterior Lighting

The exterior lighting is barely adequate. Its lenses are yellowing and the luminaires have exceeded their service life as well. The luminaires also create quite a bit of glare. They should be replaced with luminaires that provide better lighting with lower glare.
