Memo To: Aaron Banks, C.P.G. 2925-5.1  
R&M Consultants, Inc.  
From: Ben George, P.E., C.E.G.  
Charlie Hammond, C.E.G.  
Noah Kimmes, P.E., P.G.  
Landslide Technology  
Date: September 8, 2021  
**Subject: Spring Surface Reconnaissance Memo**  
**Haines Beach Road Landslide – NTP2 Task 5.1**  
**PSA Agreement No. 25213018, IRIS No. SDRER00317**

This memo is a deliverable for the Task 5.1 Spring Reconnaissance work conducted for the Haines Beach Road Landslide. It includes a brief summary of the field results and opinions on risk associated with the geohazards within the Haines Borough Area of Concern (AOC). Further evaluation and assessment of this data will be performed as the project progresses, additional data is collected and summarized, and the Findings Report is updated.

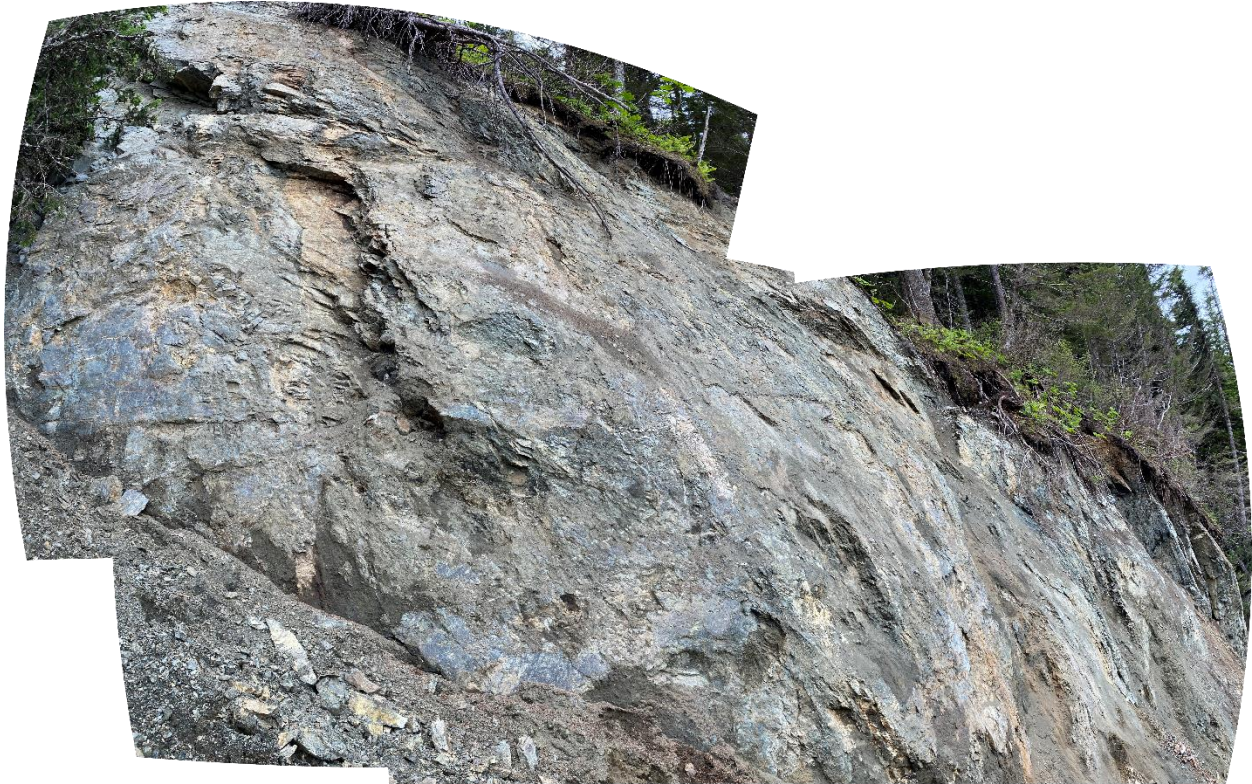
Looking southwest at the central portion of the headscarp with exposure of decomposed layers of ultramafic rock.

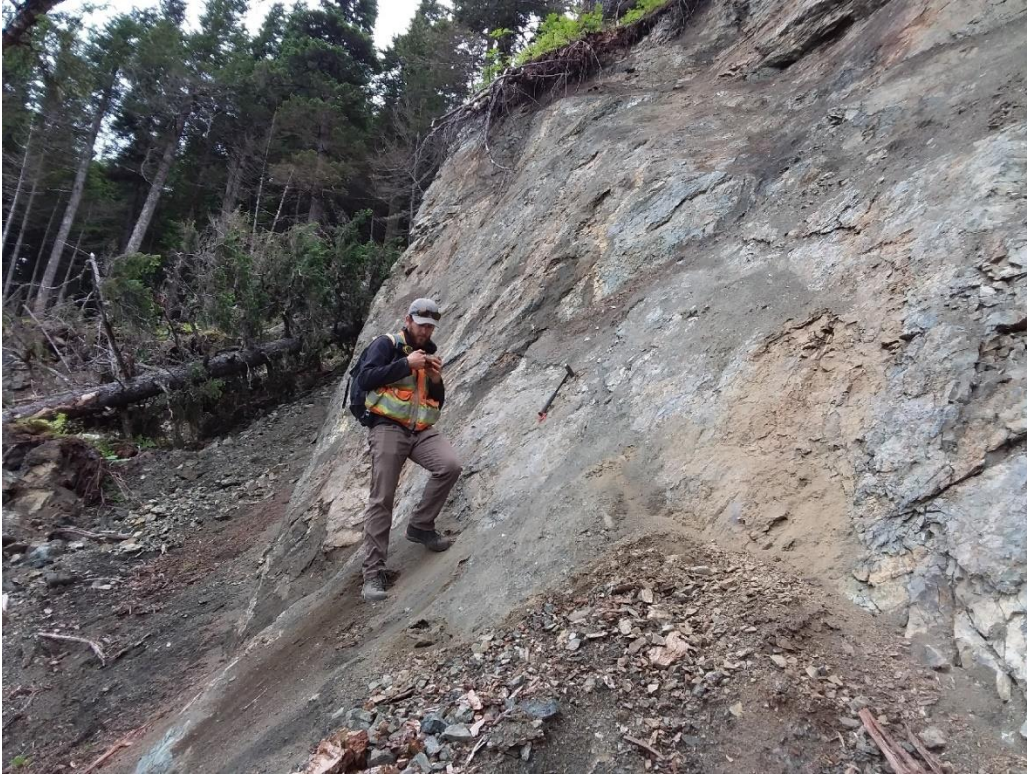
A: Looking east at the central portion of the headscarp with exposure of decomposed rock.

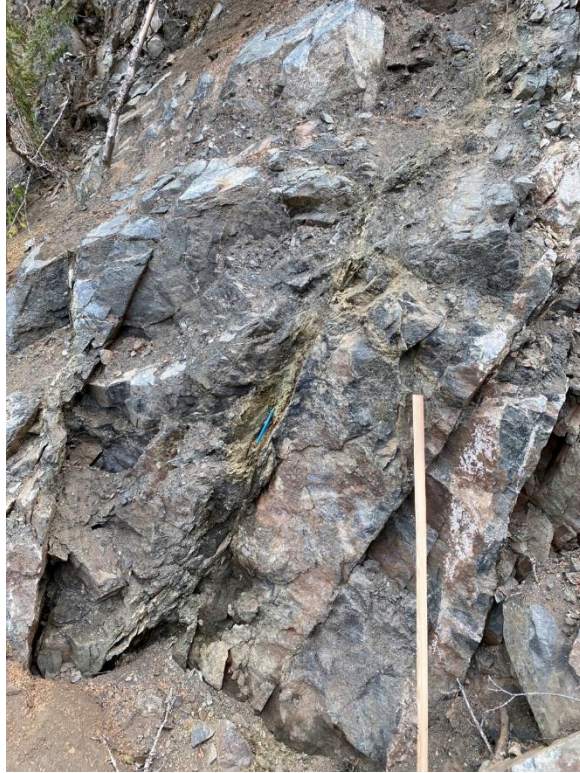
Sheared and faulted rock was observed at two locations on the eastern lateral scarp at approximate elevations 810 and 830 feet. Photo Exhibit 11 shows two areas of fractured and sheared rock that are approximately parallel to the layered ultramafics. The shear at elevation 810 feet is approximately 4 feet wide and the shear at elevation 830 feet is approximately 10 inches wide.

A: 10-inch wide shear/fault near parallel to layered rock at elev. ~830 ft in eastern lateral scarp.

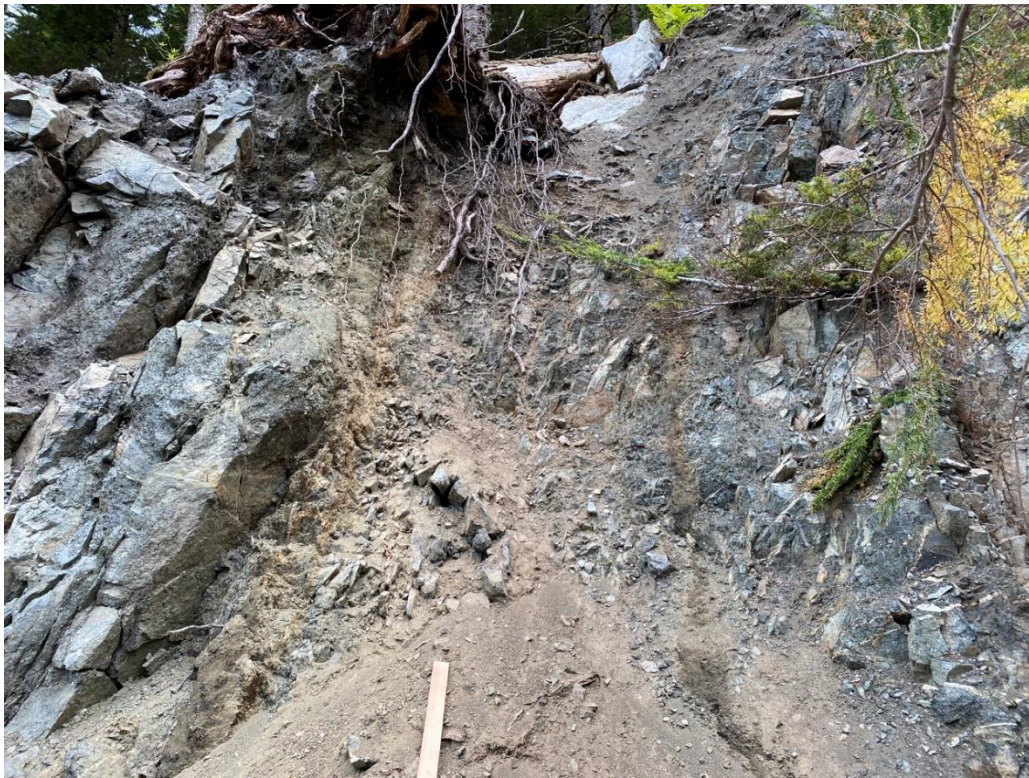
B: 4-foot wide fault near parallel to layered rock at elev. ~810 ft in eastern lateral scarp.

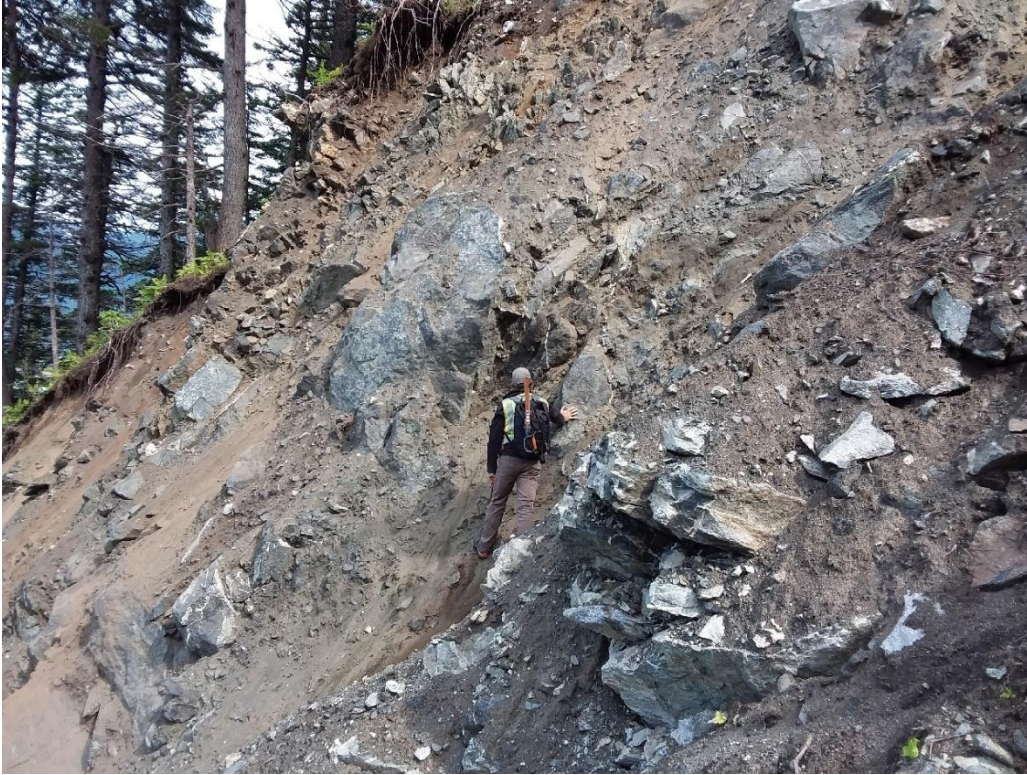
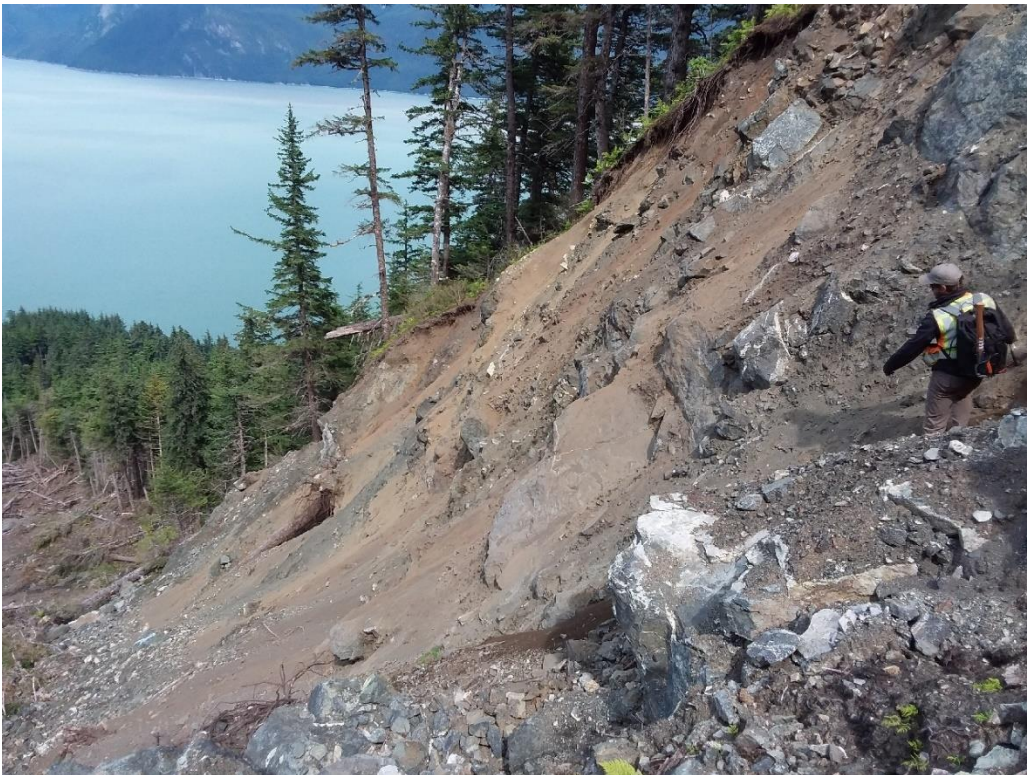
A: Looking east at the eastern lateral soil scarp below elevation 800 feet.

B: Looking northeast at the eastern lateral soil scarp below elevation 800 feet.

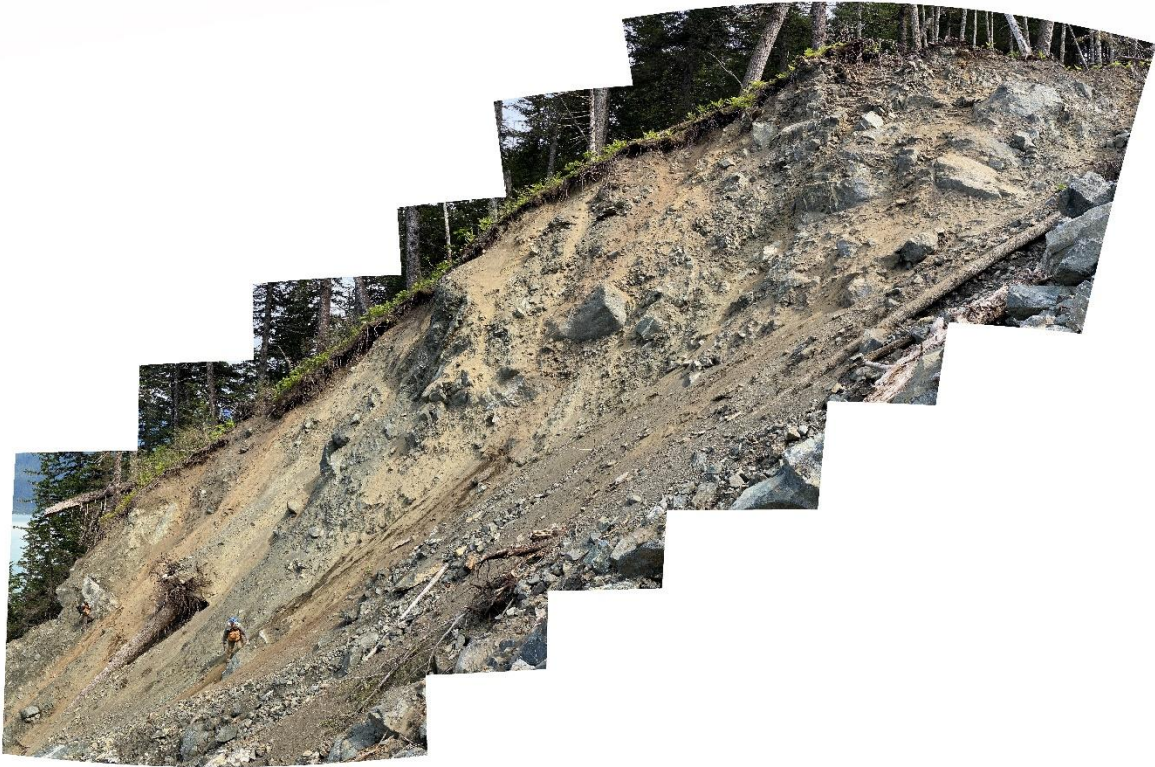
A: Panorama looking east at the eastern lateral soil scarp below elevation 800 feet.

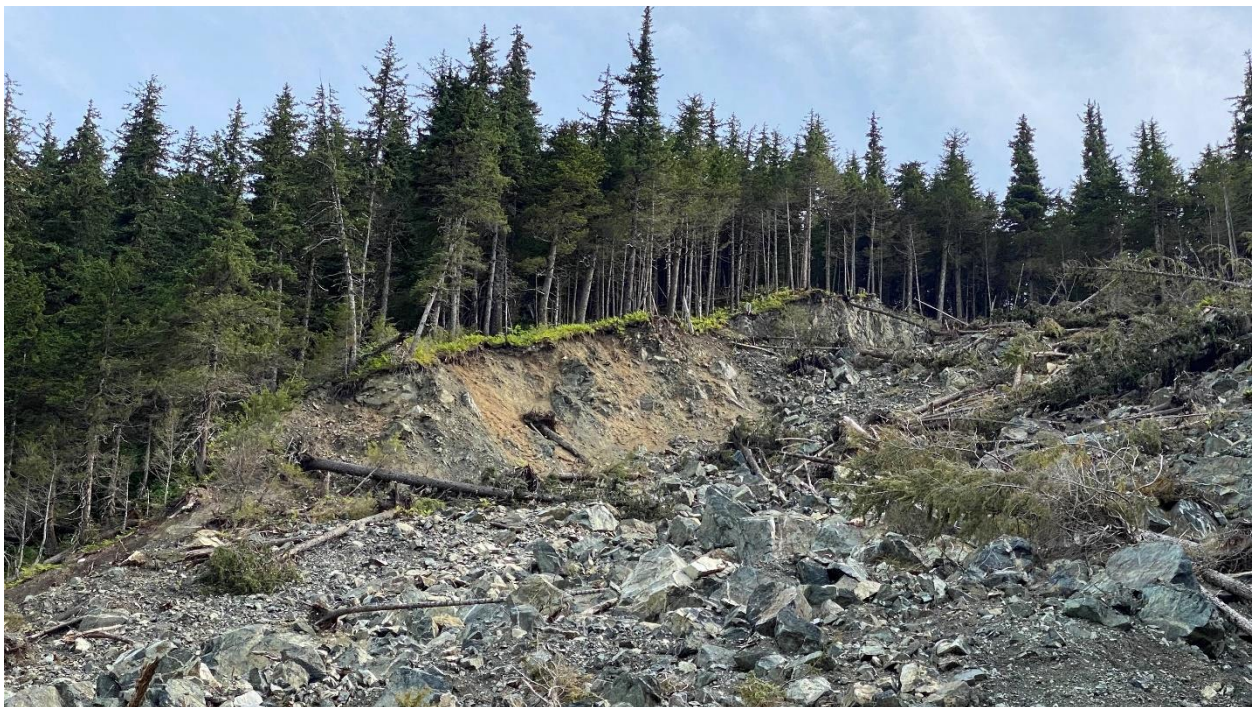
B: Looking southeast at the eastern lateral scarp, including a transition from rock (lateral rock scarp) to soil (lateral soil scarp).

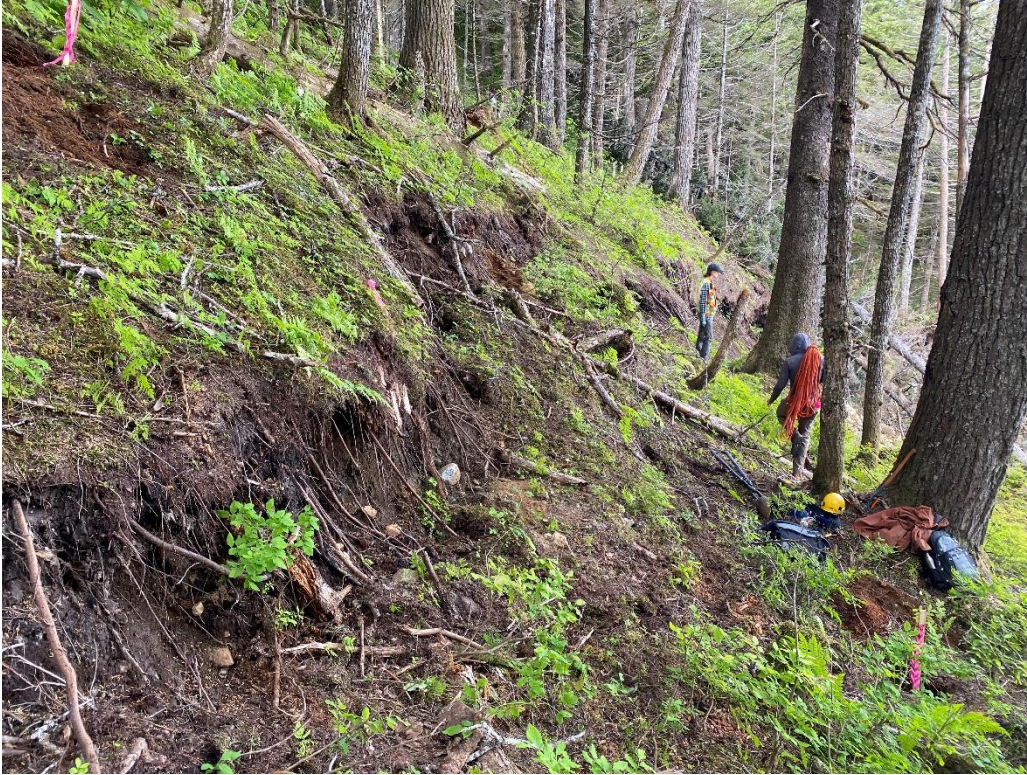
Several tension cracks are present near the eastern flank of the upper rock slump (Photo Exhibits 18 through 23). The main, upper tension crack initially extends eastward (away from the headscarp) at an approximate azimuth of 110°. The tension crack then curves to an azimuth of 045° where the crack becomes obscured or is no longer present, which is approximately 200 feet from the headscarp. Approximately 10 feet from the headscarp, the main eastern tension crack had 3.4 feet of horizontal and 4.1 feet of vertical displacement. Approximately 30 feet from the headscarp, the displacement was 3.0 feet horizontal and 3.7 feet vertical. Approximately 80 feet from the headscarp, the displacement was 1.2 feet horizontal and 1.7 feet vertical. Greater than 130 feet from the headscarp, the vertical displacement varied from 1-foot until it disappeared.

A: Looking west along the eastern tension crack.

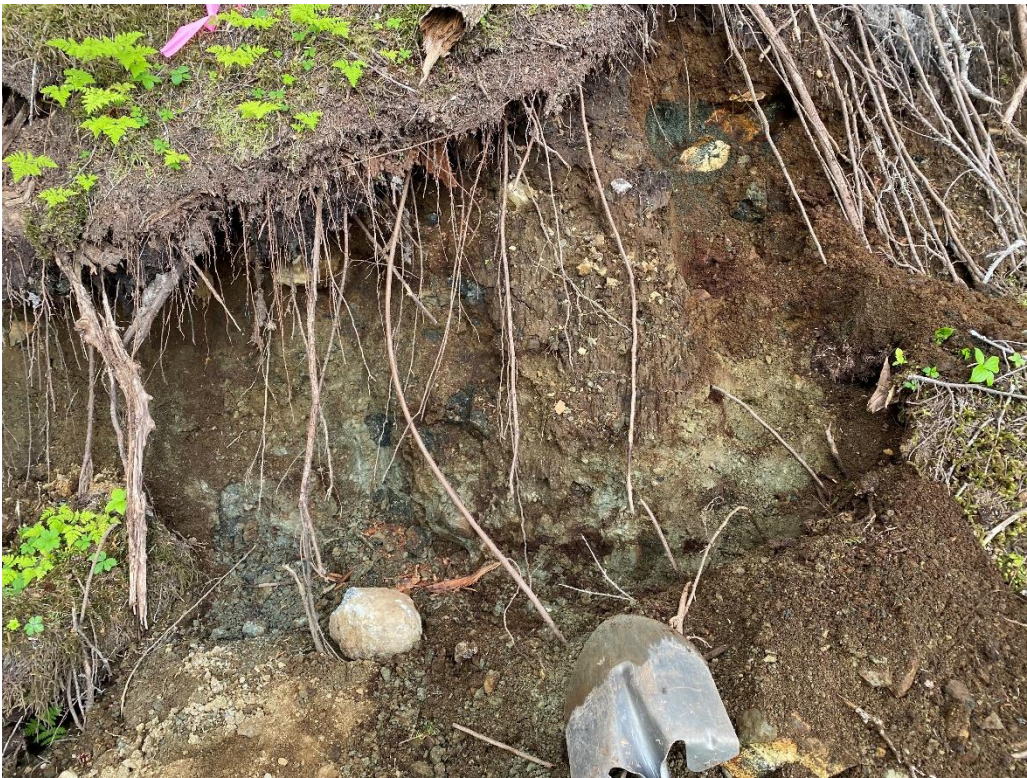
Roots stretched across the tension crack had a range of orientation with those closest to the landslide headscarp showing a relative direction of movement of azimuth 005° and those at the distal (eastern) end of the crack oriented approximately 315°. This trend of root stretch movements is generally perpendicular to the tension crack, which indicates the approximate orientation of movement toward the center of the area defined/outlined by the eastern tension crack. The horizontal and vertical movements appear to be settlement within a steep-sided slump block trending toward the slumped landslide.

B: Eastern tension crack with roots pulled in direction of movement.

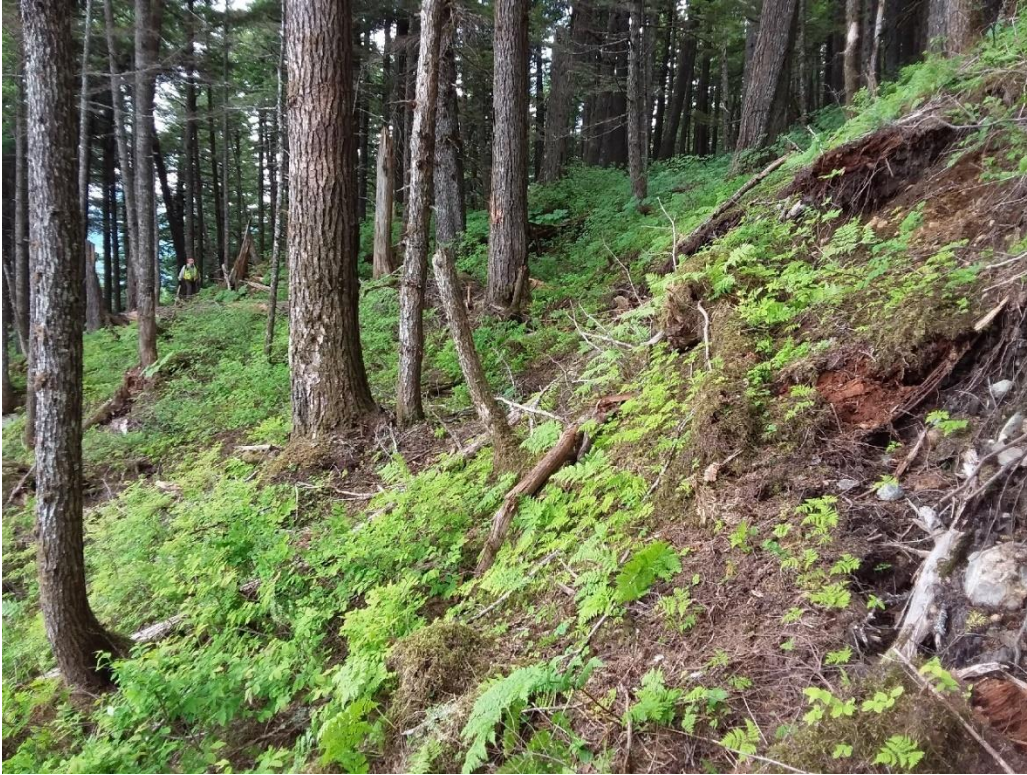
A: Tension, down drop and cavities along the eastern tension crack.

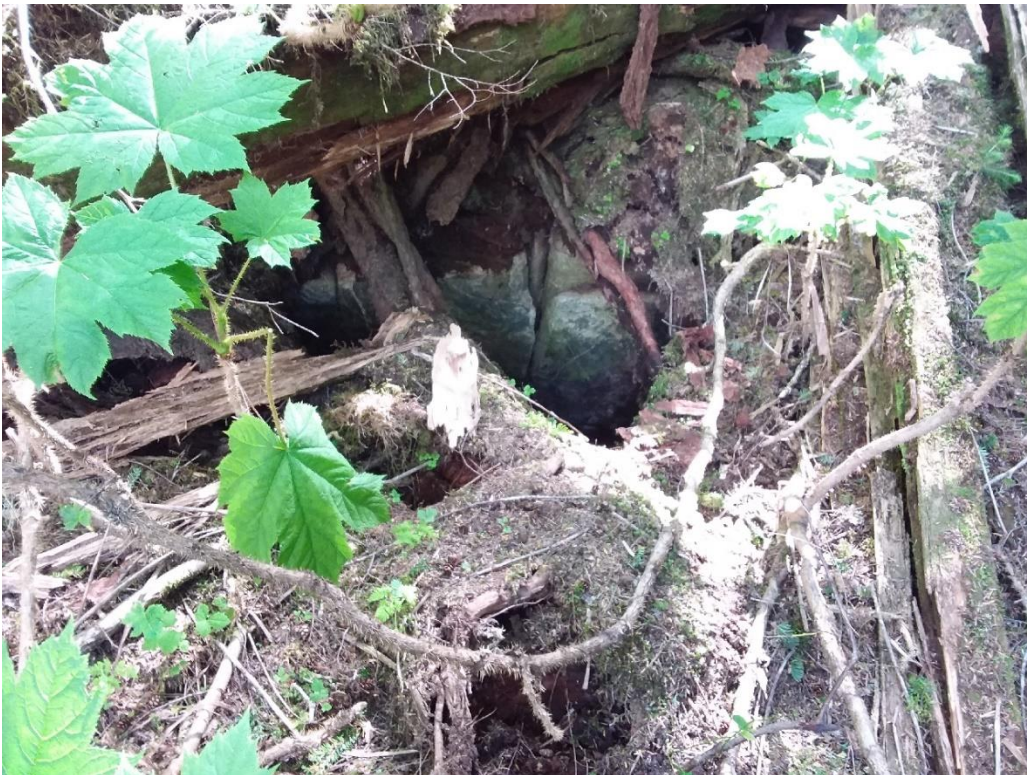
B: Looking southwest at an eastern tension crack cavity, approximately 150 feet from the headscarp.

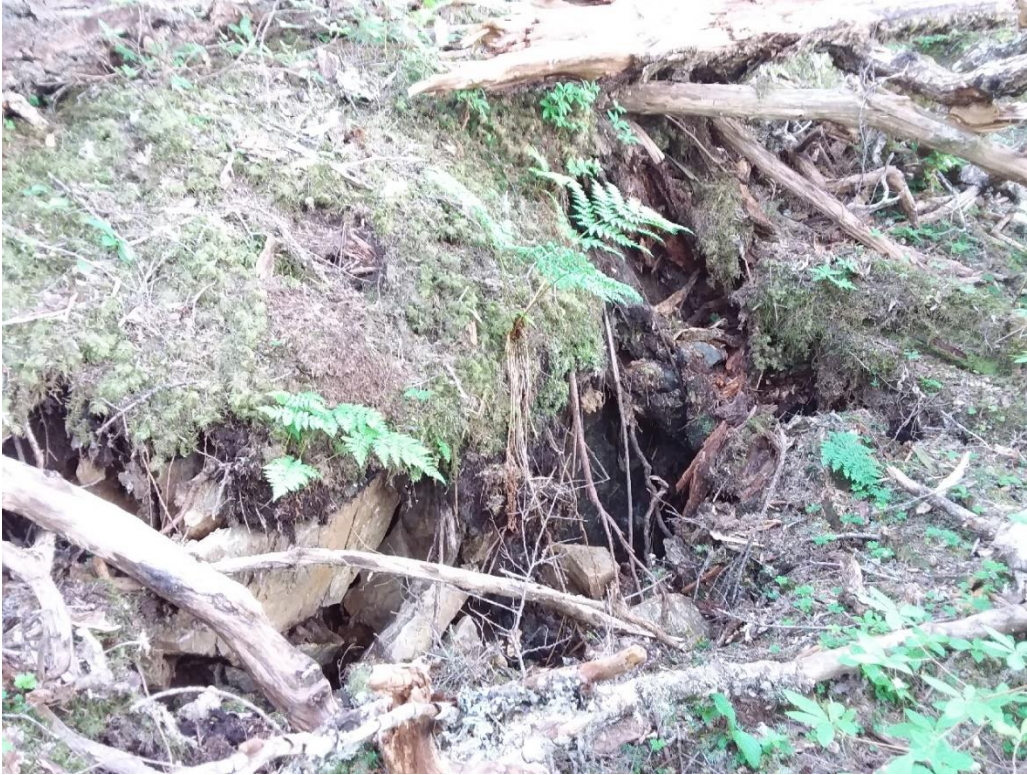
A: Cavities developed along the eastern tension crack.

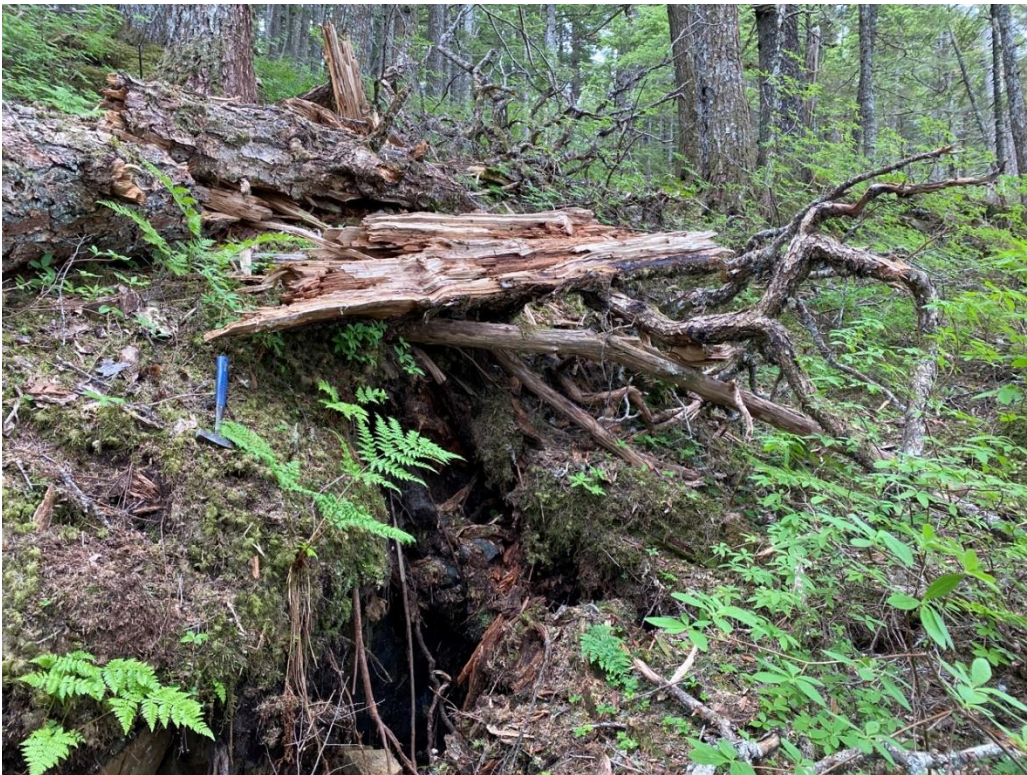
B: Looking southwest along the eastern tension crack, approximately 160 feet from the headscarp.

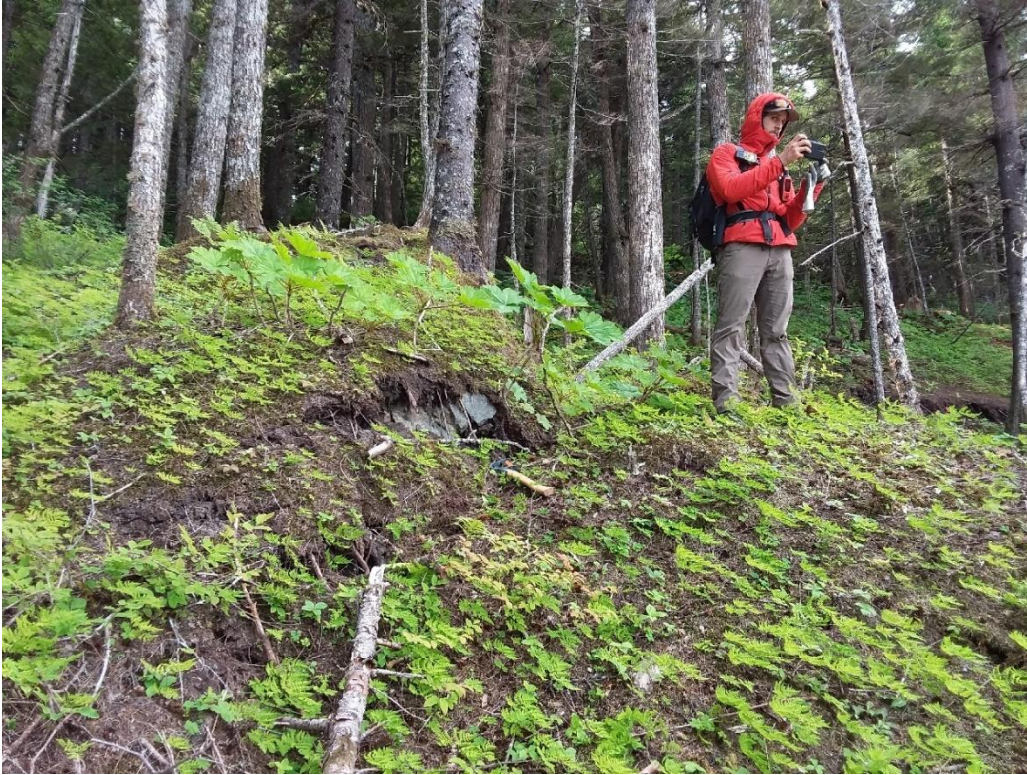
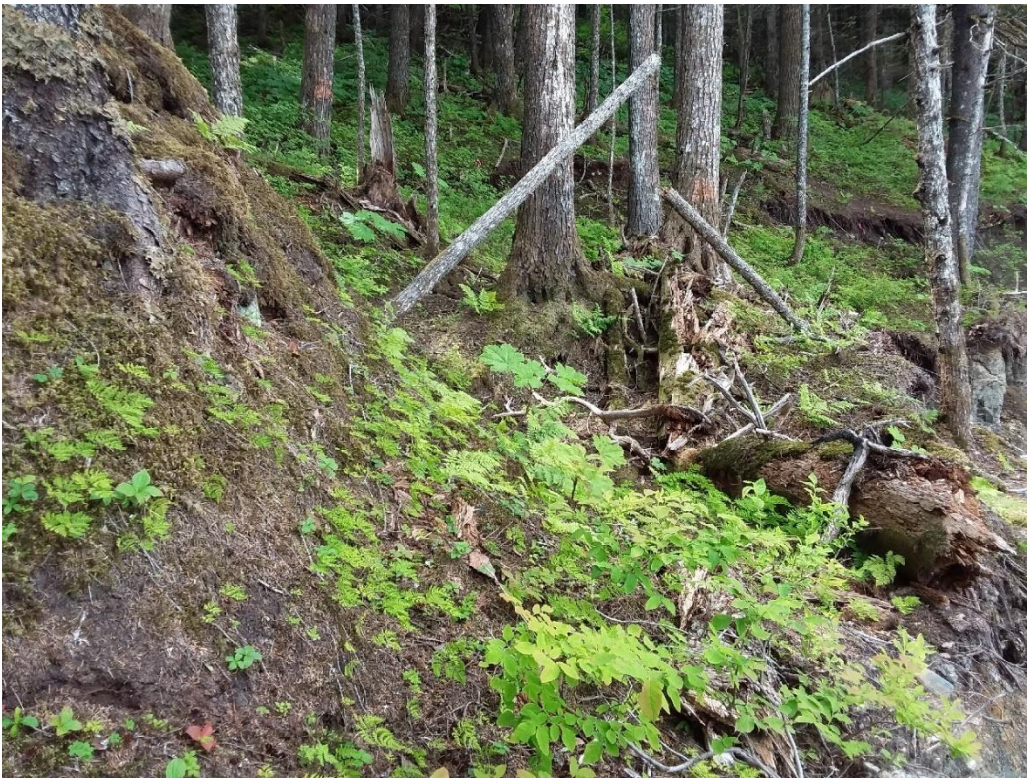
Additional tension cracking was observed adjacent to the upper eastern lateral scarp. One tension crack has azimuth orientation of 035 to 040°, and extends from elevation 840 to 875 feet where it terminates within 20 feet of the east tension crack (Photo Exhibit 21). A second crack at approximate elevation 745 to 760 feet is approximately 45 feet long (Photo Exhibit 22). These north-south trending cracks appear to be a result of relaxation of materials exposed in the eastern lateral scarp into the main body of the slide due to the loss of lateral confinement or support from materials that slid.

A: Looking southwest along a tension crack that parallels the eastern lateral scarp (i.e. 035-040° azimuth).

B: Looking southwest along a tension crack that parallels the eastern lateral scarp (i.e. 035-040° azimuth).

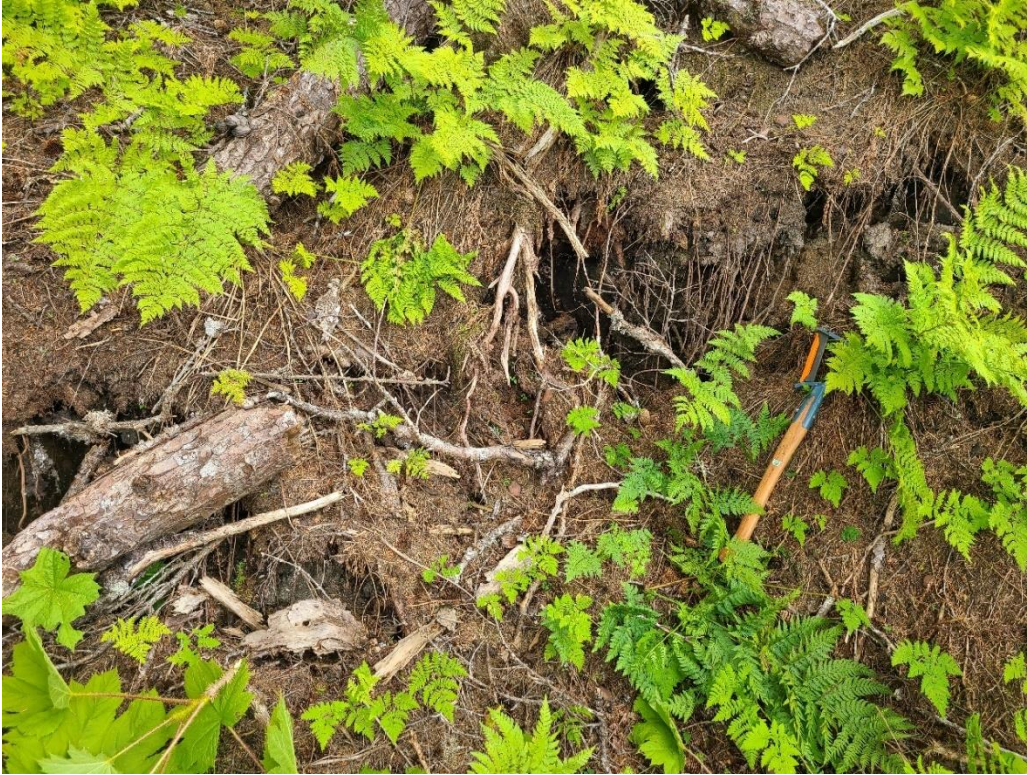
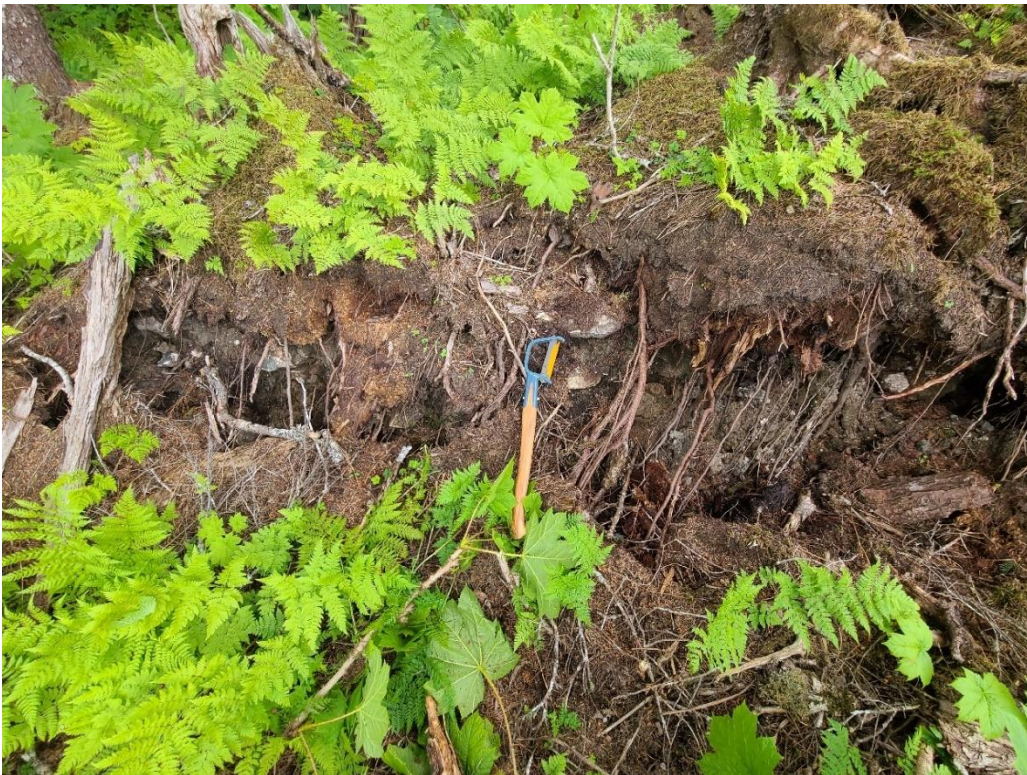
A: Looking south at a tension crack adjacent to the eastern lateral scarp near elevation 745 feet.

B: Looking south at a tension crack adjacent to the eastern lateral scarp near elevation 745 feet.

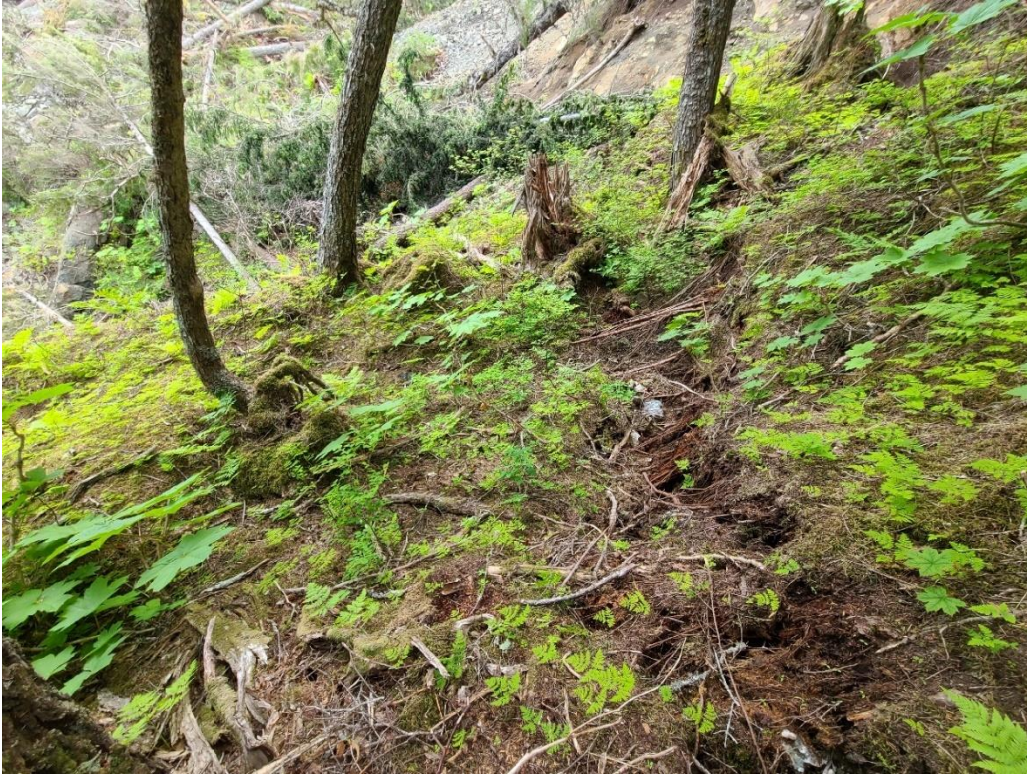
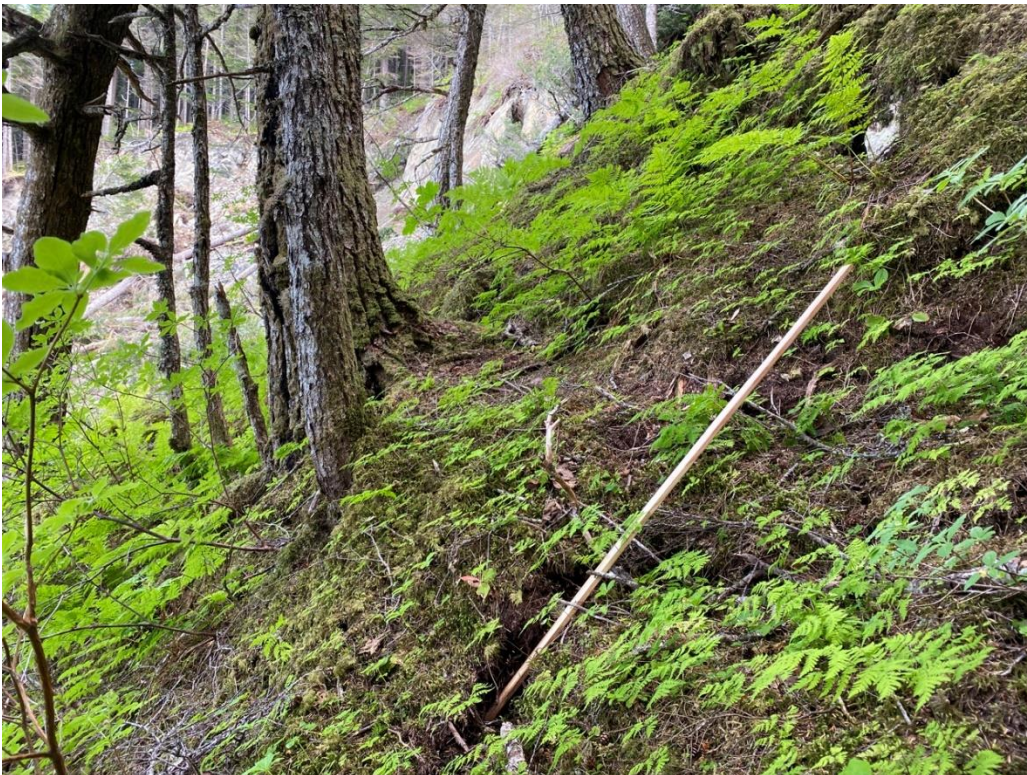
An arcuate tension crack was also observed on the western side of the upper rock slump, extending from approximate elevation 735 to 810 feet (Photo Exhibit 23). At the headscarp the western tension crack had 3 to 4 feet of vertical displacement and 1 to 2 feet of horizontal displacement, and the displacement decreased along the length of the crack as it extended to the northwest and rotated around a rock slump. This ground cracking appears to be a similar process as the tension cracking on the eastern flank, in that the materials at this location along the western flank are part of a local, steep-sided, slump block.

A: Looking east along the west tension crack adjacent to the western lateral scarp.

B: Looking northeast along the west tension crack.

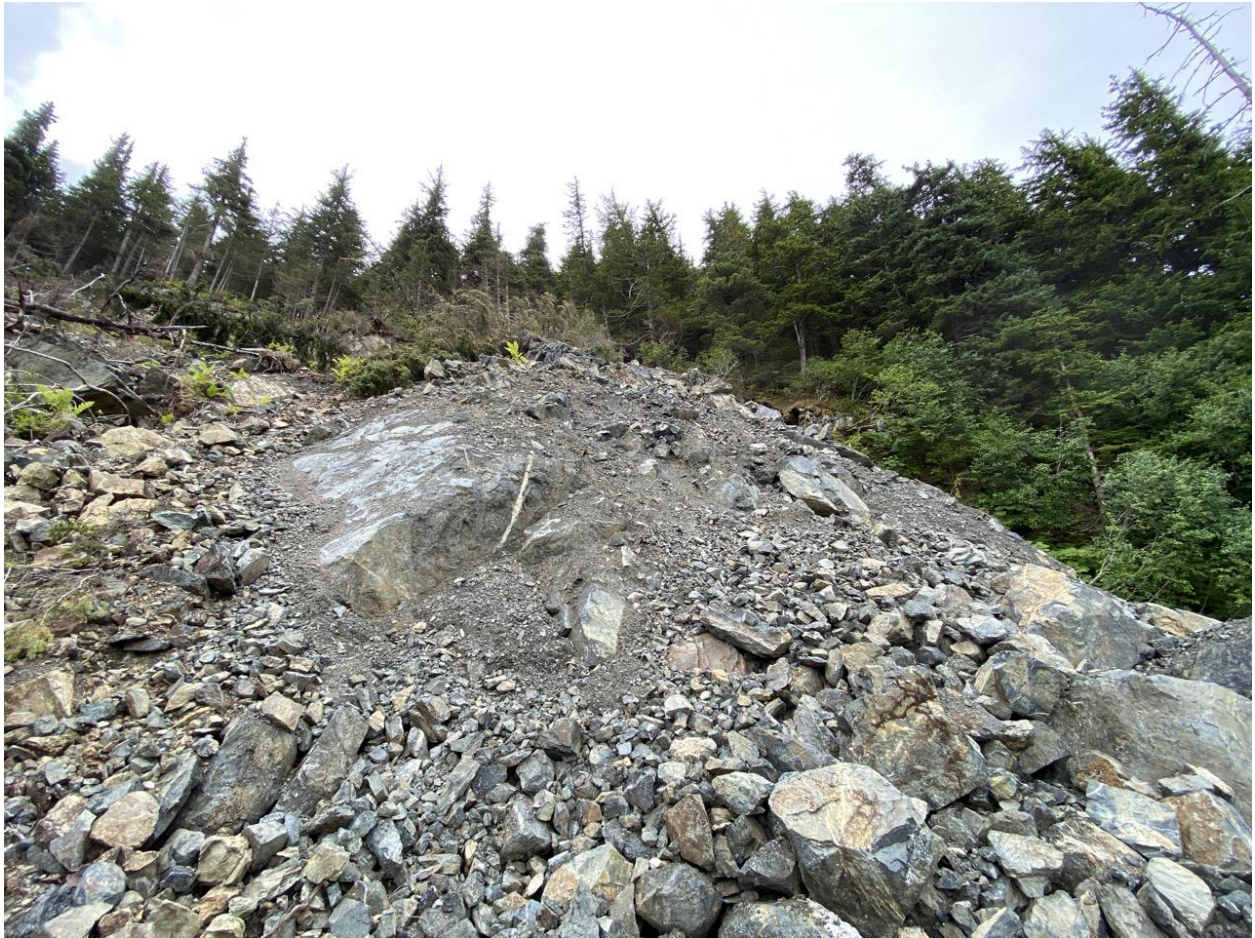
Looking south at a dilated slump block adjacent to the western lateral scarp near elevation 670 feet.

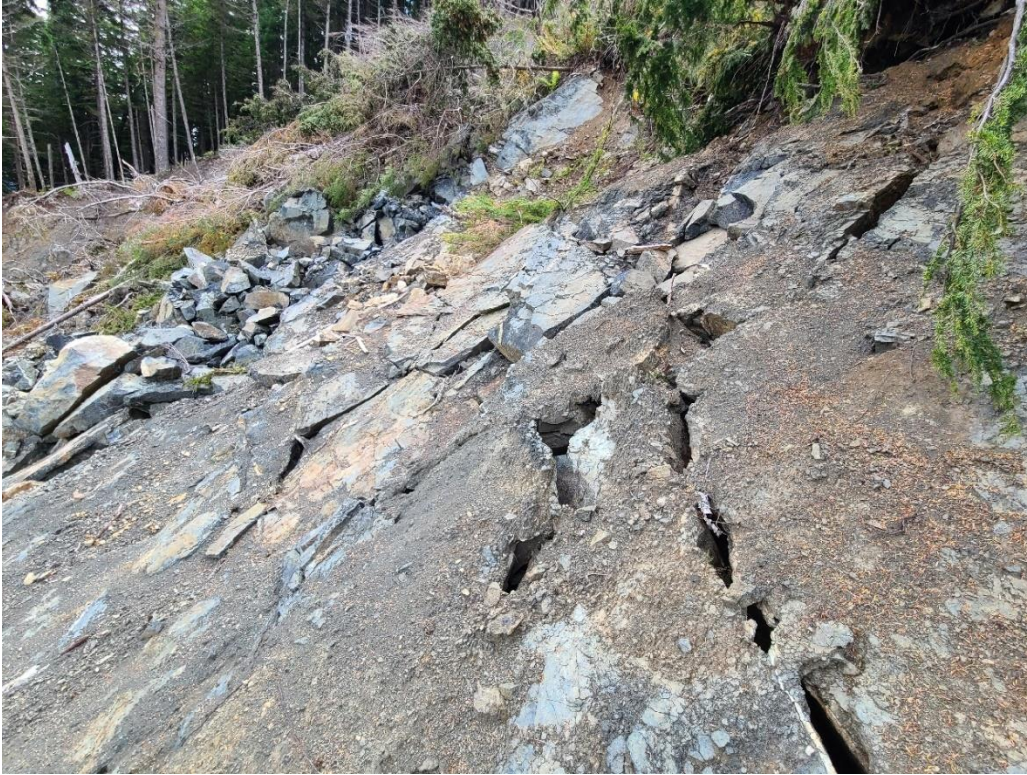
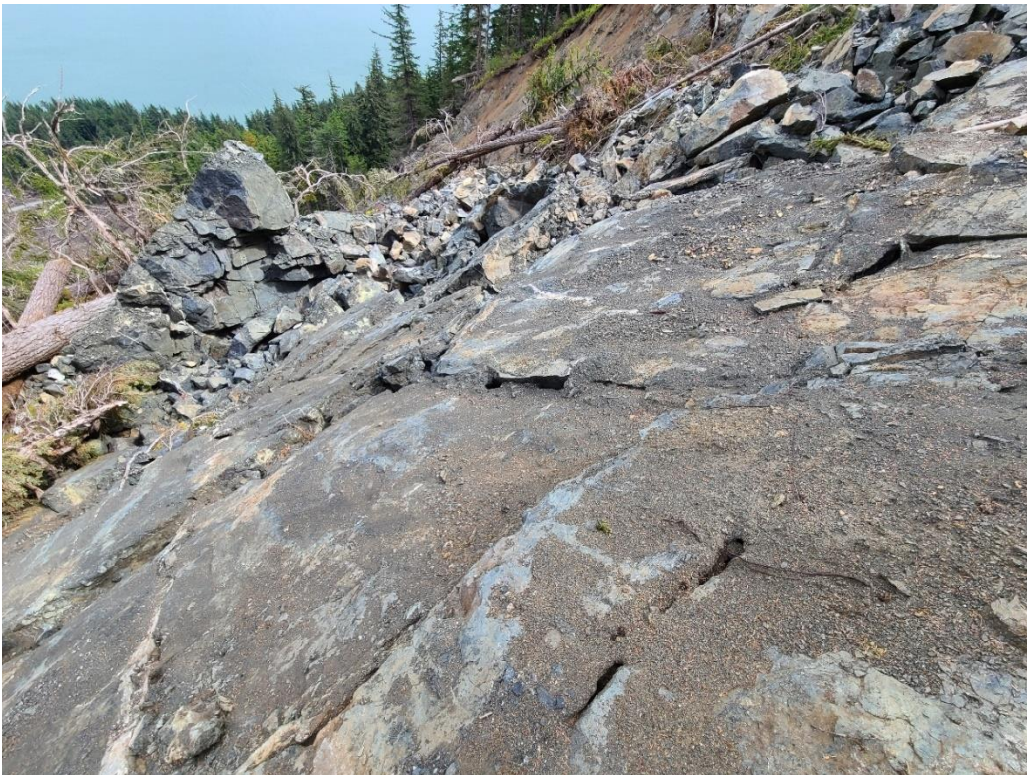
A: Looking east at a dilated rock block in the central portion of the slide near elevation 730 feet.

B: Looking northeast at a dilated rock block in the central portion of the slide near elevation 730 feet.

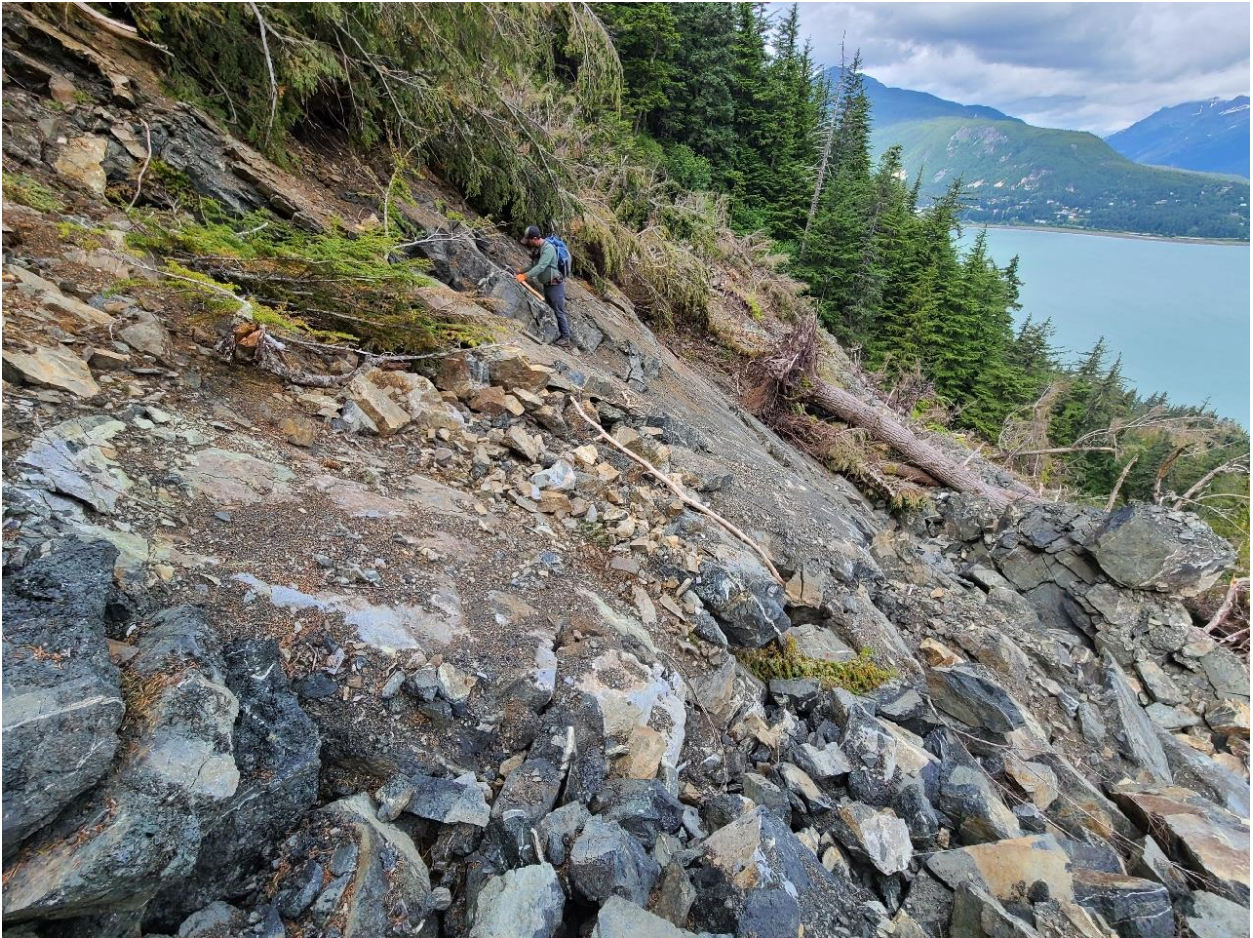
Looking west at a dilated rock block in the central portion of the slide near elevation 730 feet.

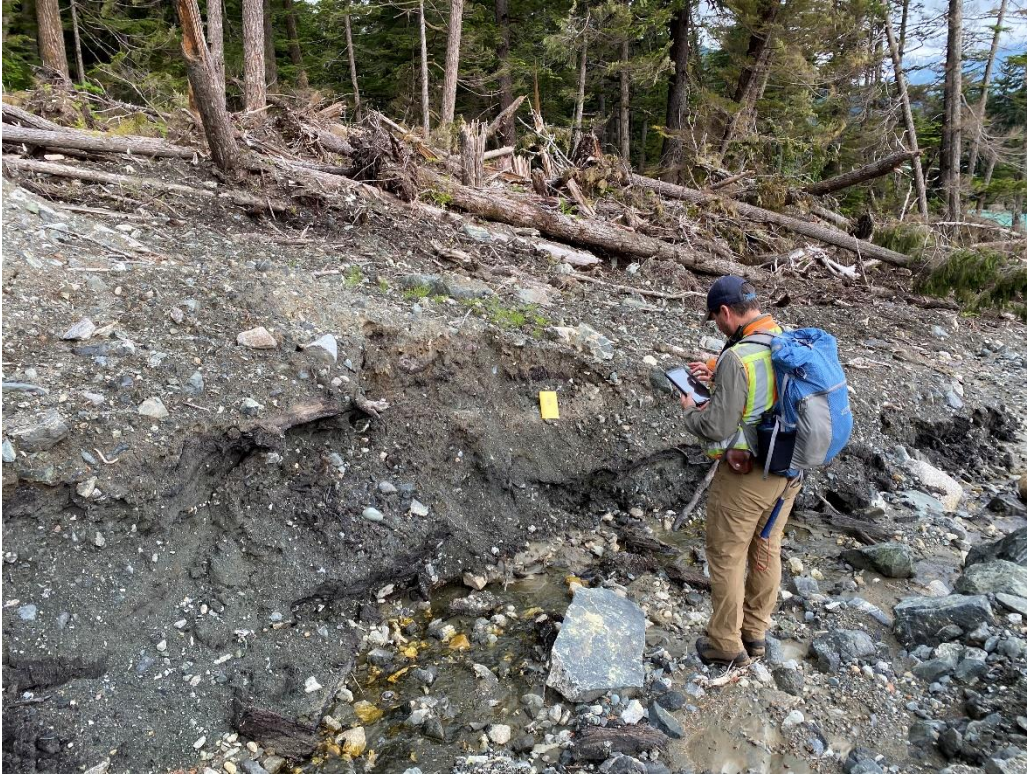
A: Looking west at exposed slide debris and pre-existing ground in the western lateral extents on the lower portion of the slide.
