Memo To: Aaron Banks, C.P.G. 2925-5.1  
R&M Consultants, Inc.  
From: Ben George, P.E., C.E.G.  
Charlie Hammond, C.E.G.  
Noah Kimmes, P.E., P.G.  
Landslide Technology  
Date: September 8, 2021  
**Subject: Spring Surface Reconnaissance Memo**  
**Haines Beach Road Landslide – NTP2 Task 5.1**  
**PSA Agreement No. 25213018, IRIS No. SDRER00317**

This memo is a deliverable for the Task 5.1 Spring Reconnaissance work conducted for the Haines Beach Road Landslide. It includes a brief summary of the field results and opinions on risk associated with the geohazards within the Haines Borough Area of Concern (AOC). Further evaluation and assessment of this data will be performed as the project progresses, additional data is collected and summarized, and the Findings Report is updated.

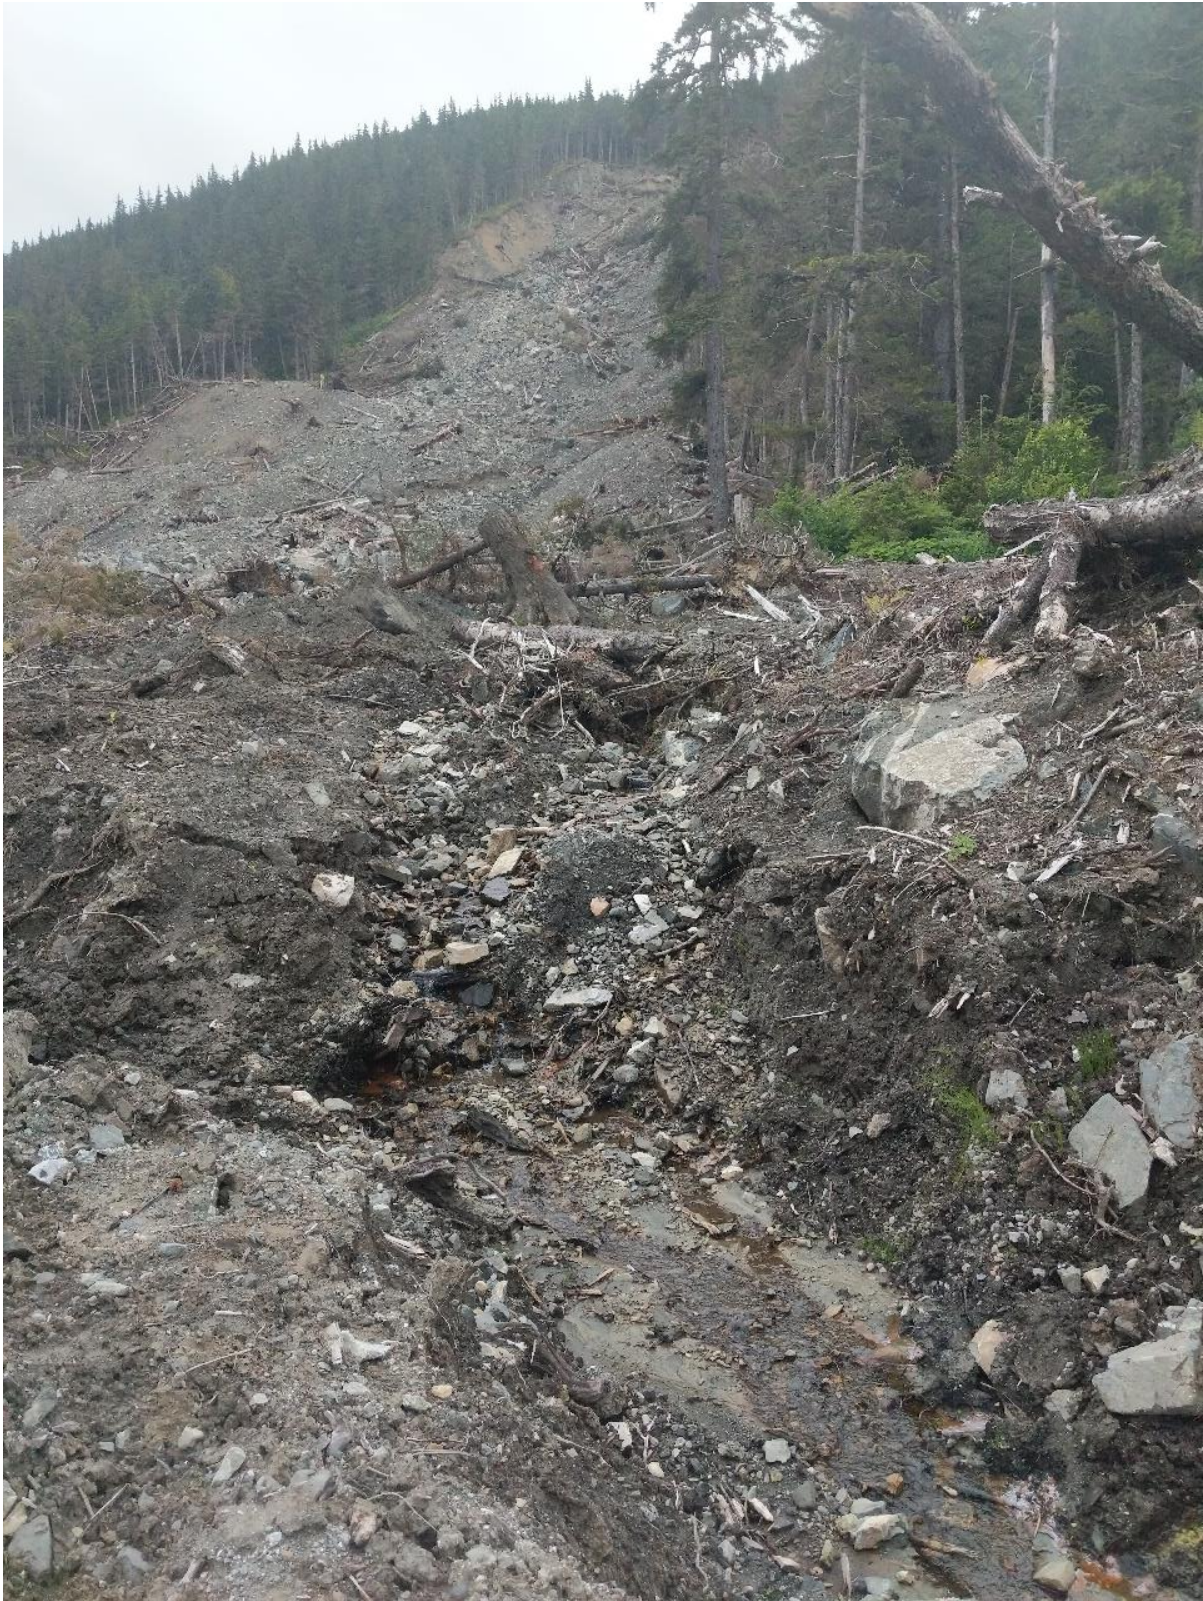
Looking south along the path of surface runoff along the western side of the slide.

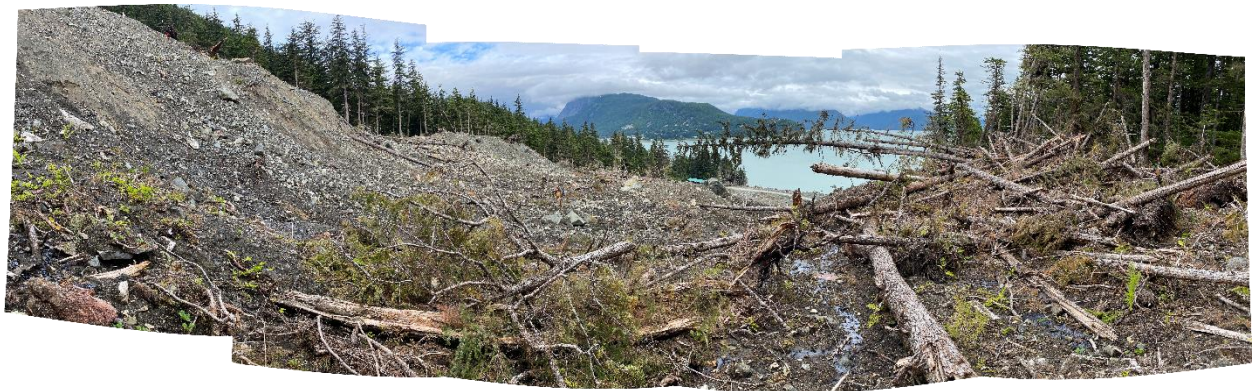
B: Panorama looking northeast from a high groundwater area on the lower bench.

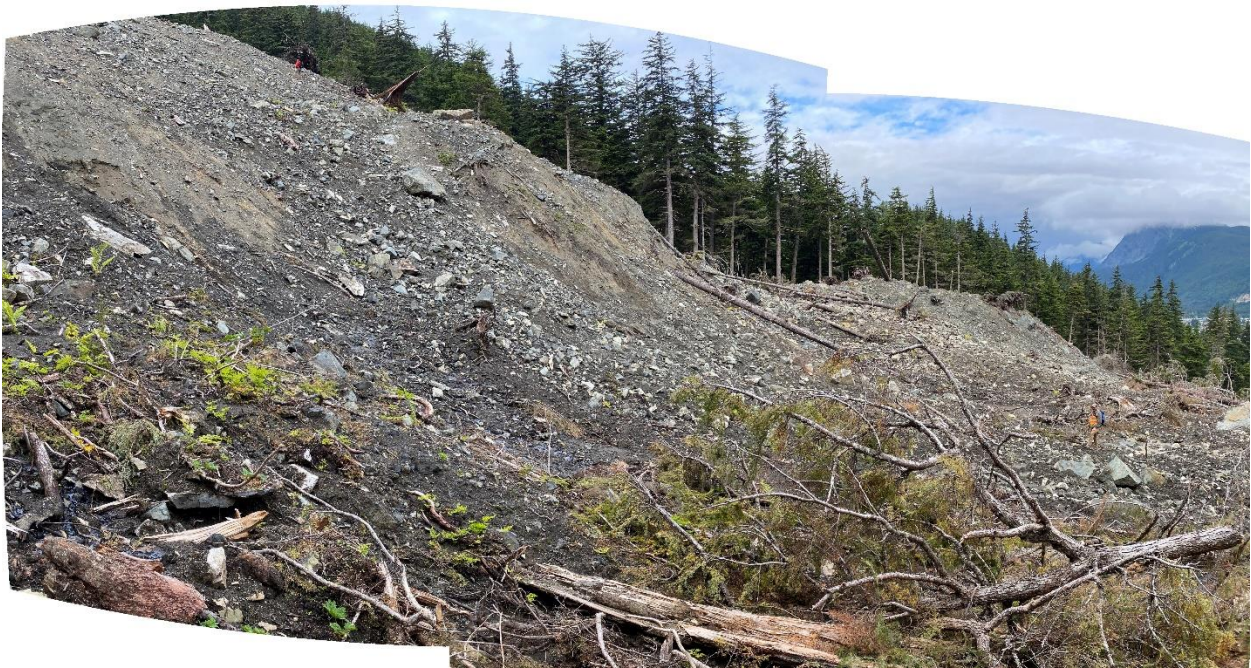
Looking west at scoured soil (middle ground center and left) between gravel and boulder debris deposits on the slope above the lower Mt. Riley Road extension bench.

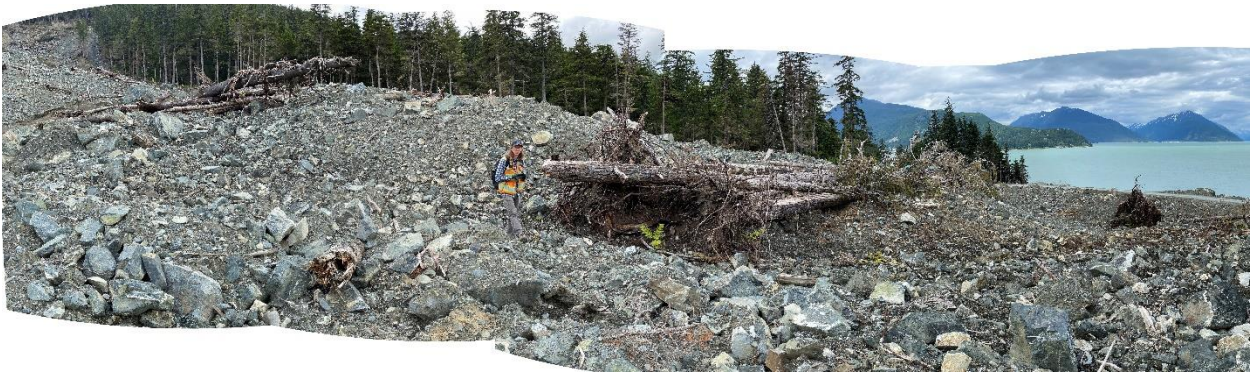
Pressure ridges observed within the lower debris flow deposits are convex downslope or lobate-shaped (Photo Exhibit 35). The pressure ridges range in height from less than 1-foot and up to approximately 10 feet, and are distributed between approximate elevation 110 and 200 feet. The pressure ridges indicate that in the late stage of the flowing debris, it encountered increasing resistance as it moved downslope (and eventually stopped), or there was a limit to materials that could maintain the load and movement.

Lobe in lower debris flow, and low-height pressure ridge in the foreground left.

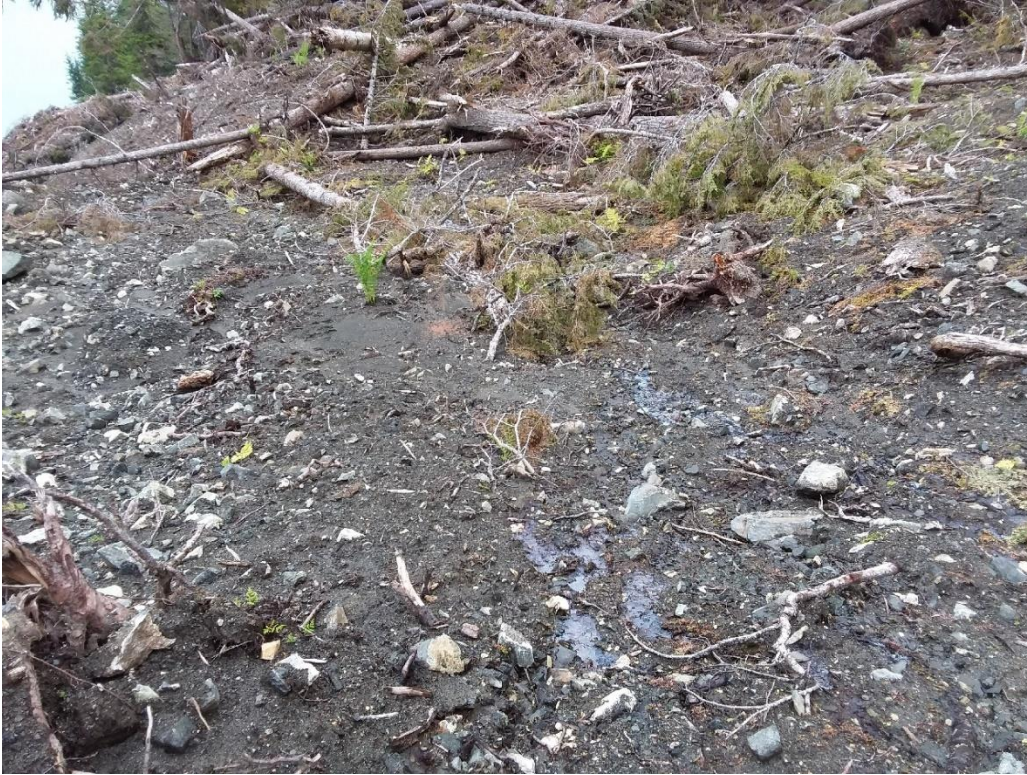
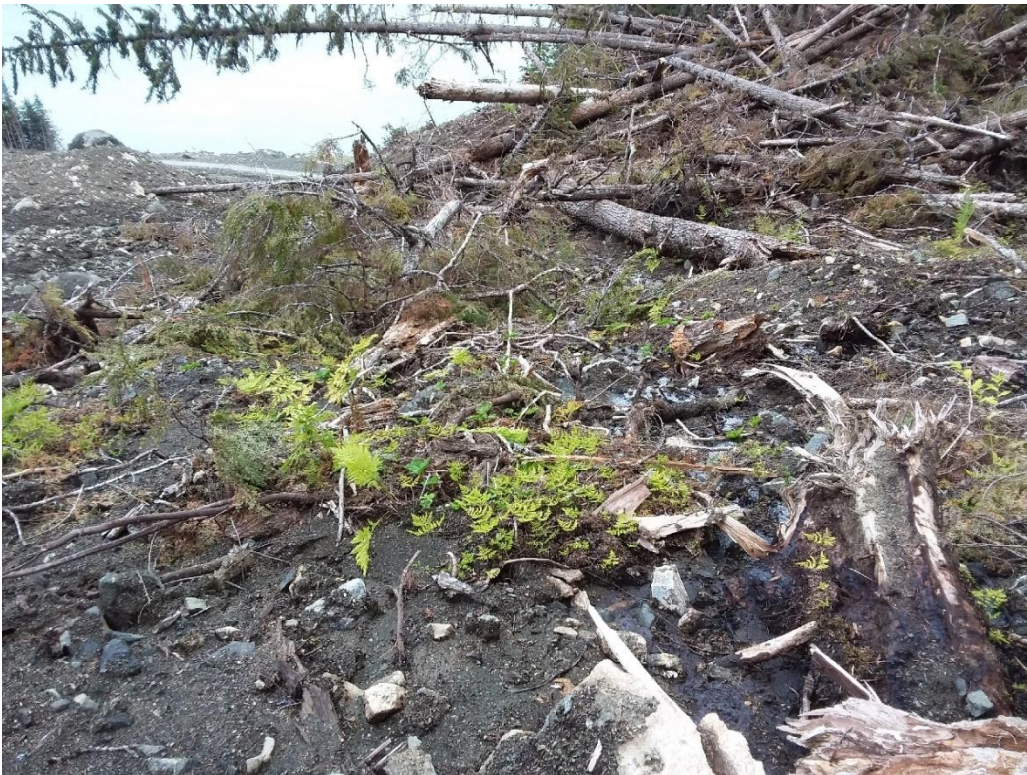
A smaller surface flow was observed on the eastern side of the slide (Photo Exhibit 30, 33 and 36). This flow appears to be capturing water from two or more seepage points and was less than 5 gpm near their source at the time of our site visit in July 2021 (Photo Exhibit 36). This flow also gains volume as it proceeds toward Beach Road.

A: Looking south at a seepage point above flow near the eastern side of the slide near elevation 280 feet.

B: Looking north at a seepage point above flow near the eastern side of the slide near elevation 280 feet.
