Winter Reconnaissance - Preliminary Findings Report Beach Road Landslide, Haines, Alaska

**WINTER RECONNAISSANCE
PRELIMINARY FINDINGS REPORT**

**BEACH ROAD LANDSLIDE
HAINES, ALASKA**

April 8, 2021

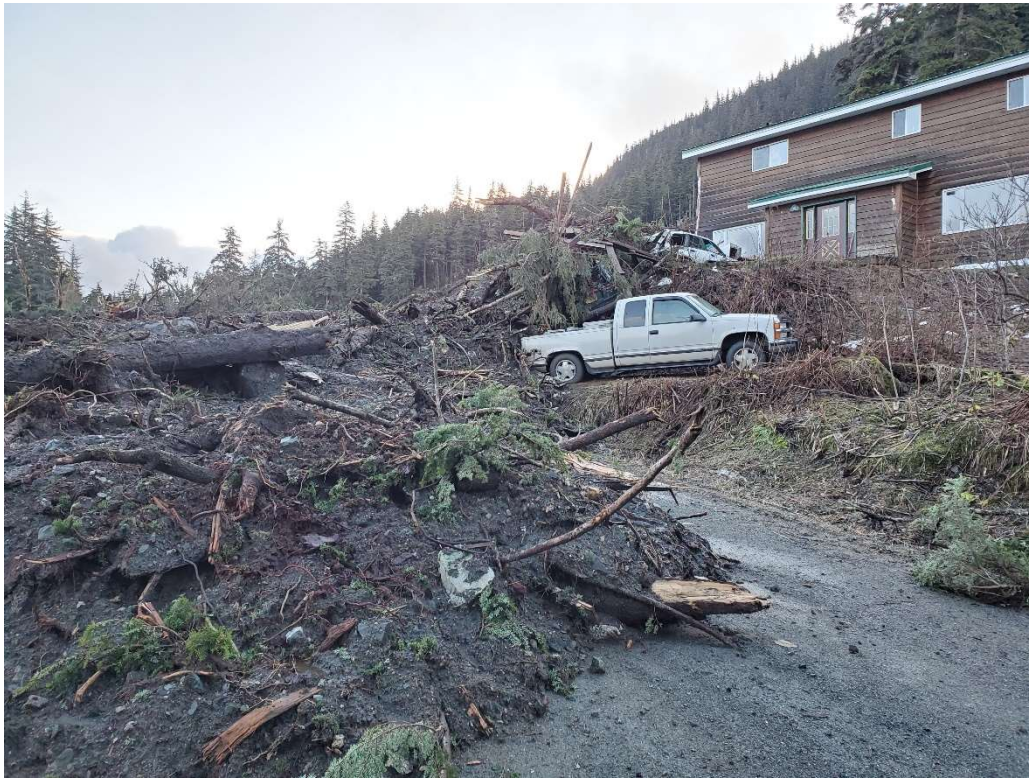
View looking southeast at landslide debris and damage to the Messano property (from Haines Avalanche Center, taken 12/9/2020).

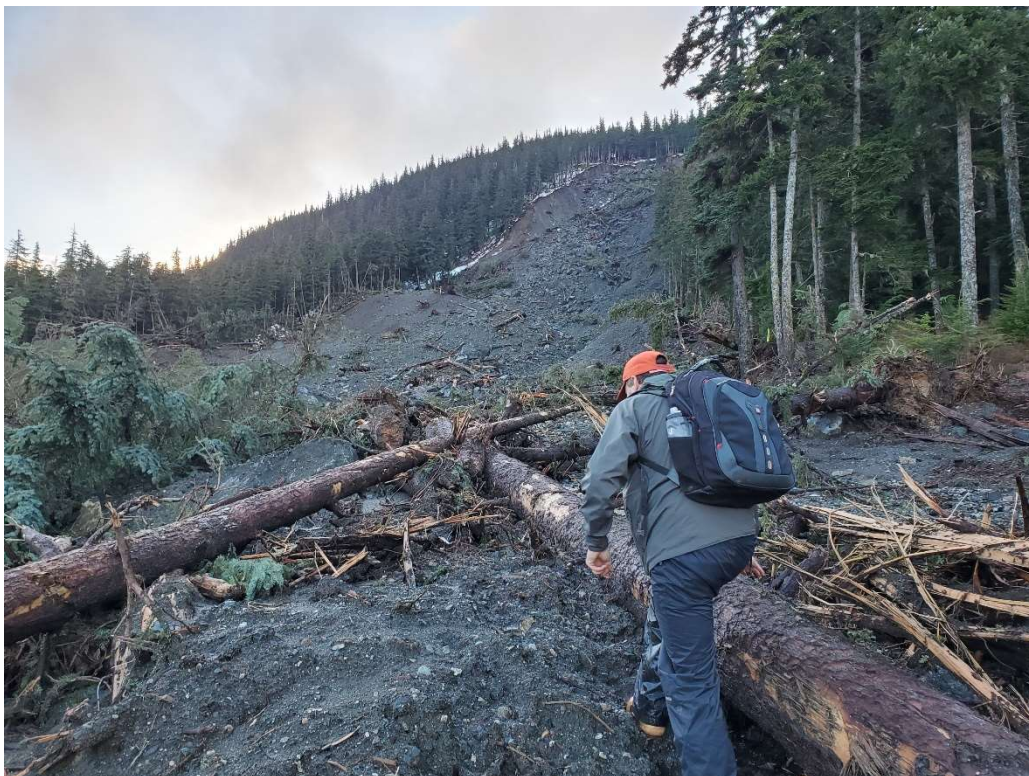
View looking at landslide debris near the western edge of the landslide (from Haines Avalanche Center, taken 12/9/2020).

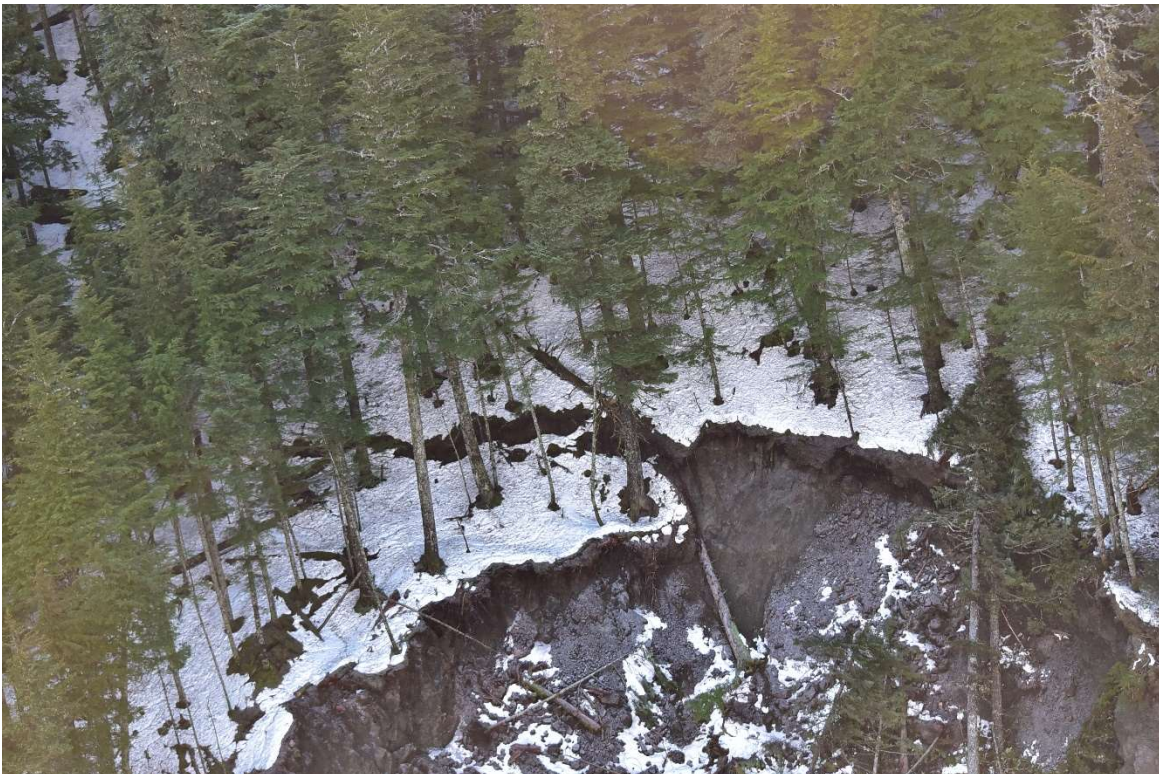
Aerial view looking south at the headscarp area (from Haines Avalanche Center, taken 12/9/2020). Note ground cracks extending east of the headscarp area.

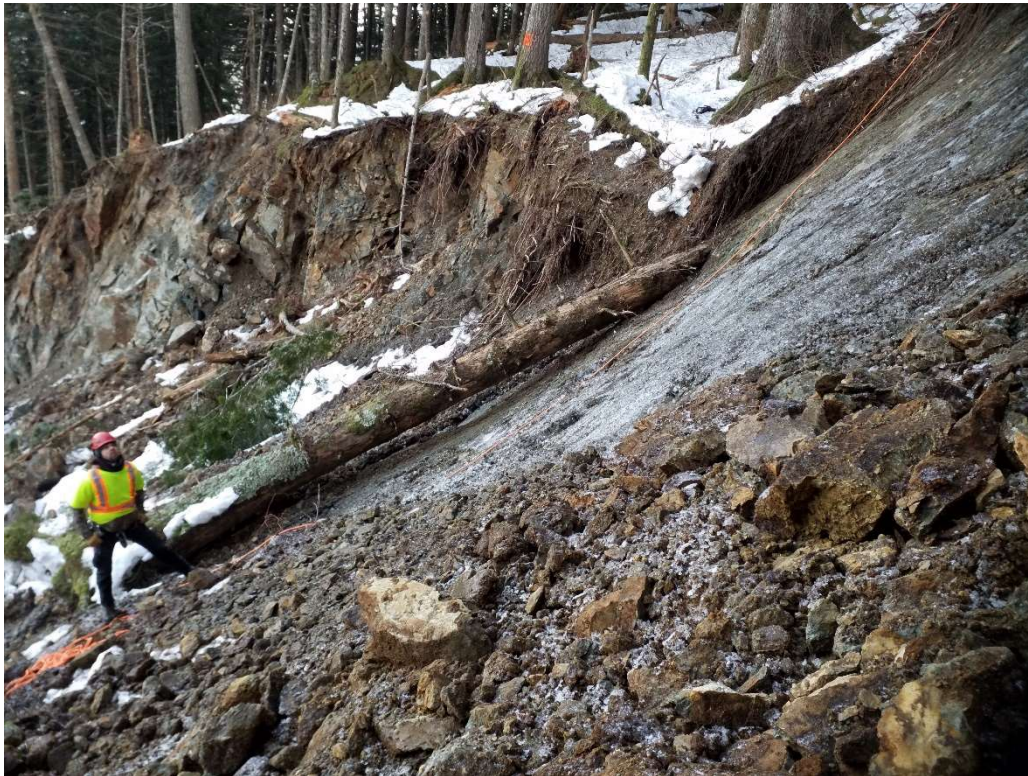
View looking east at bedrock exposed in the headscarp (from DGGs, taken 12/12/2020).

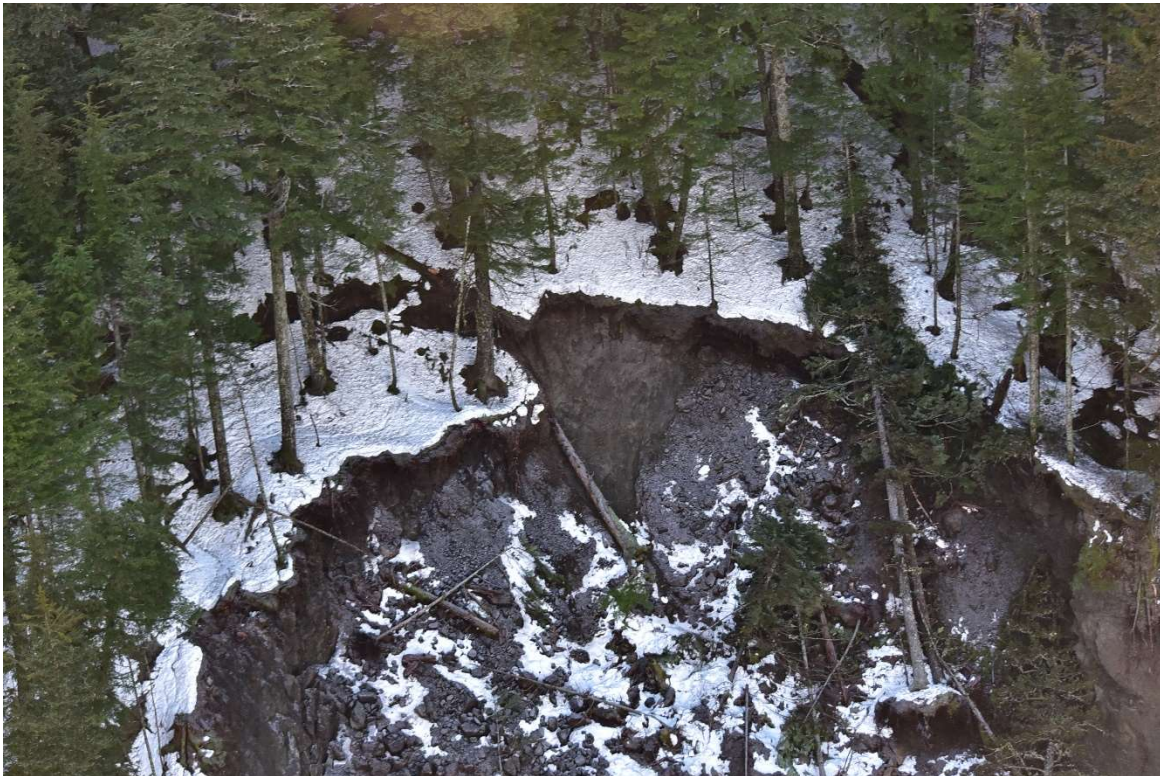
Aerial view looking south at crack extensions east of the headscarp area (from Haines Avalanche Center, taken 12/9/2020).

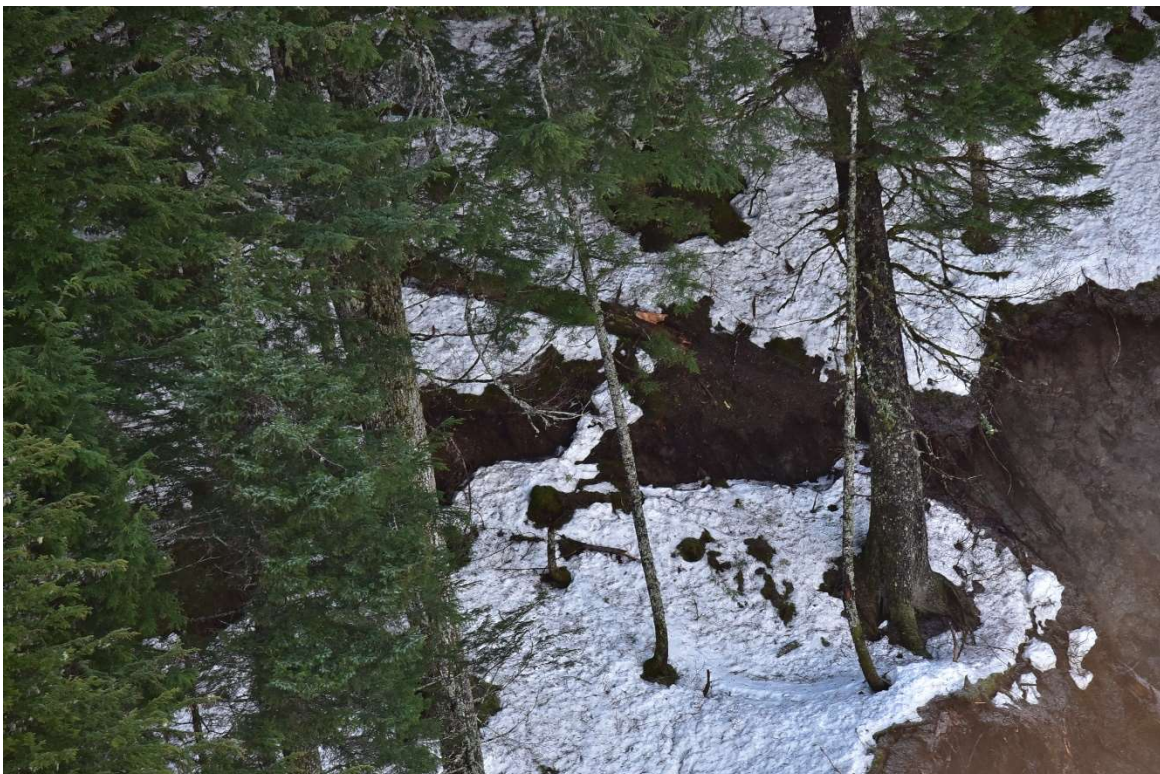
Close up view looking south at crack extensions east of the headscarp area (from Haines Avalanche Center, taken 12/9/2020).

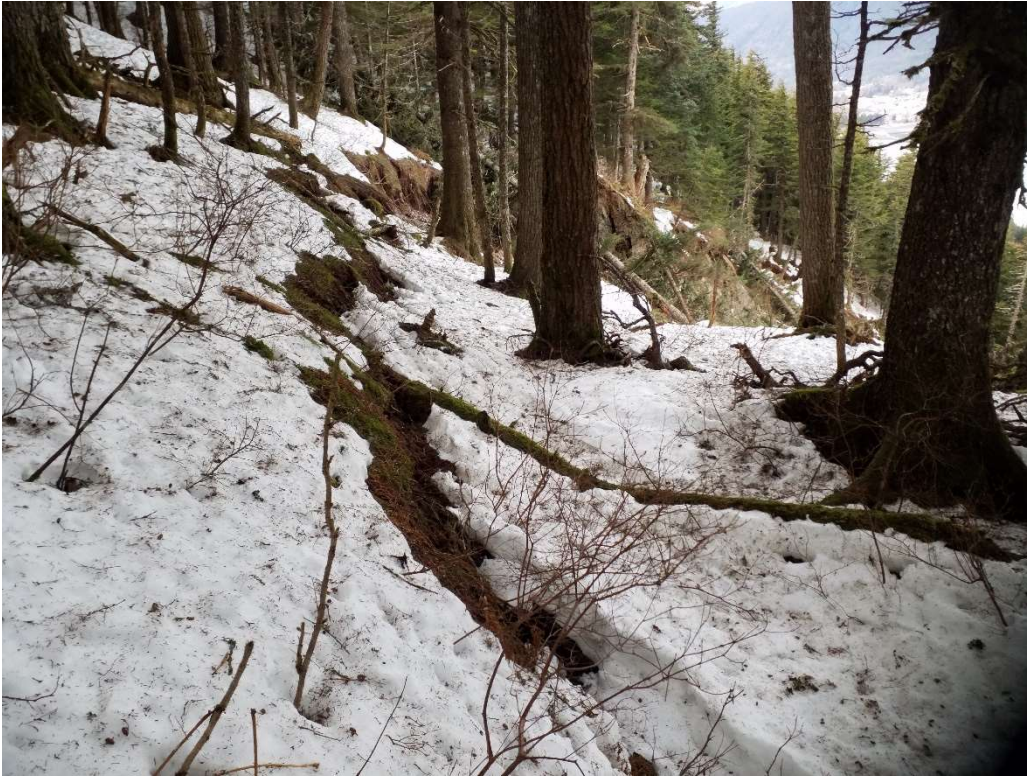
View looking west at easternmost extension of ground cracks east of the headscarp (from DGGS, taken 12/11/2020).

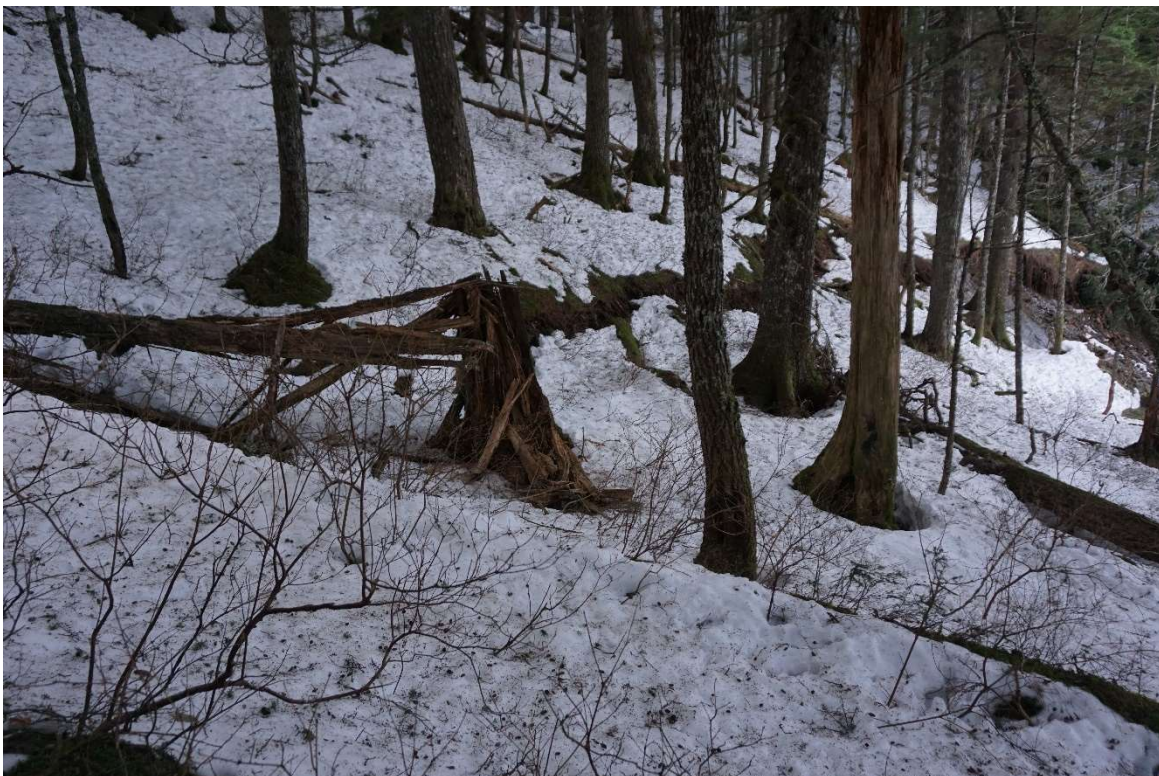
View looking southwest at easternmost extension of ground cracks east of the headscarp (from DGGS, taken 12/11/2020).

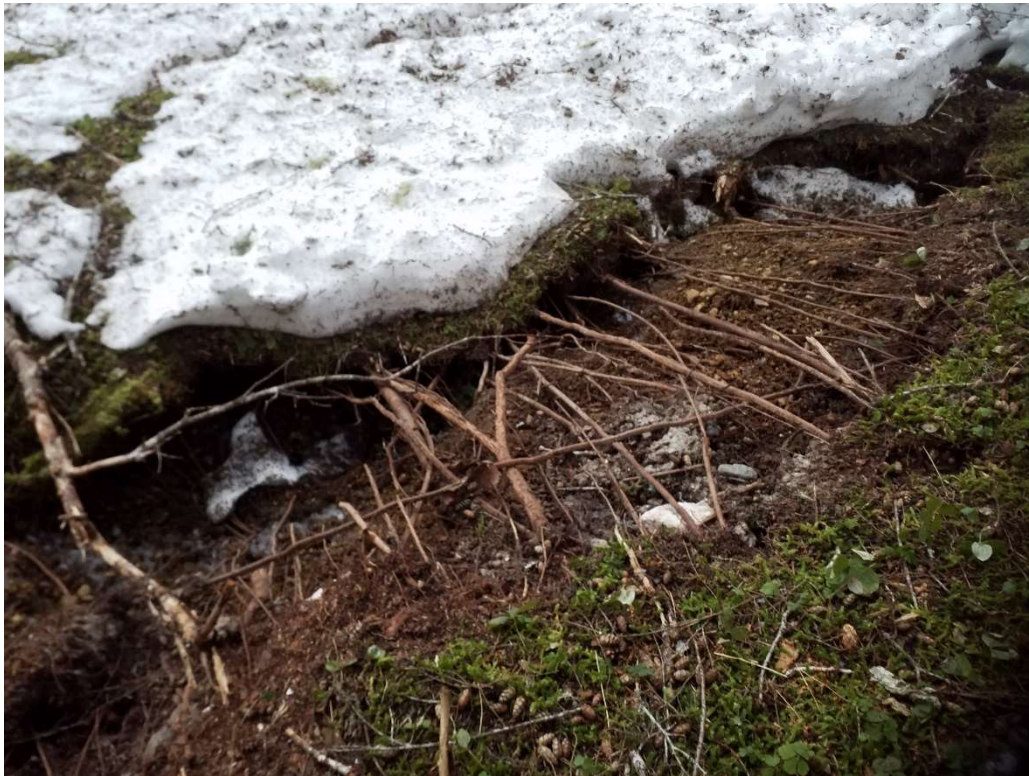
Close up view of ground cracks east of the headscarp (from DGGS, taken 12/11/2020).

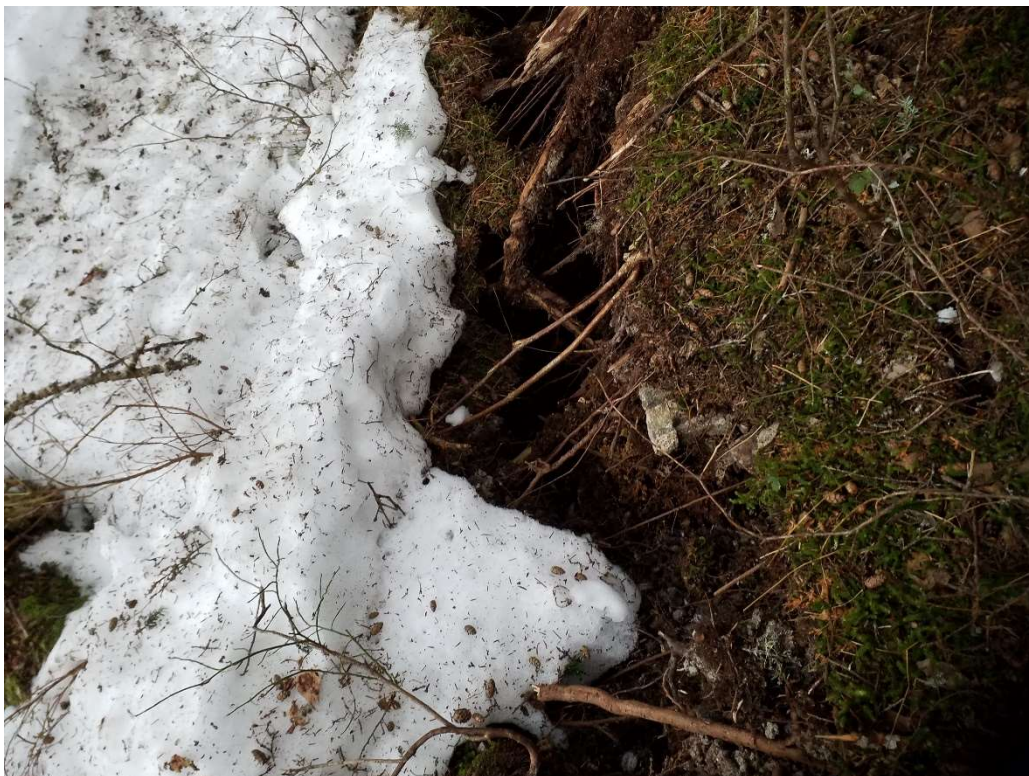
Close up view of ground cracks east of the headscarp (from DGGS, taken 12/11/2020).

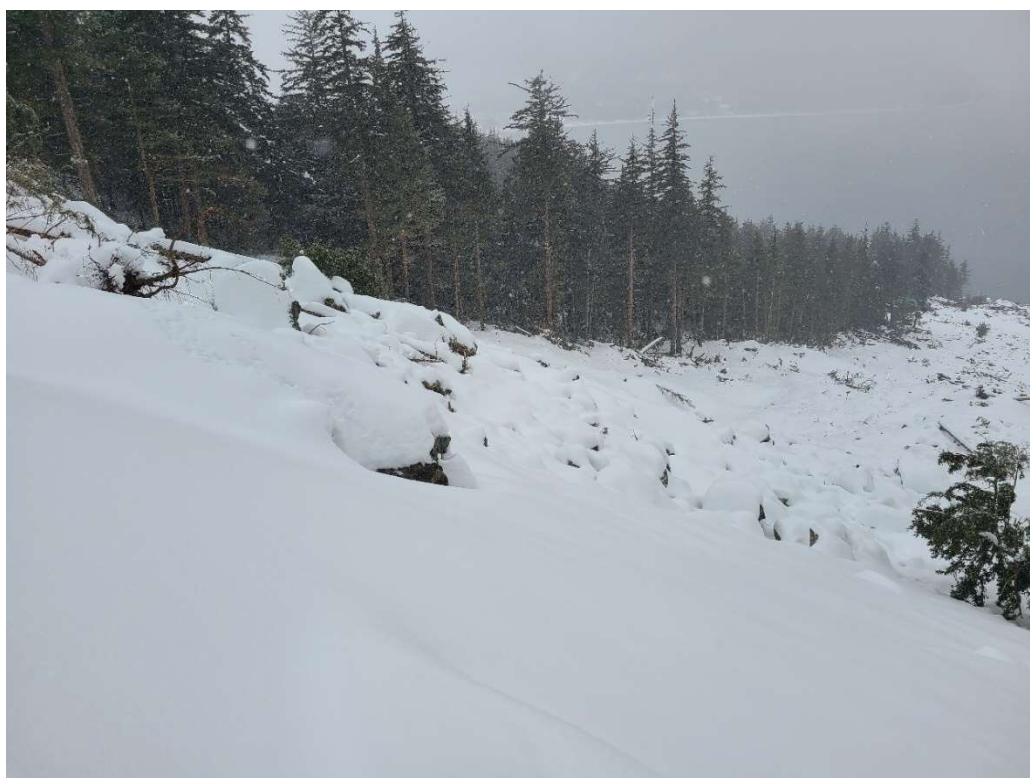
View looking southeast at rock outcrop on the western flank of the slide near elevation 550 feet (taken 2/23/2021).

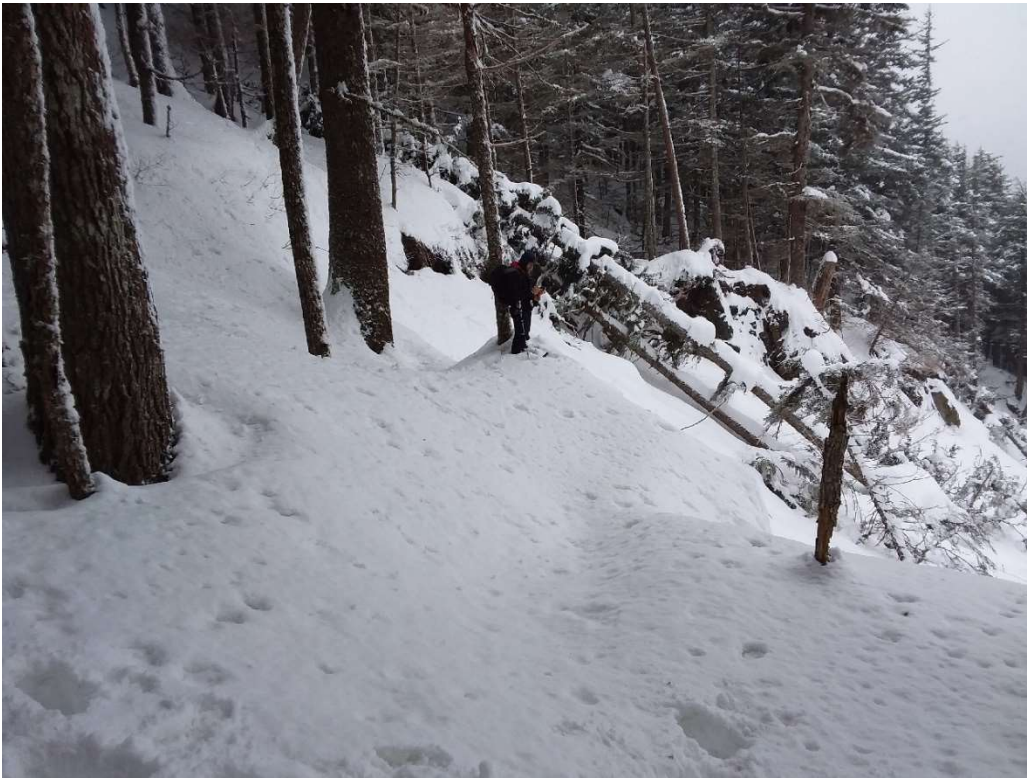
Photo of geotechnical engineer that fell into a possible void in the vicinity of the eastern ground crack extensions (taken 2/24/2021).

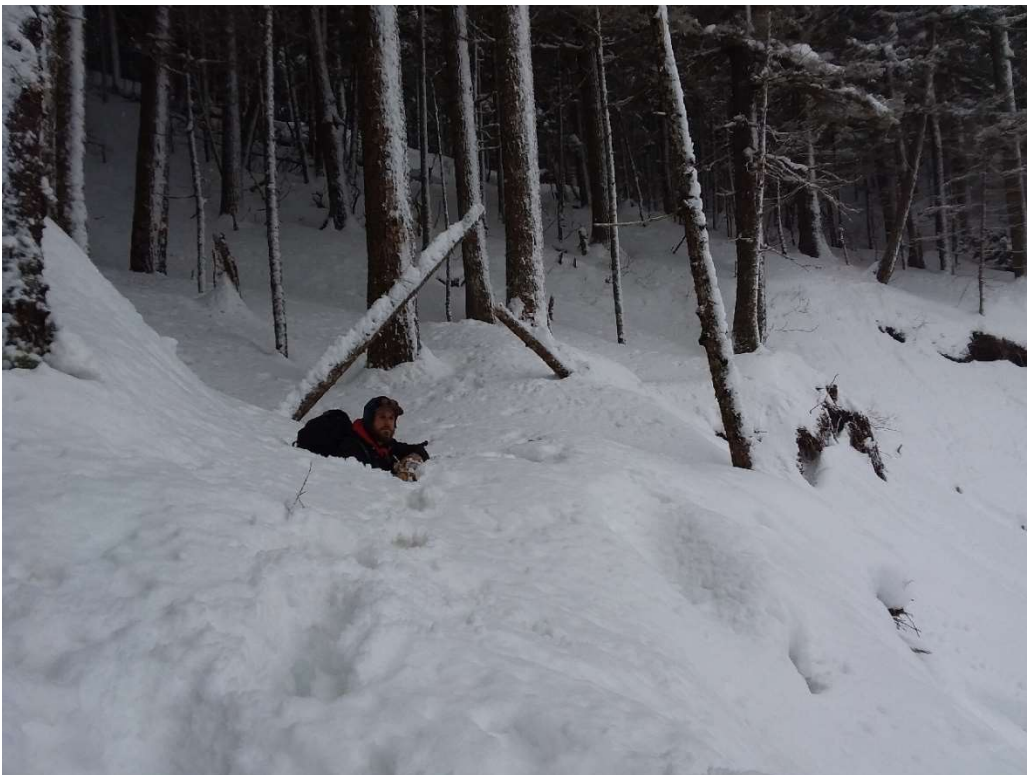
View looking north above the headscarp area. This area appears to be where concentrated surface water flowed into the headscarp area during the slide event (taken 2/24/2021).

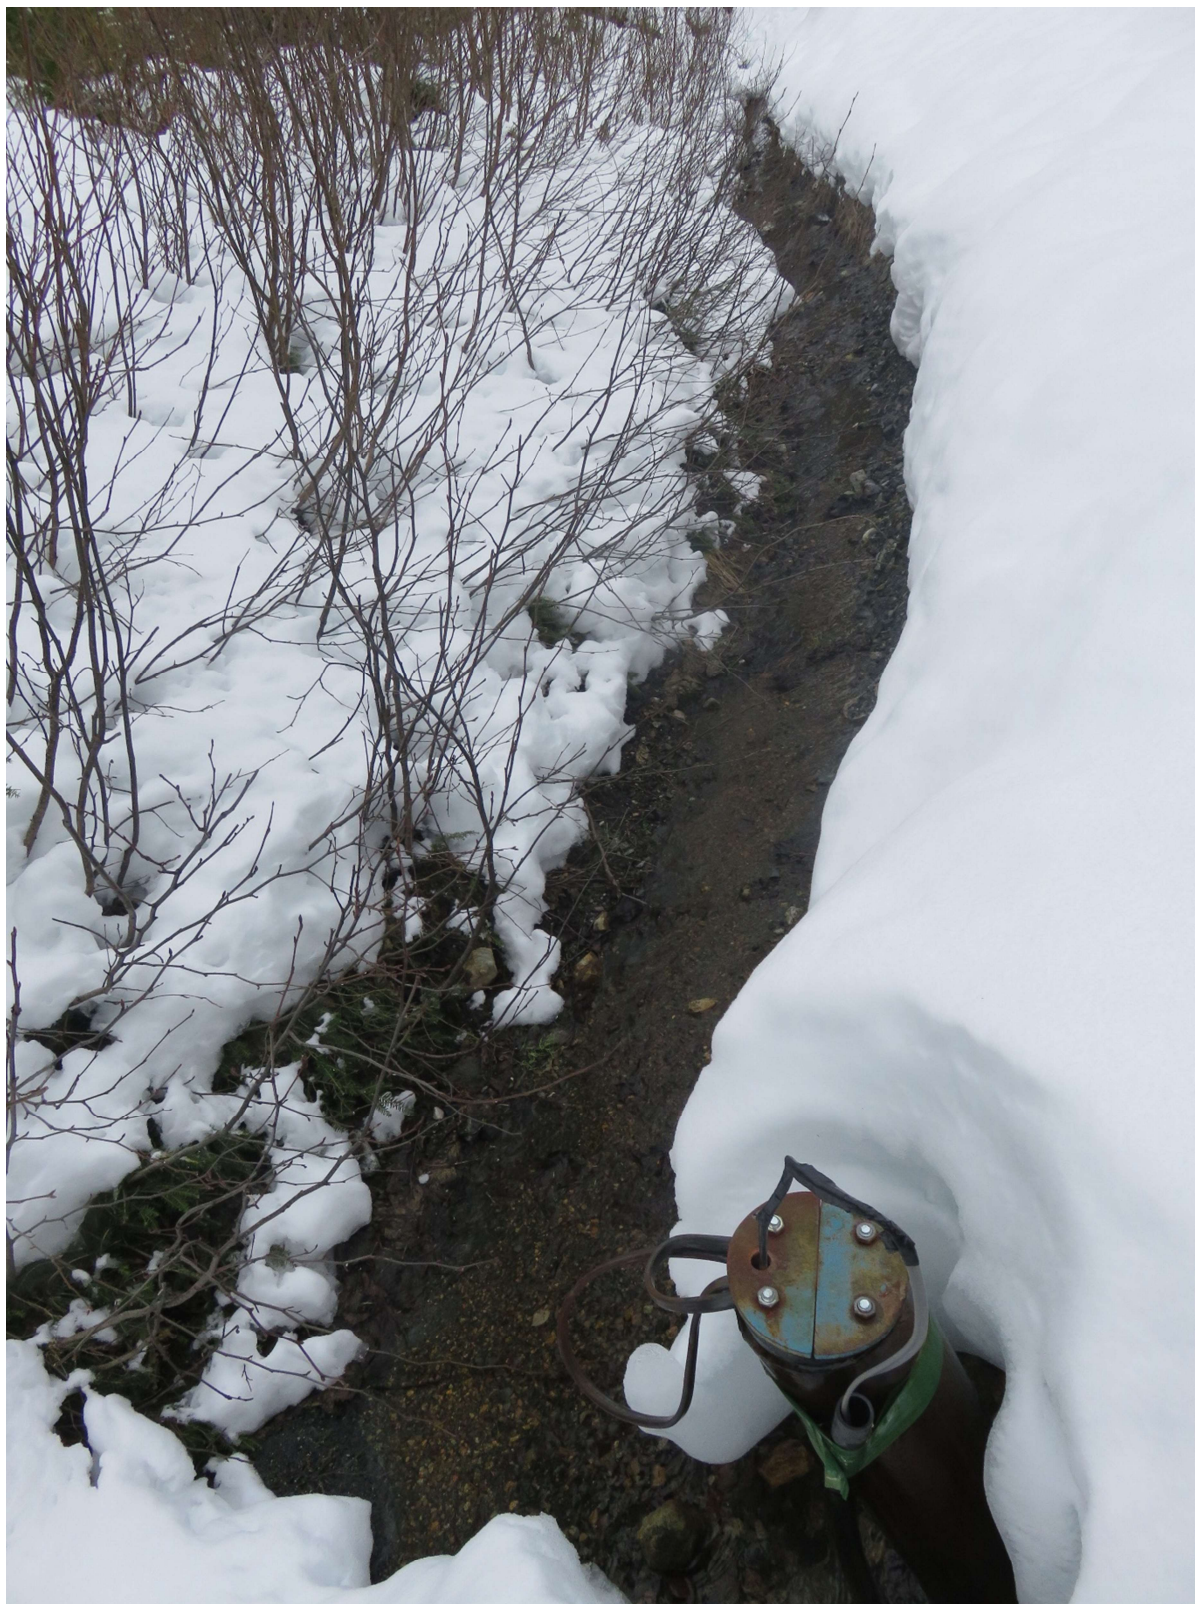
View of flowing artesian well at the Anderson Residence on east end of Beach Road (taken 2/26/2021).

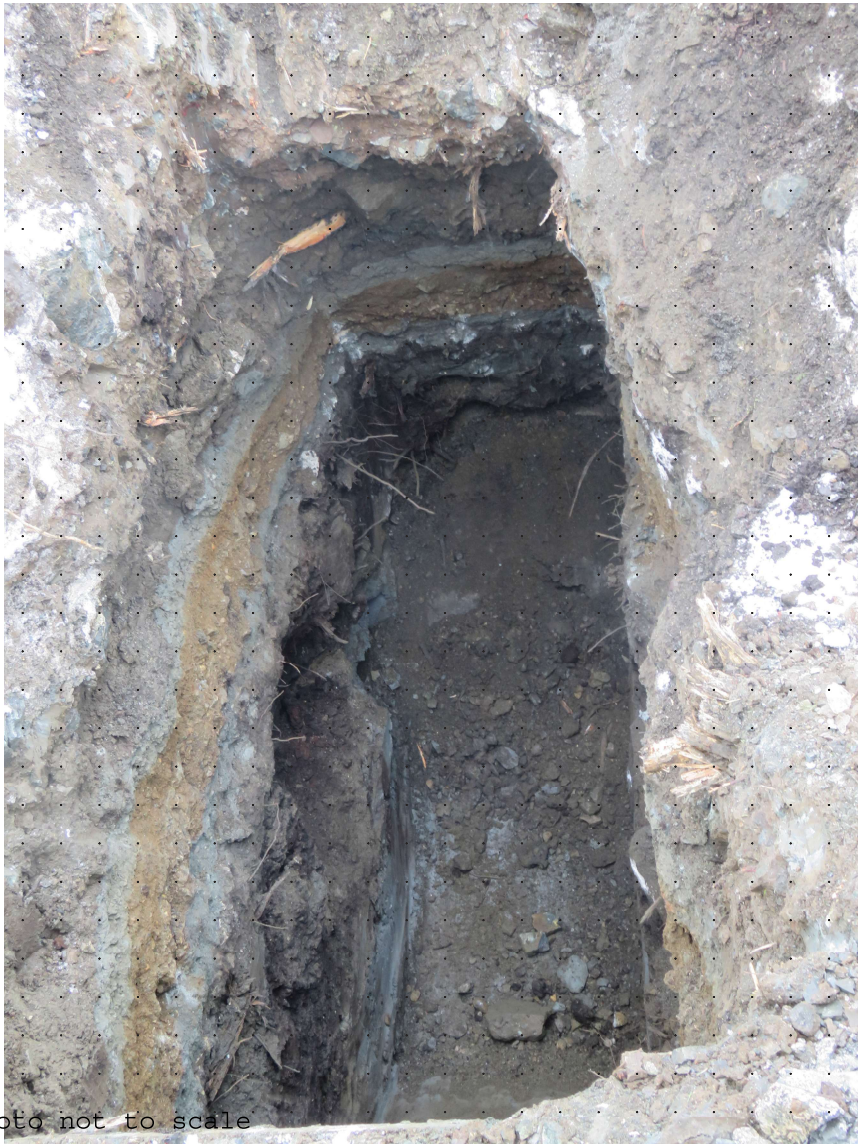
0	Top of TP is 1 ft below interim road grade elevation.
	~2 ft frozen ground.
2	~Hard excavation.
4	0 - 4.5 ft Very dense, grey, silty sand with angular rock fragments, gravel-sized up to 2 ft boulders; scattered woody debris and roots, moist (Landslide Debris).
6	5 - 5.5 ft. Grey, crushed rock, 1-in minus (Original Road Surface)
8	5.5 - 6 ft. Brown, sl. silty sand with scattered rounded gravels (Road Base - Fill). This material is underlain by 1 ft of grey, angular gravel (appears like road surfacing material).
10	7 - 8 ft Woody debris and roots inter-mixed with dark grey organic silt and sand (possible corduroy road?).
12	8 - 9 ft Loose to medium dense, brown, gravely sand, with round cobbles, moist. Rounded boulders up to 3 ft in size inter-mixed with these materials and overlying woody debris
14	(Delta Deposits/Till?)
16	9 - 18 ft Very stiff to Hard, grey, slightly sandy, v. silty clay; scattered rounded fine gravel, moist, slight lenses to no observable structure, no observable organics but organic smell
