Haines Borough Assembly Agenda Bill

Agenda Bill No.: 24-1361

Subject: Authorizing FEMA Appeal regarding
Porcupine Trail Road

A Resolution of the Haines Borough Assembly authorizing an appeal of the Department of Homeland Security's Federal Emergency Management Agency (FEMA) deobligation of funding in the amount of \$1,435,834.75 related to the permanent repair of Porcupine Trail Road and authorizing the Borough Manager to Contract with Birch Horton Bittner & Cherot for Consultation Services associated with review of appeal documents.

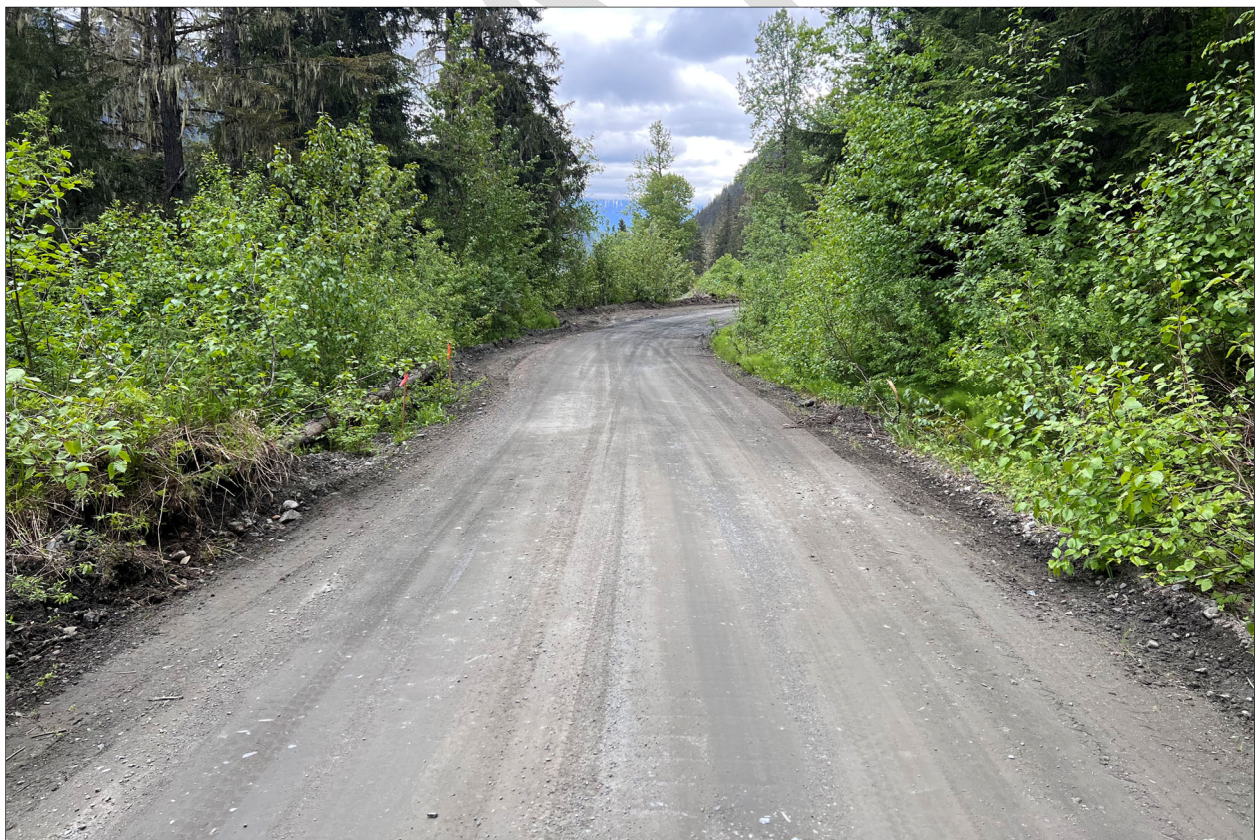
While all parties (the Borough and Porcupine Trail Road Users) have done their best over the years to keep up with routine maintenance, the road is plagued by vegetation encroachment, filling in of ditches with debris and vegetation, erosion, and potholing that one would expect of a remote gravel roadway within an Alaska temperate rainforest (see Figure 1 below).

Figure 1: A typical location of vegetation encroachment on roadway shoulders and in ditches on Porcupine Trail Road, taken 6/7/2023 prior to Applicant’s Phase 1 work. Source – Garret Gladsjo, proHNS.

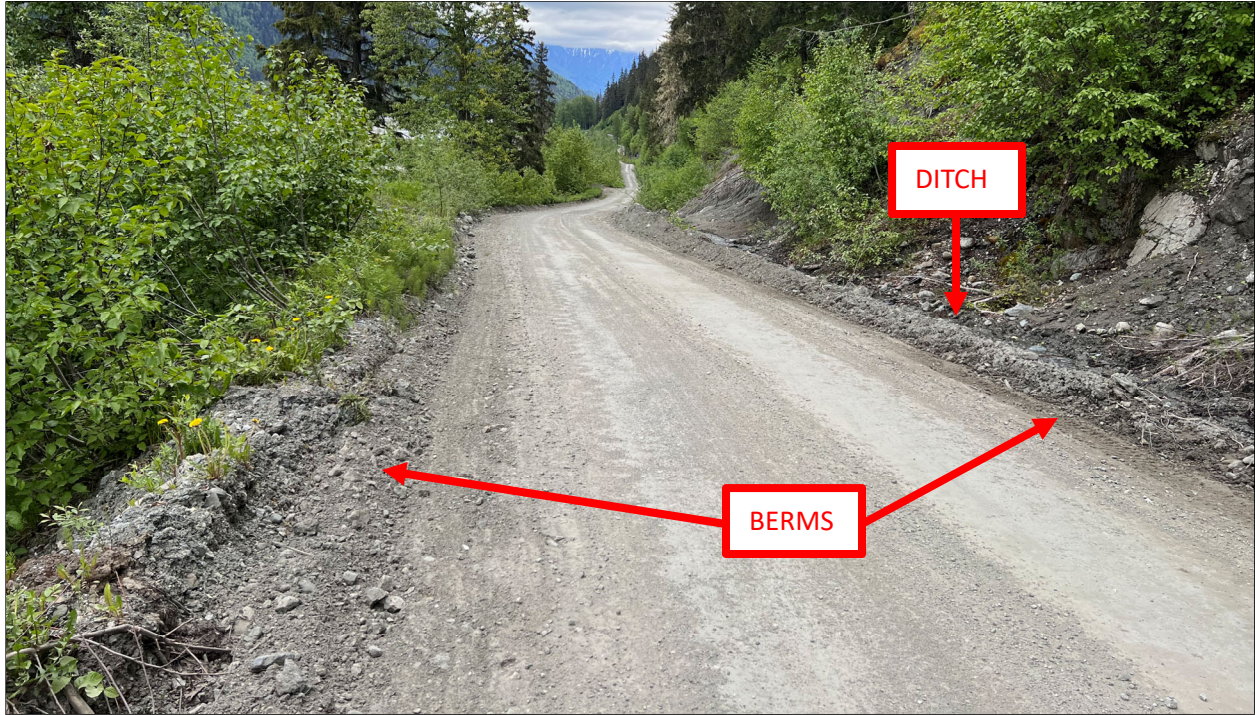
The 22-foot-wide measurement is a broad generalization of the SOW and is unrepresentative of the actual pre-existing site conditions. A gravel road is by nature unconfined, resulting in variable widths as determined by site constraints. Maintenance blading/grading of the roadway surface over the years had created berms along the roadway shoulders preventing drainage of surface storm water from leaving the roadway or entering adjoining ditches (see Figure 2 below), which Phase I work repaired through reconditioning of roadway shoulders and ditches. Existing roadway shoulders and adjoining ditches damaged by the December 2020 Storm Event were documented by FEMA during the August 26, 2021, site inspection (see Figures 3 and 4 below).

Figure 2: A typical location on Porcupine Trail Road showing vegetation encroachment on roadway shoulders and existing berms (the result of blading/grading maintenance) preventing drainage of storm water off roadway and/or to adjoining ditches, taken 6/7/2023 prior to Applicant's Phase 1 work. Source – Garret Gladsjo, proHNS.

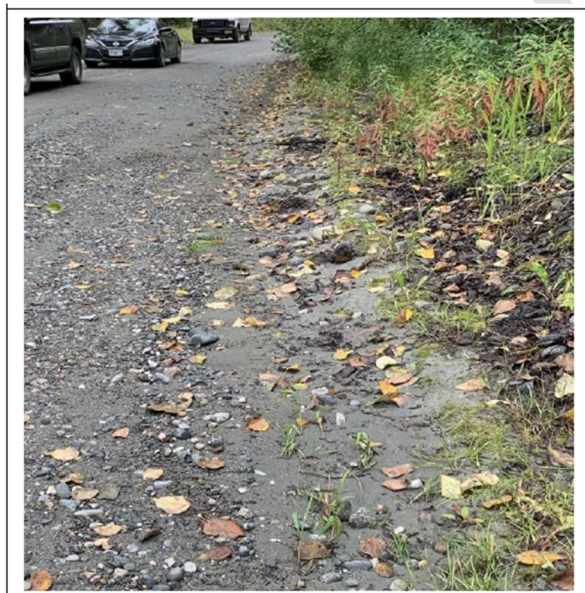
Site 2 GPS: 59.412354, -136.029592: Ditches, 7,626.6667 CY of native material drainage canals, 34,320 FT long x 3 FT wide x 2 FT deep, high volume and high velocity surface water flooding scoured and washed out ditches.

Figure 3: A location on Porcupine Trail Road showing existing roadway shoulder and adjoining ditch impacted by debris. Source – 8/26/2021 FEMA SIR Photo Page for Porcupine Trail Road.

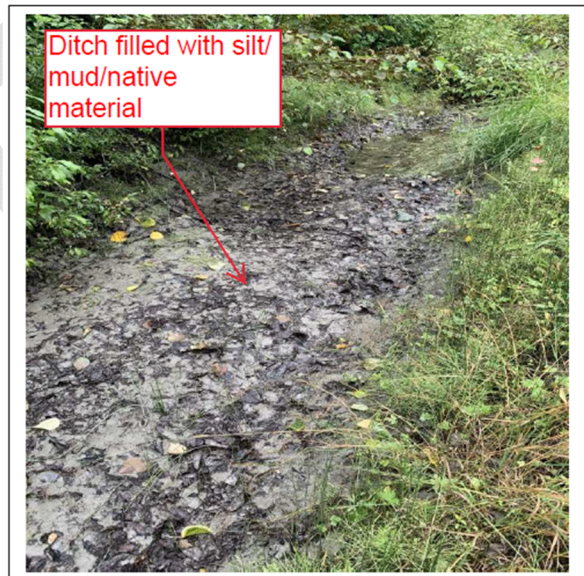
Site 2 GPS: 59.412354, -136.029592: Ditches, 7,626.6667 CY of native material drainage canals, 34,320 FT long x 3 FT wide x 2 FT deep, high volume and high velocity surface water flooding scoured and washed out ditches.

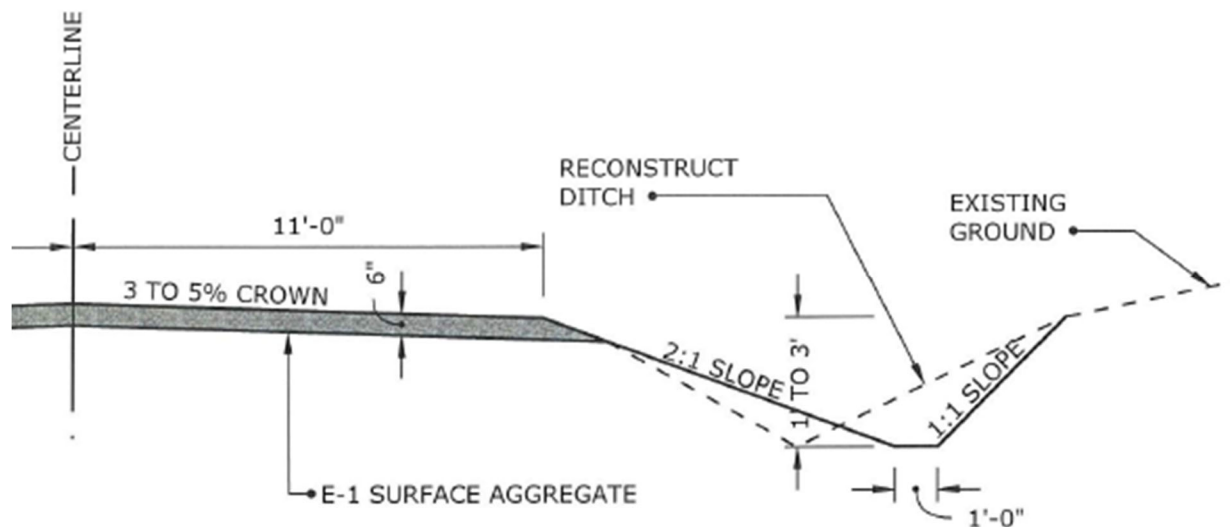
Figure 6: Source - Plan Sheet C02 Typical Section for Haines Borough Porcupine Trail Road, Phase I project.

FEMA's calculation of 2.28 acres of additional ground disturbance does not take into account the total area of ditch reconditioning under Item 303.0002.0002 that was included in the August 2022 approved SOW. As can be seen in Figure 6 below and on Plan Sheet C02 Typical Section, typical slopes, widths, and variable depths for ditch reconditioning/reconstruction were included in the approved SOW. At 1-foot deep, the total width of ditch reconditioning from the edge of the roadway shoulder would be 4-foot-wide, and at 3-feet deep the total width of ditch reconditioning would be 10-foot-wide.

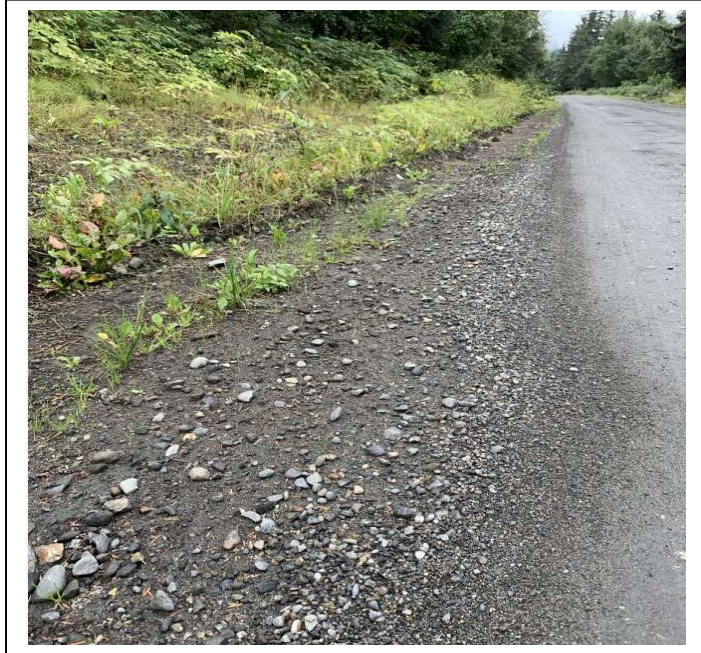
Site 1 GPS: 59.412354, -136.029592: Surface, 10,755.5556 CY of D1, 26,400 FT long x 22 FT wide x 0.5 FT deep, high volume and high velocity surface water flooding washed out road surface. Perspective view northwest.

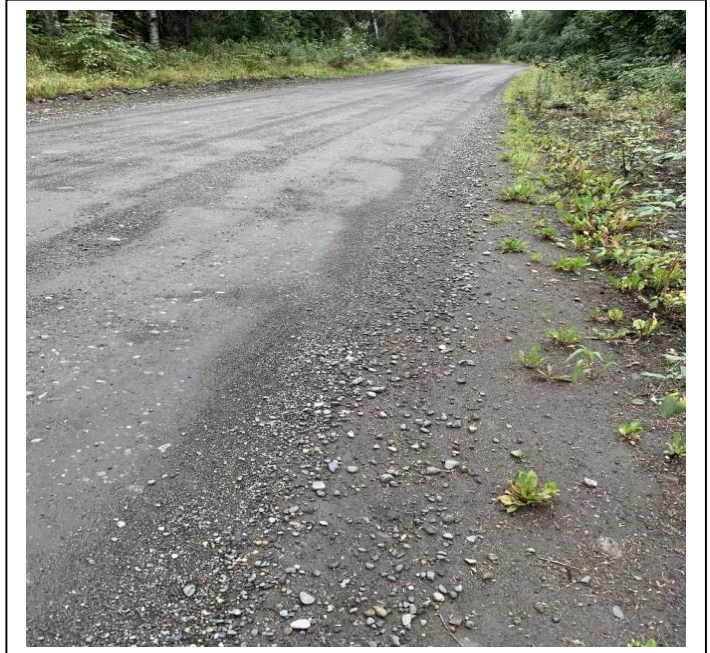
Site 1 GPS: 59.412354, -136.029592: Surface, 10,755.5556 CY of D1, 26,400 FT long x 22 FT wide x 0.5 FT deep, high volume and high velocity surface water flooding washed out road surface. Perspective view northwest.

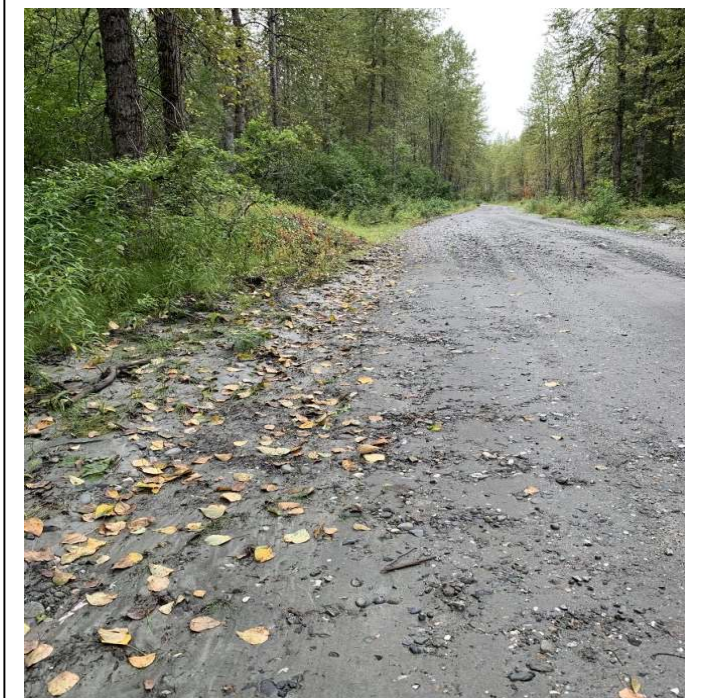
Site 1 GPS: 59.412354, -136.029592: Surface, 10,755.5556 CY of D1, 26,400 FT long x 22 FT wide x 0.5 FT deep, high volume and high velocity surface water flooding washed out road surface.

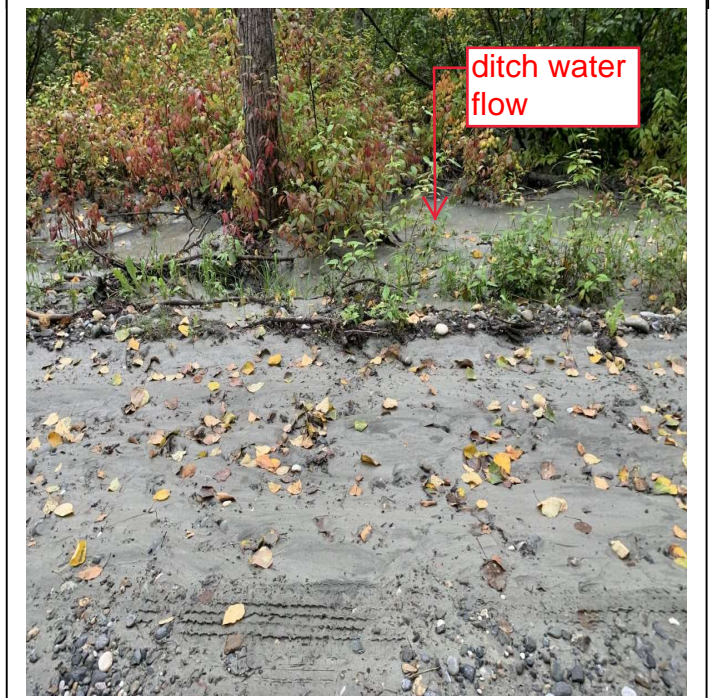
Perspective view of surface washout and normal current water flow through the ditches.

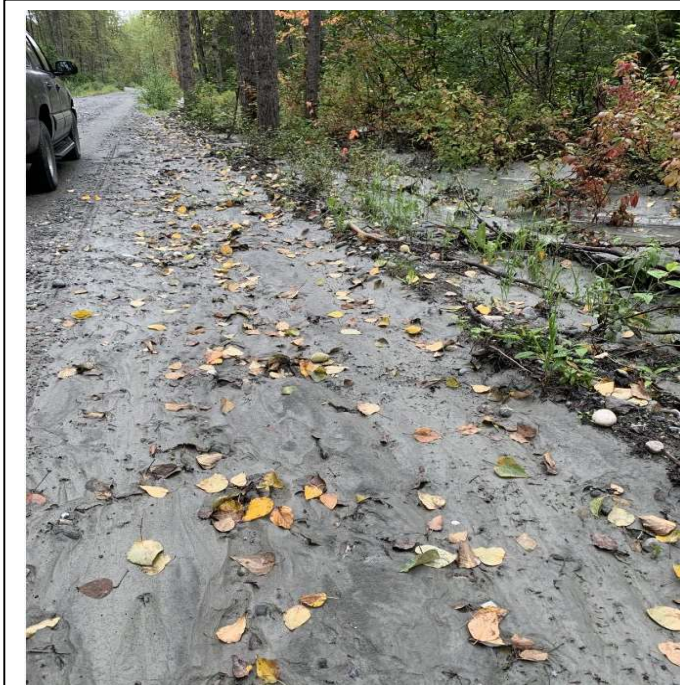
High volume and high velocity surface water flooding washed out 10,755.5556 CY of D1, 26,400 FT long x 22 FT wide x 0.5 FT deep of road surface.

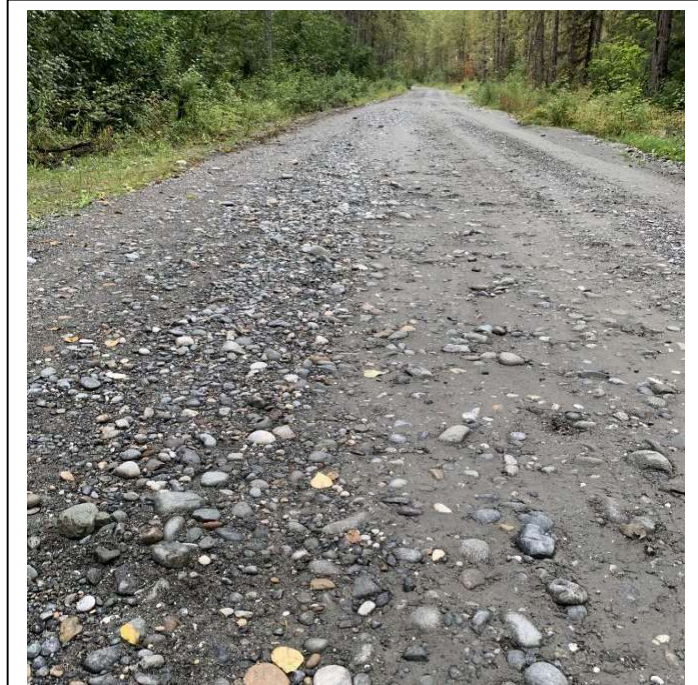
High volume and high velocity surface water flooding washed out 10,755.5556 CY of D1, 26,400 FT long x 22 FT wide x 0.5 FT deep of road surface.

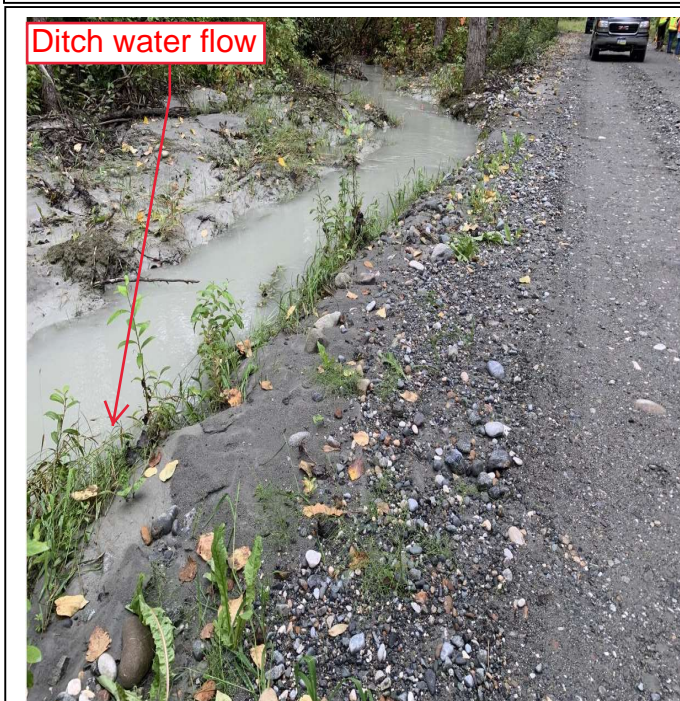
Site 2 GPS: 59.412354, -136.029592: Ditches, 7,626.6667 CY of native material drainage canals, 34,320 FT long x 3 FT wide x 2 FT deep, high volume and high velocity surface water flooding scoured and washed out ditches.

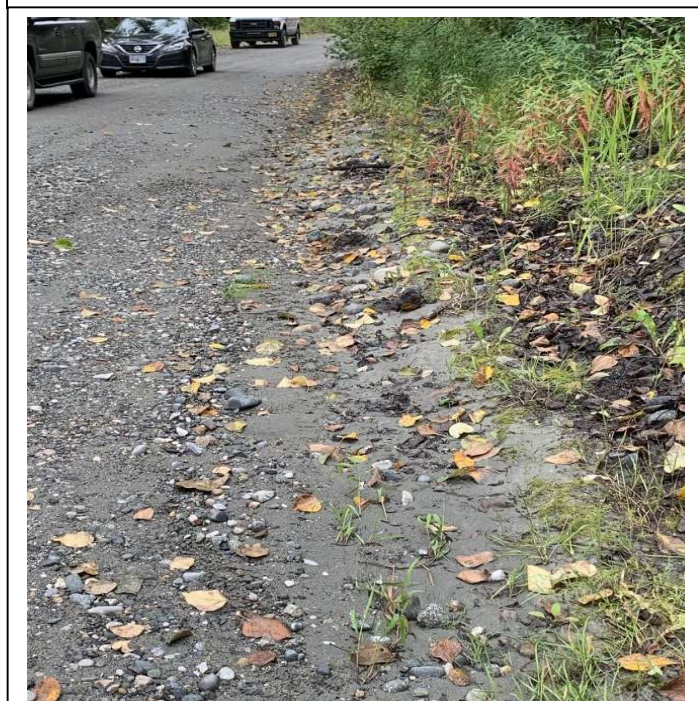
Site 2 GPS: 59.412354, -136.029592: Ditches, 7,626.6667 CY of native material drainage canals, 34,320 FT long x 3 FT wide x 2 FT deep, high volume and high velocity surface water flooding scoured and washed out ditches.

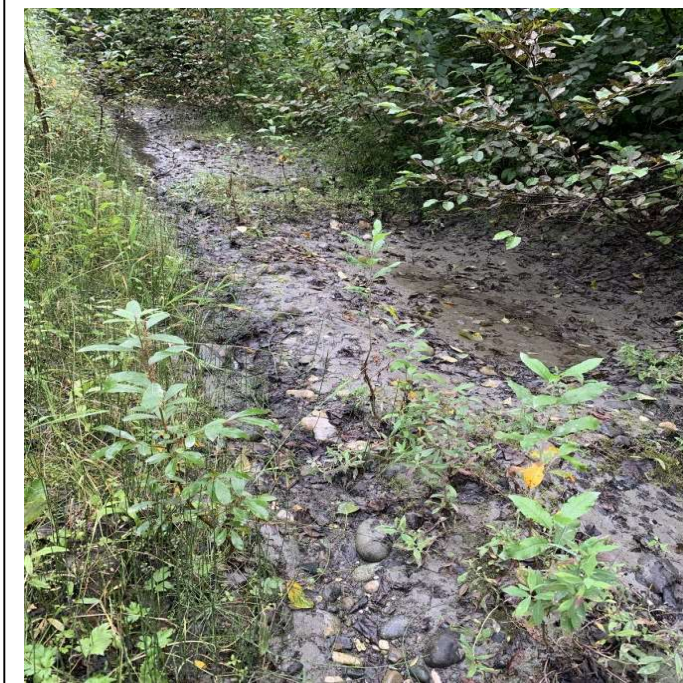
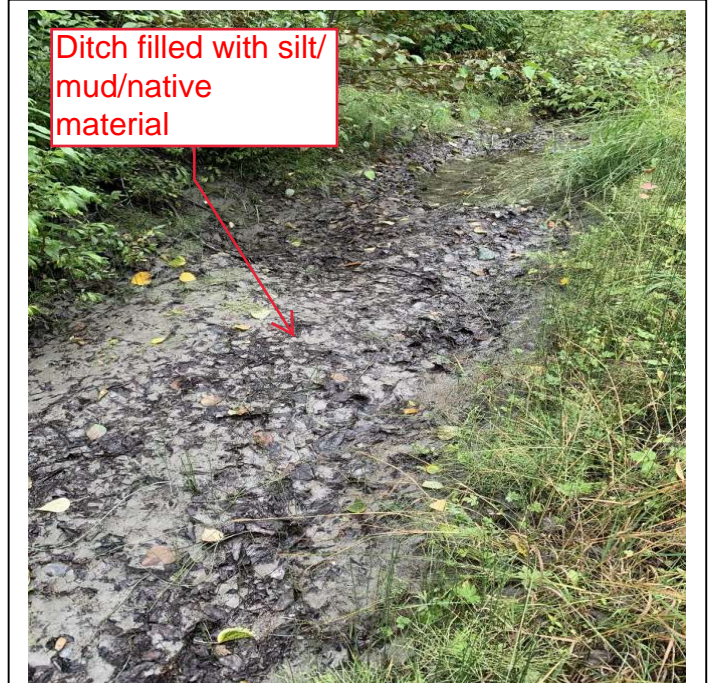
Site 2 GPS: 59.412354, -136.029592: Ditches, 7,626.6667 CY of native material drainage canals, 34,320 FT long x 3 FT wide x 2 FT deep, high volume and high velocity surface water flooding scoured and washed out ditches.

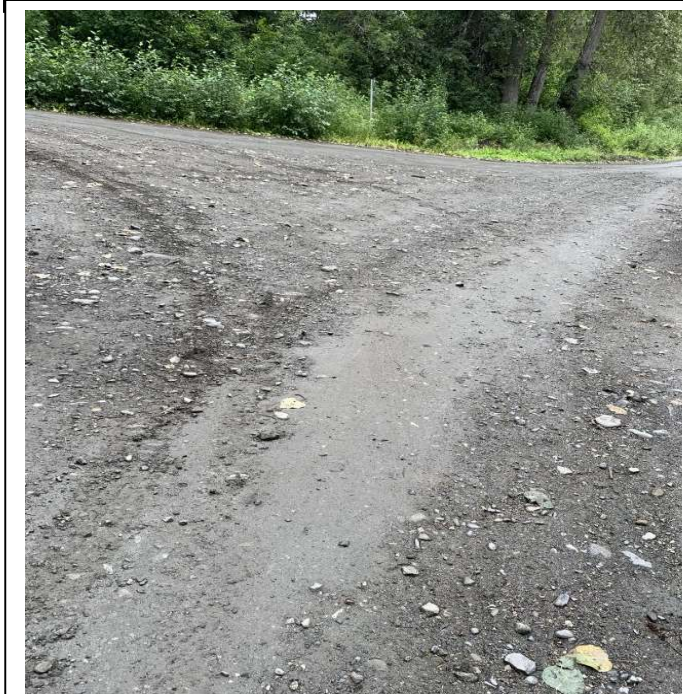
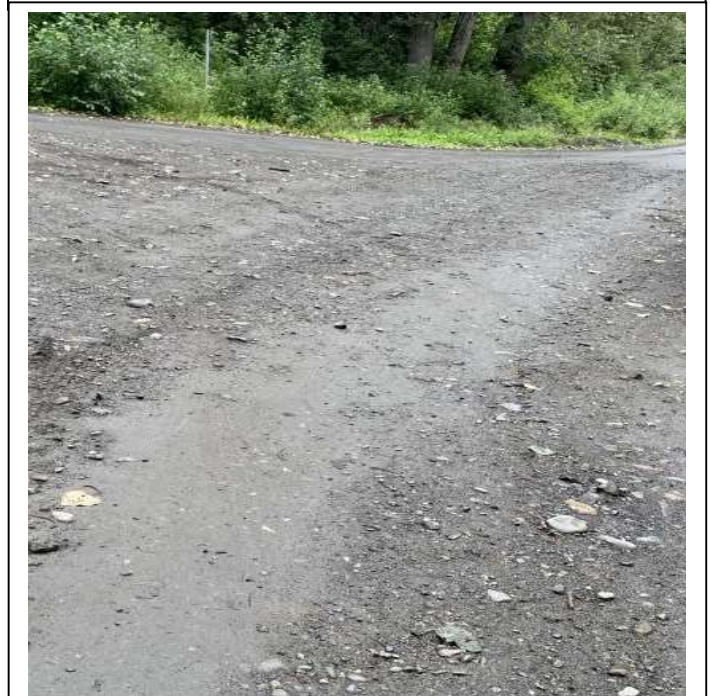
High volume and high velocity surface water flooding washed out 10,755.5556 CY of D1, 26,400 FT long x 22 FT wide x 0.5 FT deep of road surface. Perspective view south.

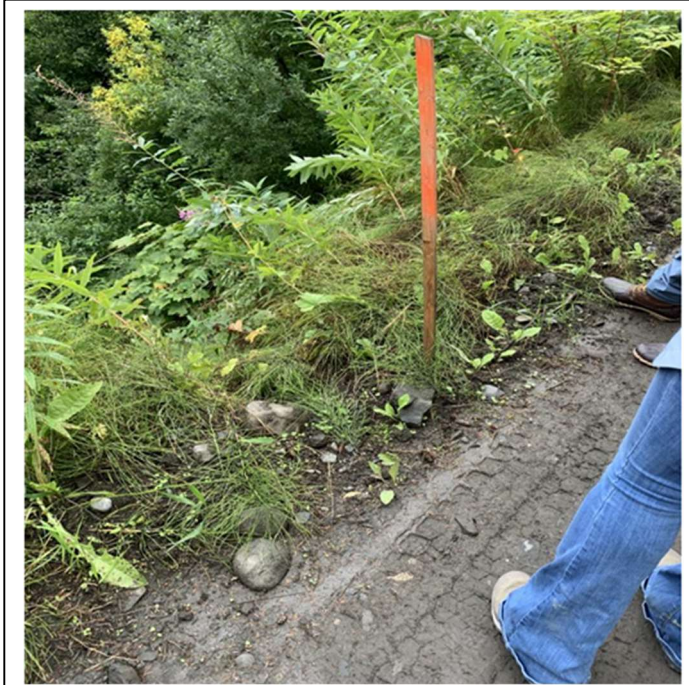
Site 3 GPS: 59.42065, -136. 19023: Embankment #1: 533.3333 CY of native material sloped embankment, 30 FT long x 16 FT wide x 30 FT deep, high volume and high velocity surface water flooding scoured and washed out embankment

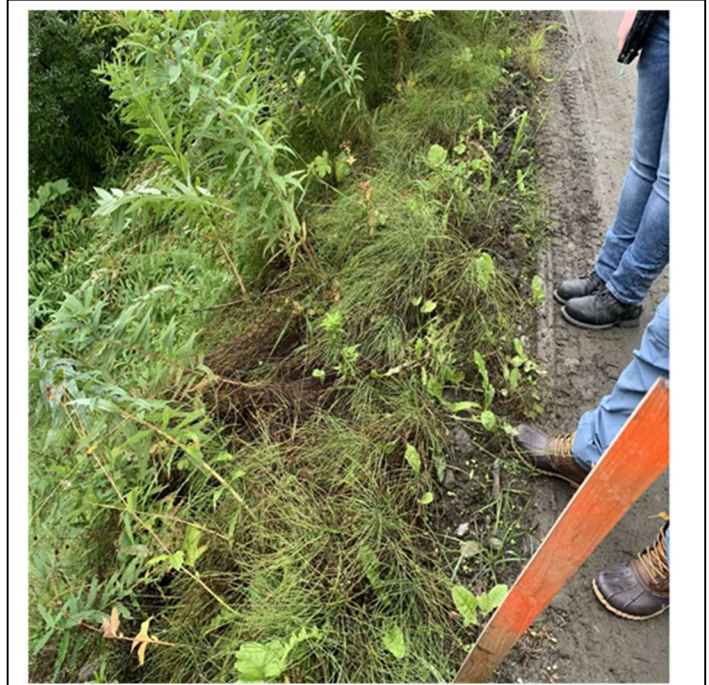
Site 3 GPS: 59.42065, -136. 19023: Embankment #1: 533.3333 CY of native material sloped embankment, 30 FT long x 16 FT wide x 30 FT deep, high volume and high velocity surface water flooding scoured and washed out embankment

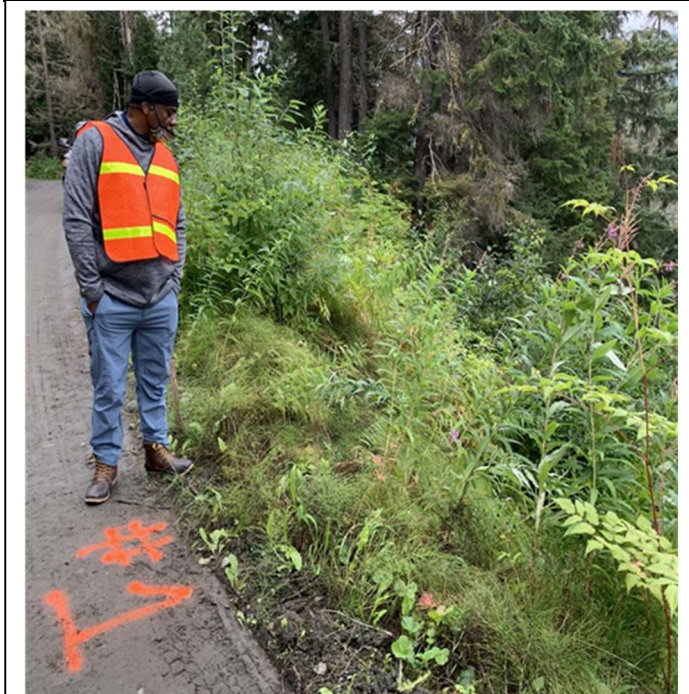
Site 3 GPS: 59.42065, -136. 19023: Embankment #1: 533.3333 CY of native material sloped embankment, 30 FT long x 16 FT wide x 30 FT deep, high volume and high velocity surface water flooding scoured and washed out embankment

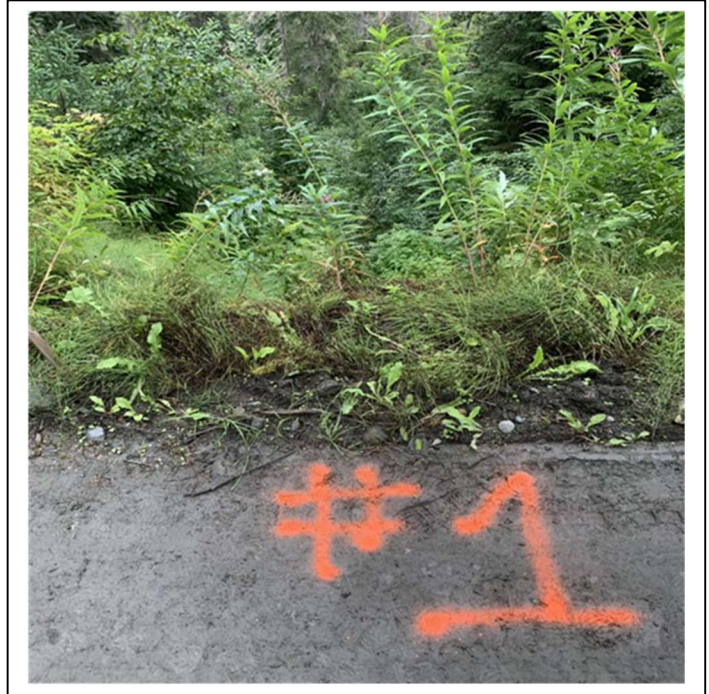
Site 3 GPS: 59.42065, -136. 19023: Embankment #1: 533.3333 CY of native material sloped embankment, 30 FT long x 16 FT wide x 30 FT deep, high volume and high velocity surface water flooding scoured and washed out embankment

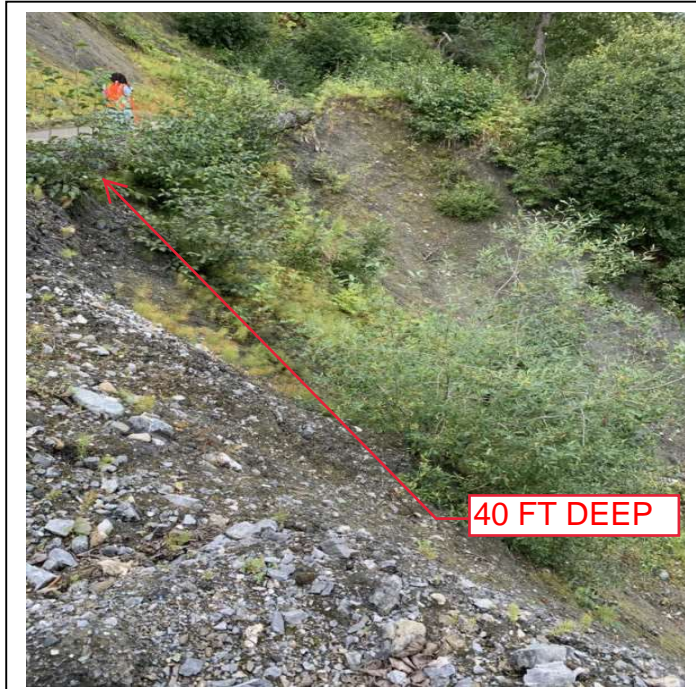
Site 4 GPS: 59.42115, -136.17052: Embankment #2, 260.7407 CY of native material sloped embankment, 8 FT long x 22 FT wide x 40 FT deep, high volume and high velocity surface water flooding scoured and washed out embankment.

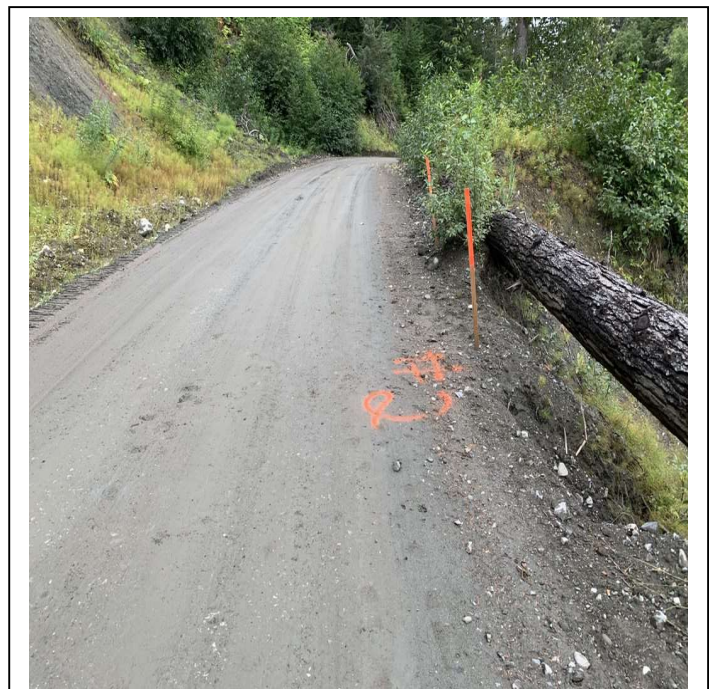
Site 4 GPS: 59.42115, -136.17052: Embankment #2, 260.7407 CY of native material sloped embankment, 8 FT long x 22 FT wide x 40 FT deep, high volume and high velocity surface water flooding scoured and washed out embankment.

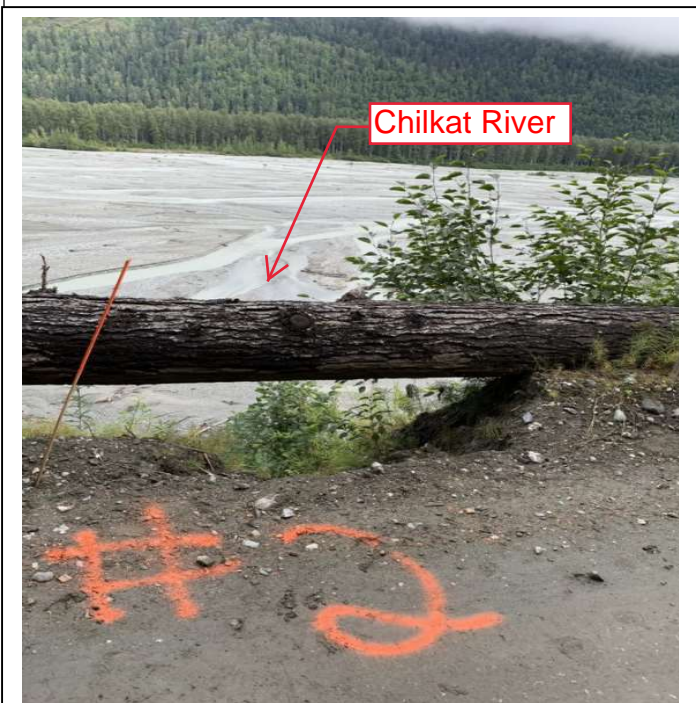
Site 4 GPS: 59.42115, -136.17052: Embankment #2, 260.7407 CY of native material sloped embankment, 8 FT long x 22 FT wide x 40 FT deep, high volume and high velocity surface water flooding scoured and washed out embankment.

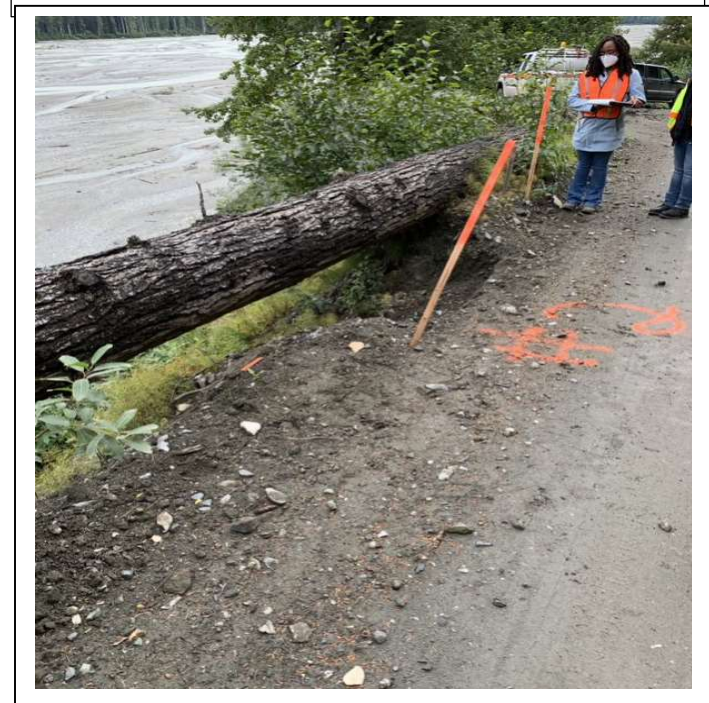
Site 4 GPS: 59.42115, -136.17052: Embankment #2, 260.7407 CY of native material sloped embankment, 8 FT long x 22 FT wide x 40 FT deep, high volume and high velocity surface water flooding scoured and washed out embankment.

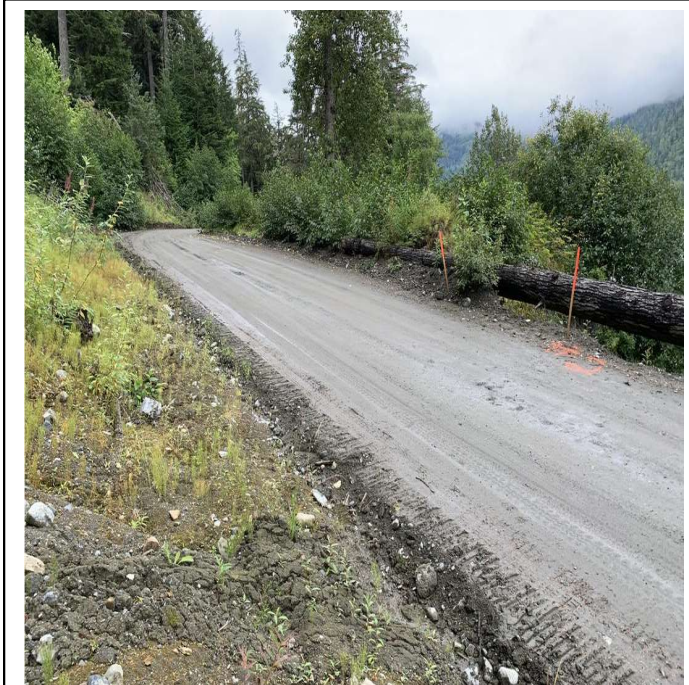
Site 4 GPS: 59.42115, -136.17052: Embankment #2, 260.7407 CY of native material sloped embankment, 8 FT long x 22 FT wide x 40 FT deep, high volume and high velocity surface water flooding scoured and washed out embankment.

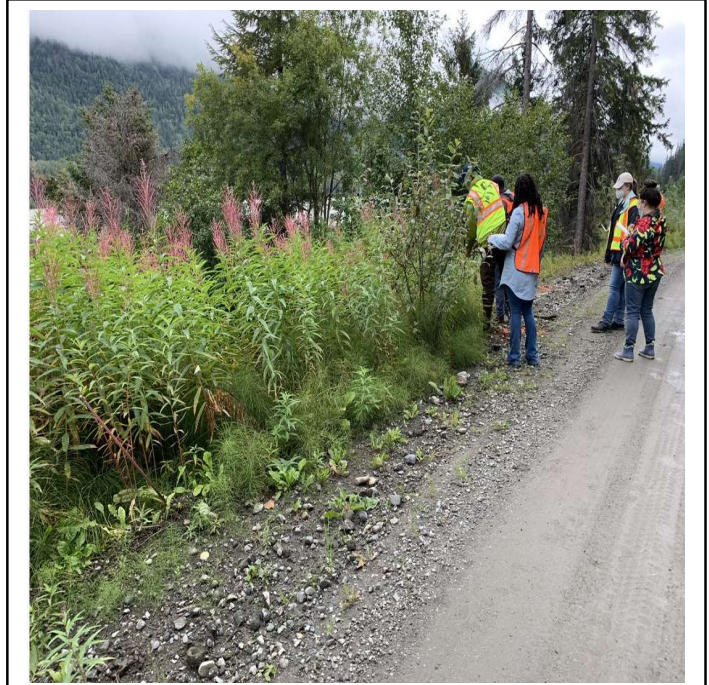
Site 5 GPS: 59.421307, -136.169618: Embankment #3, 88.8889 CY of native material sloped embankment, 6 FT long x 16 FT wide x 25 FT deep, high volume and high velocity surface water flooding scoured and washed out embankment.

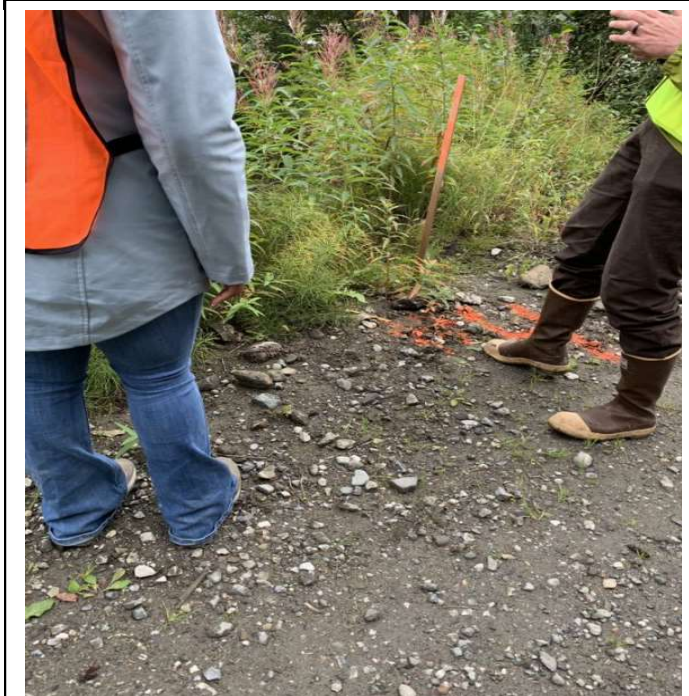
Site 6 GPS: 59.421280, -136.169301: Embankment #4, 88.8889 CY of native material sloped embankment, 6 FT long x 16 FT wide x 25 FT deep, high volume and high velocity surface water flooding scoured and washed out embankment.

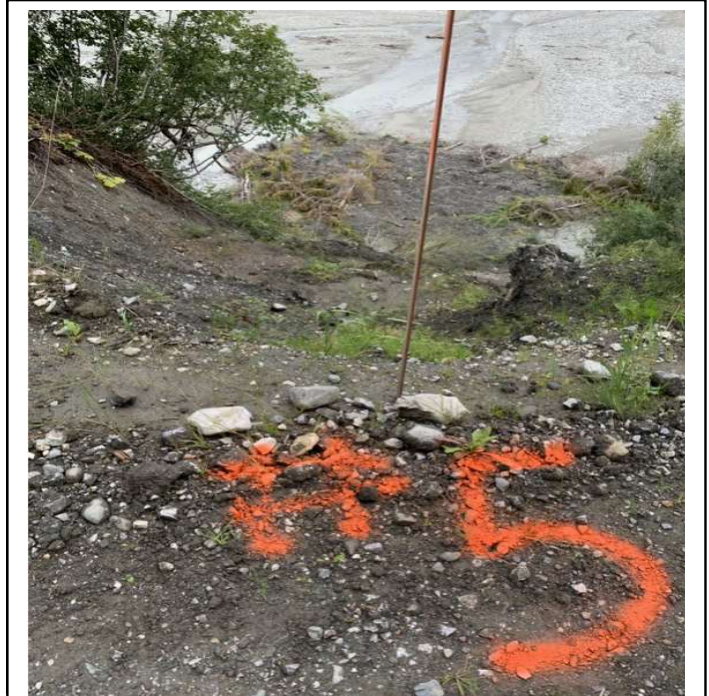
Site 7 GPS: 59.421530, -136.169010: Embankment #5, 1,111.1111 CY of native material sloped embankment, 20 FT long x 50 FT wide x 30 FT deep, high volume and high velocity surface water flooding scoured and washed out embankment.

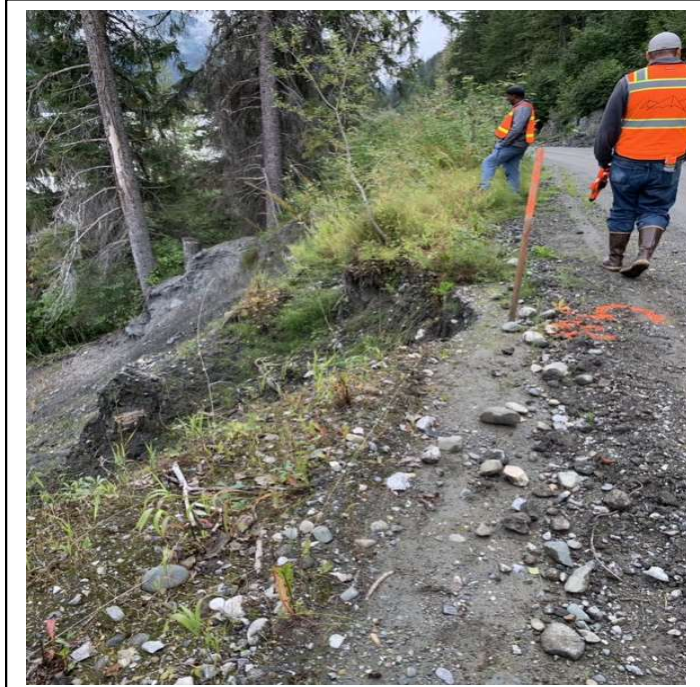
Site 7 GPS: 59.421530, -136.169010: Embankment #5, 1,111.1111 CY of native material sloped embankment, 20 FT long x 50 FT wide x 30 FT deep, high volume and high velocity surface water flooding scoured and washed out embankment.

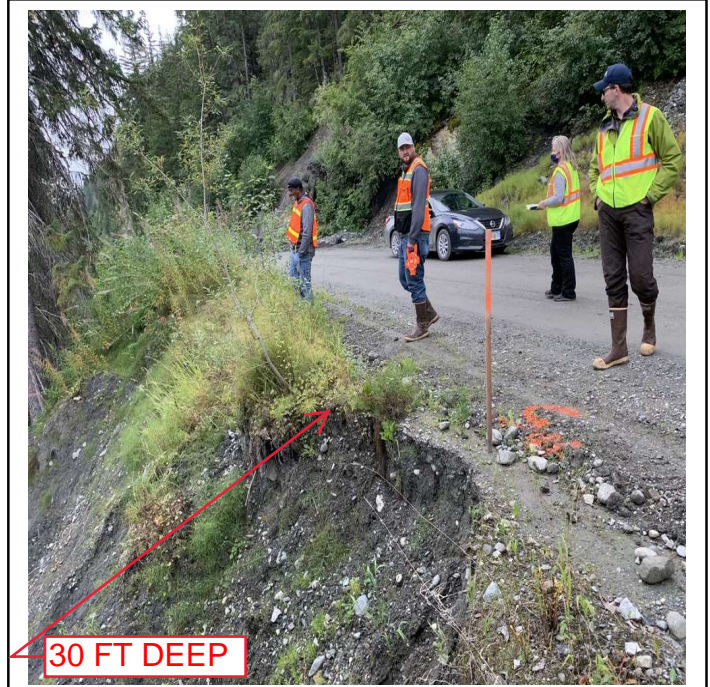
Site 7 GPS: 59.421530, -136.169010: Embankment #5, 1,111.1111 CY of native material sloped embankment, 20 FT long x 50 FT wide x 30 FT deep, high volume and high velocity surface water flooding scoured and washed out embankment.

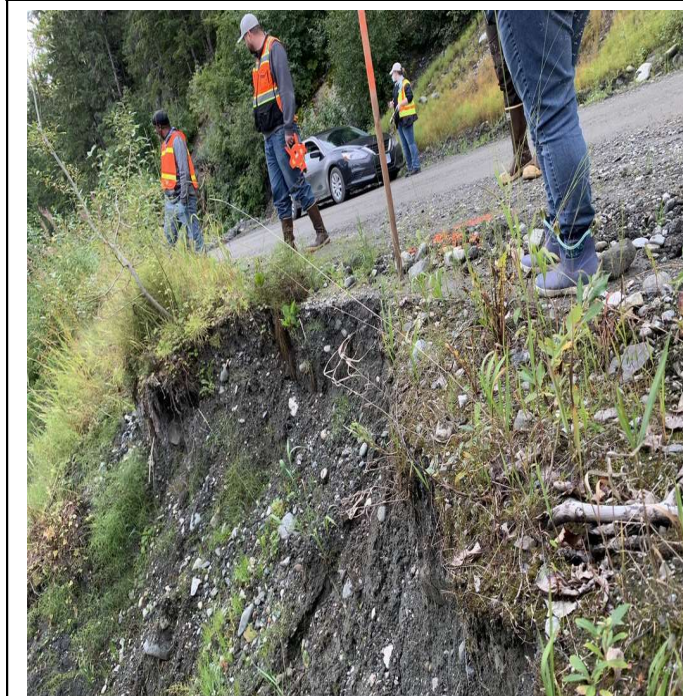
Site 7 GPS: 59.421530, -136.169010: Embankment #5, 1,111.1111 CY of native material sloped embankment, 20 FT long x 50 FT wide x 30 FT deep, high volume and high velocity surface water flooding scoured and washed out embankment.

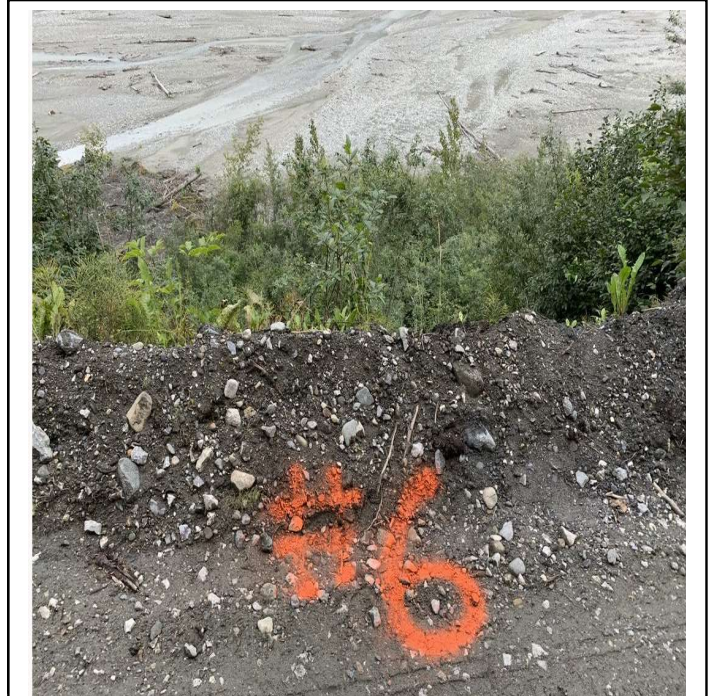
Site 8 GPS: 59.421193, -136.168441. Embankment, 1,356.6667 CY of native material sloped embankment, 30 FT long x 33 FT wide x 37 FT deep, high volume and high velocity surface water flooding scoured and washed out embankment.

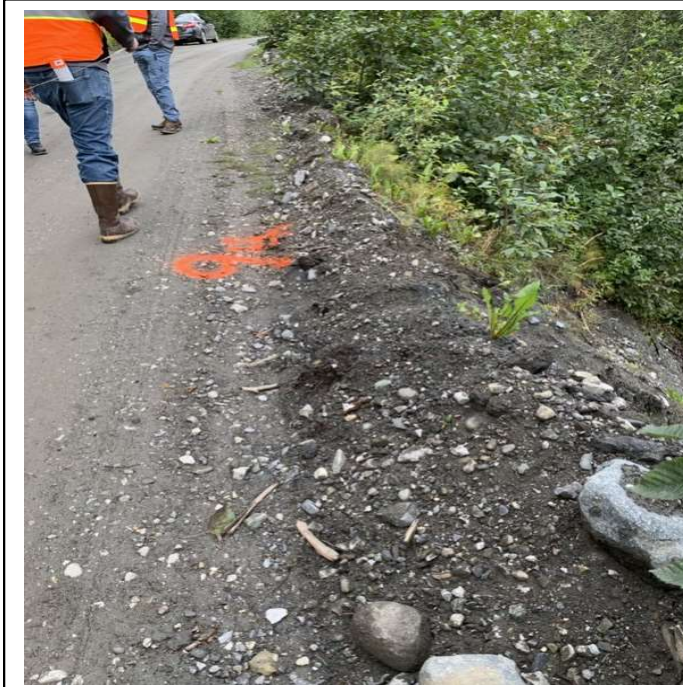
Site 8 GPS: 59.421193, -136.168441. Embankment, 1,356.6667 CY of native material sloped embankment, 30 FT long x 33 FT wide x 37 FT deep, high volume and high velocity surface water flooding scoured and washed out embankment.

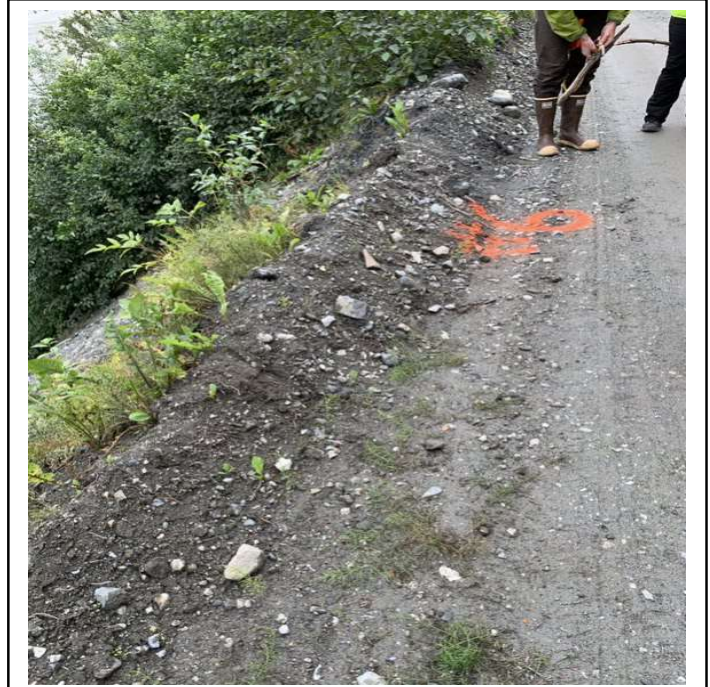
Site 8 GPS: 59.421193, -136.168441. Embankment, 1,356.6667 CY of native material sloped embankment, 30 FT long x 33 FT wide x 37 FT deep, high volume and high velocity surface water flooding scoured and washed out embankment.

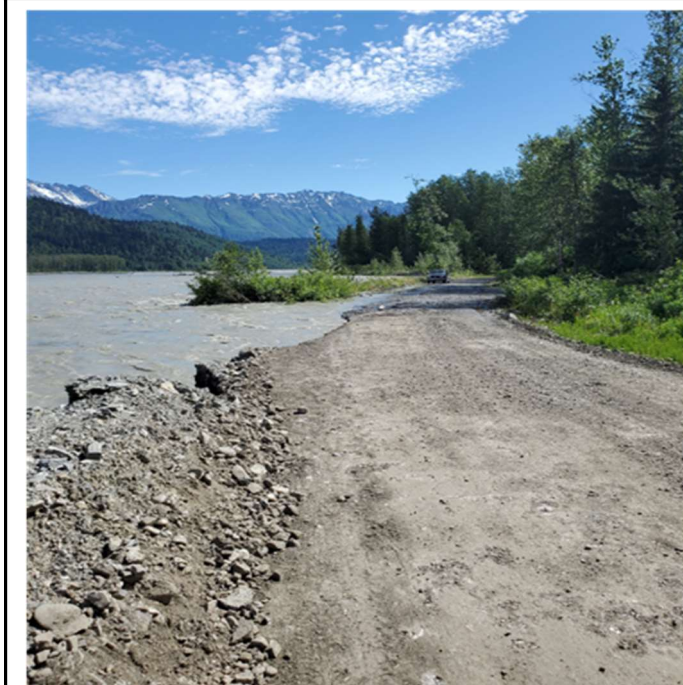
Site 9 GPS START: 59.41416, -136.08884 GPS END: 59.414363, -136.085552: Photo from applicant taken in June 2021.

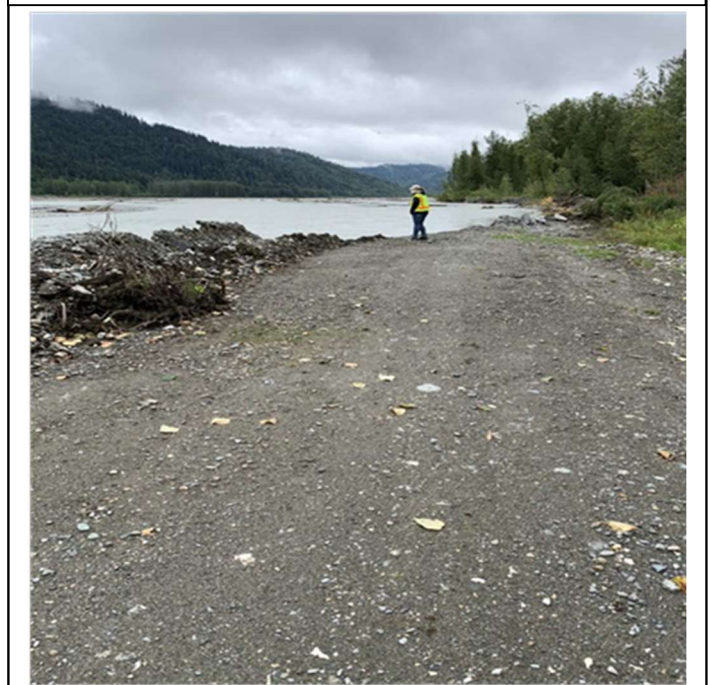
Site 9 GPS START: 59.41416, -136.08884 GPS END: 59.414363, -136.085552: Photo Taken August 26, 2021. Base, 471.1111 CY of native material, 636 FT long x 20 FT wide x 1 FT deep, high volume and high velocity surface water flooding washed out base.

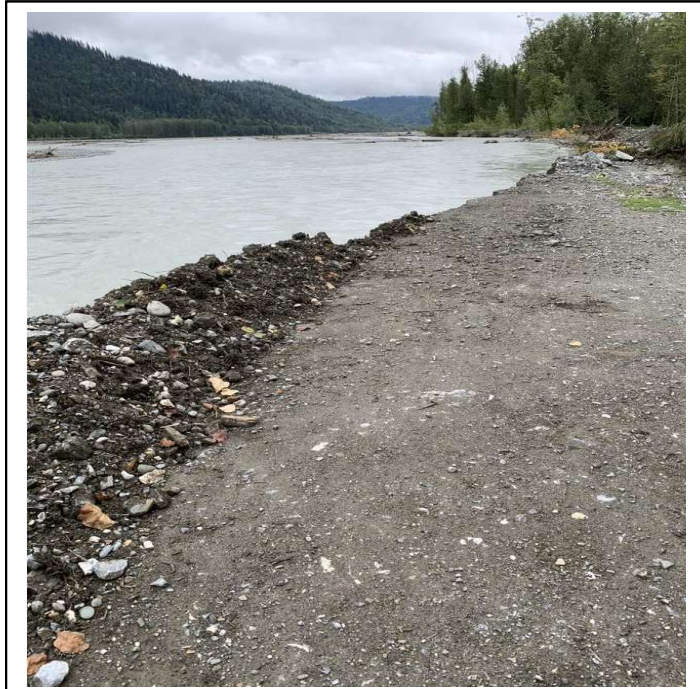
Site 9 GPS START: 59.41416, -136.08884 GPS END: 59.414363, -136.085552:
Photo Taken August 26, 2021. Base, 471.1111 CY of native material, 636 FT long x 20 FT wide x 1 FT deep, high volume and high velocity surface water flooding washed out base

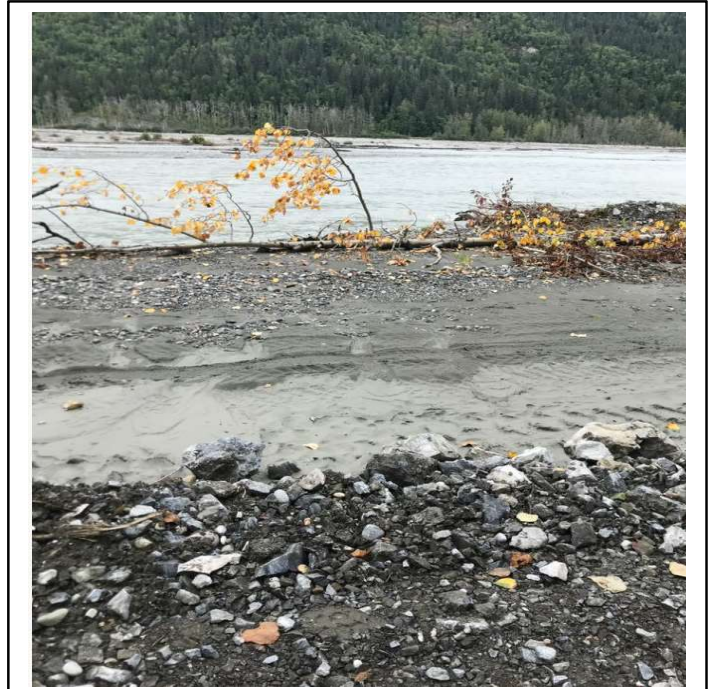
Site 9 GPS START: 59.41416, -136.08884 GPS END: 59.414363, -136.085552.
Borrow Fill, 942.2222 CY of borrow fill, 636 FT long x 20 FT wide x 2 FT deep, high volume and high velocity surface water flooding scoured and washed out fill

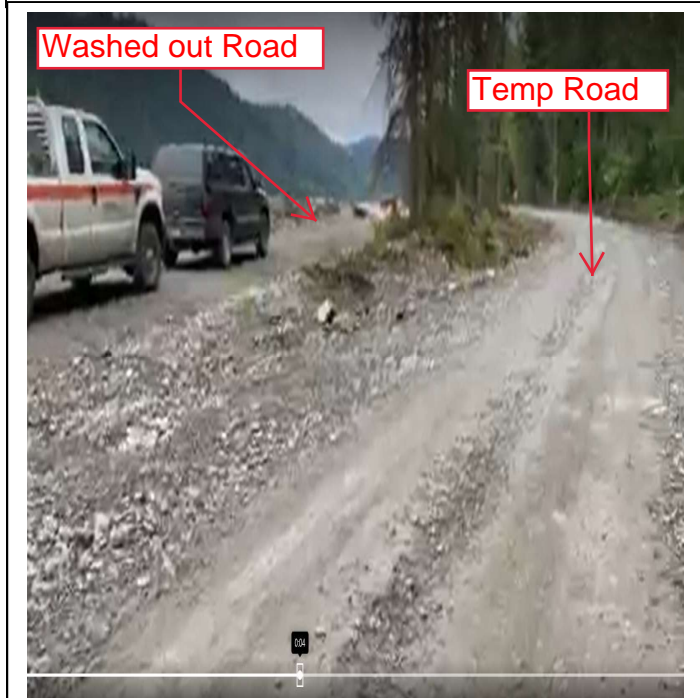
Perspective view south of damaged road and temporary road out in Porcupine Trail Road, adjacent to Site 9
