Haines Borough Assembly Agenda Bill

Agenda Bill No.: 24-1361

Subject: Authorizing FEMA Appeal regarding
Porcupine Trail Road

A Resolution of the Haines Borough Assembly authorizing an appeal of the Department of Homeland Security's Federal Emergency Management Agency (FEMA) deobligation of funding in the amount of \$1,435,834.75 related to the permanent repair of Porcupine Trail Road and authorizing the Borough Manager to Contract with Birch Horton Bittner & Cherot for Consultation Services associated with review of appeal documents.

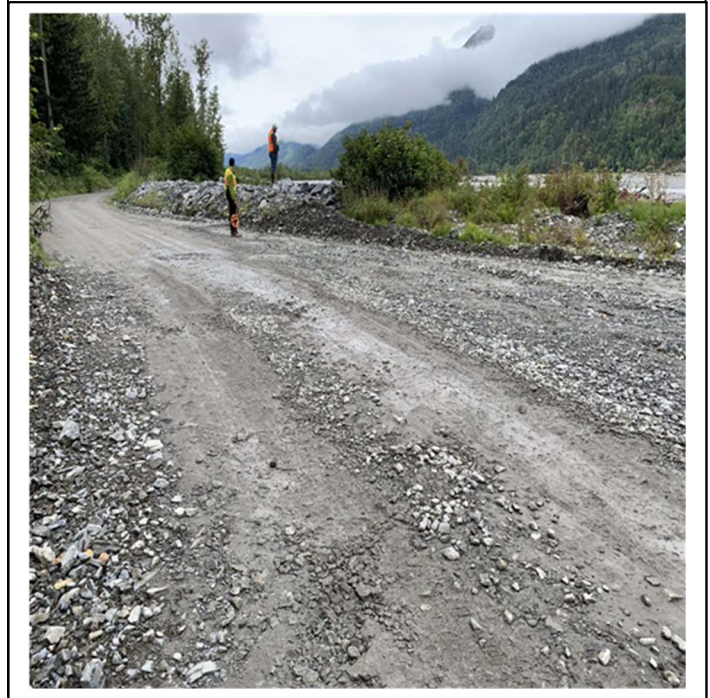
Site 9B GPS START: 59.41416, -136.08884 GPS END: 59.414363, -136.085552: Riprap armor rock embankment, 2,449.7778 CY of 24-48 inch minus, 636 FT long x 13 FT wide x 8 FT deep, high volume and high velocity flooding washed out riprap embankment.

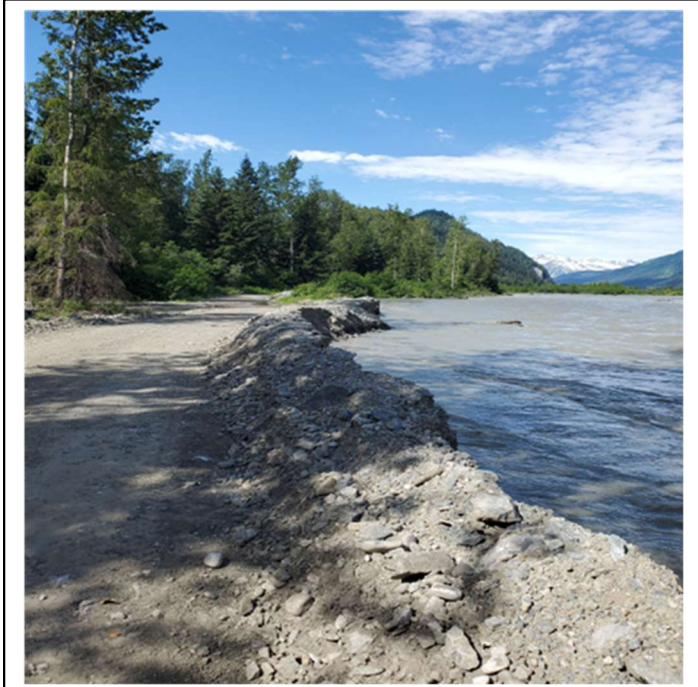
Riprap armor rock embankment, 2,449.7778 CY, 24–48-inch, 636 FT long x 13 FT wide x 8 FT deep, high volume and high velocity flooding washed out riprap embankment. Photo from applicant taken June 2021.

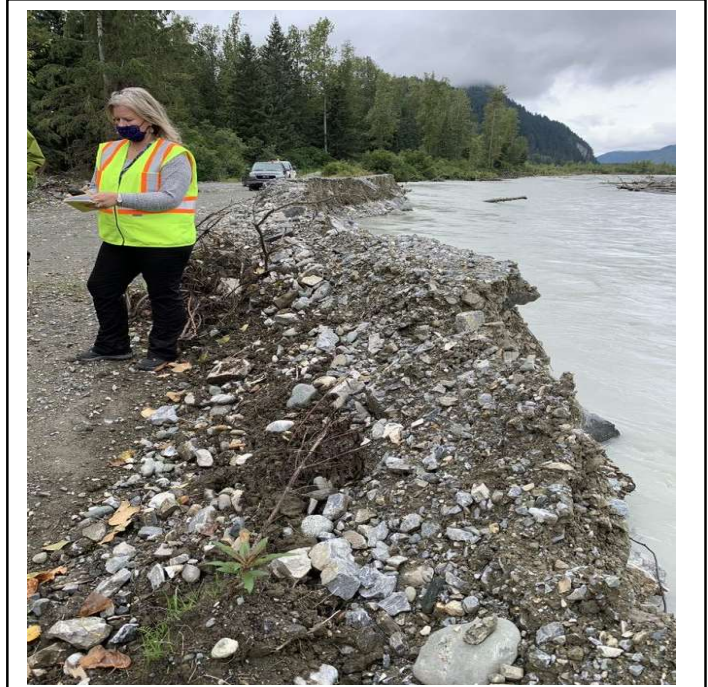
Riprap armor rock embankment, 2,449.7778 CY, 24-48 inch, 636 FT long x 13 FT wide x 8 FT deep, high volume and high velocity flooding washed out riprap embankment. Photo taken August 26, 2021

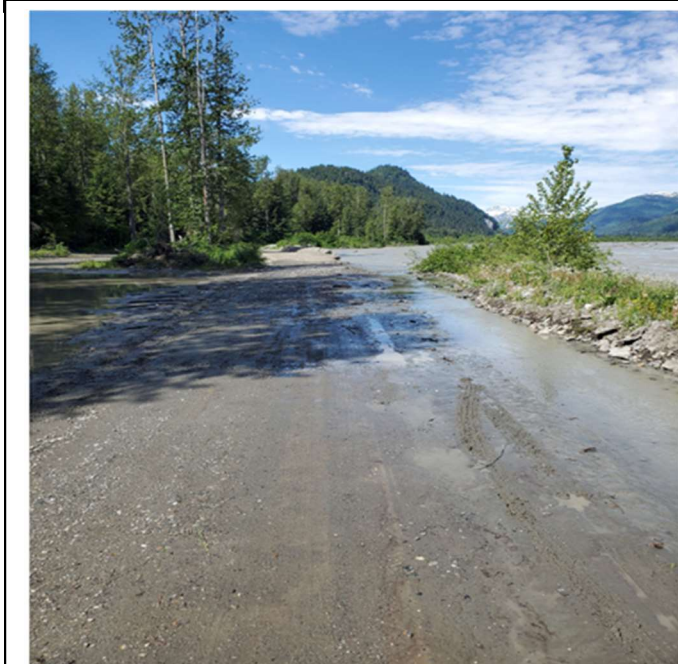
Perspective view west, Site 9 of road wash out. Photo taken August 26, 2021.

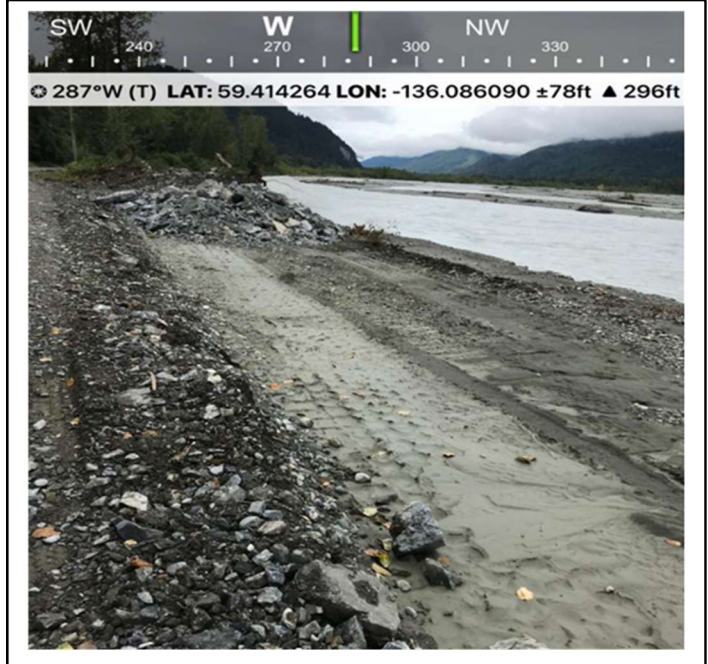
Perspective view west of Porcupine Trail Road, Site 9 taken June 2021.
