RE: DR-4585 PW 13 - FEMA Questions for Porcupine Road (EHP RFI)
Response to 9/20/2023 Request for Information

Completed Work, Phase I (Scope of Work Details):

Attachment A – Start/Stop GPS Points for Third-Party and Porcupine Trail Road Phase I Work

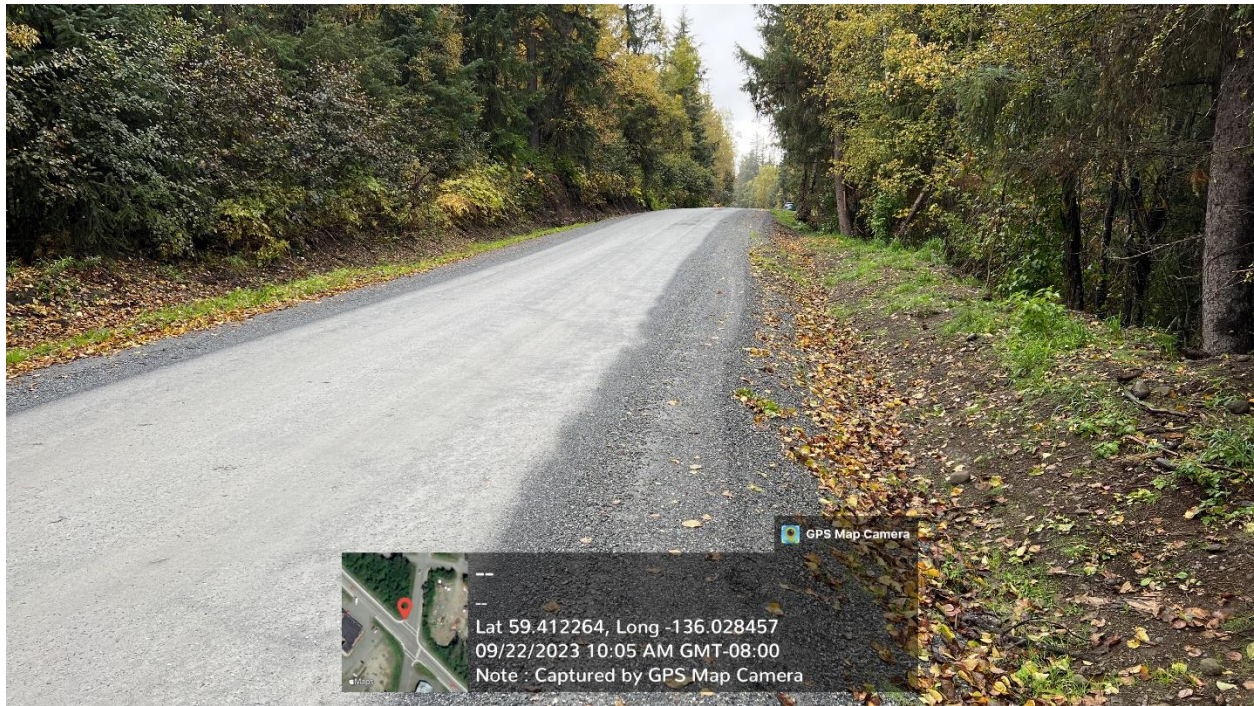
Figure A.1 – Porcupine Trail Road Phase I start of work, photo facing end of road. **Begin Phase I project.**

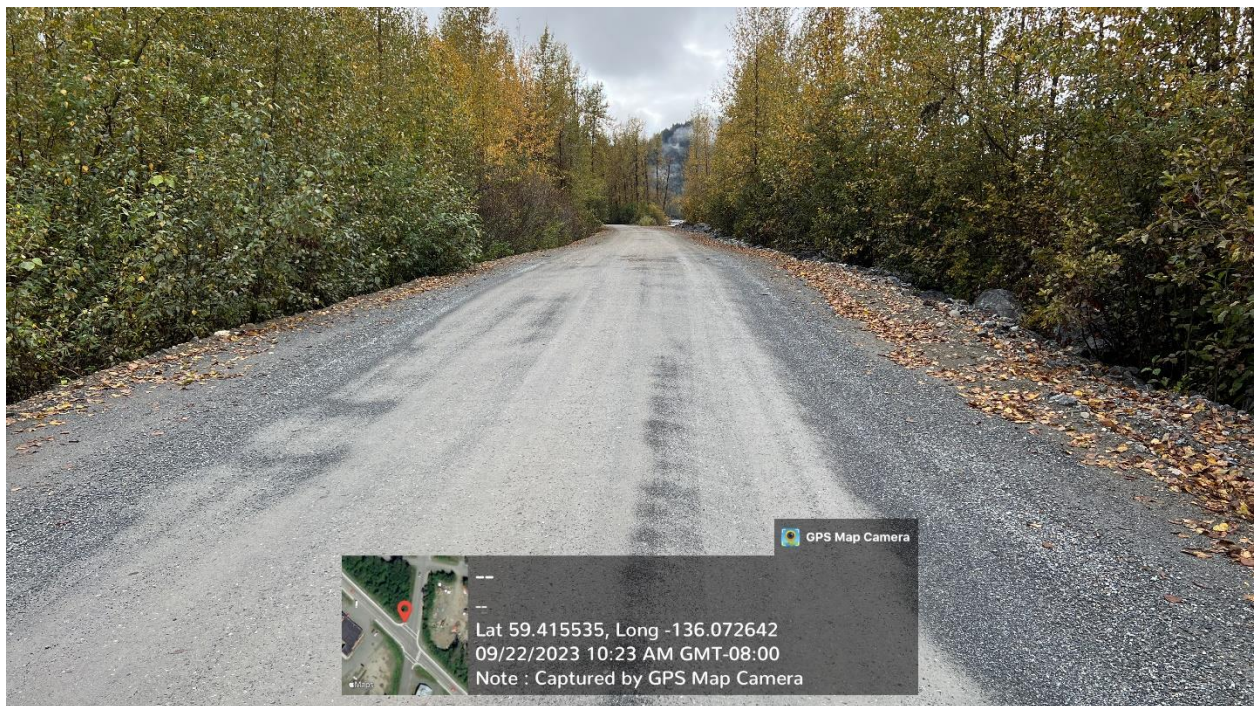
Figure A.2 – Porcupine Trail Road Phase I stop of work, photo facing end of road. Also shown is the start of third-party Site 1 work. Note the stop of Phase I surfacing material placement and start of third-party 3' fill placement. No Phase I ditch reconditioning performed adjacent to, or surfacing material placed over third-party fill section.

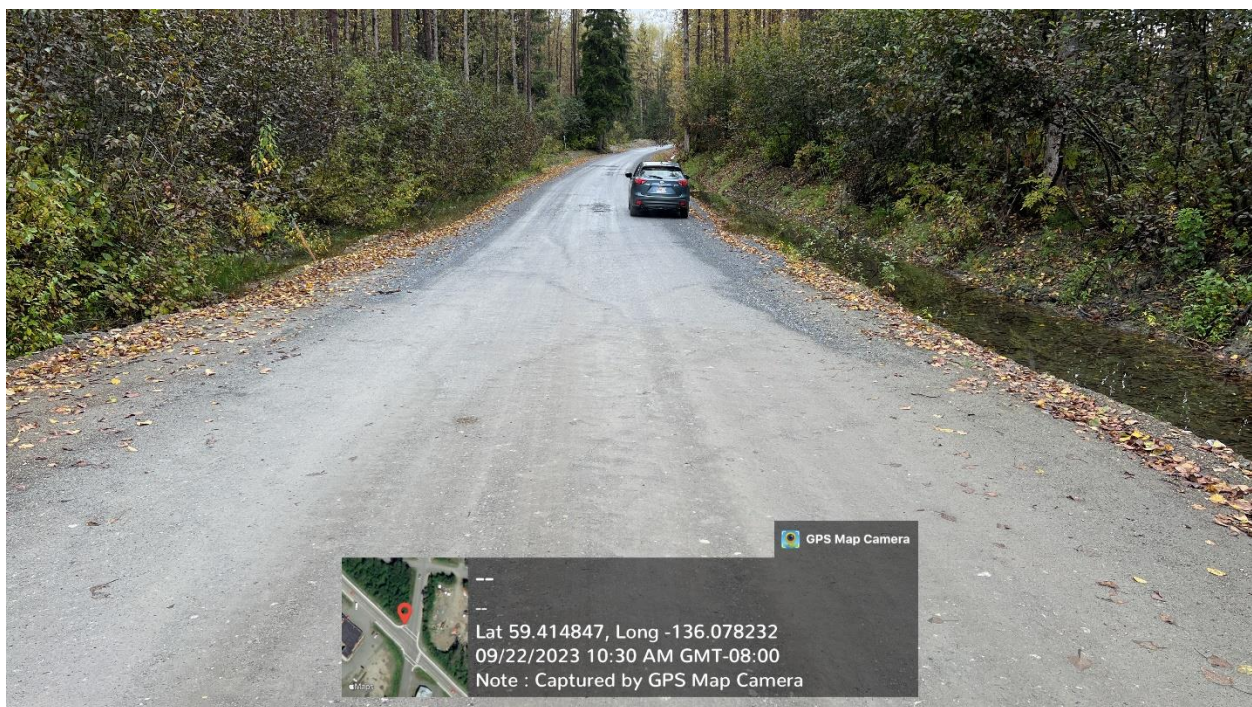
Figure A.4 – Same location as Figure A.3. Third-party stop of work for Site 1, photo facing end of road. Porcupine Trail Road Phase I start of work limits near vehicle in background. Note the change in surfacing.

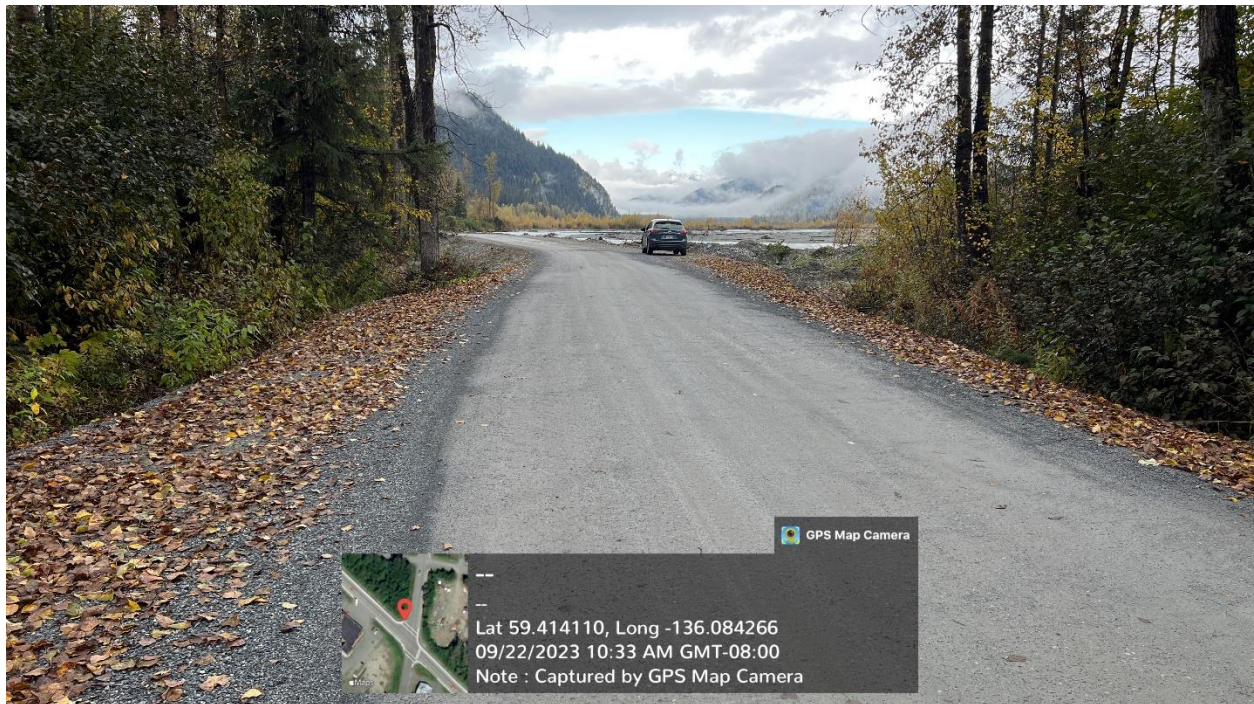
Figure A.5 - Porcupine Trail Road Phase I stop of work, photo facing end of road. Also shown is start of third-party Site 2 work. This location is near the start of yet to be designed Phase II work.

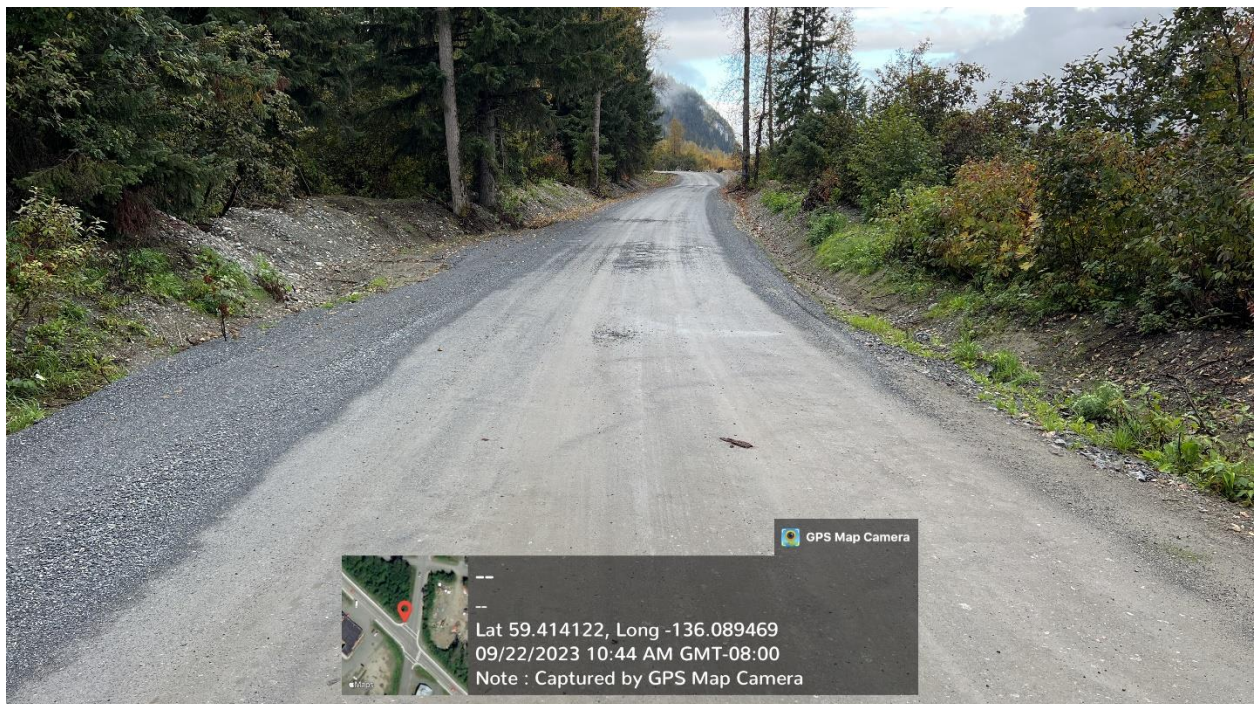
Figure A.6 - Third-party stop of work for Site 2, photo facing end of road. Also shown is start of a short section of Porcupine Trail Road Phase I work, approximately 300' segment between end of third-party Site 2 work (foreground) and beginning of third-party Site 3 work (distant background).

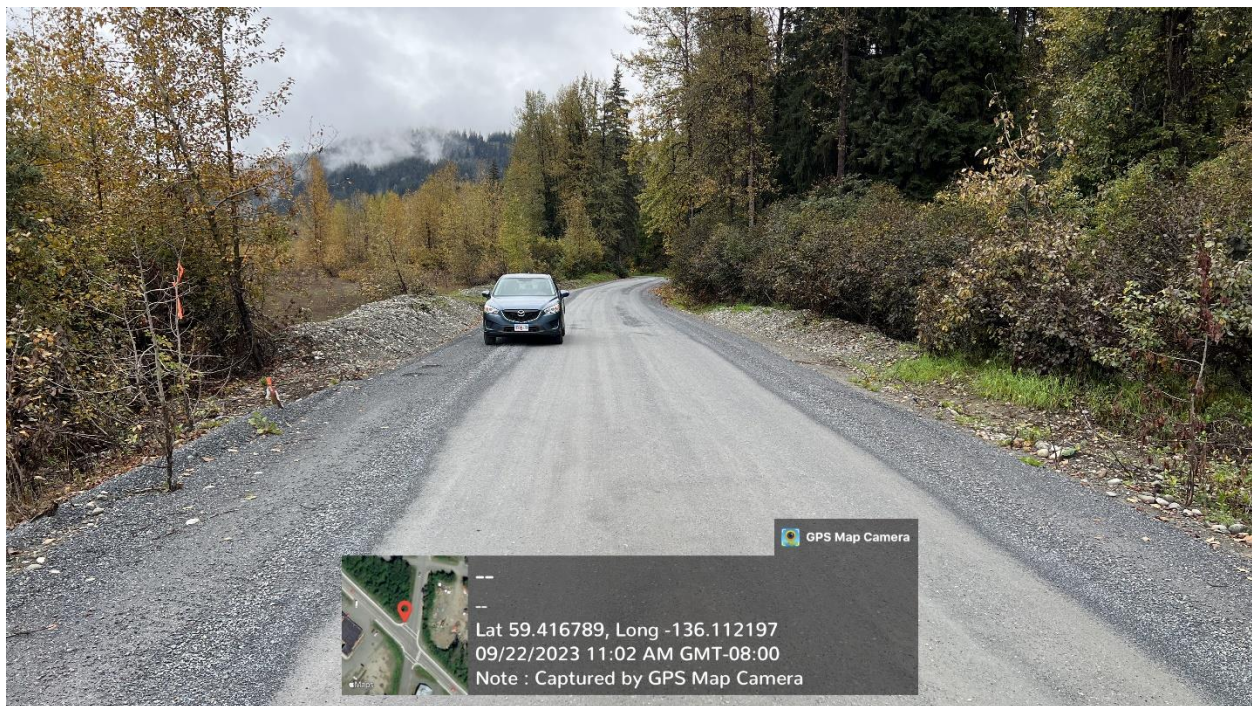
Figure A.12 - Porcupine Trail Road Phase I stop of work, photo facing beginning of road. Same location as Figure A.11.

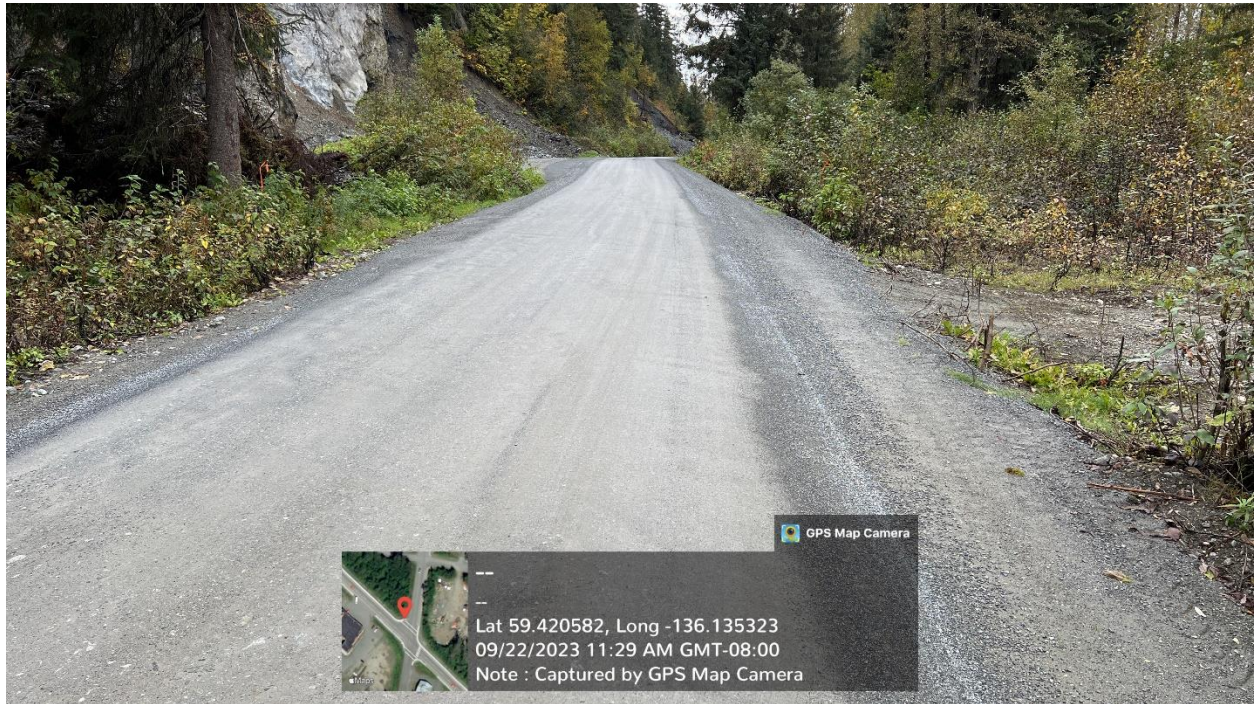
Figure A.13 - Porcupine Trail Road Phase I start of work, photo facing end of road.

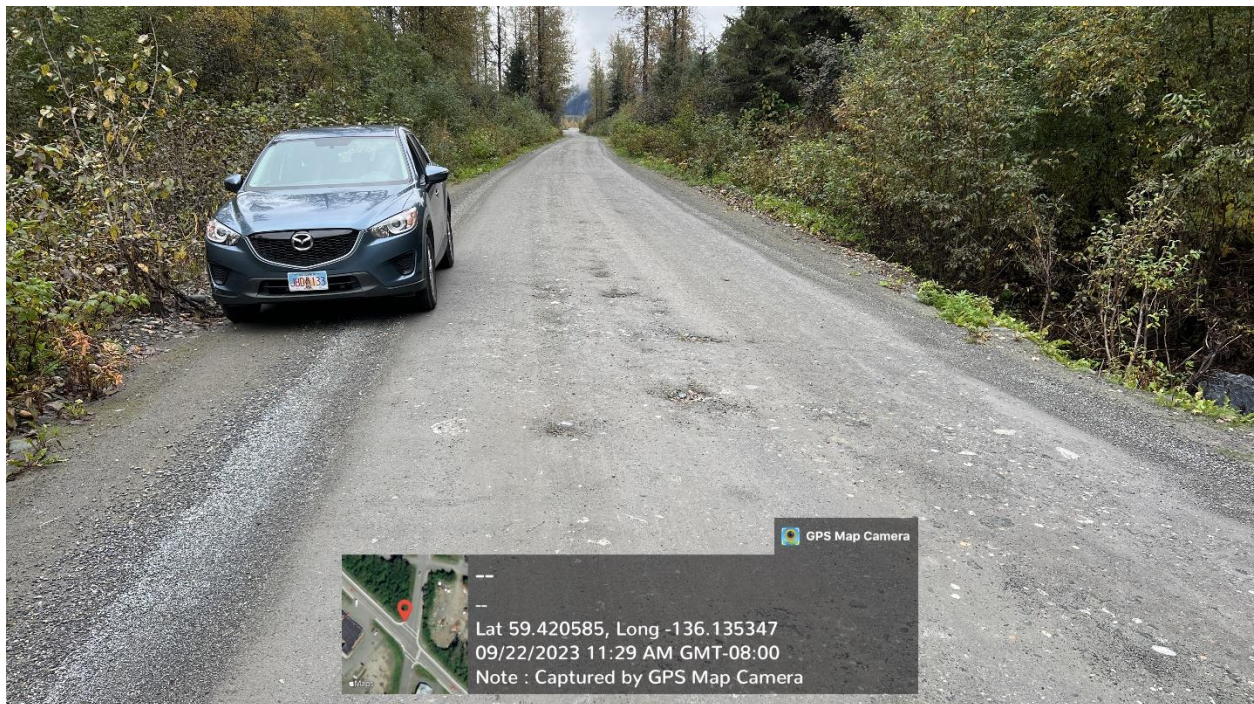
Figure A.14 - Porcupine Trail Road Phase I start of work, photo facing beginning of road. Same location as figure A.13.

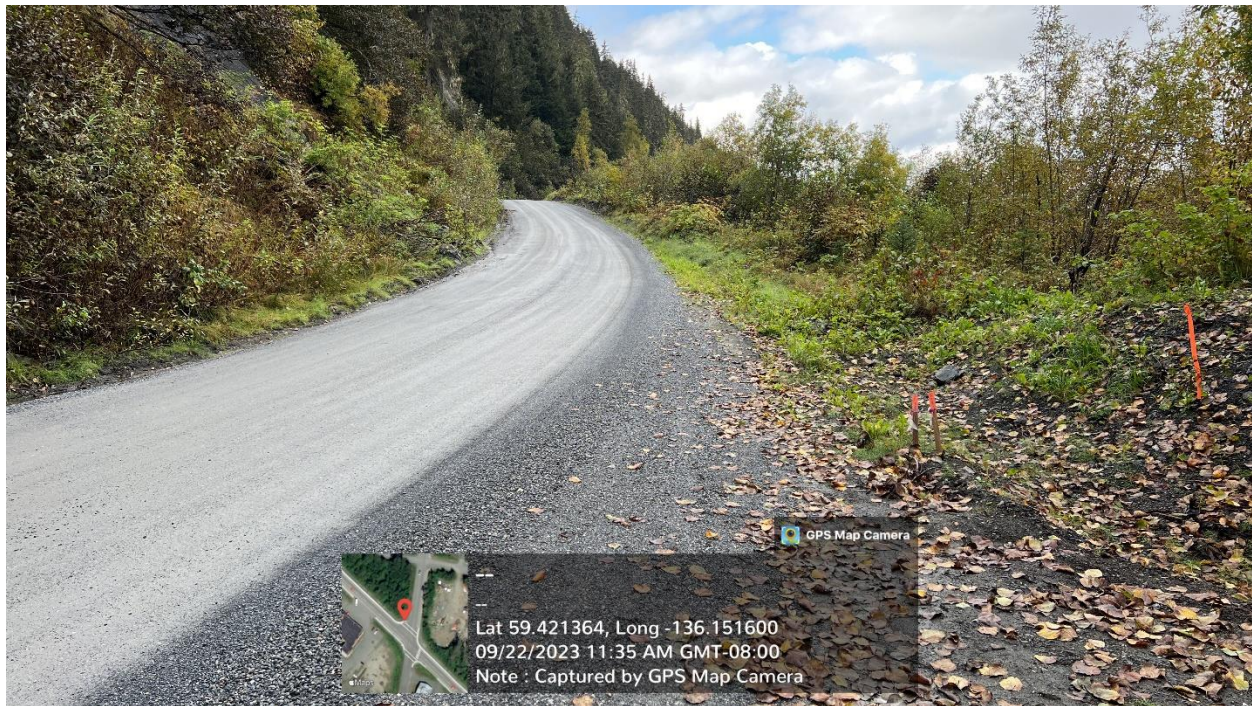
Figure A.15 - Porcupine Trail Road Phase I stop of work, photo facing end of road.

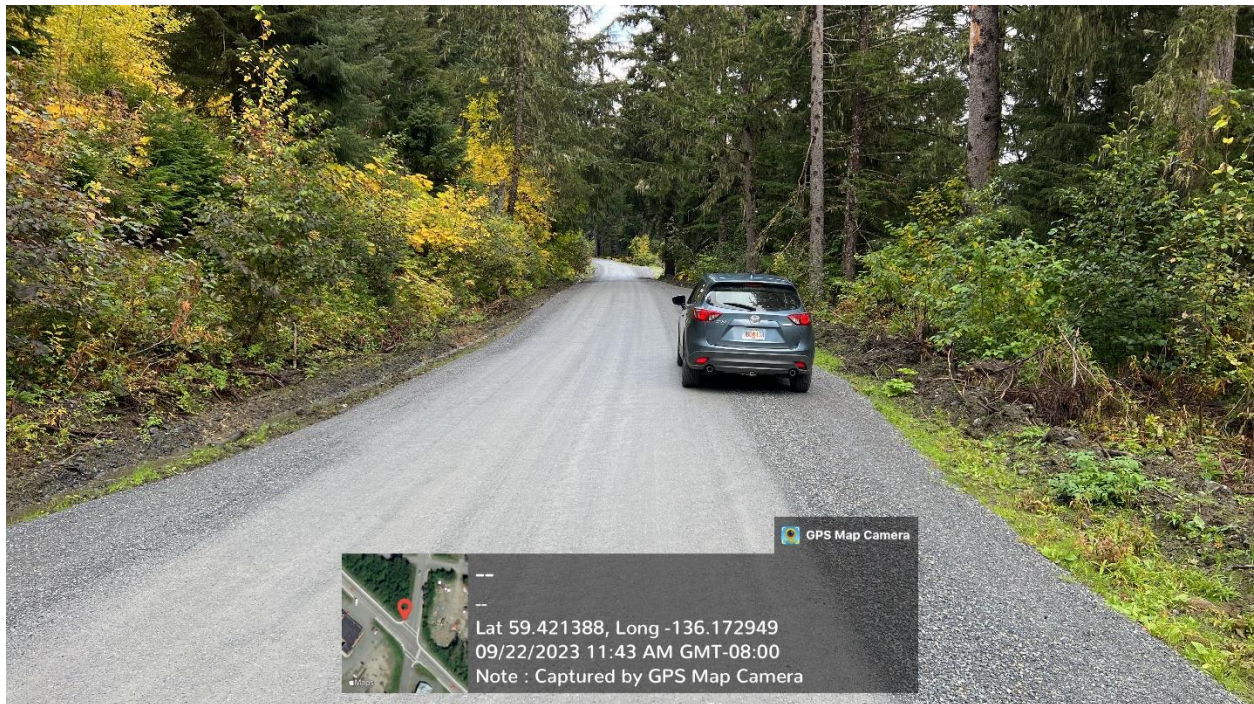
Figure A.17 - Porcupine Trail Road Phase I start of work, photo facing end of road.

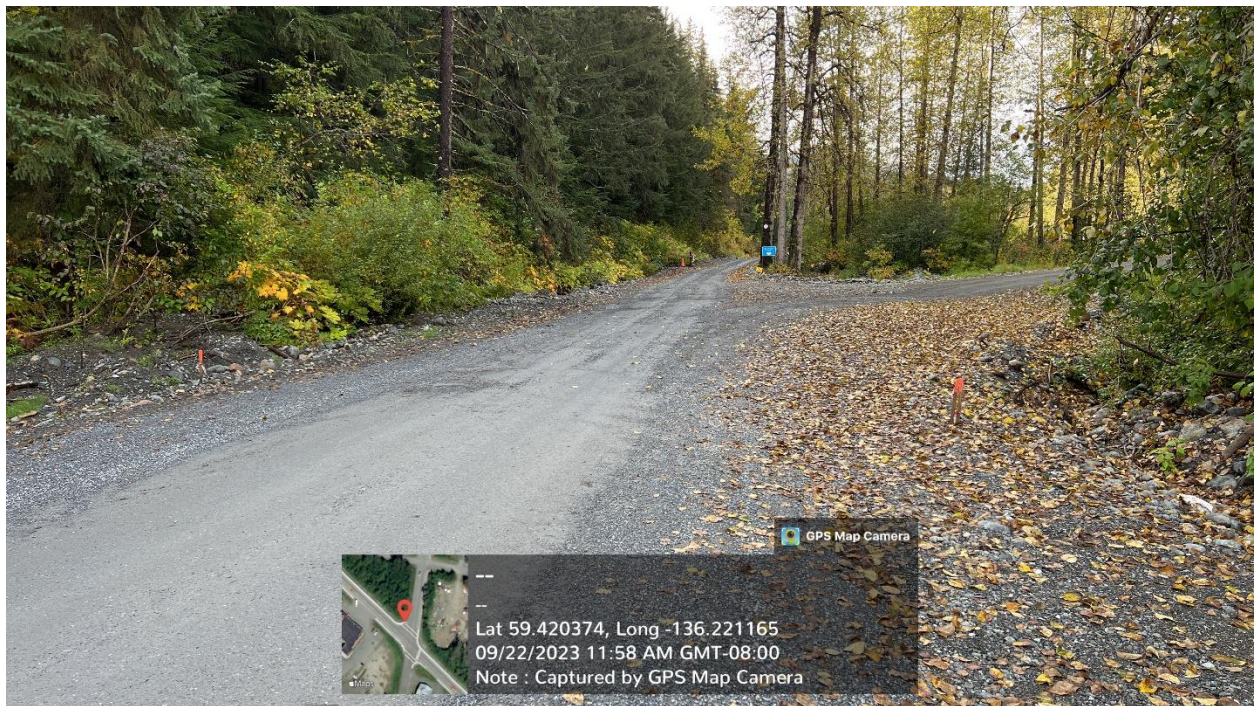
Figure A.18 - Porcupine Trail Road Phase I stop of work, photo facing end of road.

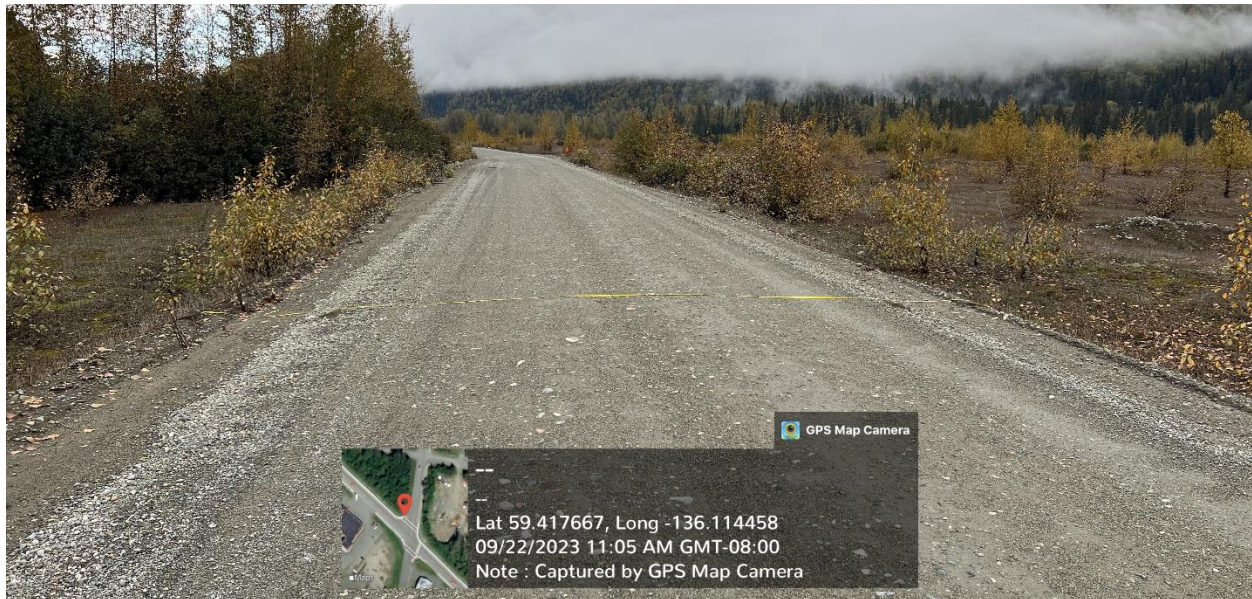
Figure C.1 – Existing, pre-disaster condition of Porcupine Trail Road outside of Phase I and Third-Party work limits. Edge of shoulder to edge of shoulder width is 28’ at this location, and width to outside edges of travel lanes (driving surface) is 20’. Theoretically, a 3’ deep section of fill with 1:1 sloped embankment could be placed here and still achieve a 22’-wide top driving surface. Photos of measurements can be provided upon request.

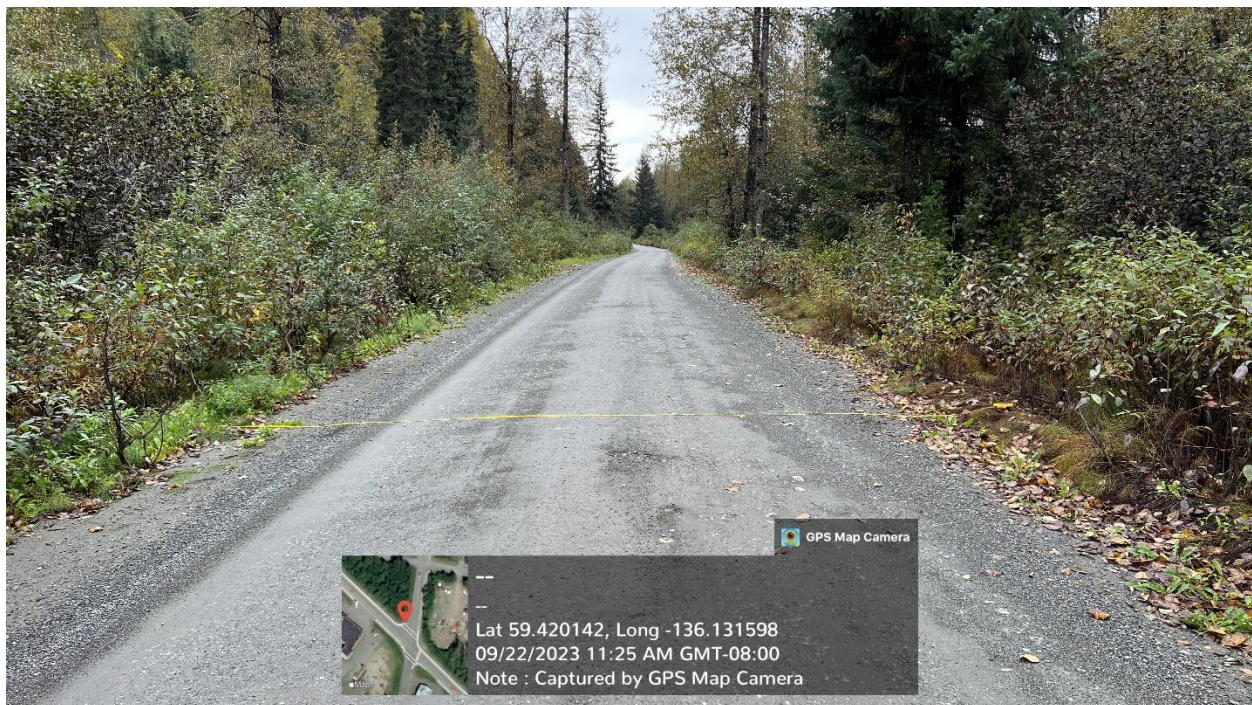
Figure C.2 – Another example of existing, pre-disaster condition of Porcupine Trail Road outside of Phase I and Third-Party work limits. Edge of shoulder to edge of shoulder width is 24’ at this location, and width to outside edges of travel lanes (driving surface) is 16.4’. Adjacent existing ditches are not included in these measurements. Photos of measurements can be provided upon request.

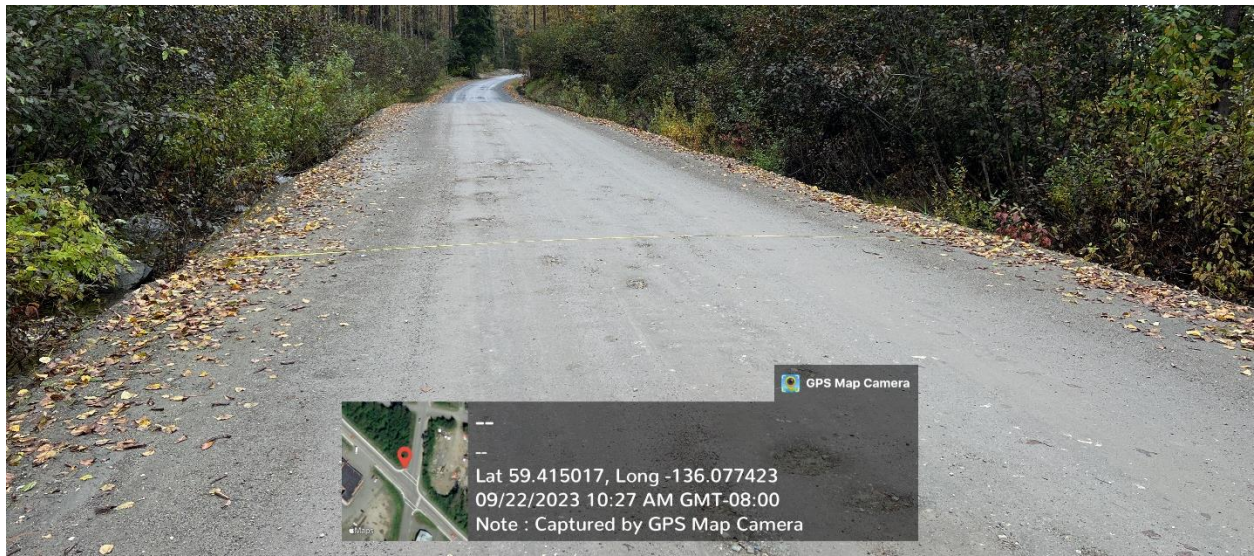
Figure C.3 – Cross section of third-party work site 1 fill area on Porcupine Trail Road, outside of Phase I work limits. Edge of shoulder to edge of shoulder width is 28’ at this location, and width to outside edges of travel lanes (driving surface) is 19’. Third-party work at this site was placement of 3’ fill only – no gravel surfacing or riprap materials were placed. Photos of measurements can be provided upon request.

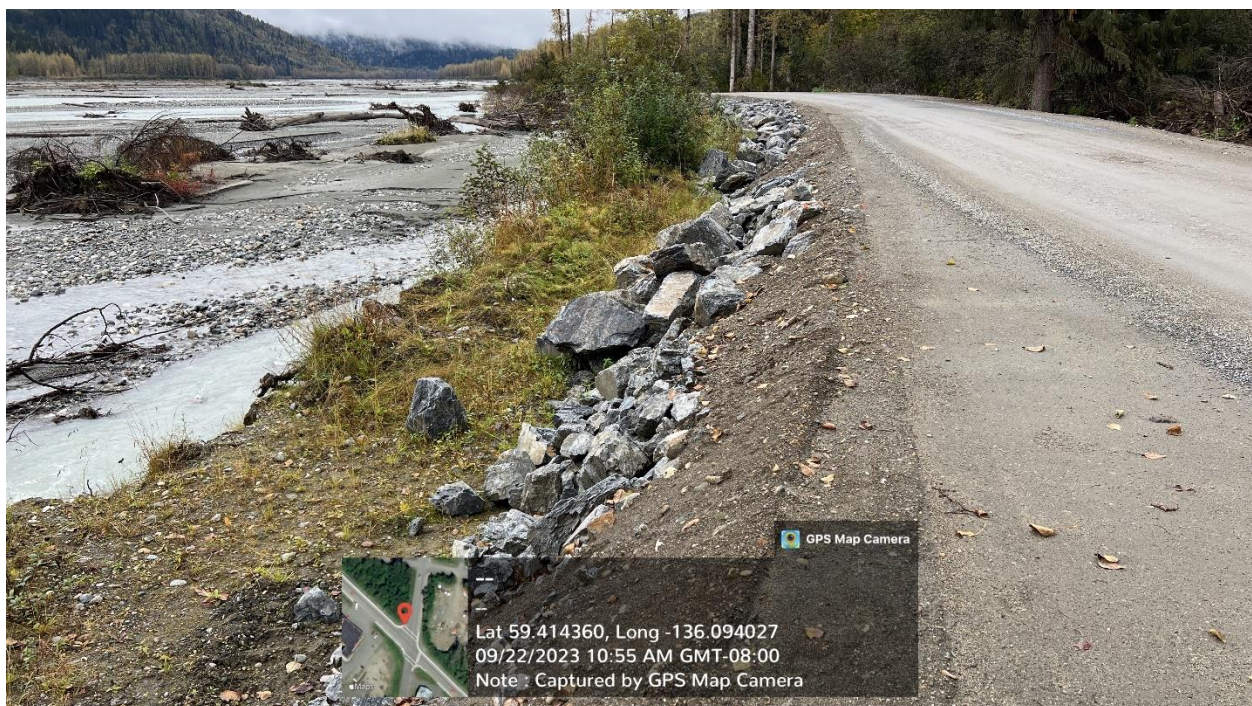
Figure C.9 – Riprap placed at third-party work site 3 on Klehini River side of roadway fill slope above ordinary high water. Note the presence of existing uplands vegetation between toe of fill and river, as well as the existing undisturbed roadway grade at toe of fill in foreground.

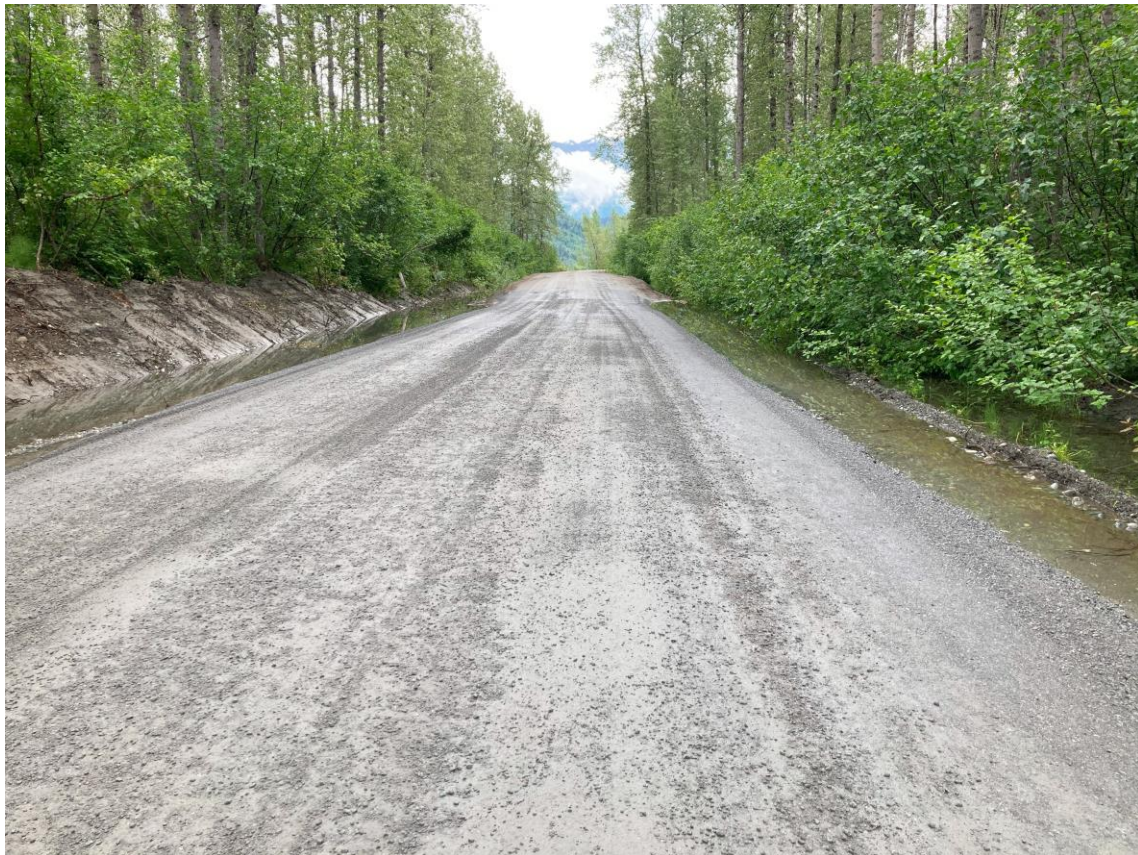
Area that water exceeded ditches

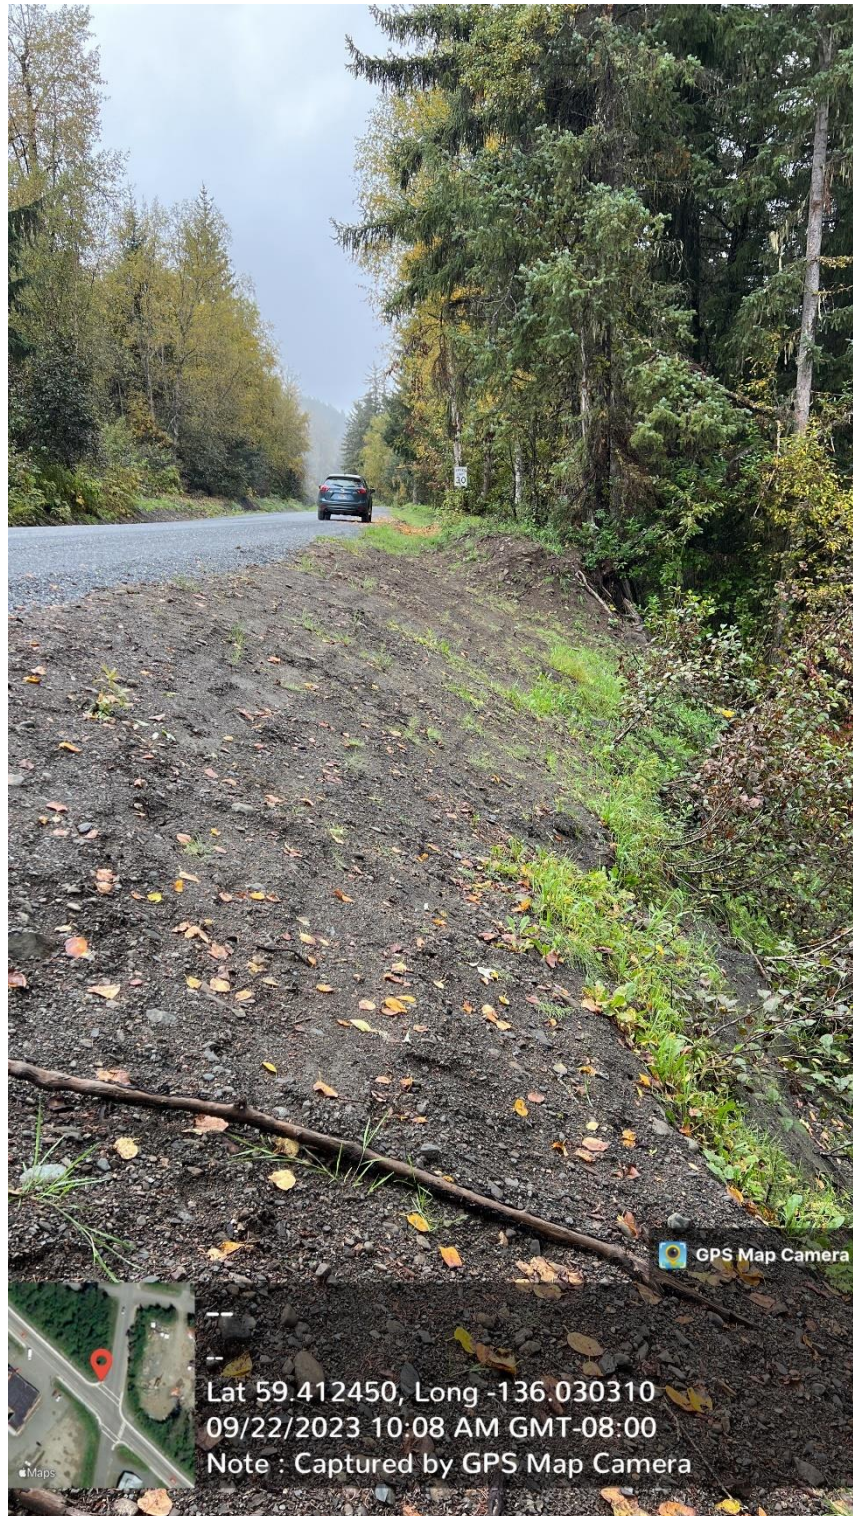
Figure F.1 – Performed as part of Phase I work, ditch and roadway reconditioning spoils were placed on the downslope side of the existing Porcupine Trail Road corridor to facilitate positive drainage from roadway surface and ditch in background of photo. Roadway reconditioning removed an existing berm along the edge of the road which blocked surface drainage and spread it downslope as shown.

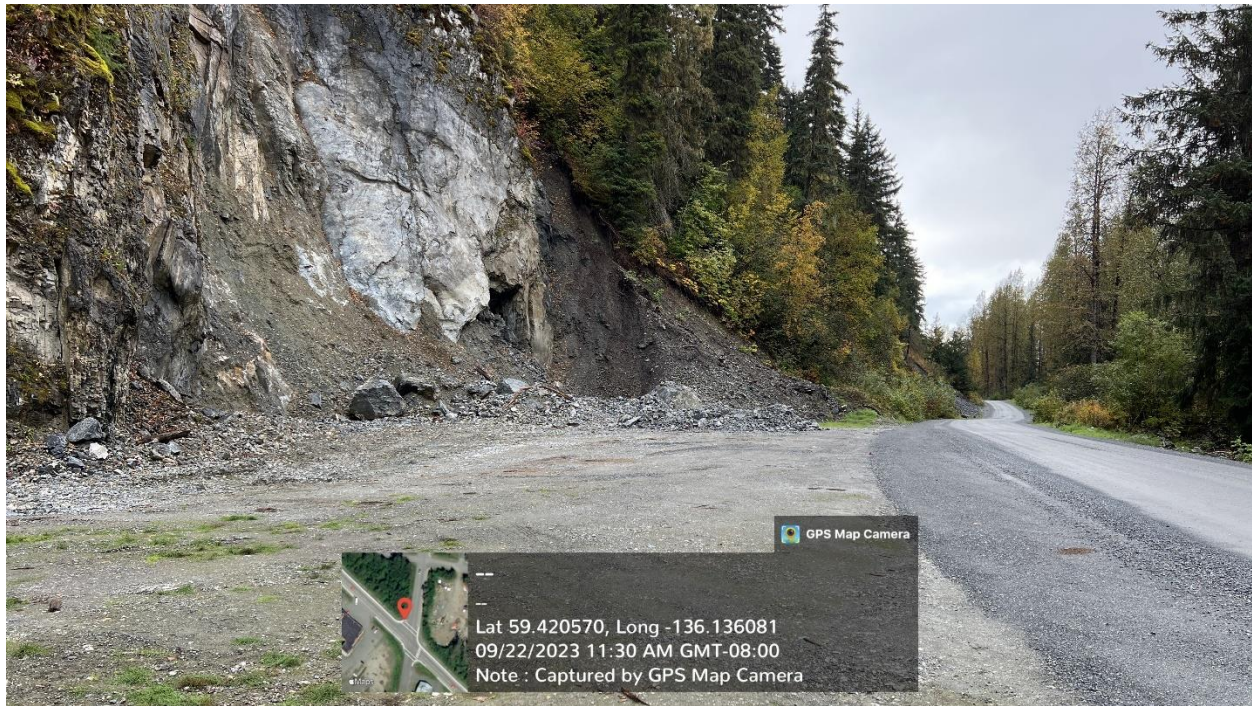
Figure G.1 – This existing material source on Porcupine Trail Road was not used for either Phase I or Third-Party work.

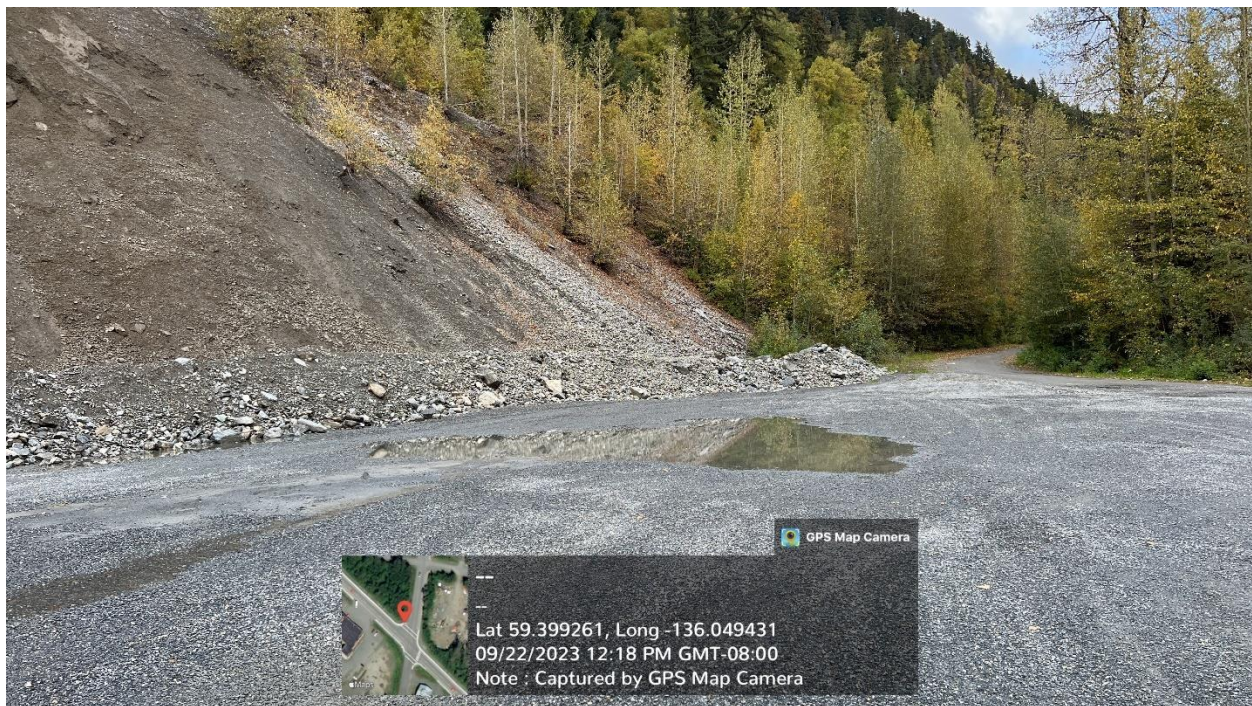
Figure G.2 – This existing material source at Sunshine Mountain was used to produce gravel surfacing for Phase I work, and riprap for Third-Party work site #3. This is also the source for materials used as part of emergency repair and protection work summarized in Attachment I. Additional photos are available.

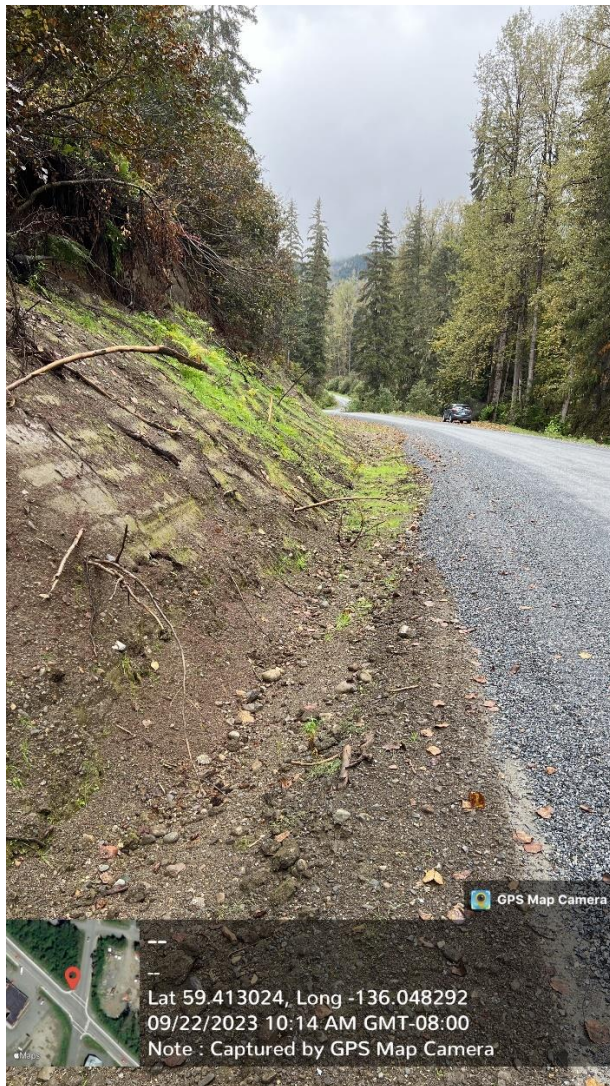
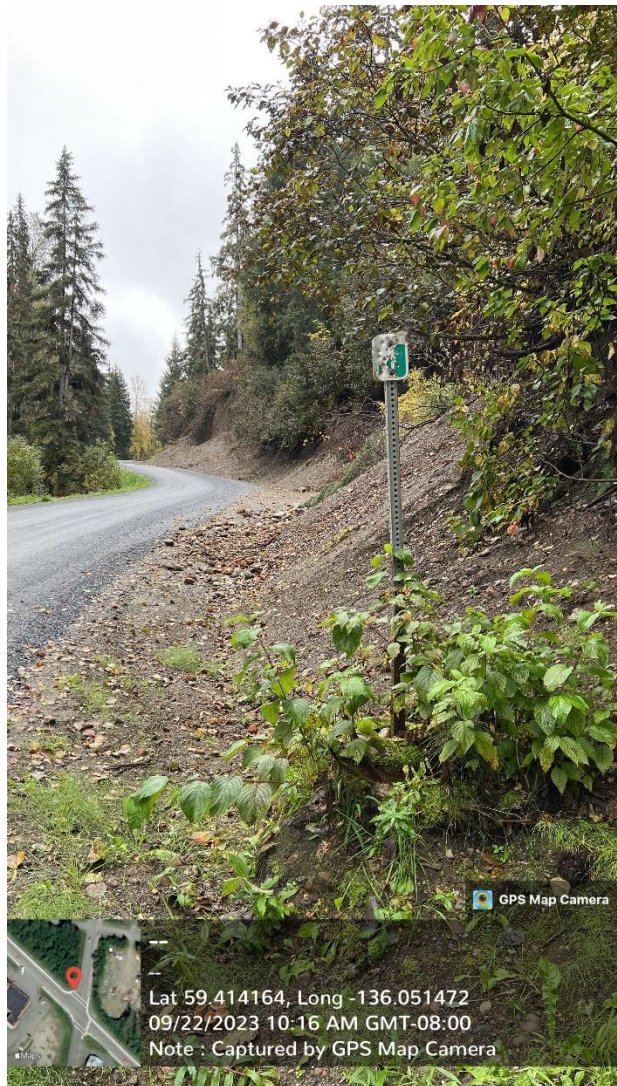
Figures G.3 (LT) and G.4 (RT) – Source of Third-Party work fill material for sites 1-3. Contractor sourced native material for fill, with approval from Alaska DNR, from existing slope adjacent to Porcupine Trail Road near Milepost 1. No other material was sourced from this location, which is within the roadway right-of-way.

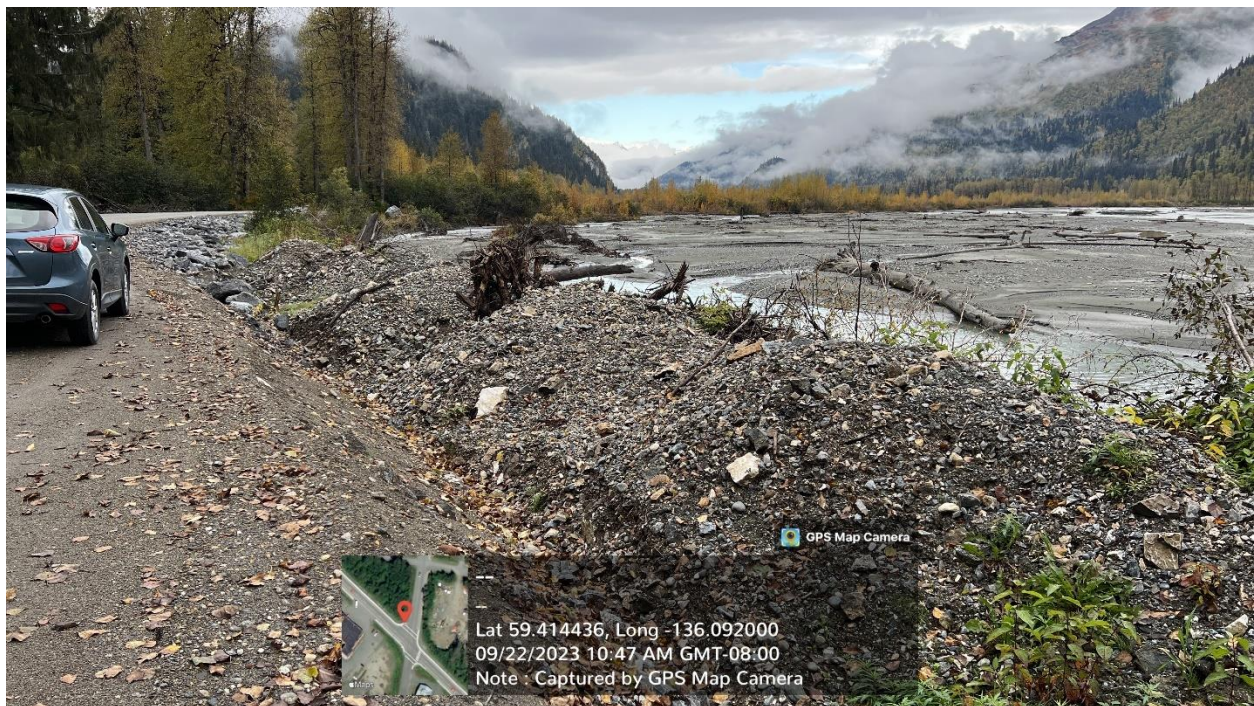
Figure H.6 – Berm on right was placed in 2022 as described in FH22-I-0090. This is the same location as 2023 Third-Party Work Site 3. Third-party work placed 3' of road fill up against backside of berm placed in 2022. Riprap placement above ordinary high water by third-party work in 2023 can be seen beyond front of vehicle in this photo (refer to Figures C.8 and C.9).

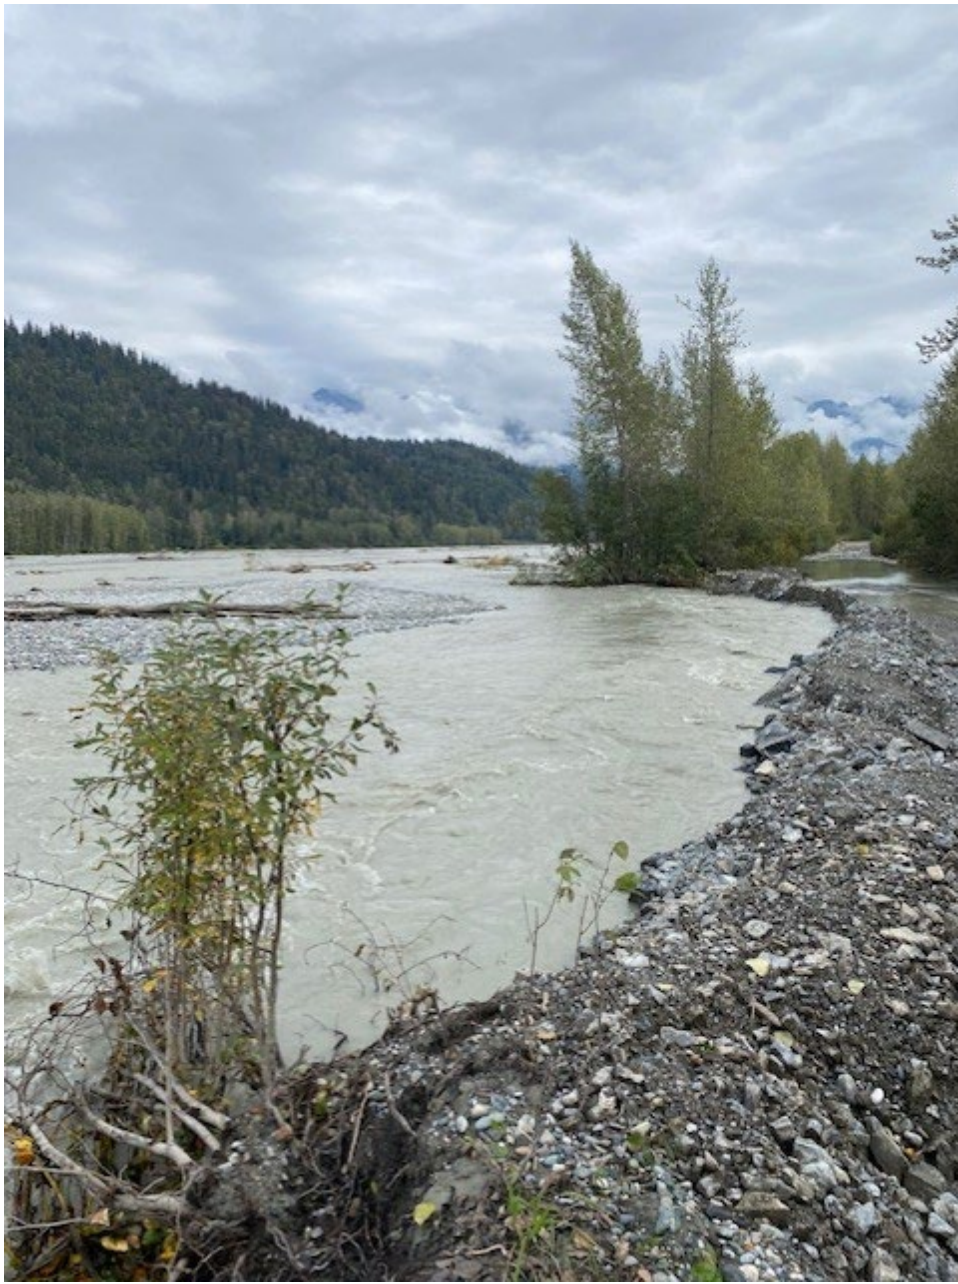
River water flowing into Herman Creek
