# Updated Findings Report

## Beach Road Landslide, Haines, Alaska

**GEOTECHNICAL INVESTIGATION, UPDATED FINDINGS REPORT  
BEACH ROAD LANDSLIDE, HAINES, ALASKA**

March 18, 2022

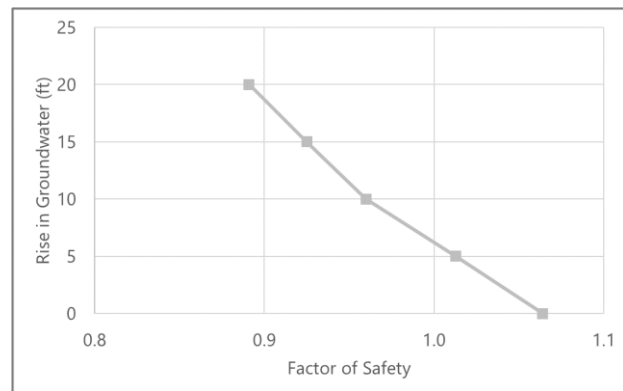
Graph 1: Section 1A – Back Analysis Results

The analyses started with a back-calculation of the existing remnant slump block represented on Cross Section 1A, which utilized 2020 topography. The purpose of the analysis was to calibrate the shear strength along the Rock 3' transition zone and headscarp (east tension crack) where marginal stability exists and the instrumentation measured slight displacements along the transition zone when groundwater spikes occurred due to significant rainfall events. The results of the analysis are presented on Figure 24 and Graph 1. The analyses confirmed that the estimated Rock 3' shear strength derived using the Hoek-Brown method is reasonable, and that the FS temporarily drops below 1.0 when groundwater pressures surge, based on the interpreted model and estimated properties. This drop in FS represents the creep movement that has been observed in the ShapeArray data for the slump block.

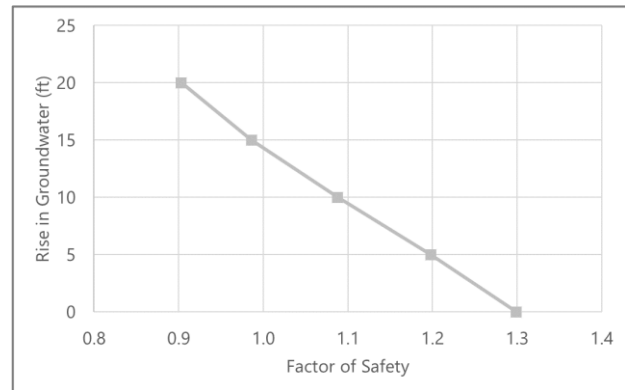
Graph 2: Section 1 – Slide 1 (Pre-Failure) Analysis Results

(Section 1 – Slide 1) followed by an upper slide (Section 1 – Slide 2) representing the documented two slide events that occurred. In the second approach, the lower slide (Section 1 – Slide 1) assumed that groundwater levels increased in the colluvium in the Mt. Riley mid-slope bench and caused liquefaction and/or instability of the slope, which triggered the landslide. As the initial slide occurred, the colluvium slumped and flowed, and its headscarp resulted in a loss of support to the upper rock block (Rock 3), decreasing the FS below 1.0 and causing the upper block to fail and collapse into the colluvium downslope (Section 1 – Slide 2). The global and local landslide analyses are illustrated on Figure 25 through Figure 27 and Graph 2 through Graph 4. The analysis results are plotted graphically, showing the effect of rising

groundwater on the Factor of Safety, ultimately leading to failure when the FS dips below 1.0.

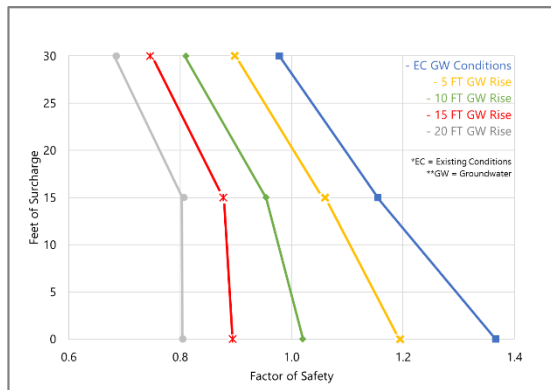
Graph 5: Section 1 – Global Slide Analysis (Post-Failure) Results

Another series of analyses were performed to model current conditions following the landslide event, and to estimate the stability as seasonal groundwater level or storm-induced spikes occur. Two landslide slip surfaces were modeled. The first slip surface assumes the landslide head is located high on the slope, and the second slip surface assumes the head located just upslope of the Mt. Riley mid-slope bench, as illustrated on Figure 28 and Figure 29. The toe of the slide for both cases was assumed at the same location as the toe of the original landslide case. The stability analyses indicate that the FS is above 1.0 for normal conditions where there is no significant precipitation, and there would be a potential for renewed slide movement when groundwater levels increase due to significant rainfall events. The results of the analyses are presented on Figure 28 and Figure 29, and Graphs 5 and 6 (zero surcharge results).

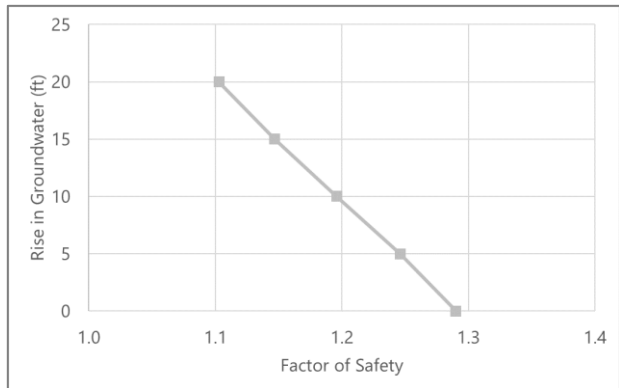
Graph 7: Section 2 Analysis Results

Section 2 represents the hillside immediately to the east of the landslide and east slump block (east tension crack), where boring LT-2 was drilled. The analyses show why this area of the hillside did not fail during the December 2020 storm. With groundwater at current baseline levels, the FS would be approximately 1.3. Even if the groundwater level rises 20 feet, the resulting FS would be greater than 1.0, approximately 1.1. The results of the stability analyses are presented on Figure 30 and Graph 7.

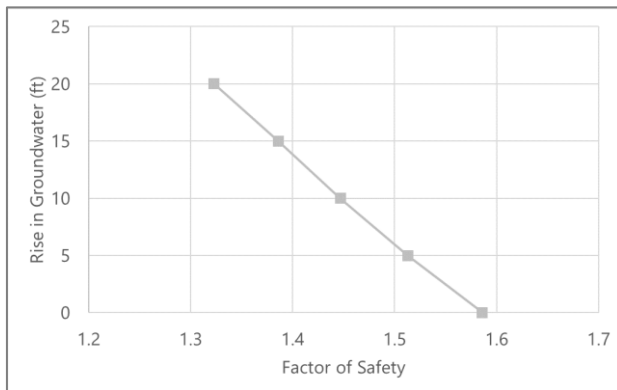
Graph 8: Section 3 Analysis Results

Section 3 represents the hillside in the east portion of the AOC, where boring LT-1 was drilled. The analyses show why this area of the hillside did not fail during the December 2020 storm. With groundwater at current baseline levels, the FS would be approximately 1.5. Even if the groundwater level rises 20 feet, the resulting FS would be greater than 1.0, approximately 1.3. The results of the stability analyses are presented on Figure 31 and Graph 8.

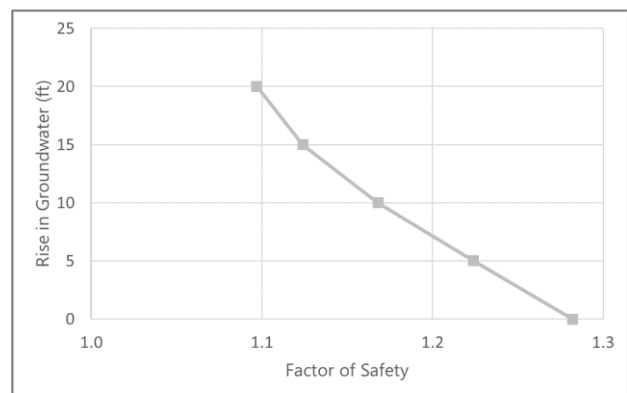
Graph 9: Section 4 Analysis Results

Section 4 represents the hillside in the west portion of the AOC, where borings LT-8, LT-9, and LT-10 were drilled. The analyses show why this area of the hillside did not fail during the December 2020 storm. With groundwater at current baseline levels, the FS would be approximately 1.3. Even if the groundwater level rises 20 feet, the resulting FS would be greater than 1.0, approximately 1.1. The results of the stability analyses are presented on Figure 32 and Graph 9.

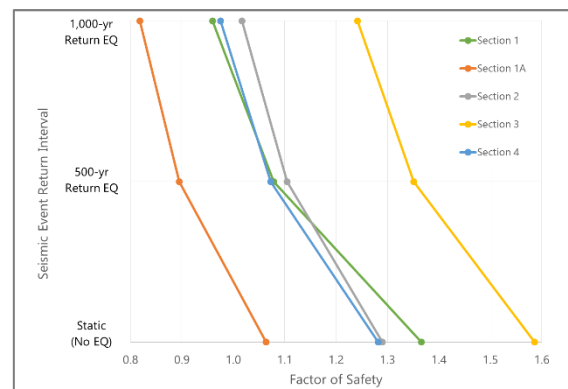
Graph 10: Pseudo-Static Seismic Stability Results

Pseudo-static stability analyses utilize a seismic coefficient to estimate earthquake forces impacting the stability of the landslide. Typically, the seismic coefficient is a proportion of the PGA, accounting for the transitory nature of the ground motions and the variability of the motions within different parts of the landslide. Analyses utilized a seismic coefficient,  $k_h$ , of  $0.5 \cdot \text{PGA} = 0.14\text{g}$  for the 1,000-year return and  $0.09\text{g}$  for the 500-year return. The groundwater pressure profiles used in the seismic analyses assume current conditions without estimated increased due to rainfall events. The results of the pseudo-static stability analyses are shown on Graph 10.

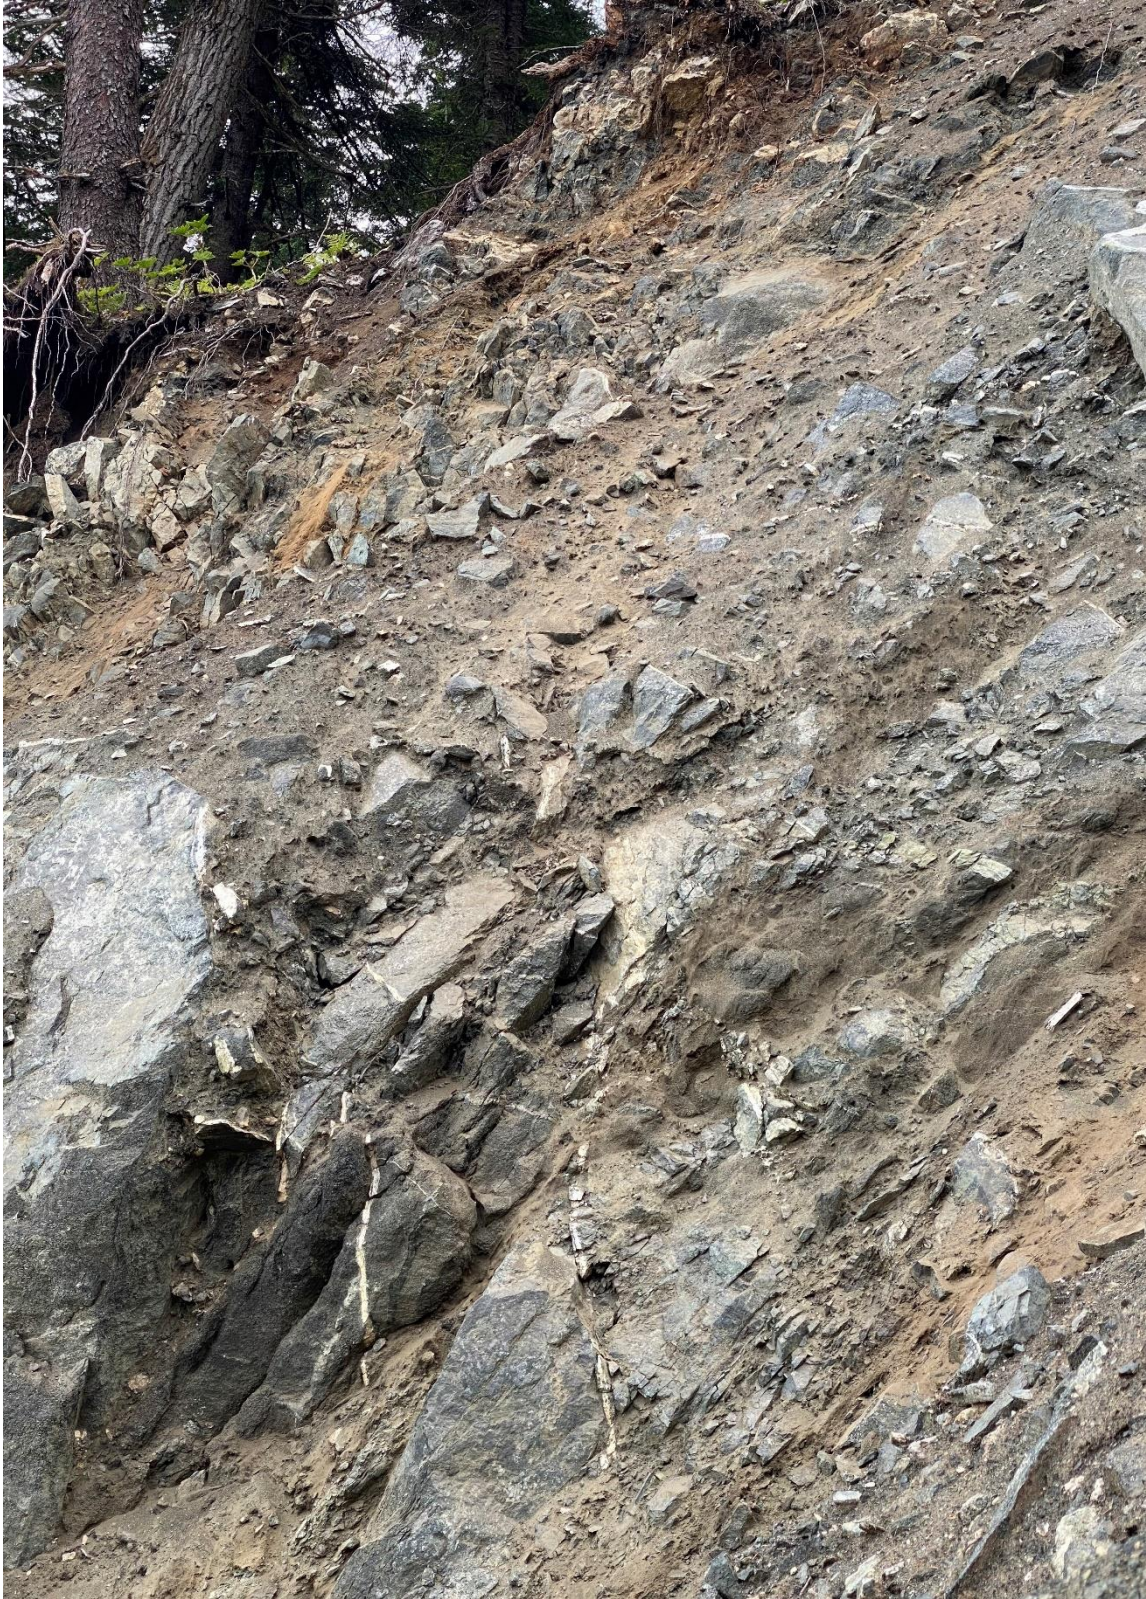
Colluvium 1 at elevation 670-680 on the West Soil Scarp.

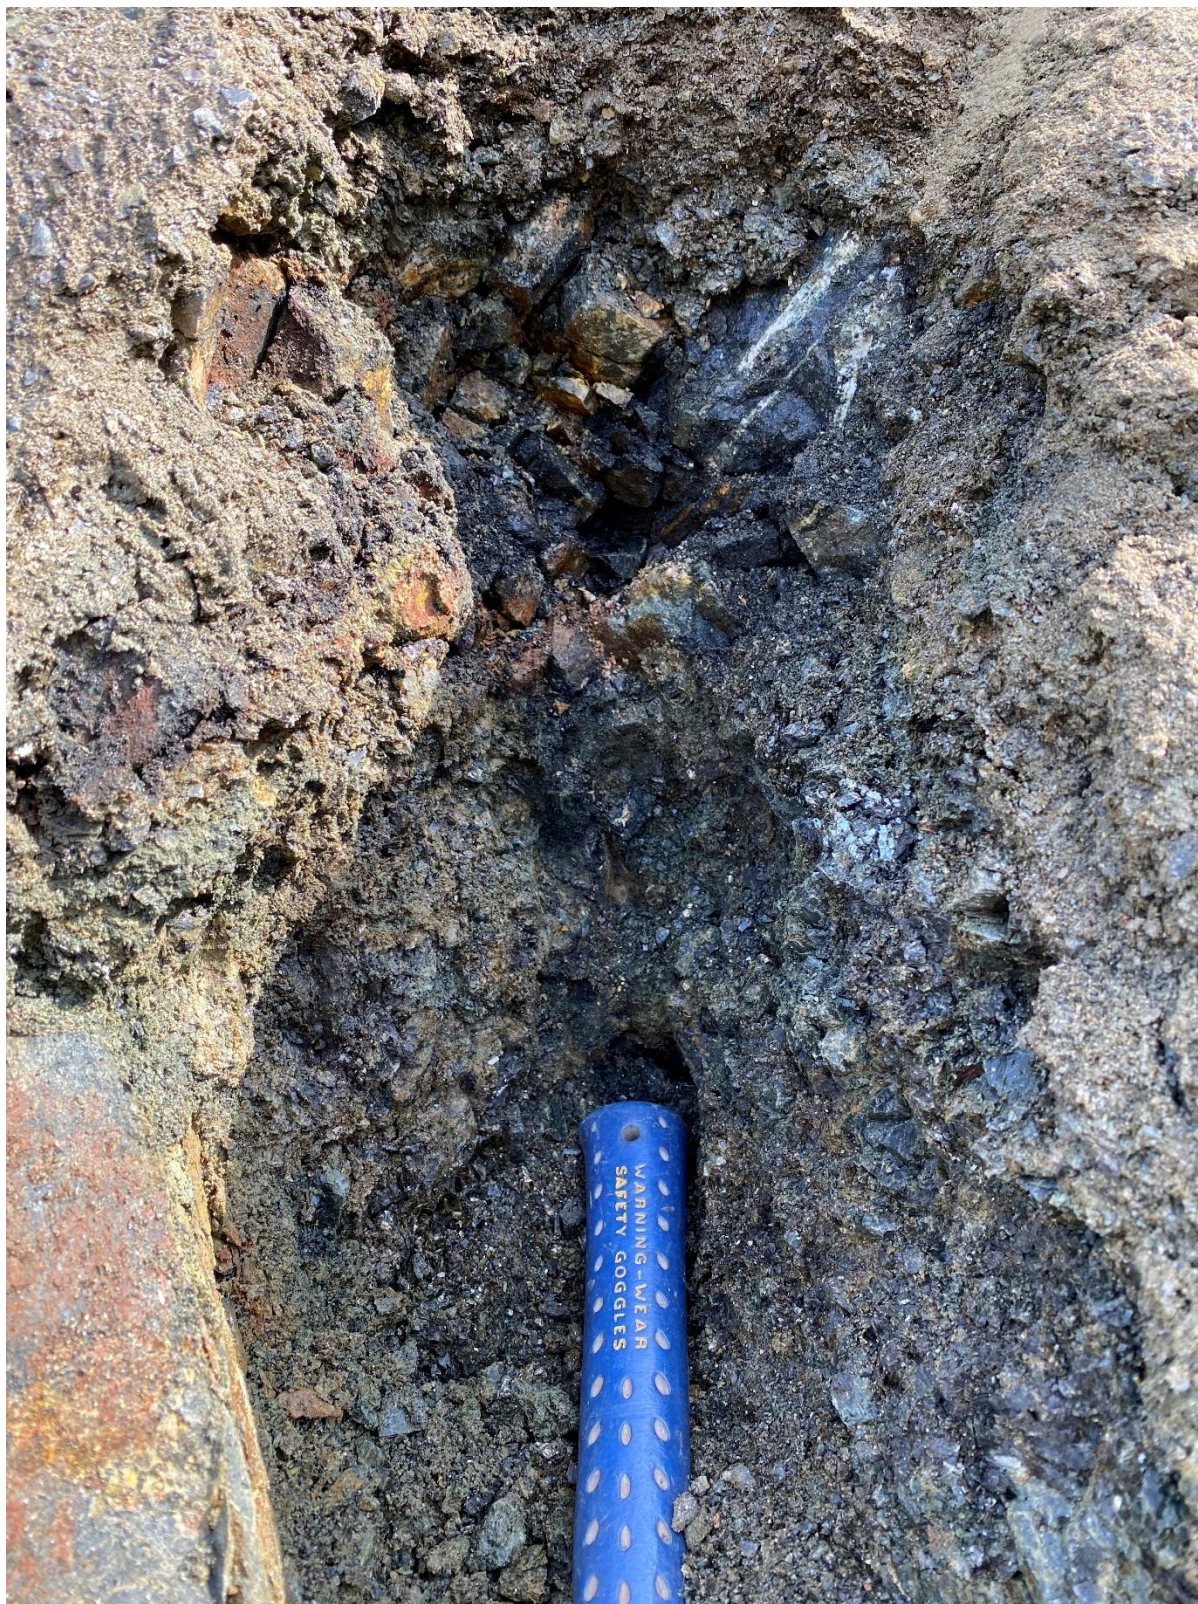
Colluvium 1 at elevation 630 feet on the West Soil Scarp.
