Inspection and Assessment of Lutak Dock Haines, Alaska

May 2014
14-2449

**RE: Inspection and Assessment of Lutak Dock,
Haines, Alaska**

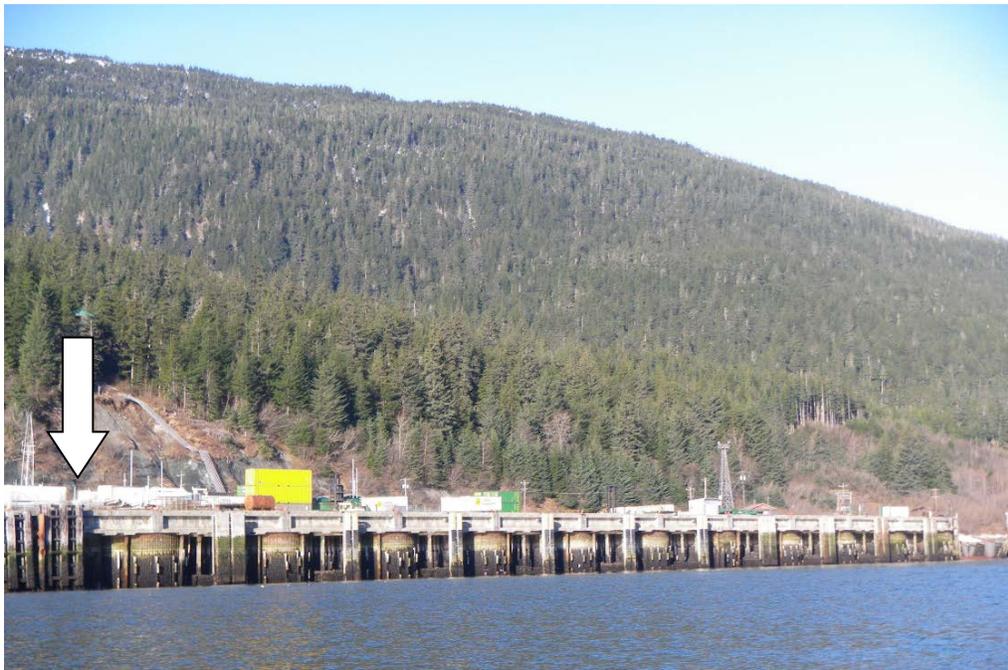
PHOTO No. 1: Lutak Dock, Looking Southwest - Note the arrow indicating the division between the western end owned by the Borough of Lutak and the eastern portion owned by the State. Cell 1 is located in the distance at the west end of the structure.

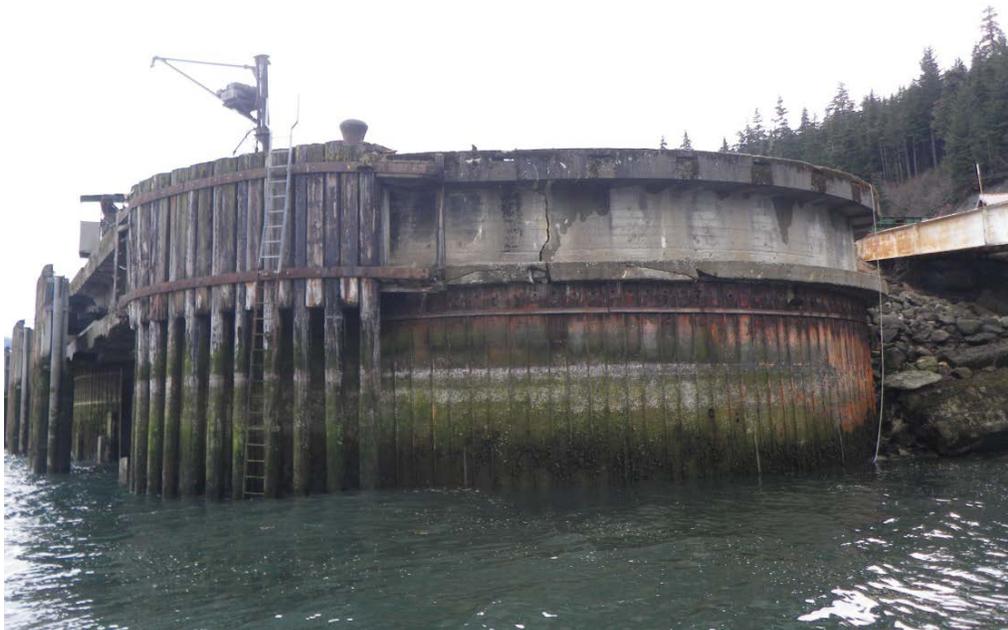
PHOTO No. 2: Main Cell No. 1, Looking East - Inspection noted that this portion of the cell has not been outfitted with any sacrificial anodes. The inspection did note on-going surface corrosion in this area.

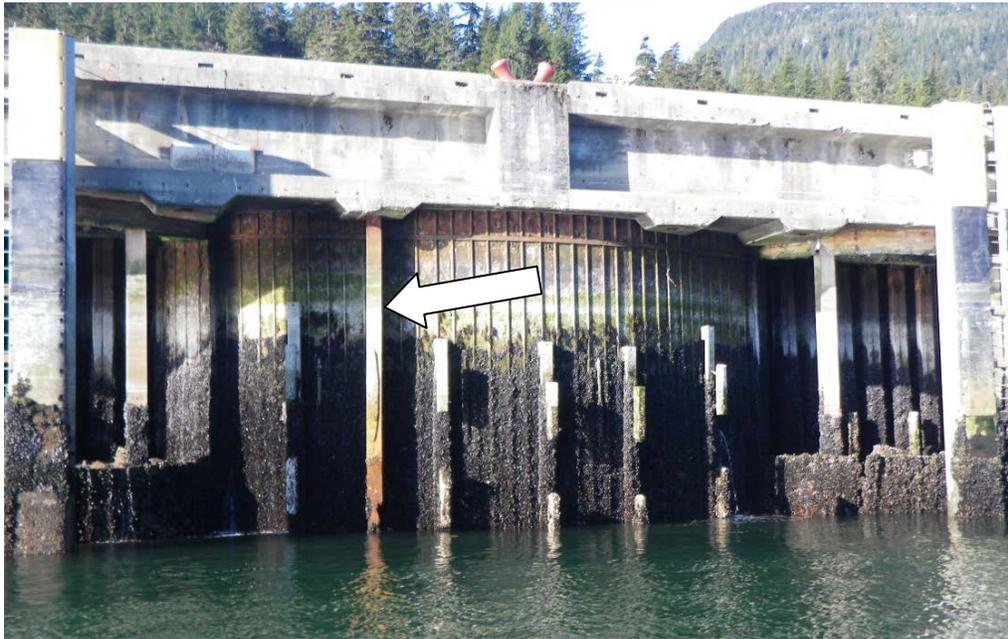
7. Inspection of the anodes found them to be in overall good condition with an estimated 75-90% of their volume remaining. Refer to Photo No. 3.
8. Level III ultrasonic thickness testing was conducted on three (3) main cells. Level II cleaning and site preparation was carried out using a combination chipping hammer, wire brushing and grinding. Areas at and near the mudline were found to have a very

PHOTO No. 3: Main Cell No. 9 - Note the two elevations of sacrificial anodes visible above water. Also note the lower original circular closure arcs and the straight repair sections of the closure arcs on each side of the main cell. The arrow indicates a derelict H-pile that has been made redundant by the maintenance repair work.

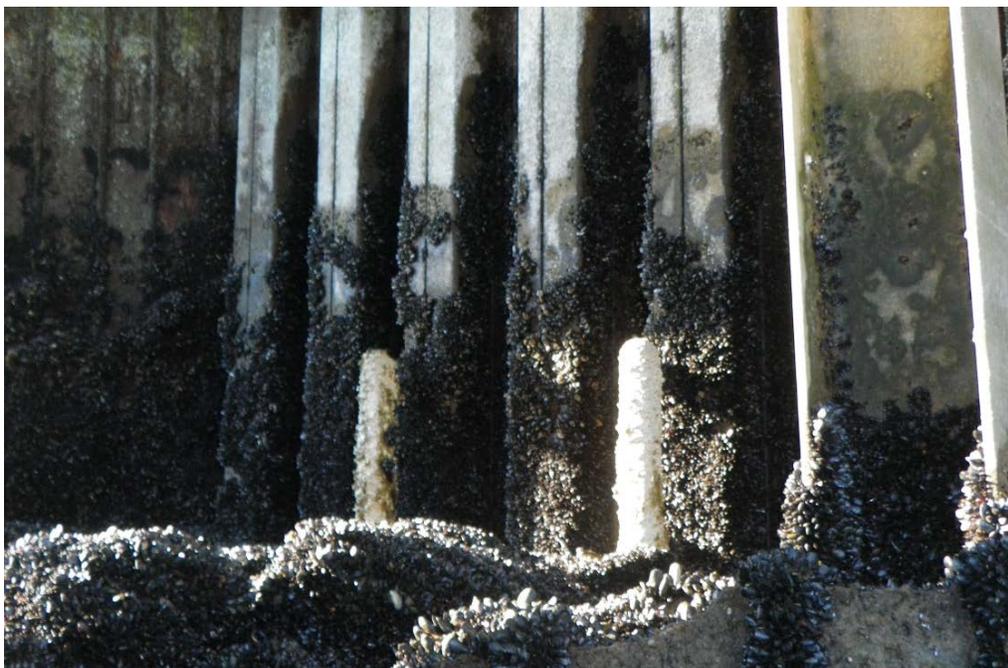
PHOTO No. 4: Closure Arc No. 1.5 Repair - Note the good condition of the new steel and the sacrificial anodes that have been estimated to retain ~75% of their original volume.

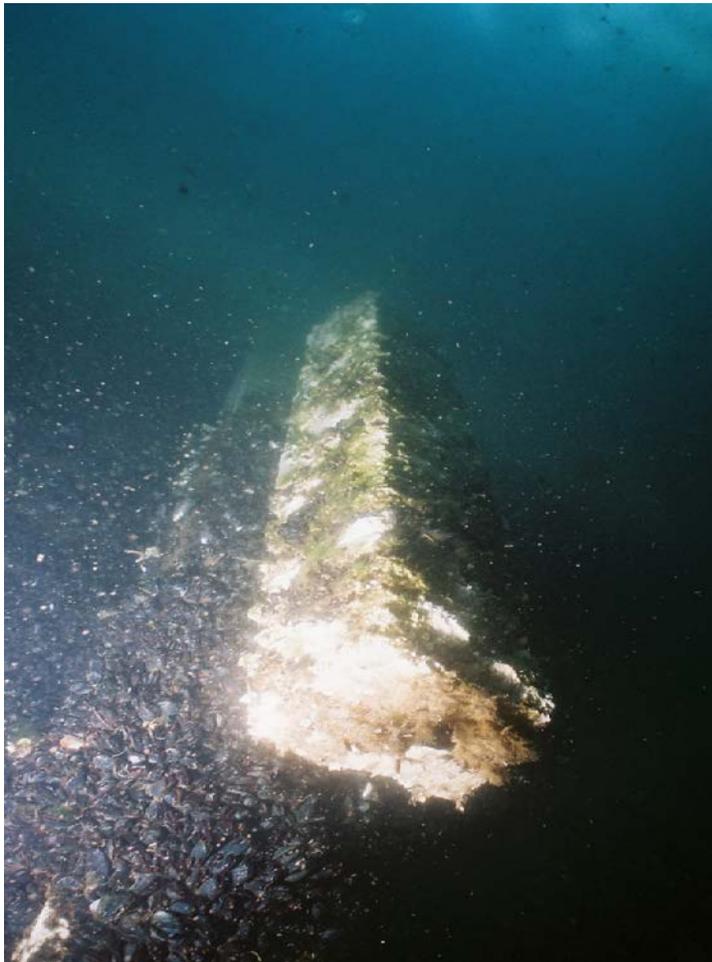
6. Inspection of the main cells found that each has been outfitted with five sets of sacrificial anodes spaced evenly around the curve of the cell and attached to the sheet piles with welded connections. Each set of anodes consists of a vertical channel with five (5) anodes spaced evenly from the intertidal zone to near the mudline. Based on the reference drawings provided, the anodes are 250 lb. stand-off anodes. Refer to Photo No's 3 and 5.

PHOTO No. 5: Main Cell No. 4, Anode - Inspection of the submerged anodes found them to retain an estimated 75-90% of their original volume.

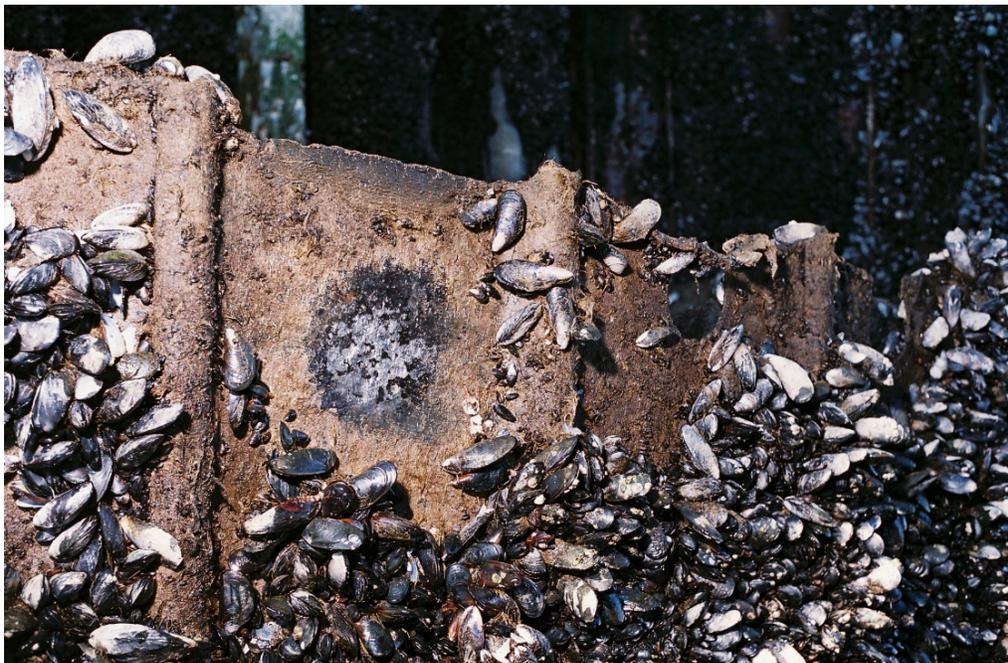
PHOTO No. 6: Closure Arc No. 6.5, Test Site - This Level II and Level III Test site is located at ~El. +3' on the center of the cell (i.e. 6 o'clock position). Note the uneven surface of the steel in the cleaned area.

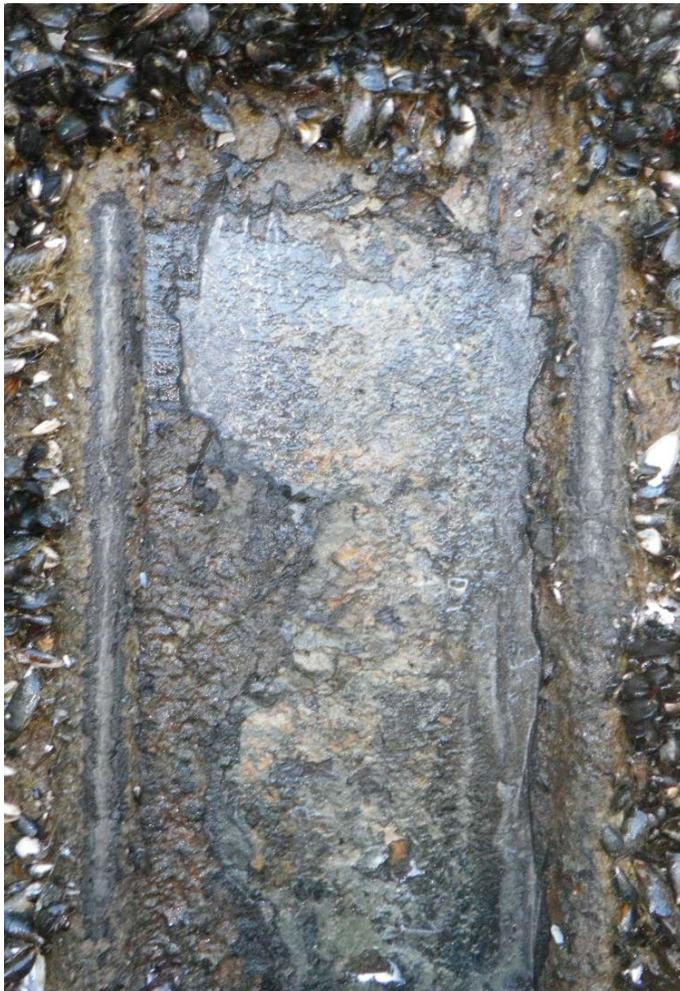
4. Level II spot cleaning found the base metal to be irregular with areas of striation and pitting. Loss of section was evident and based on visual observation the loss of thickness was estimated at 1/32 – 1/8 inch. Refer to Photo No. 7.

PHOTO No. 7: Main Cell No. 6, Test Site - Note the surface corrosion that is visible along the edges of the cleaned area at this El. 0' test site . The scale at this location is typical of the intertidal zone and was approximately 1/16 to 1/8 inch thick. Also note the uneven surface of the underlying cleaned steel.

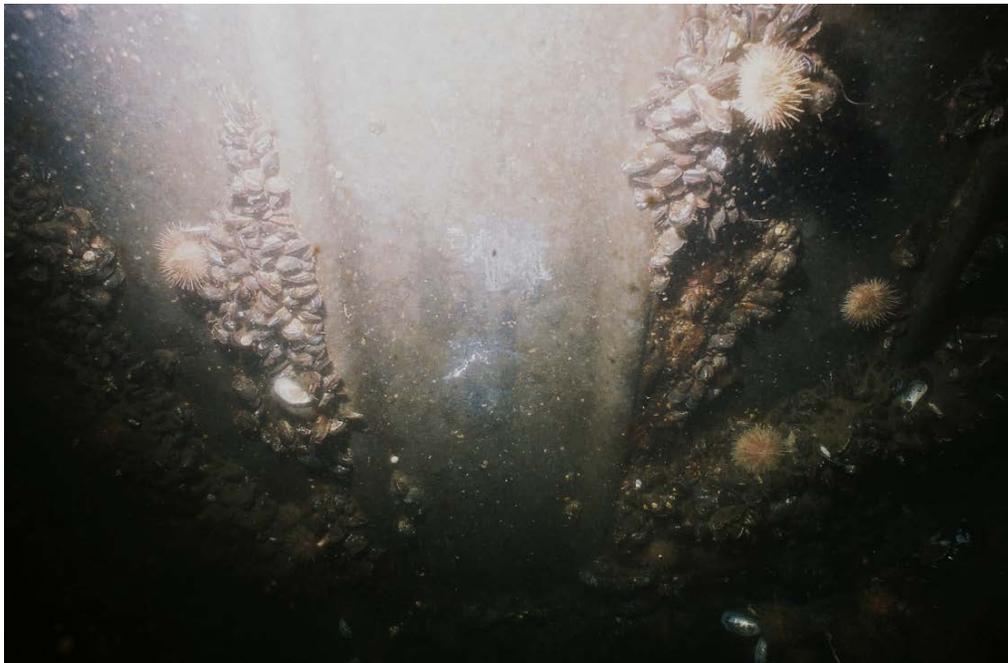
PHOTO No. 8: Closure Arc 9.5, Test Site - This location within the submerged zone, near the mudline was found to be generally clear of significant scale and smooth making Level III readings easier to obtain. This condition was not typical of the conditions encountered.

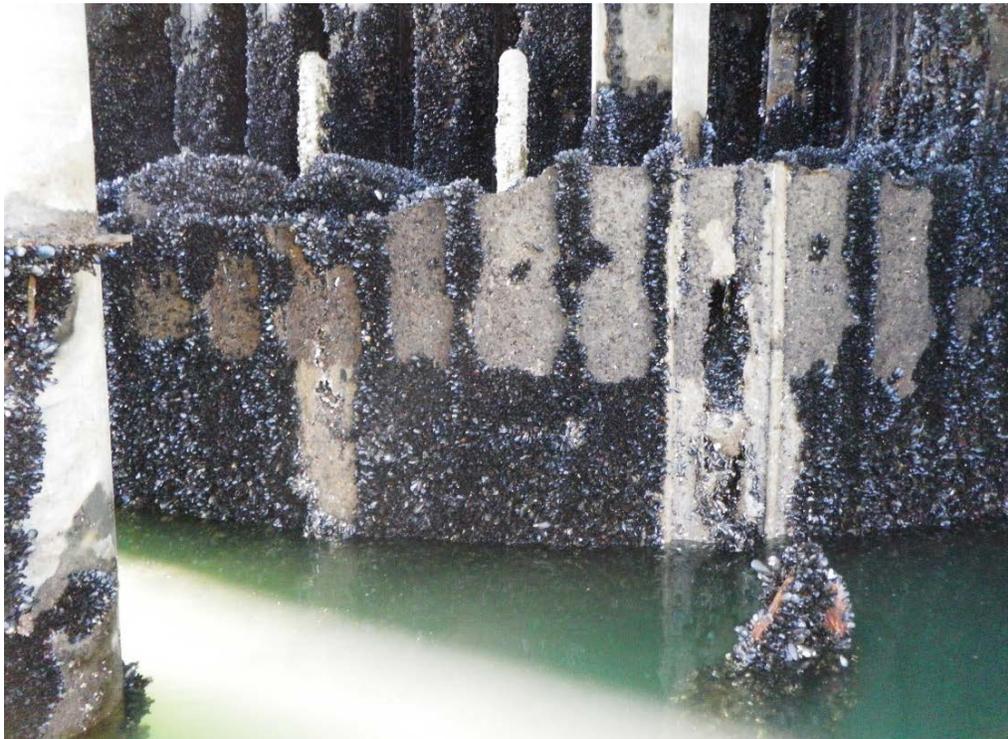
PHOTO No. 9:
Closure Arc No. 1.5, West Side -
Note the sheet piles which have been cleaned showing areas of perforation.

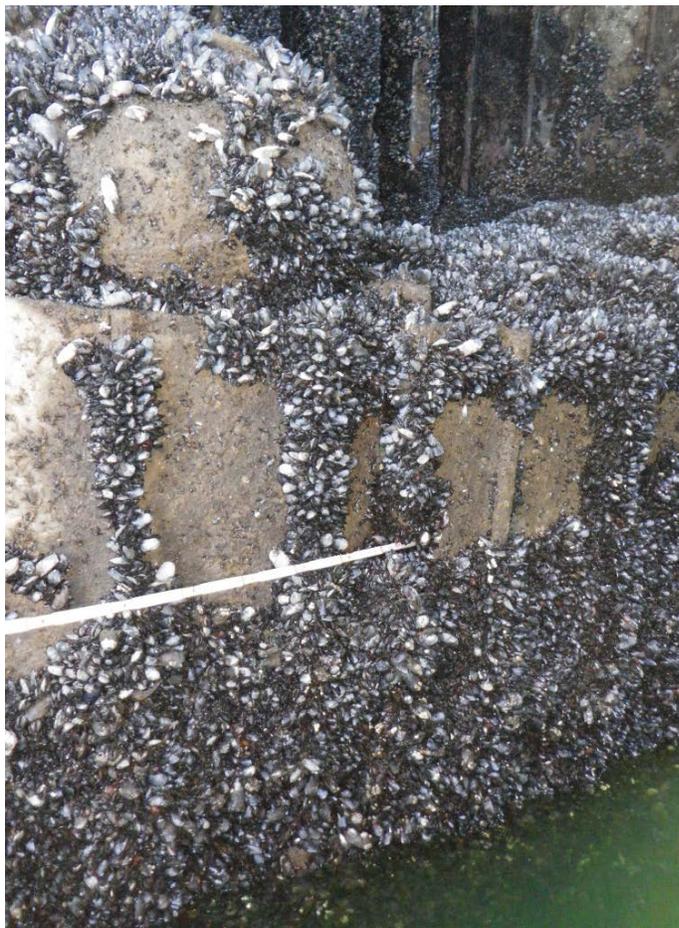
PHOTO No. 10: Closure Arc No. 1.5, East Side - Note the aluminum rod inserted into a perforation in the sheet pile. Also note the typical moderate to heavy coating of mussels that is present in the intertidal and submerged zones which hinders visible observation of defects.

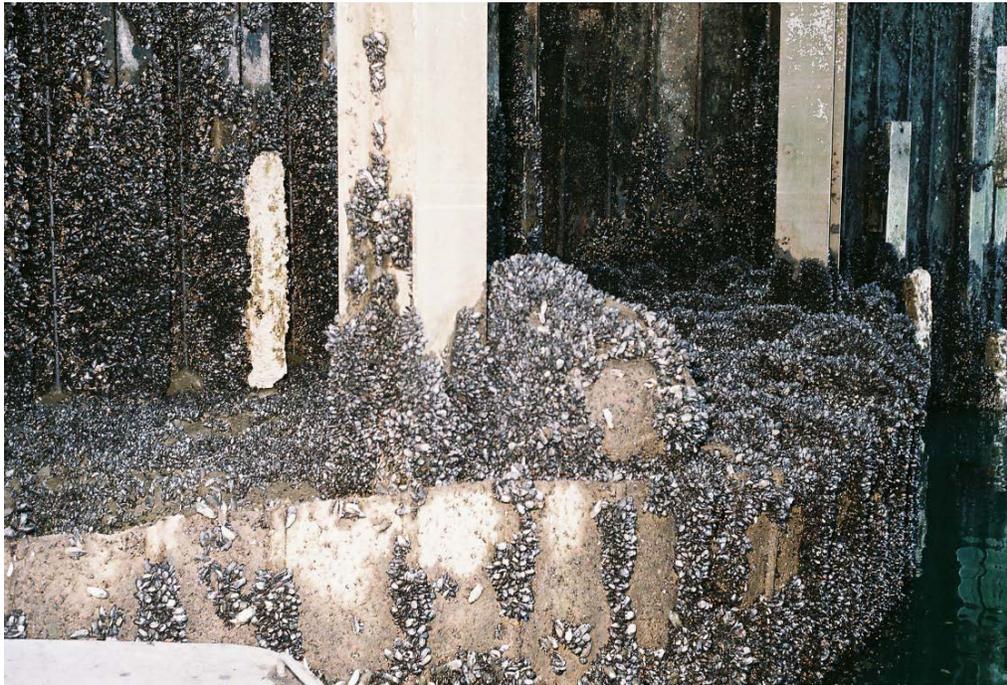
PHOTO No. 11: Closure Arc No. 1.5, Looking West - Note the elevation of the backfill present behind the original closure arc cell. Investigation did not find any evidence indicating loss of fill at this location.

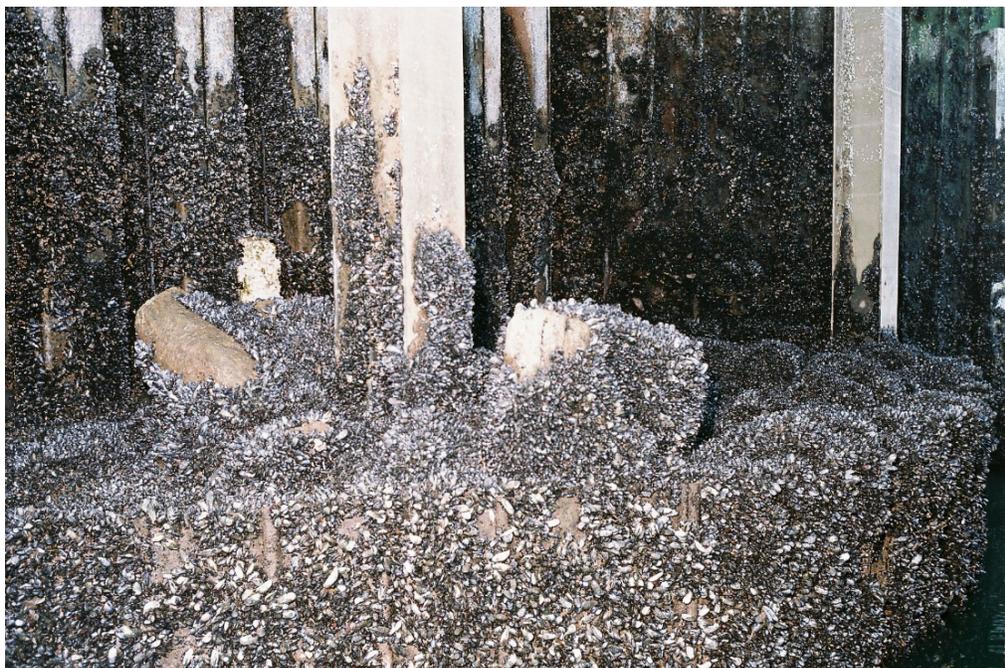
PHOTO No. 12: Closure Arc No. 2.5, Looking West - Investigation of this closure arc found three perforations of the sheet piling but no visible loss of backfill.

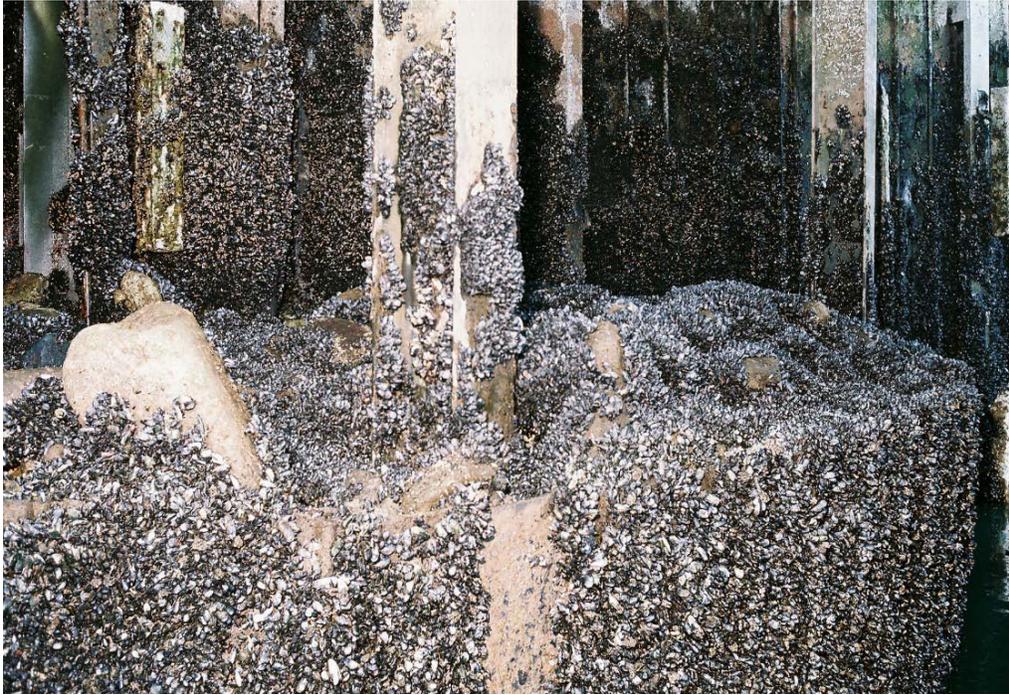
PHOTO No. 13: Closure Arc No. 3.5, Looking West - No evidence of perforation of the sheet piling or loss of backfill was found associated with this circular closure arc.

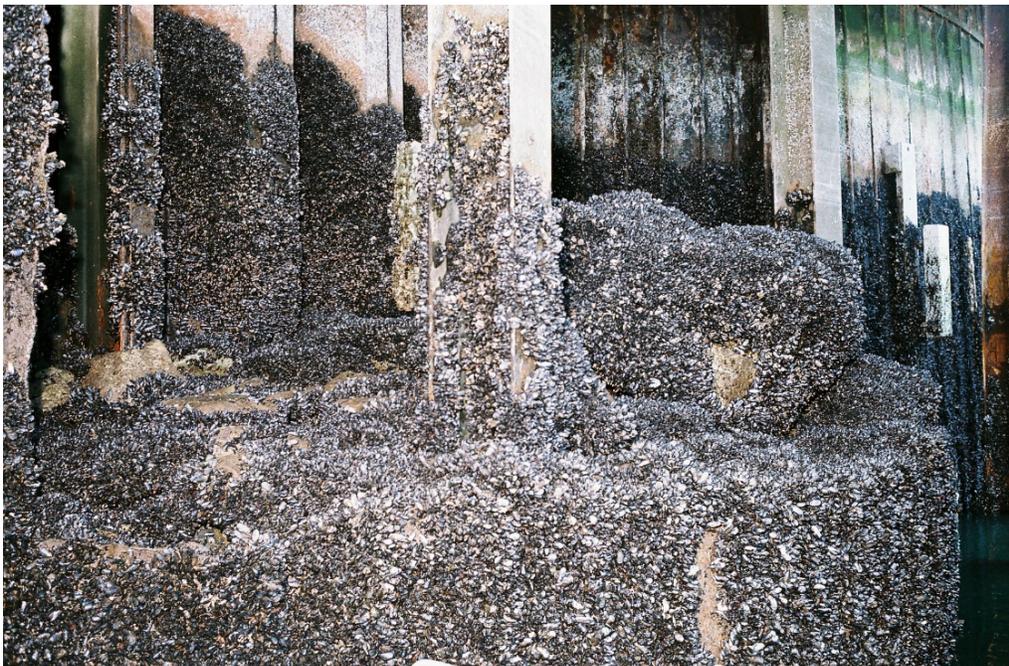
PHOTO No. 14: Closure Arc No. 4.5, Looking West - No evidence of perforation of the sheet piling or loss of backfill was found associated with this circular closure arc.

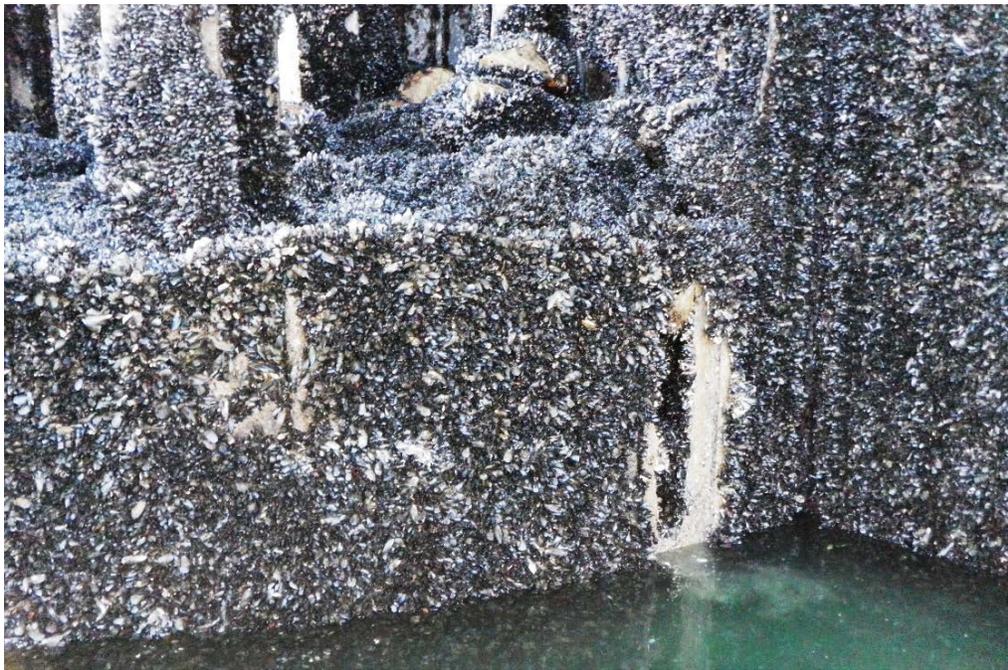
PHOTO No. 15: Closure Arc No. 5.5, West Side - Note the Level II cleaned area revealing perforation of the sheet pile.

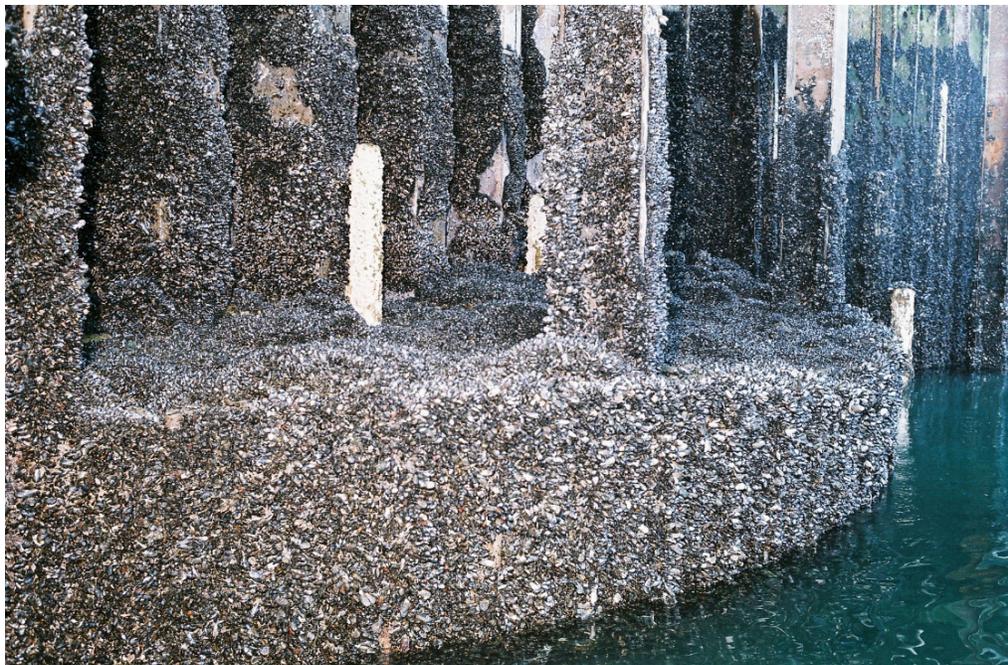
PHOTO No. 16: Closure Arc No. 5.5, East Side - No evidence of perforation was identified on the east side of this closure arc. Note the level of the back fill and the overall good condition of the anodes.

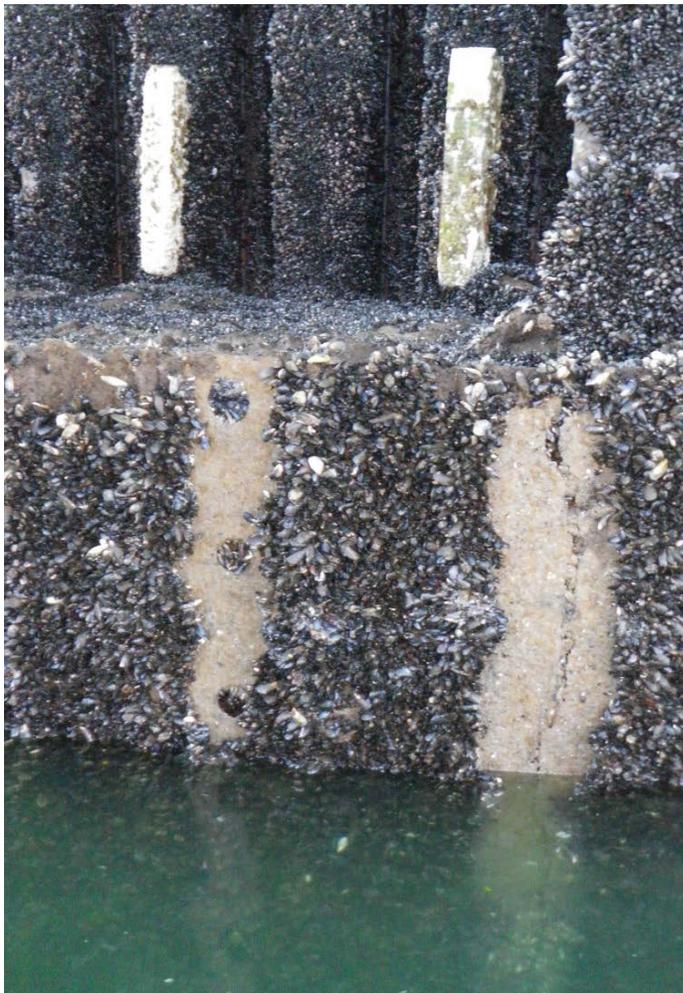
PHOTO No. 17: Closure Arc No. 6.5, West Side - Note the rip along the right sheet pile and the multiple construction / weep holes in the sheet pile on the left which have both been subjected to Level II cleaning.

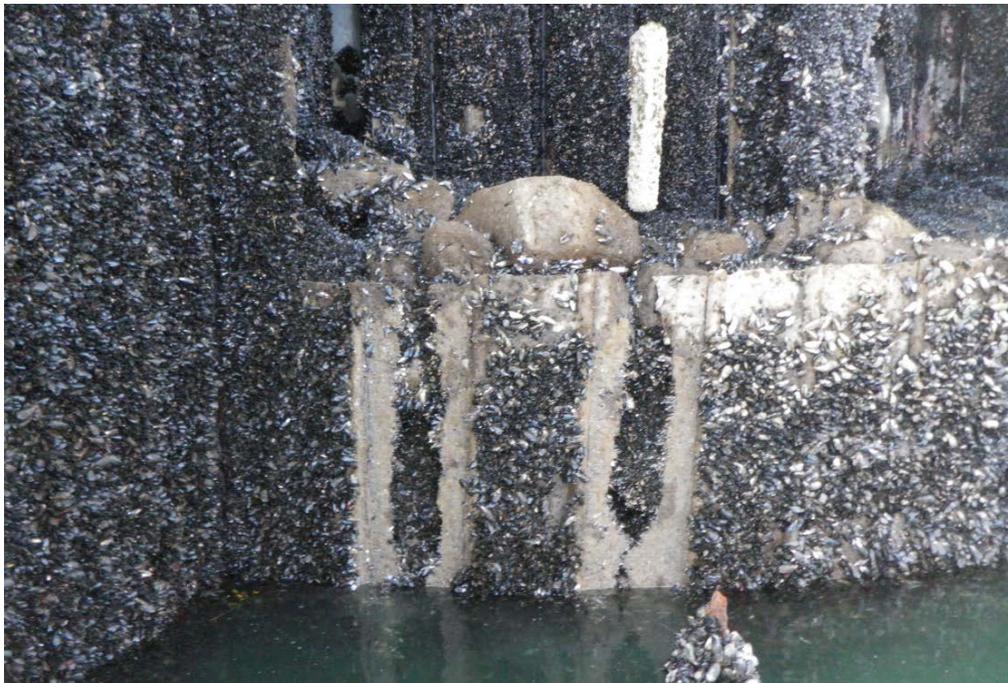
PHOTO No. 18: Closure Arc No. 6.5, East Side - Inspection also found these two sheet piles which have also failed due to corrosive section loss.

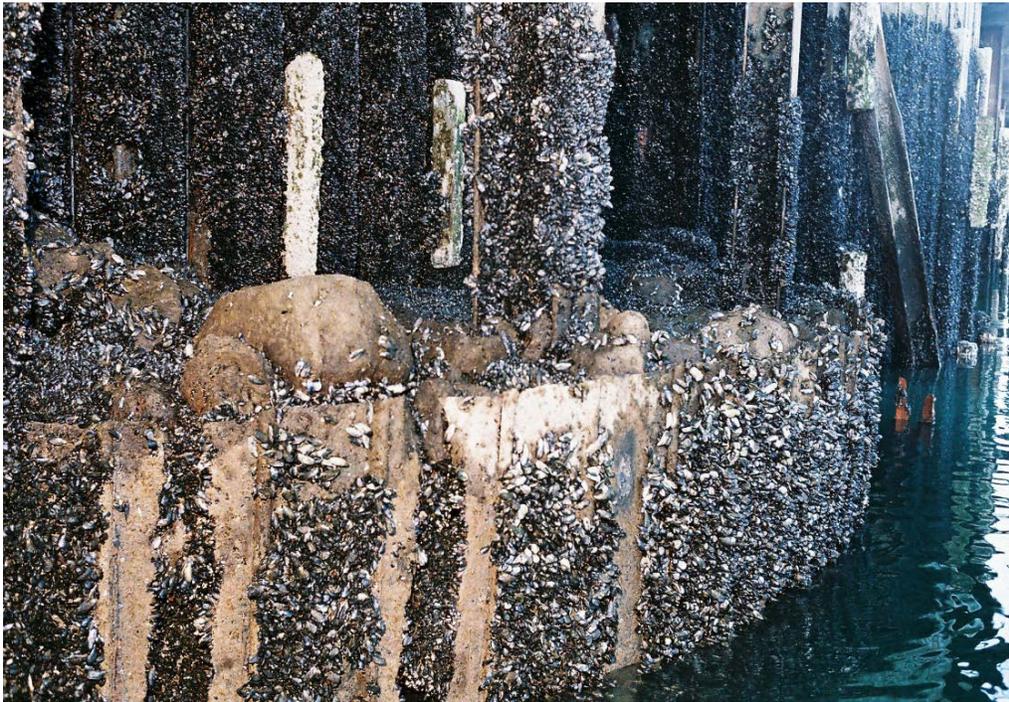
PHOTO No. 19: Closure Arc No. 6.5, Looking West - Note the backfill is level with the top of the circular closure arc. Investigation did not identify any evidence of loss of backfill at this closure arc.

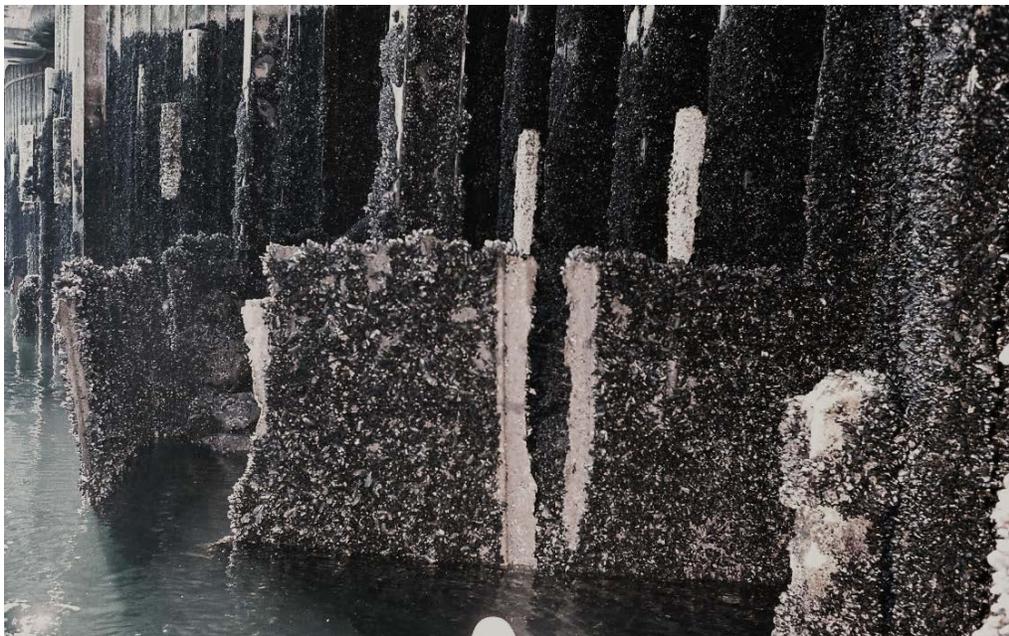
edges of the perforation noted evidence of both corrosive section loss, as well as plastic deformation prior to tensile failure. Refer to Photo No's 21 and 22. A number of additional perforations were noted around the perimeter of this closure arc and there is a visible lowering of the backfill immediately behind this structure. Refer to Photo No's 20, 23 and 24.

PHOTO No. 20: Closure Arc No. 7.5, West Side - Investigation found that this closure arc has failed due to corrosive section loss. Also note the loss of fill at this location. Investigation of the fill against the straight closure arc repair found no evidence of migration of the backfill from under the sheet piling.

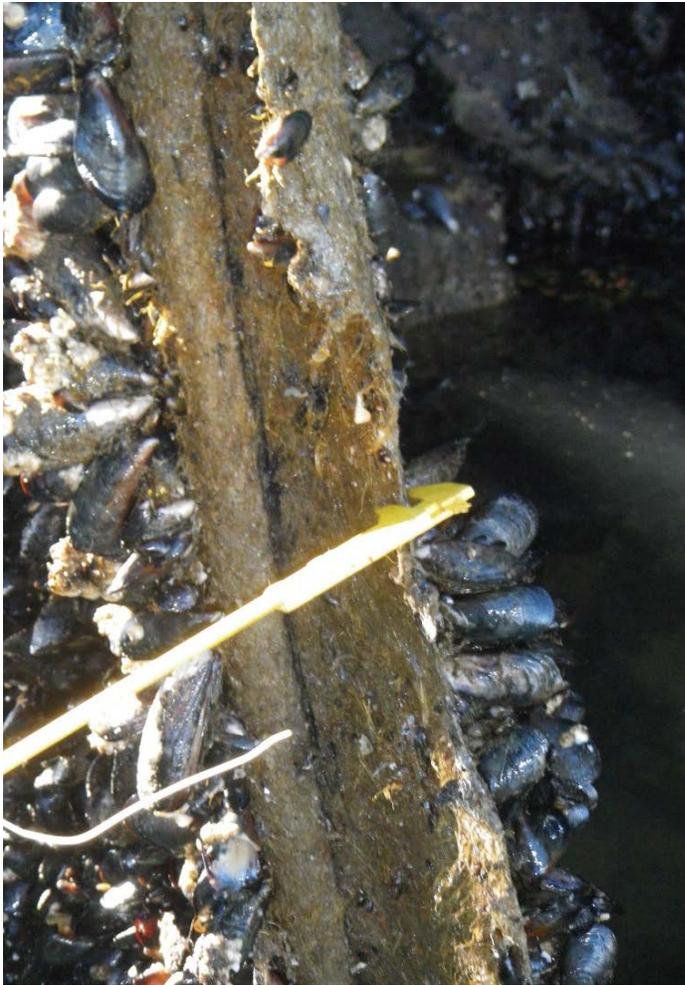
4. Inspection of Closure Arc No. 7.5 found that it has failed with at least one of the sheet piles noted to have ripped from the top, full length to the mudline. Investigation of the

PHOTO No. 21: Closure Arc No. 7.5, Failed Sheet Pile - Note the knife edge thinning of the failed sheet piling located on the east edge of the failure.

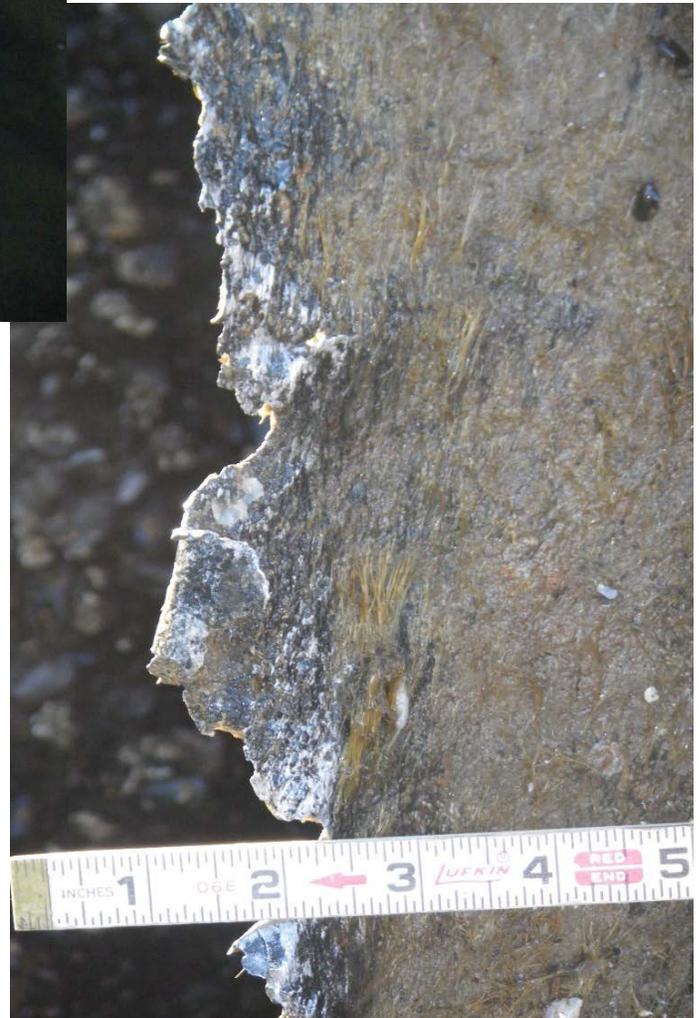
PHOTO No. 22: Closure Arc No. 7.5, Failed Sheet Pile - Note the, thin and uneven edge of the steel resulting from the plastic deformation and ultimate tensile failure of the pile's web. Visible corrosion and thinning were evident on the piles. Investigation of the failed piles found the tear to extend to the mudline.

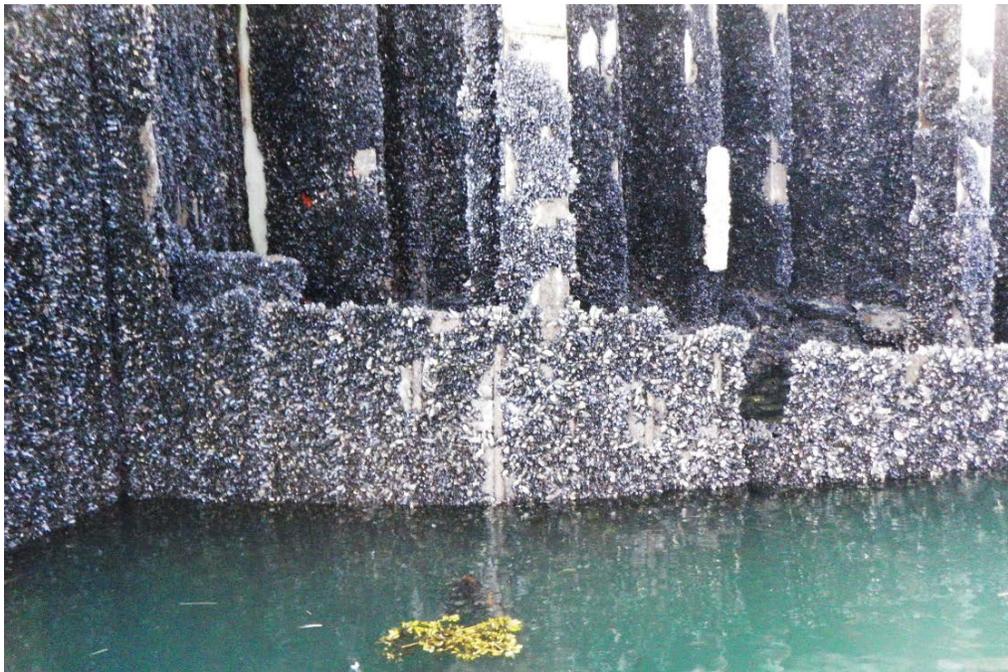
PHOTO No. 23: Closure Arc No. 7.5, East Side - Piles with additional perforation and failure were also identified on this side of the closure arc.

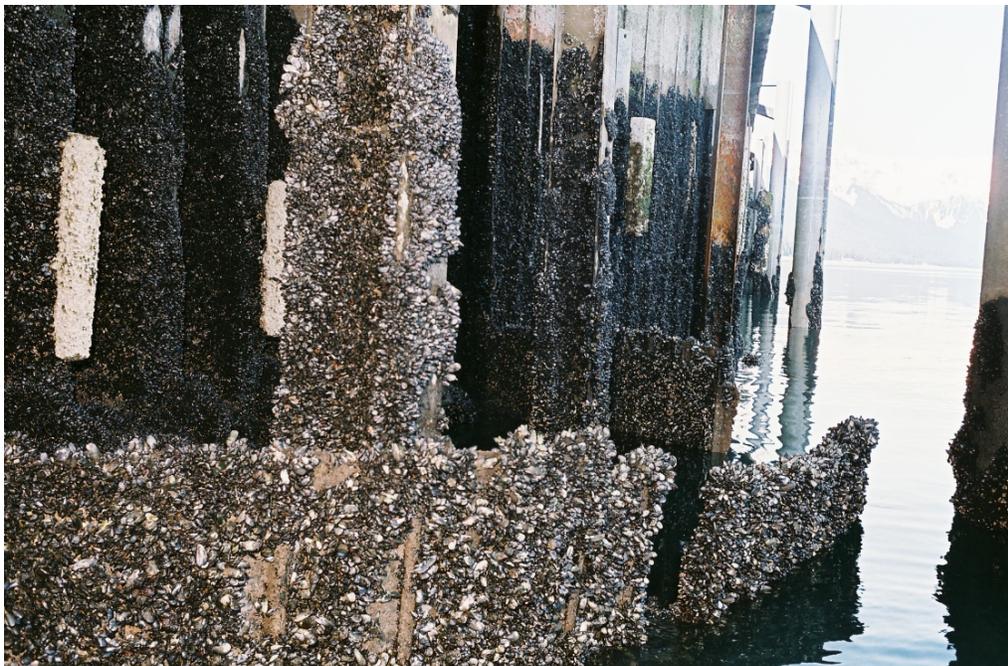
PHOTO No. 24: Closure Arc No. 7.5, Looking West - Note the loss of backfill from behind the circular closure arc and the overall good condition of the anodes attached to the straight, repair portion of the closure arc.

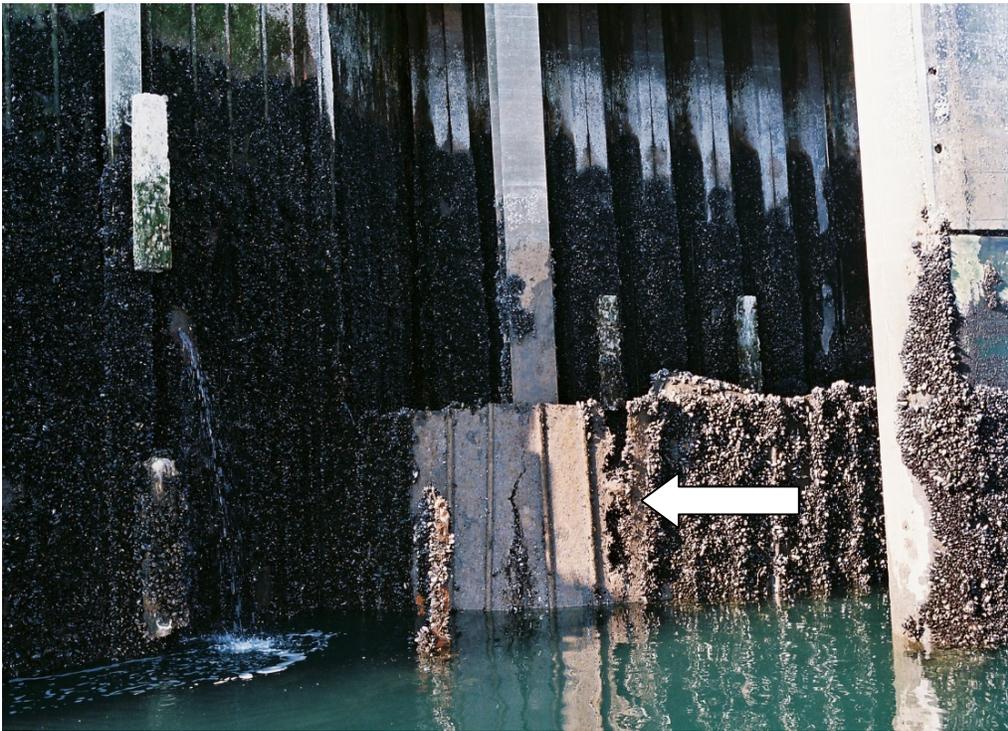
PHOTO No. 25:
Closure Arc No. 8.5, East Side - Note the Level II cleaned area in front of the H-pile exposing the perforation of the sheet pile. Also note the failure of the sheet pile to the right indicated by the arrow.

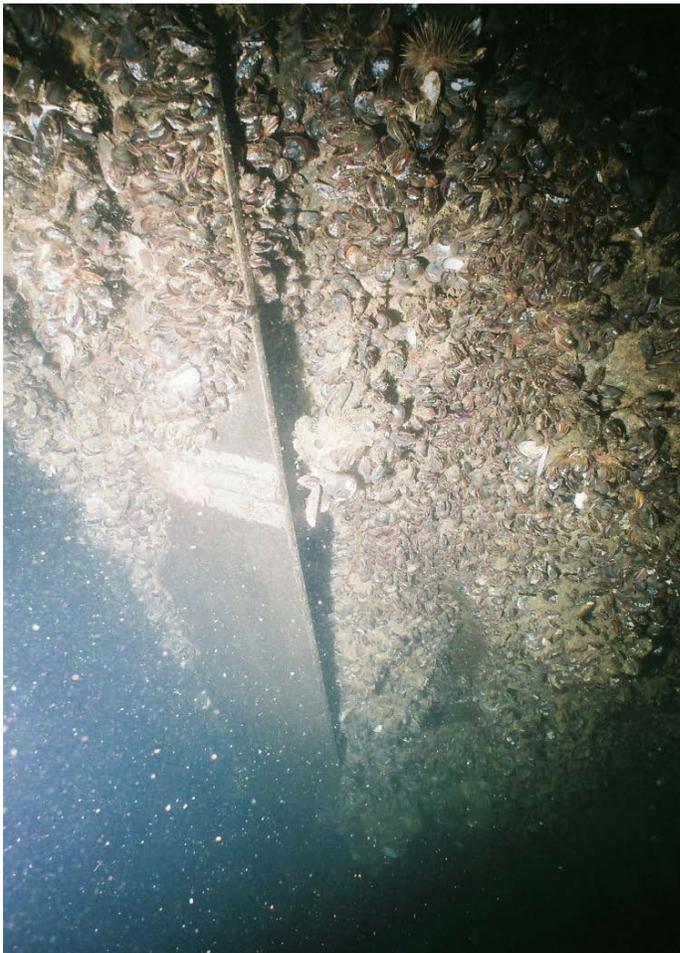
PHOTO No. 26: Closure Arc No. 8.5, East Side - Inspection found that the H-pile that supports the concrete deck, and was installed as part of the repair work, has been driven through the original circular closure arc in the submerged zone. Note the flange of the H-pile which is visible outside of the sheet piling at this location.

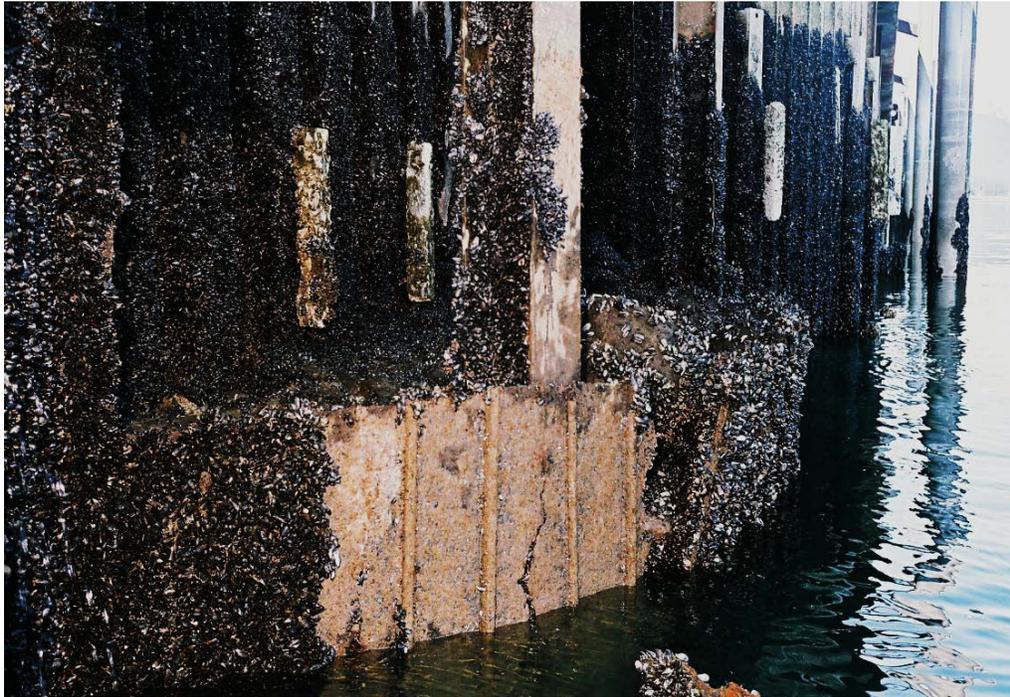
Further investigation of Closure Arc No. 8.5 noted partial failure and apparent lowering of the backfill, however the level of the backfill after completion of the repair work conducted in 2008 is unknown. Refer to Photo No. 27.

PHOTO No. 27: Closure Arc No. 8.5, Looking West - Note the level of the backfill behind the circular closure arc. No evidence of any loss of fill was found associated with this closure arc.

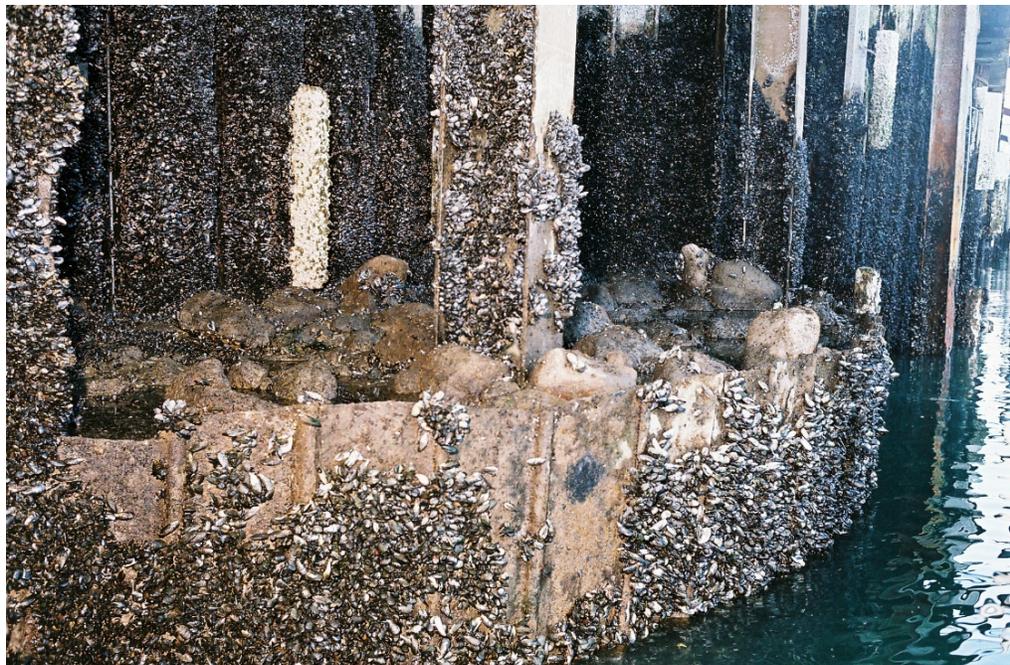
PHOTO No. 28: Closure Arc No. 9.5, Looking West - Inspection did not identify any perforation or significant loss of fill associated with this closure arc. Note the overall good condition of the anode attached to the straight repair portion of the closure.

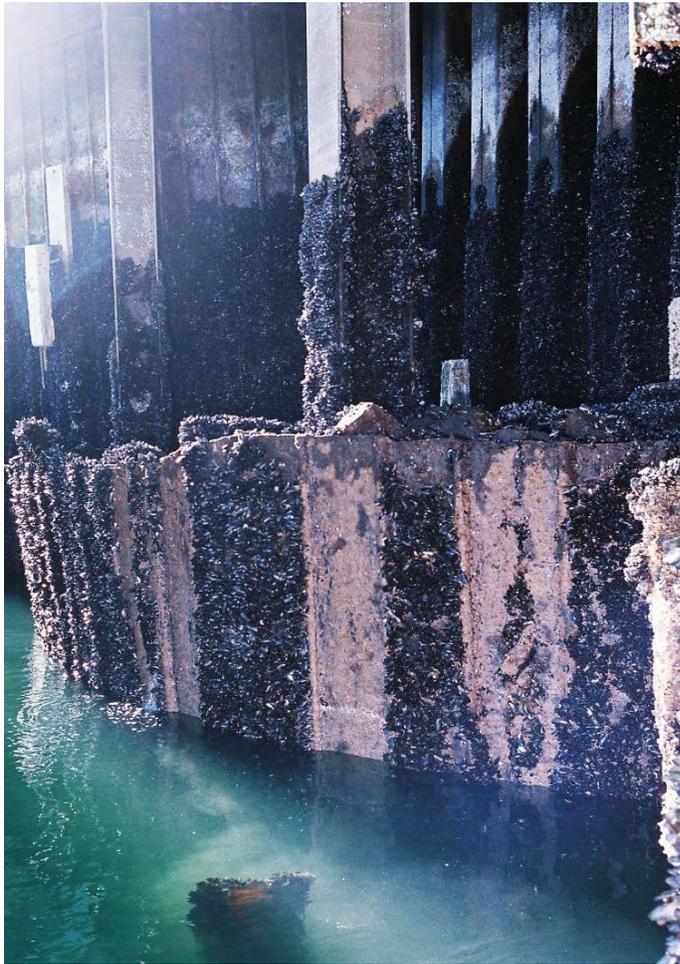
5. The Level I visual inspection also identified two closure arcs that have been punctured during the installation and driving of the newer Steel H-piling that support the renewed concrete cap / deck above. Inspection within the submerged zone found that one flange end of the H-pile cross section has perforated the eastern side of Closure Arc No. 8.5 and the western side of Closure Arc No. 10.5. Refer to Photo No. 26. Additionally, the pattern and location of the sheet pile perforations may indicate that the driving of these H-piles generated increased pressure behind the wall, increasing the stress on the sheet piles resulting in acceleration of the perforation and failure. Refer to Photo No's 27, 29 and 30.

PHOTO No. 29: Closure Arc No. 10.5, West Side - Note the perforation damage to the three sheet piles which have received Level II cleaning. Inspection below water found that this western H-pile has also been driven through the sheet piling in the submerged zone.

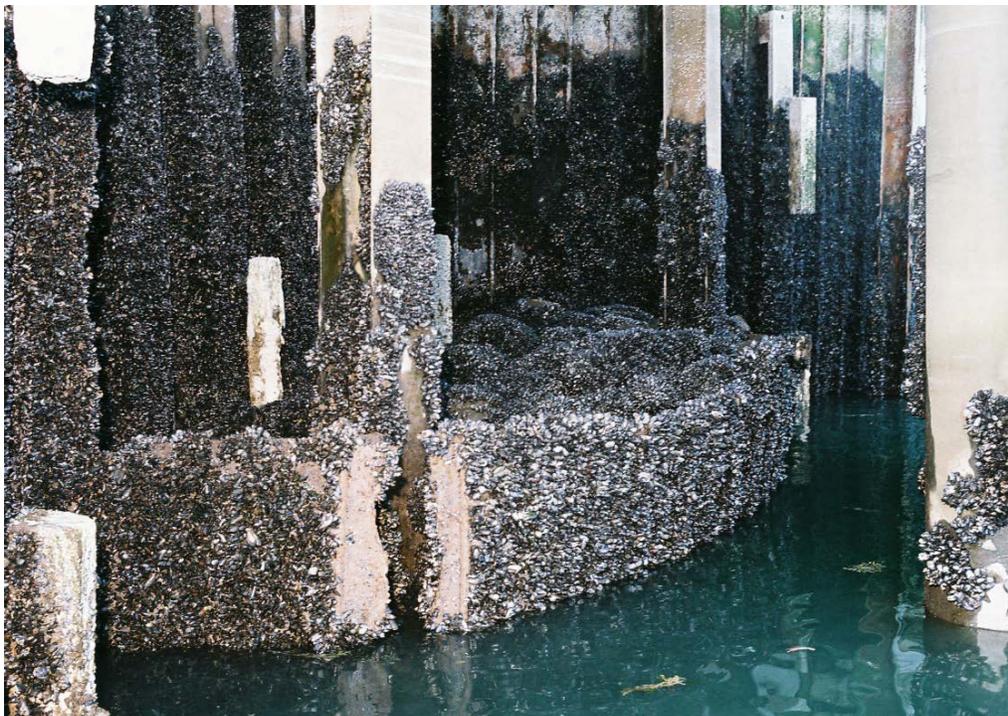
PHOTO No. 30: Closure Arc No. 10.5, East Side - Investigation of the east side of this closure arc also identified damage and failure of the sheet piling. Investigation of the back fill did note it to be slightly lower, but no visible evidence of loss was apparent.
