Inspection and Assessment of Lutak Dock Haines, Alaska

May 2014
14-2449

**RE: Inspection and Assessment of Lutak Dock,
Haines, Alaska**

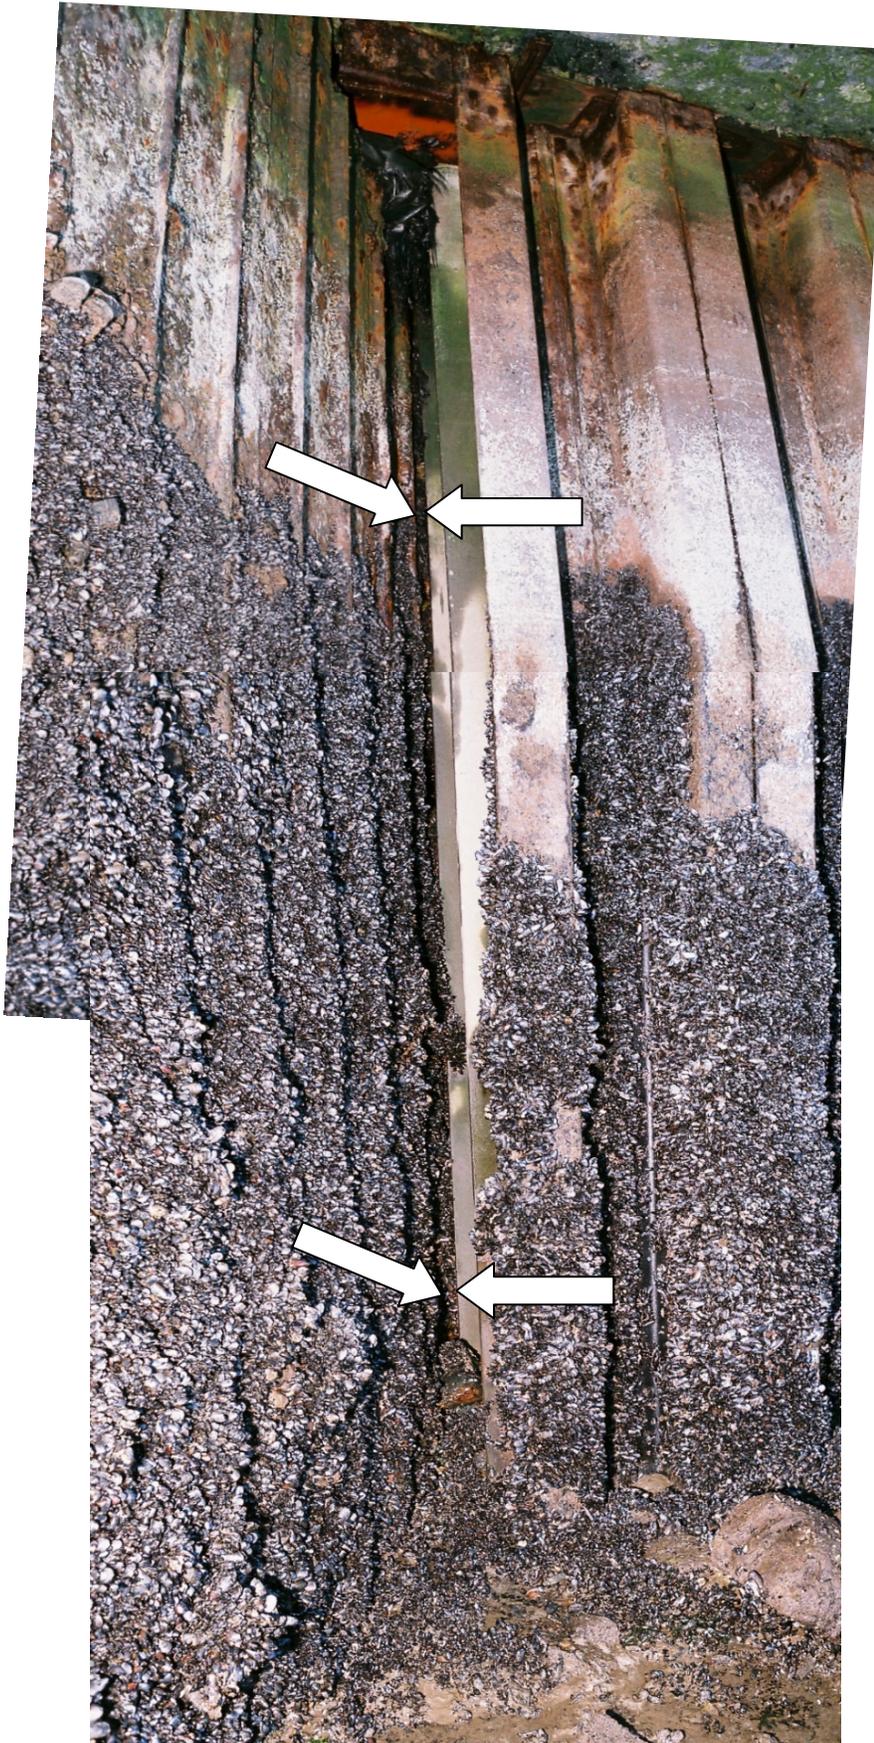
Closure Arc No. 9.5 Repair, East End - Note the gap between the steel H-pile, designed to terminate and seal the end of the closure repair, and the main cell. No evidence of any intact geotextile fabric or any fines was visible through the gap.
