# Lutak Dock Structural Assessment

City of Haines, Alaska

OCTOBER 2014

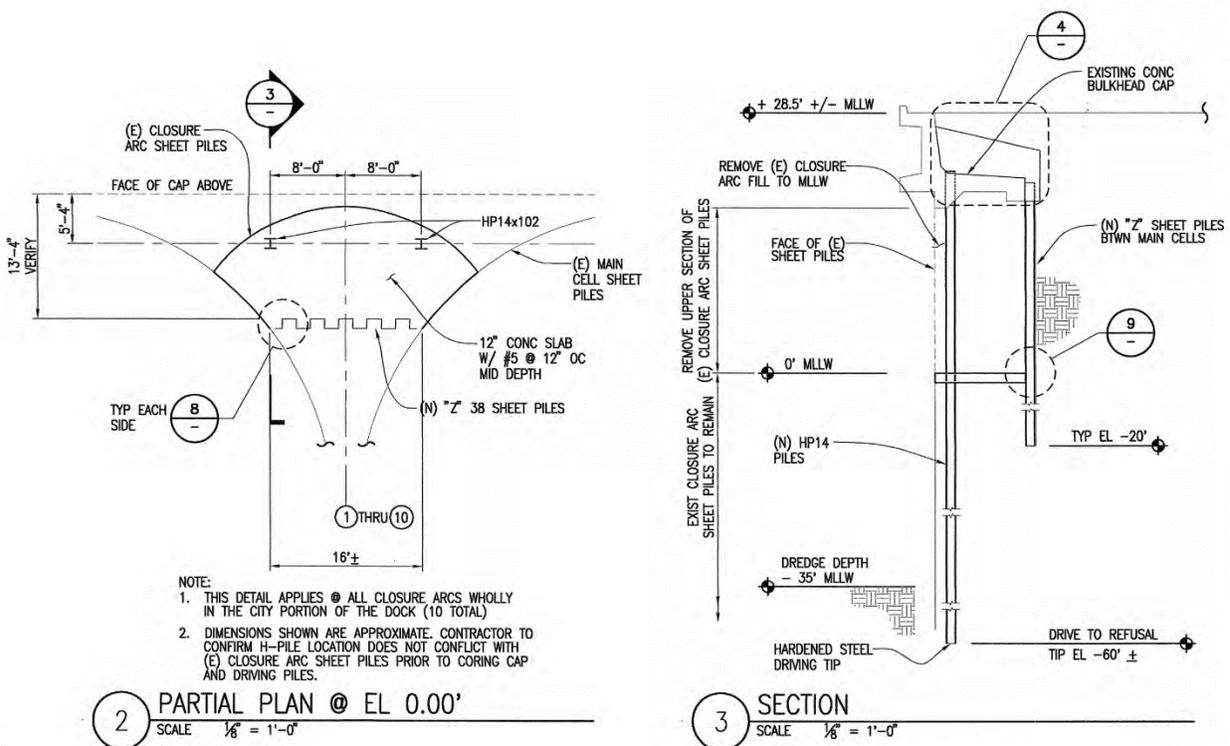
Figure 3-1. Closure Arc Repair Detail

Lutak Dock was most recently modified sometime after 2002 according to the Shannon and Wilson Report (Ref. #1) by an unidentified contractor. The documentation of these repairs indicates that z-sheet pile closure walls were driven 13'-4" behind the bulkhead, as well as supporting H-Piles were driving through the concrete facing beam. Once these additional supporting piles were installed, the closure arcs were cut down to El. 0'. Figure 3-1 is a detail excerpted from the 2002 repair drawings depicting repairs to the closure arcs (Ref. #8).

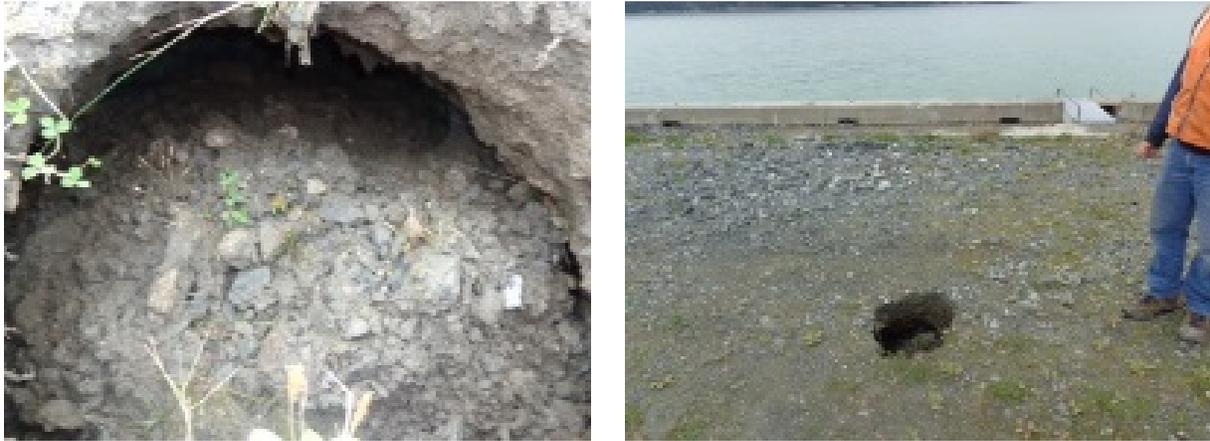
Figure 3-2. Sink Holes Observed at Lutak Dock

After completion of these repairs, sink holes formed behind the z-sheet pile bulkhead (Figure 3-2). The cause of these holes is believed to be soil escaping through gaps between the z-sheet wall and the main cells. Some attempt was made to utilize geotextile fabric along with the H-pile closure detail to ensure soil was retained through flushing effects of successive tide cycles. The magnitude of the sinkholes suggests that significant volumes of material have been lost, which de-stabilizes the working surface of

the dock. Highly loaded vehicles may suddenly fall into an undetected hole with potentially severe consequences to persons, and equipment and property.

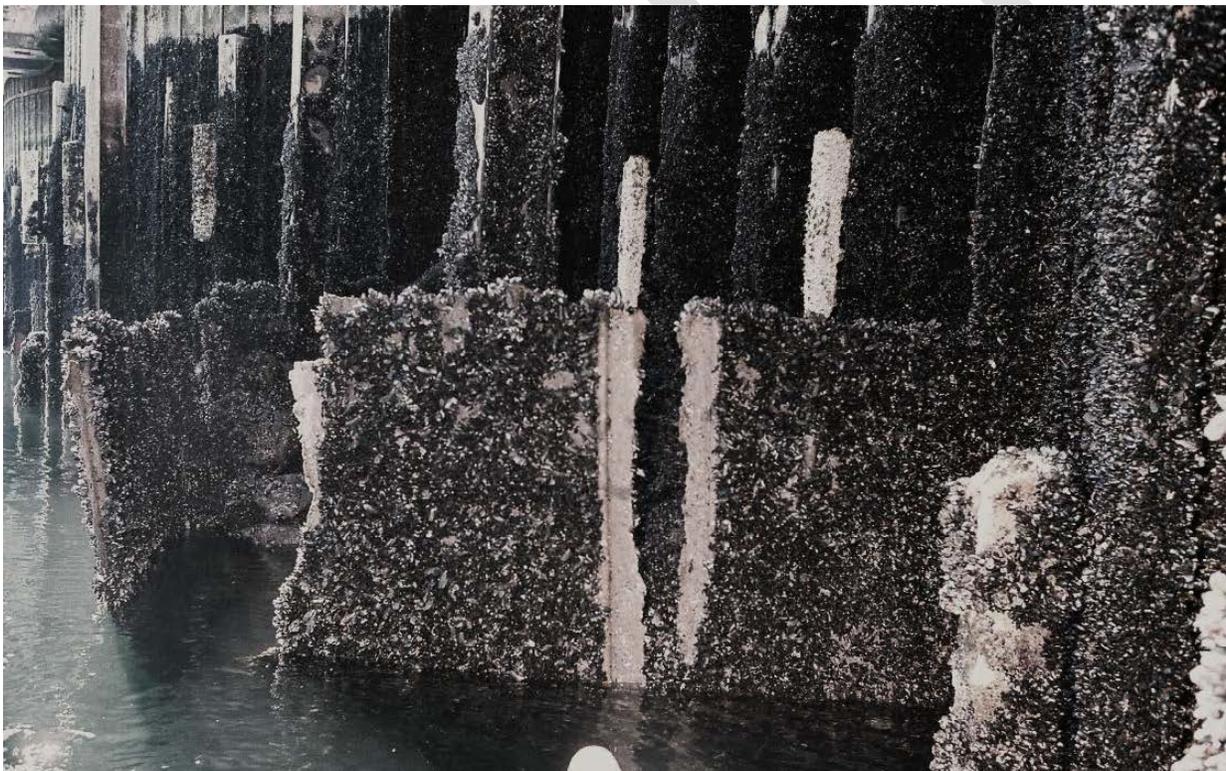
Figure 3-3. Failure at Closure Arc 7.5

Recent inspections indicate Closure Arc 7.5, located roughly at the centerline of the bulkhead, has failed. Figure 3-3 depicts the damaged closure arc. It is not known to PND precisely when this failure occurred. However, failure of Closure Arc 7.5 must have occurred approximately around 2002 as the sheet pile in the closure arc have clearly been cut down.

A splitting failure of lower Closure Arc 7.5 has occurred since 2002, based on inspection report prepared by Echelon (Ref. #4). It is uncertain whether the failure of Closure Arc 7.5 is due to structural loading to support the lower end of the Z-sheet pile wall installation, or from damage arising during initial pile driving. Some damage has occurred at Closure Arc numbers 1.5, 5.5, 6.5, 8.5, and 10.5 as a result of driving of H-piles. The piles sliced into the thinner corroded webs of the lower closure arcs. Condition of the lower arcs is stated in Ref. #4 to be from fair to poor, with heavy corrosion loss and pitting noted at the testing/sample locations.

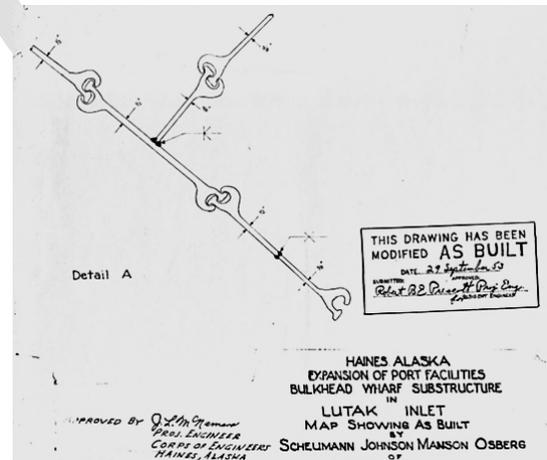
Figure 3-6. Connection Detail at Lutak Dock, 1953

In 1965, the connection detail utilizing a 90-degree “tee” between the main and closure arc was specifically prohibited by the USACE after a series of “tee” failures on temporary cellular structures utilized for lock and dam construction (Figure 3-4)(Ref. #14). [Note: the USACE uses the terms Primary Cell and Intersecting Arc, our terminology is amended to match earlier inspection reports.]

Figure 3-5 depicts the current USACE endorsed configuration for the connections between the main cell and the closure. The geometry of the connection utilized at Lutak in 1953 (Figure 3-6) is identical to those subsequently prohibited by USACE. In 2007, PND investigated options for a private cement company to repair damage resulting from failure of an identical “tee” joint between closure arc and main cell at a structure constructed in 1964. Photographs and observations of the cement company failure are consistent with the mechanism observed by the USACE at other cellular structures.

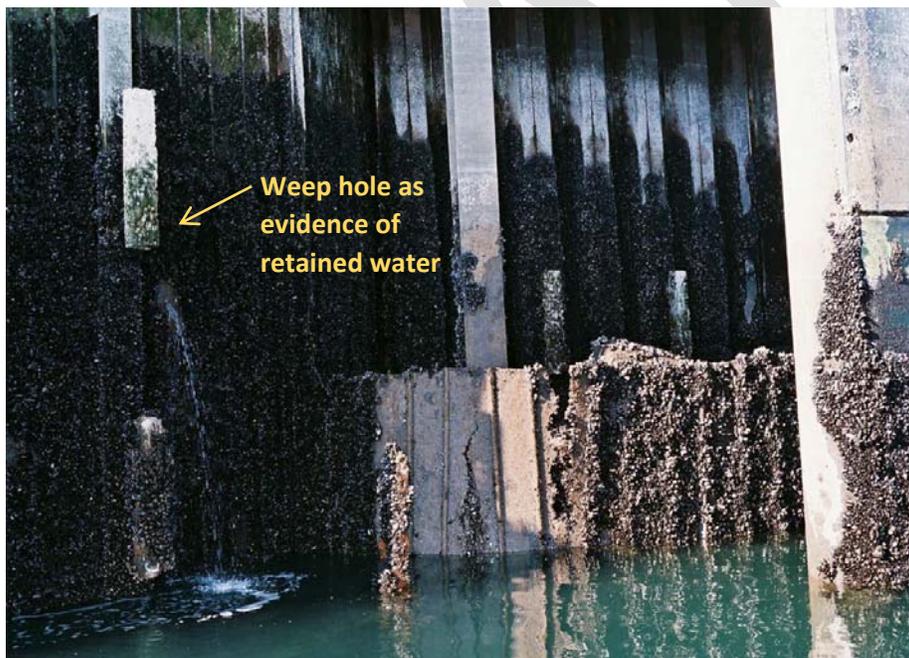
Figure 7-1. Retained Water Behind Main Cell

During the inspection, water was observed to be retained behind the Z-sheet sheet pile bulkhead. Figure 7-1, excerpted from the Echelon’s inspection report, depicts water flowing out of a weep hole several feet above the outboard water surface elevation. Based on the scale of the photograph, the fall height of the water could be between 6’ and 11’. Further, the water surface elevation behind the sheet pile would have to be higher than the elevation of the weep hole.

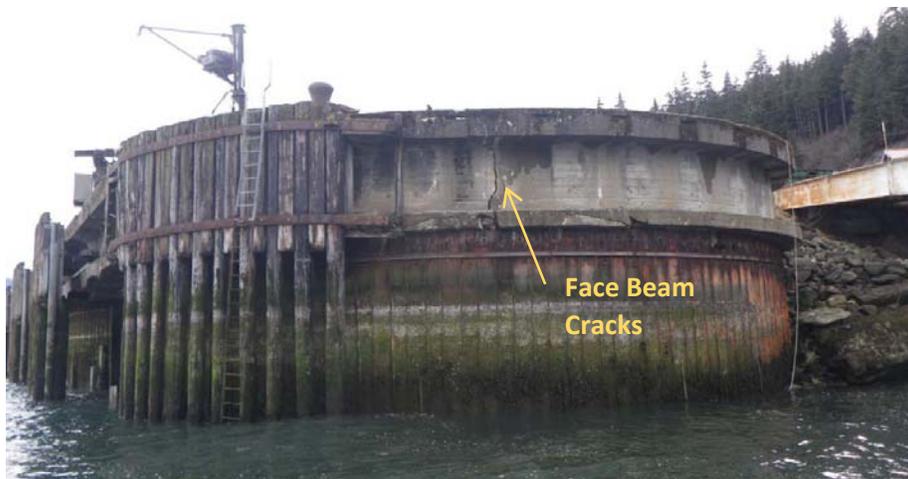
Figure 7-2. Cracking in Facing Beam near Mid-Line of the Bulkhead

There is evidence, shown in Echelon’s inspection report, of the tilting of the bulkhead. Figure 7-2 depicts a full depth crack in the bulkhead facing beam, as the beam wraps around the western side of the dock. This crack is located near the mid-line of the cellular structure.

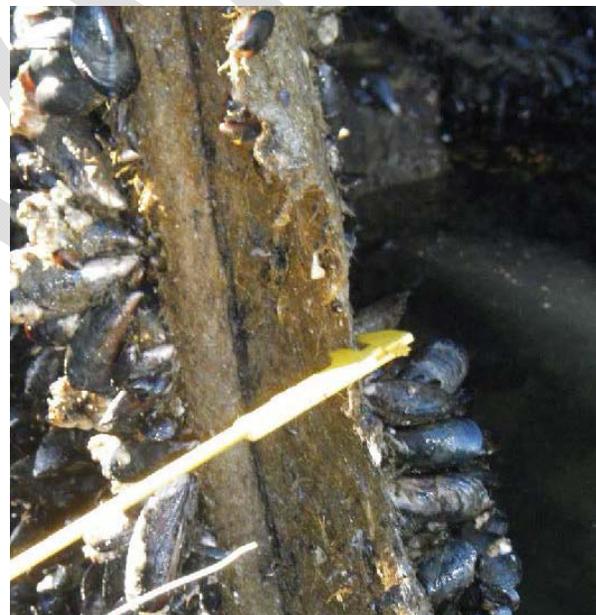
Figure 7-3. Tension Necking and Rupture of Sheet Pile Web

Echelon observed indication of tensile yielding failure at Closure Arc 7.5. Figure 7-3 depicts necking of the sheet pile web prior to failing.

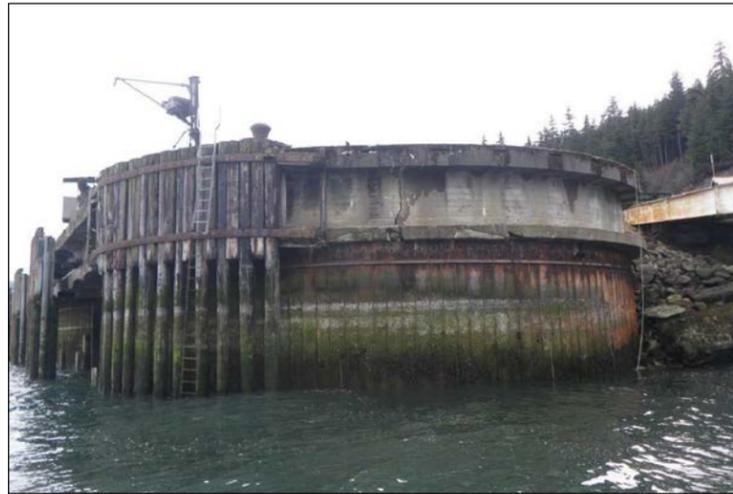
**02**  
1 **PHOTO NO. 02**

MAIN CELL NO. 1, LOOKING EAST – INSPECTION NOTED THAT THIS PORTION OF THE CELL HAS NOT BEEN OUTFITTED WITH ANY SACRIFICIAL ANODES. THE INSPECTION DID NOTE ON-GOING SURFACE CORROSION IN THIS AREA.

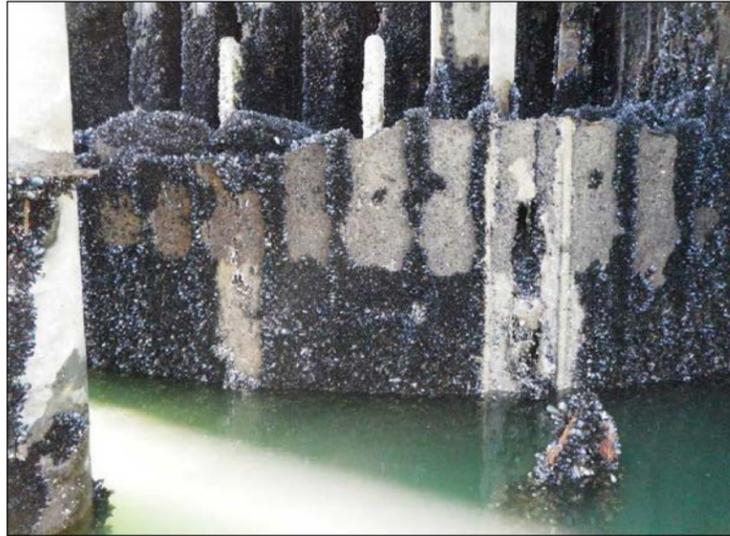
**09**  
1 **PHOTO NO. 09**

CLOSURE ARC NO. 1.5, WEST SIDE – NOTE THE SHEET PILES WHICH HAVE BEEN CLEANED SHOWING AREAS OF PERFORATION.

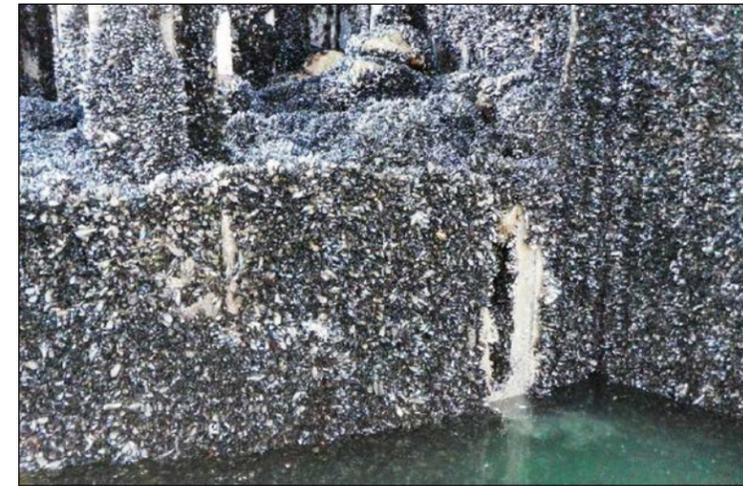
**15**  
1 **PHOTO NO. 15**

CLOSURE ARC NO. 5.5, WEST SIDE – NOTE THE LEVEL II CLEANED AREA REVEALING PERFORATION OF THE SHEET PILE.

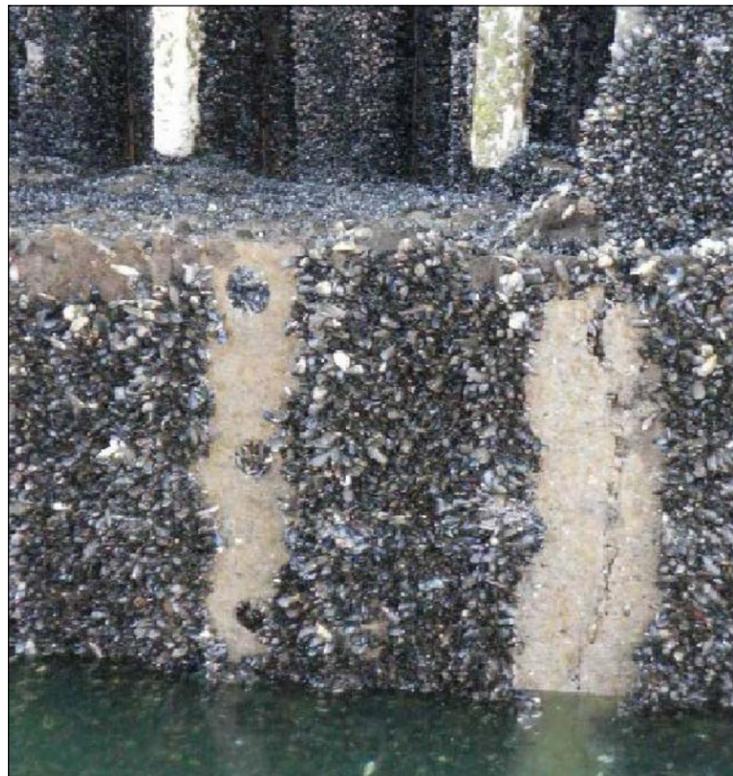
**17**  
1 **PHOTO NO. 17**

CLOSURE ARC NO. 6.5, WEST SIDE – NOTE THE RIP ALONG THE RIGHT SHEET PILE AND THE MULTIPLE CONSTRUCTION / WEEP HOLES IN THE SHEET PILE ON THE LEFT WHICH HAVE BOTH BEEN SUBJECTED TO LEVEL II CLEANING.

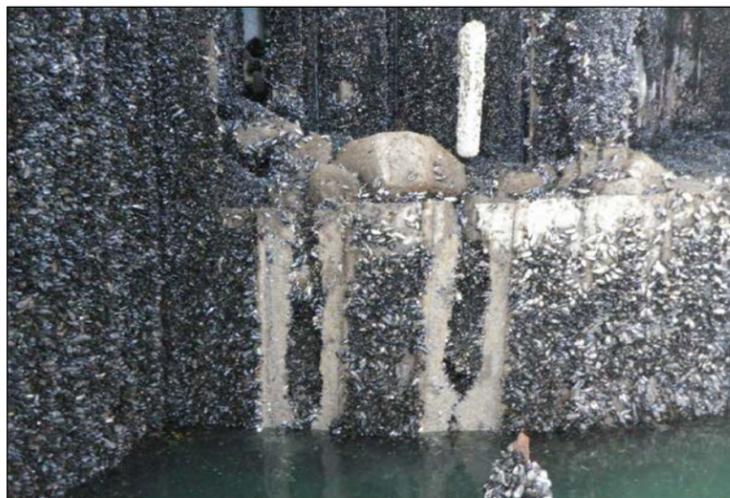
**18**  
1 **PHOTO NO. 18**

CLOSURE ARC NO. 6.5, EAST SIDE – INSPECTION ALSO FOUND THESE TWO SHEET PILES WHICH HAVE ALSO FAILED DUE TO CORROSIVE SECTION LOSS.

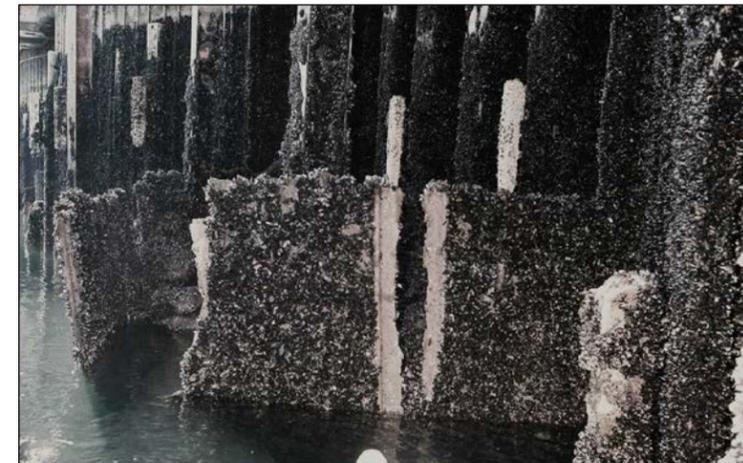
**20**  
1 **PHOTO NO. 20**

CLOSURE ARC NO. 7.5, WEST SIDE – INVESTIGATION FOUND THAT THIS CLOSURE ARC HAS FAILED DUE TO CORROSIVE SECTION LOSS. ALSO NOTE THE LOSS OF FILL AT THIS LOCATION. INVESTIGATION OF THE FILL AGAINST THE STRAIGHT CLOSURE ARC REPAIR FOUND NO EVIDENCE OF MIGRATION OF THE BACKFILL FROM UNDER THE SHEET PILING.

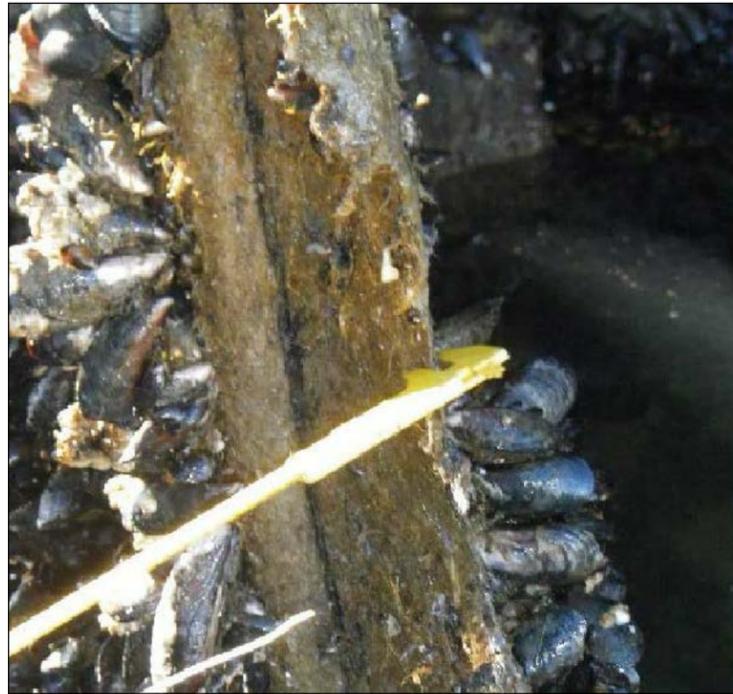
**21**  
1 **PHOTO NO. 21**

CLOSURE ARC NO. 7.5, FAILED SHEET PILE - NOTE THE KNIFE EDGE THINNING OF THE FAILED SHEET PILING LOCATED ON THE EAST EDGE OF THE FAILURE.

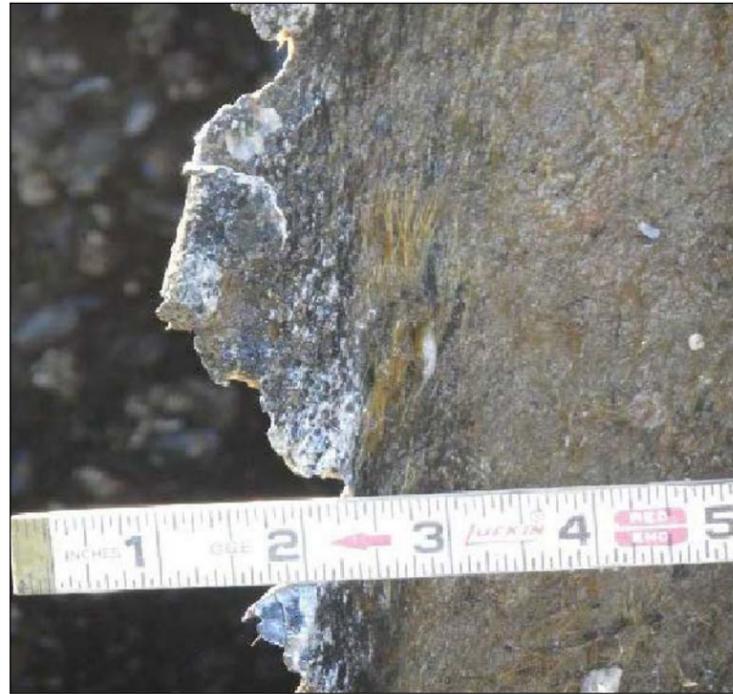
**22**  
1 **PHOTO NO. 22**

CLOSURE ARC NO. 7.5, FAILED SHEET PILE - NOTE THE, THIN AND UNEVEN EDGE OF THE STEEL RESULTING FROM THE PLASTIC DEFORMATION AND ULTIMATE TENSILE FAILURE OF THE PILE'S WEB. VISIBLE CORROSION AND THINNING WERE EVIDENT ON THE PILES. INVESTIGATION OF THE FAILED PILES FOUND THE TEAR TO EXTEND TO THE MUDLINE.

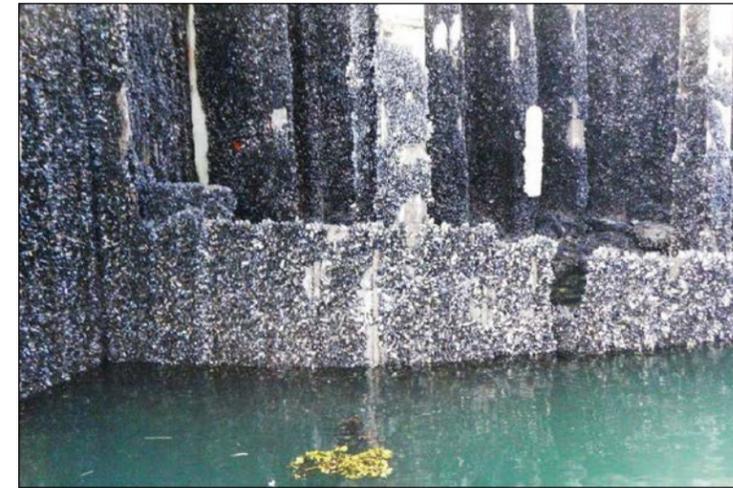
**23**  
1 **PHOTO NO. 23**

CLOSURE ARC NO. 7.5, EAST SIDE - PILES WITH ADDITIONAL PERFORATION AND FAILURE WERE ALSO IDENTIFIED ON THIS SIDE OF THE CLOSURE ARC.

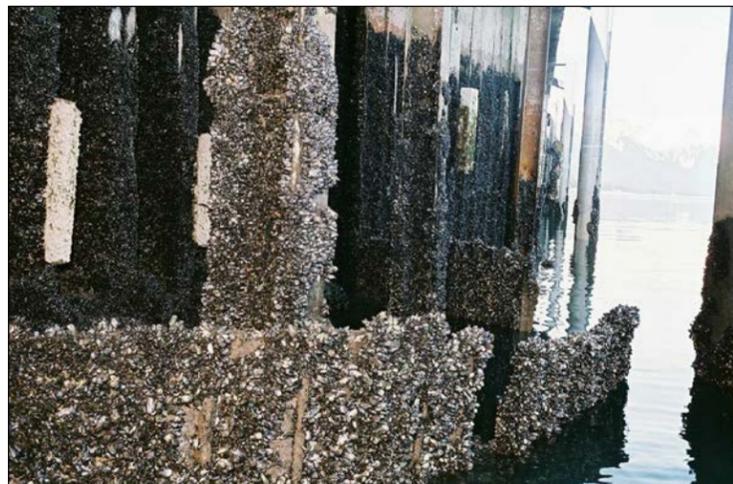
**24**  
1 **PHOTO NO. 24**

CLOSURE ARC NO. 7.5, LOOKING WEST - NOTE THE LOSS OF BACKFILL FROM BEHIND THE CIRCULAR CLOSURE ARC AND THE OVERALL GOOD CONDITION OF THE ANODES ATTACHED TO THE STRAIGHT, REPAIR PORTION OF THE CLOSURE ARC.

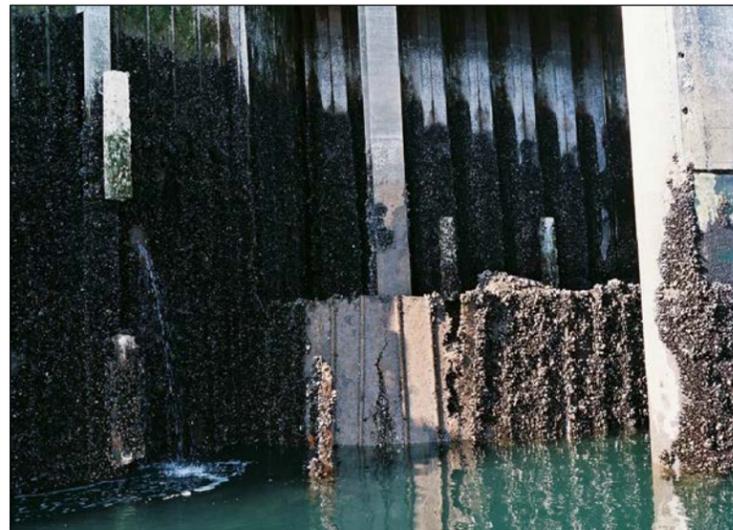
**25**  
1 **PHOTO NO. 25**

CLOSURE ARC NO. 8.5, EAST SIDE - NOTE THE LEVEL II CLEANED AREA IN FRONT OF THE H PILE EXPOSING THE PERFORATION OF THE SHEET PILE. ALSO NOTE THE FAILURE OF THE SHEET PILE TO THE RIGHT INDICATED BY THE ARROW.

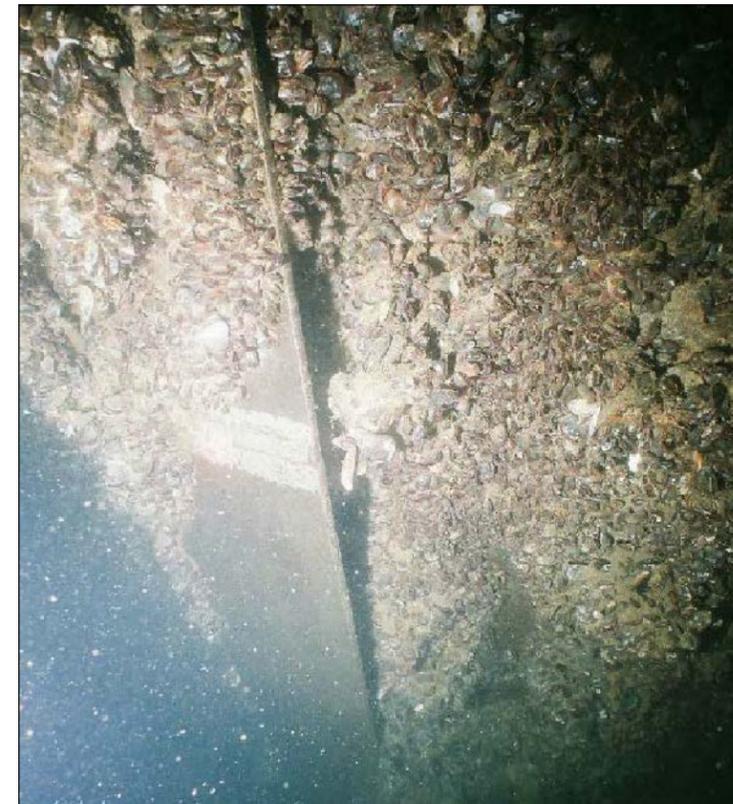
**26**  
1 **PHOTO NO. 26**

CLOSURE ARC NO. 8.5, EAST SIDE - INSPECTION FOUND THAT THE H-PILE THAT SUPPORTS THE CONCRETE DECK, AND WAS INSTALLED AS PART OF THE REPAIR WORK, HAS BEEN DRIVEN THROUGH THE ORIGINAL CIRCULAR CLOSURE ARC IN THE SUBMERGED ZONE. NOTE THE FLANGE OF THE H PILE WHICH IS VISIBLE OUTSIDE OF THE SHEET PILING AT THIS LOCATION.

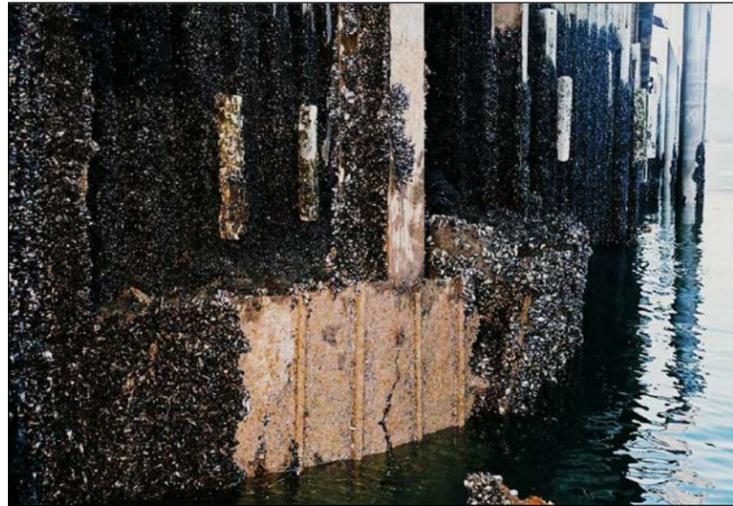
**27**  
**1** **PHOTO NO. 27**

CLOSURE ARC NO. 8.5, LOOKING WEST - NOTE THE LEVEL OF THE BACKFILL BEHIND THE CIRCULAR CLOSURE ARC. NO EVIDENCE OF ANY LOSS OF FILL WAS FOUND ASSOCIATED WITH THIS CLOSURE ARC.

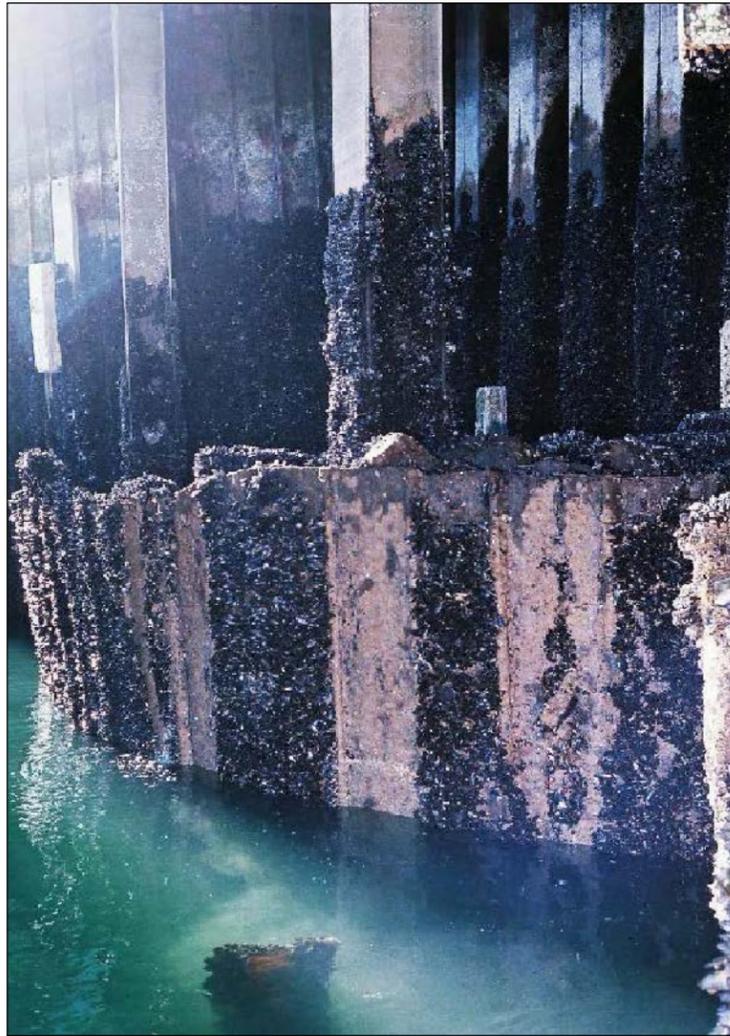
**29**  
**1** **PHOTO NO. 29**

CLOSURE ARC NO. 10.5, WEST SIDE - NOTE THE PERFORATION DAMAGE TO THE THREE SHEET PILES WHICH HAVE RECEIVED LEVEL II CLEANING. INSPECTION BELOW WATER FOUND THAT THIS WESTERN H-PILE HAS ALSO BEEN DRIVEN THROUGH THE SHEET PILING IN THE SUBMERGED ZONE.

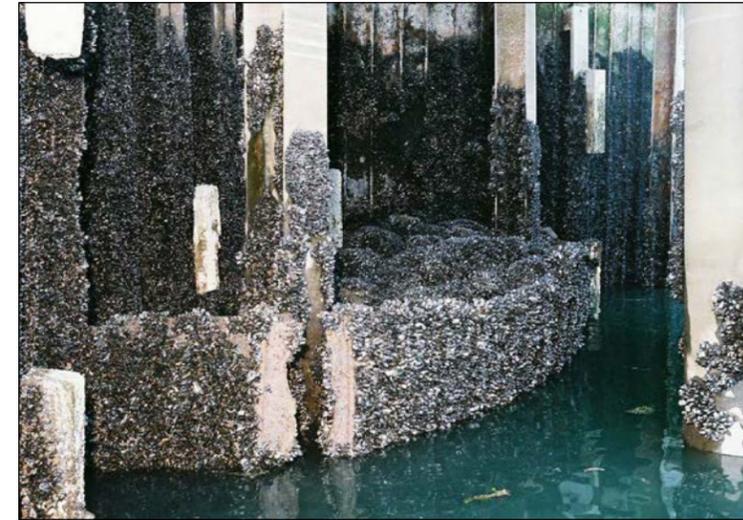
**30**  
**1** **PHOTO NO. 30**

CLOSURE ARC NO. 10.5, EAST SIDE - INVESTIGATION OF THE EAST SIDE OF THIS CLOSURE ARC ALSO IDENTIFIED DAMAGE AND FAILURE OF THE SHEET PILING. INVESTIGATION OF THE BACK FILL DID NOTE IT TO BE SLIGHTLY LOWER, BUT NO VISIBLE EVIDENCE OF LOSS WAS APPARENT.

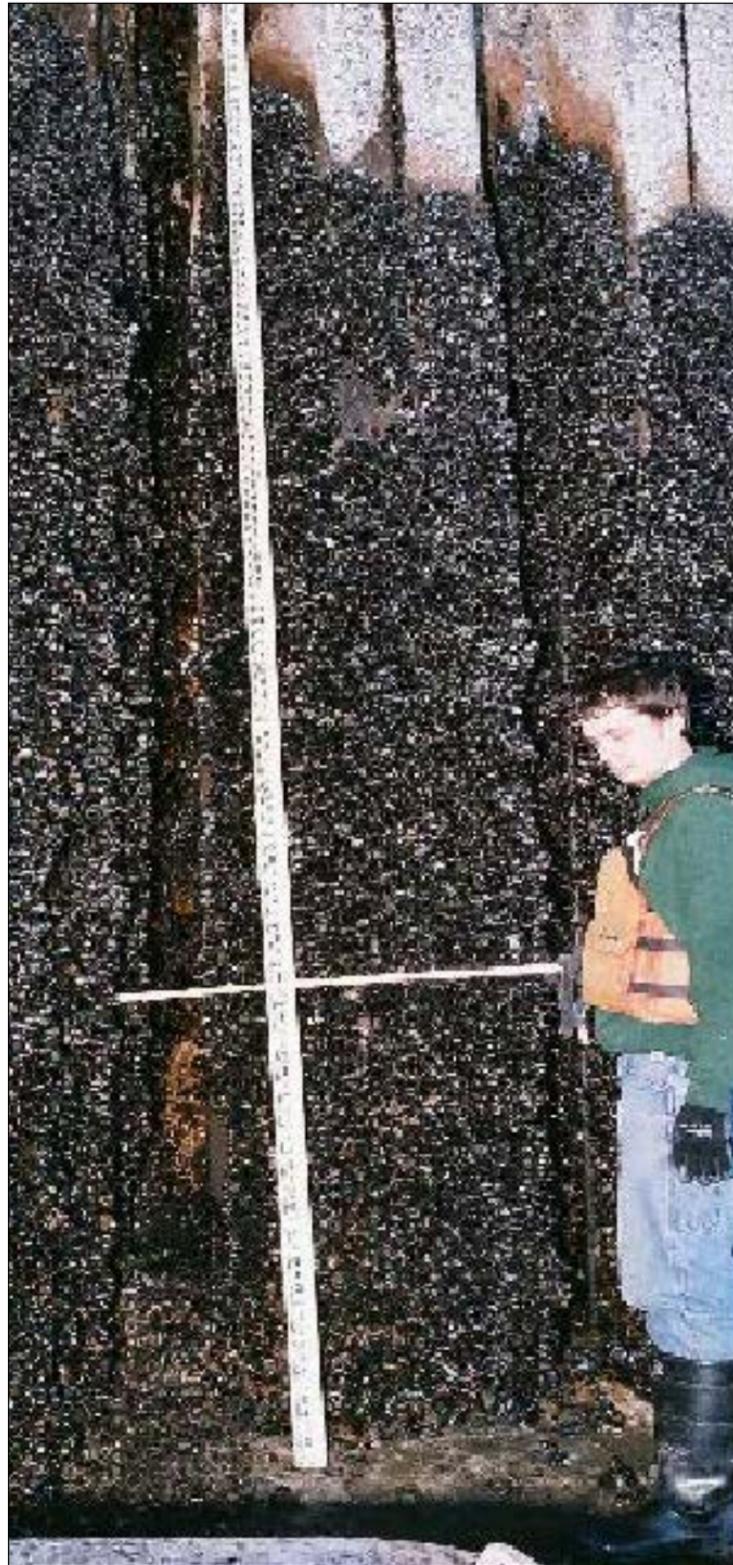
**31**  
1 **PHOTO NO. 31**

CLOSURE ARC NO. 8.5 REPAIR, EAST END - NOTE THE REPAIRED SECTION OF THE 8.5 CLOSURE ARC TO THE RIGHT OF THE STADIA ROD AND THE MAIN CELL NO. 9 ON THE LEFT. THE ARROWS INDICATE THE GAP BETWEEN THE MAIN CELL AND THE EAST END OF THE REPAIR SECTION. NOTE A CLEANED PORTION OF THE STEEL H-PILE SHOWN ON REFERENCE DRAWING S-3, DETAIL 8, CAN BE SEEN JUST ABOVE THE LOWER RIGHT THE UPPER RIGHT ARROW INDICATES A LARGE (~2' DIA.) ROCK IN THE BACKFILL. NO EVIDENCE OF ANY FINES OR INTACT GEOTEXTILE FABRIC WAS VISIBLE THROUGH THIS GAP. REMNANTS OF THE GEOTEXTILE FABRIC WAS FOUND AT THE BOTTOM OF THE GAP. THIS CONDITION IS TYPICAL OF THE LOCATIONS SHOWN IN THE FOLLOWING SERIES OF PHOTOS NO. 32-36.

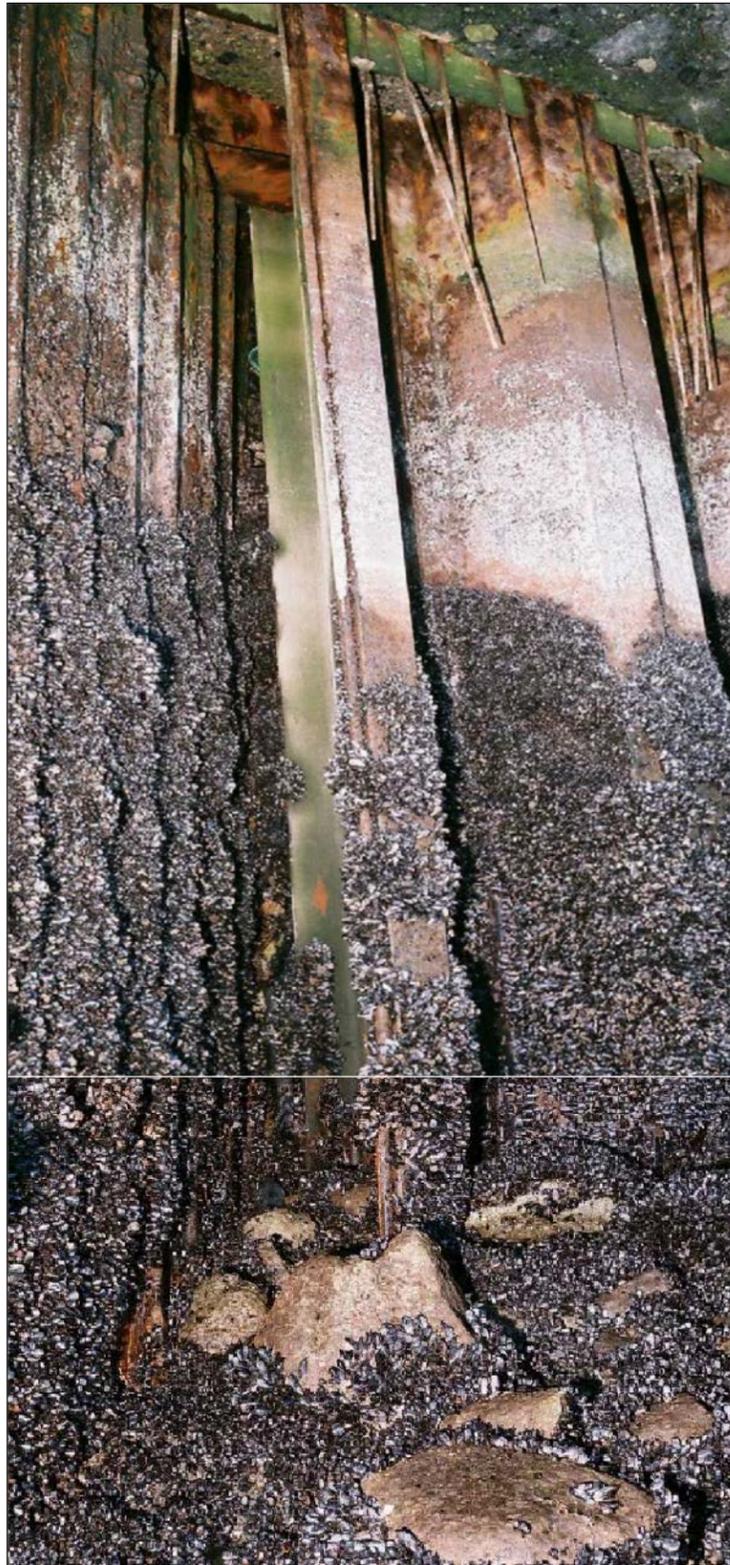
**32**  
1 **PHOTO NO. 32**

CLOSURE ARC NO. 4.5 REPAIR, EAST END - NOTE THE GAP BETWEEN THE STEEL H-PILE, DESIGNED TO TERMINATE AND SEAL THE END OF THE CLOSURE REPAIR, AND THE MAIN CELL. NO EVIDENCE OF ANY INTACT GEOTEXTILE FABRIC OR ANY FINES WAS VISIBLE THROUGH THE GAP.

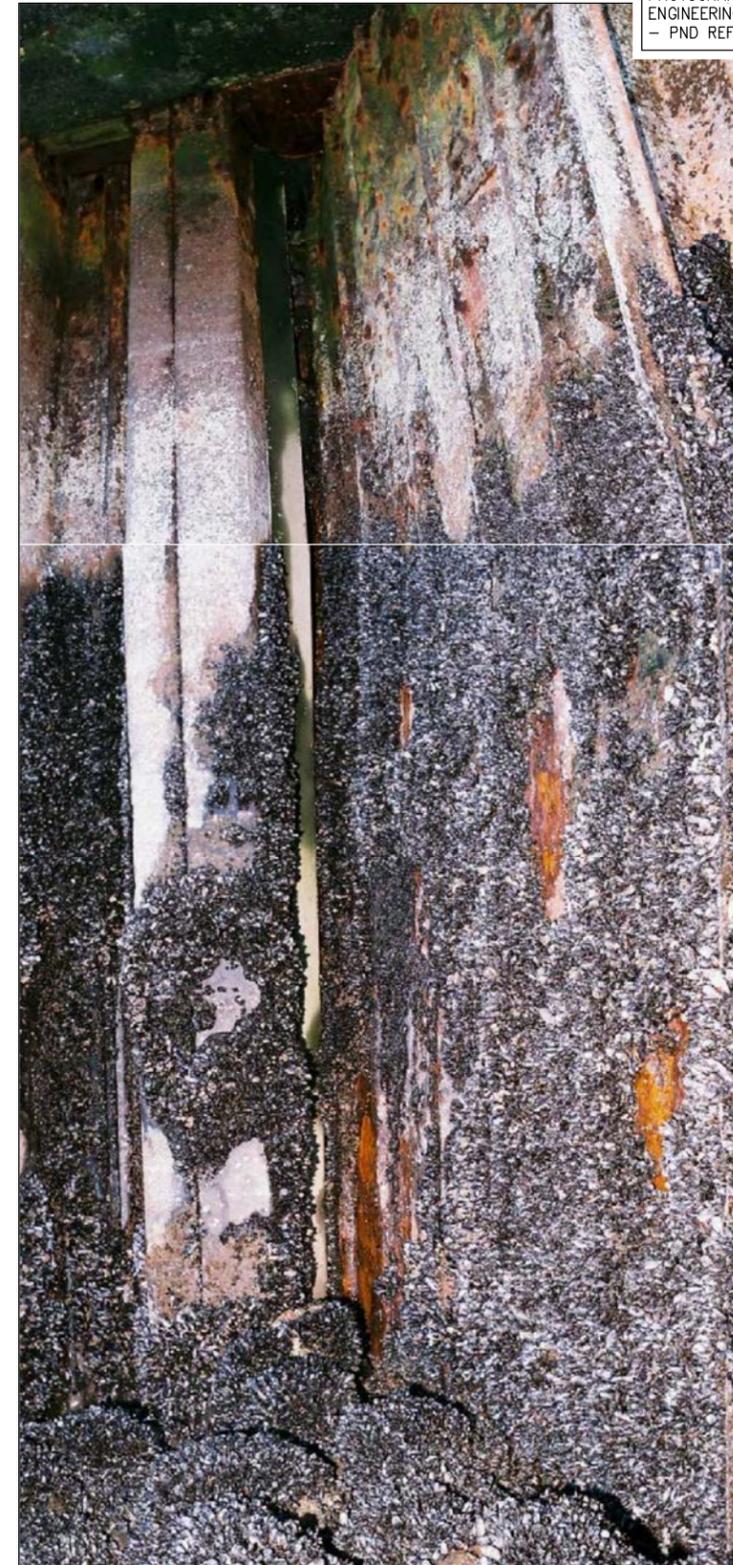
**33**  
1 **PHOTO NO. 33**

CLOSURE ARC NO. 6.5 REPAIR, WEST END - NOTE THE GAP BETWEEN THE STEEL H-PILE, DESIGNED TO TERMINATE AND SEAL THE END OF THE CLOSURE REPAIR, AND THE MAIN CELL. NO EVIDENCE OF ANY INTACT GEOTEXTILE FABRIC OR ANY FINES WAS VISIBLE THROUGH THE GAP.

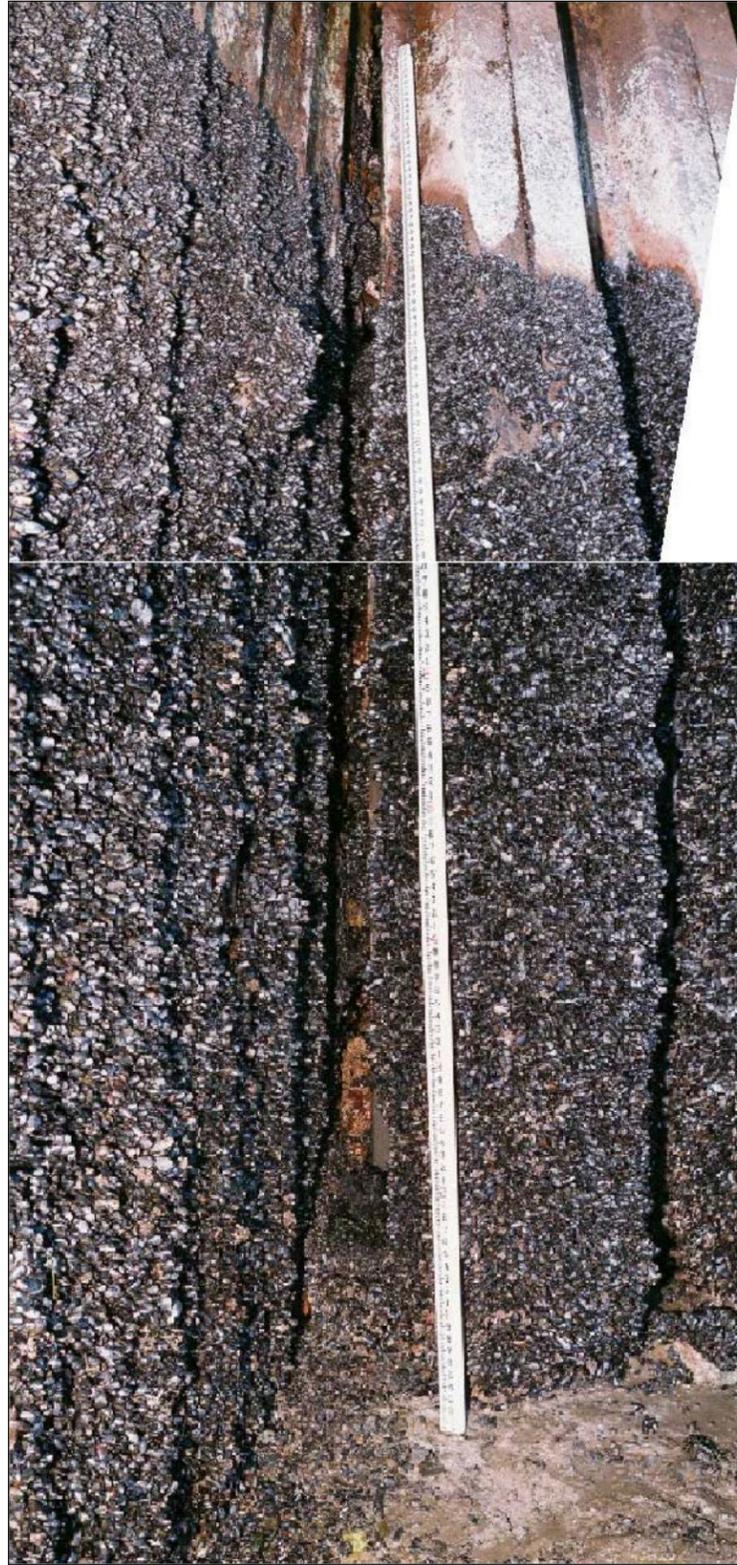
**34**  
1 **PHOTO NO. 34**

CLOSURE ARC NO. 8.5 REPAIR, EAST END - NOTE THE GAP BETWEEN THE STEEL H-PILE / END SHEET PILE AND THE MAIN CELL. NO EVIDENCE OF ANY INTACT GEOTEXTILE FABRIC OR ANY FINES WAS VISIBLE THROUGH THE GAP. (ALSO SHOWN IN PHOTO NO. 31).

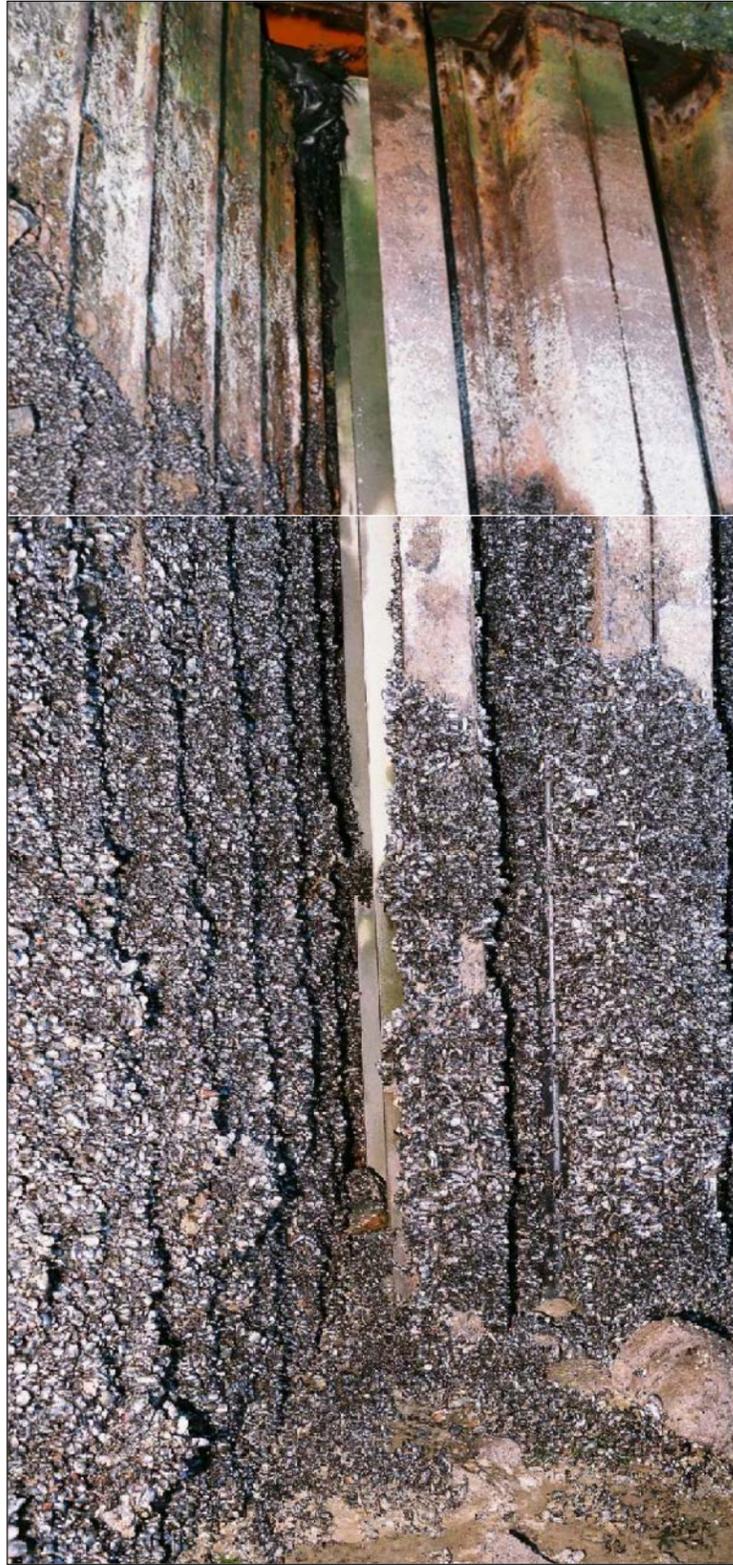
**35**  
1 **PHOTO NO. 35**

CLOSURE ARC NO. 9.5 REPAIR, EAST END - NOTE THE GAP BETWEEN THE STEEL H-PILE, DESIGNED TO TERMINATE AND SEAL THE END OF THE CLOSURE REPAIR, AND THE MAIN CELL. NO EVIDENCE OF ANY INTACT GEOTEXTILE FABRIC OR ANY FINES WAS VISIBLE THROUGH THE GAP.

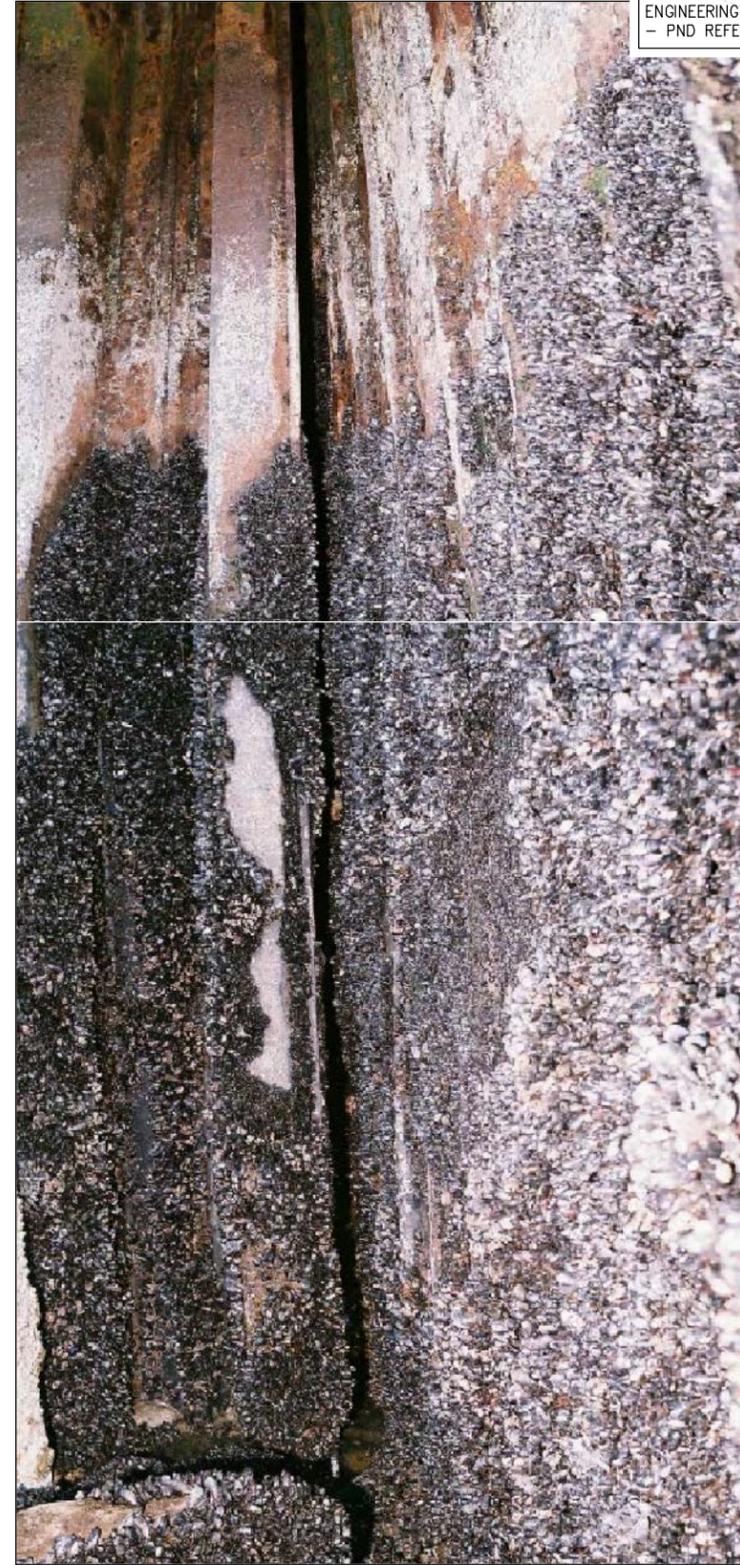
**36**  
1 **PHOTO NO. 36**

CLOSURE ARC NO. 10.5 REPAIR, WEST END - NOTE THE GAP BETWEEN THE LAST STEEL PILE AND THE MAIN CELL. NO EVIDENCE OF ANY INTACT GEOTEXTILE FABRIC OR ANY FINES WAS VISIBLE THROUGH THE GAP.
