Condition Survey of

Chilkat Center for the Arts

May 2008

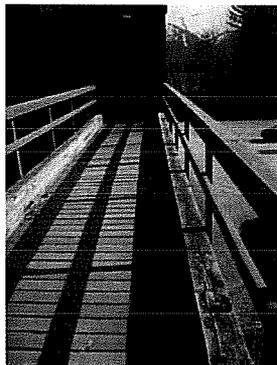
Second Floor Bridge

There is a significant exit deficiency that should be corrected as soon as possible. A required second floor exit from the south wing discharges to grade via a bridge. The bridge is severely deteriorated, and not safe to use. Without it, the large meeting space in this wing should not be used.

- D) Replace existing second floor bridge. Provide additional structure within building, foundation improvements, railings, decking and other measures as required to make bridge fully ADA accessible. Bridge structure should be covered, unless galvanized steel beams, decking, railings and connections are used.

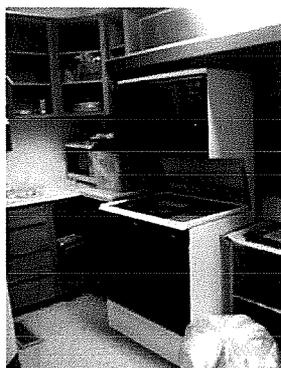
Existing Kitchen Appliances

The kitchen area does not serve properly to support food service or concessions to activities at the center. It is well past its useful life, not sanitary, not ADA compliant and poorly configured. It should be completely reconfigured, with all appliances and furnishings replaced.

L) Replace kitchen area with new appliances, counters, wall surfaces, serving area. Reconfigure to improve serving and preparation area efficiency.

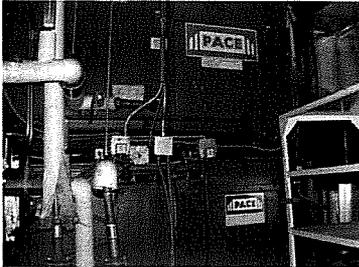
VENTILATION UNITS HV-1 & HV-2

HV-1 and HV-2: Two ventilation units are located in the lower level Mechanical Room. HV-1 supplies ventilation air to the three floors of the building addition and HV-2 supplies air to the Auditorium and the basement level below the stage area. The two ventilation systems share outside air and relief/return air plenum systems constructed mainly of gypsum lined surfaces. The building appears to experience easy transfer of air and have high infiltration/exfiltration construction so relief air will move to adjacent areas and to the outside fairly easily. HV-1 ventilation air is supplied through floor grilles for the upper floors and side wall grilles on exposed ductwork throughout the lower basement floor. The auditorium HV-2 ventilation air is delivered to the space through floor grilles with the return air grille located high up on the south wall. About half of the exposed ductwork was of a non metal fiber board type. No duct access doors were found for maintenance and inspection. No record of the balancing log was found and it does not appear that the ventilation systems were ever adjusted.

Long Term Cost; Replace and revise ventilation systems: \$200,000.

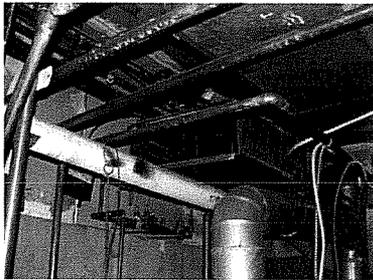
SUPPLY AIR DUCT TO BASEMENT AREAS DISCONNECTED IN BOILER ROOM

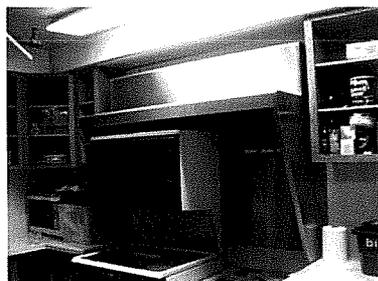
KITCHEN HOOD

A wall mounted fan, located on the north side of the building, exhausts air from a back shelf design Type 1 exhaust hood system that covers the propane range in the kitchen plus an additional 18 inches to the side of the range. It appears that the cooking range was replaced sometime in the past with a smaller one so the hood covers a larger area that it should. The hood has grease filters but they appear to be a fabricated older type that is not very effective. The hood does not have chemical fire suppression system and the range propane system is not connected for interoperability with the exhaust air system; both serious code violations. The original plans called for an interlock of the exhaust fan with HV-3 and increased OSA damper positioning, but this feature was not functioning. The controls for HV-3 are non-functioning and there is no makeup air source for the exhaust hood other than the ventilation air supplied by HV-3 to the lobby area adjacent to the auditorium. The exhaust fan is wall mounted exhausting under a roof overhang. The fan is old and does not meet current code requirements for grease duty.

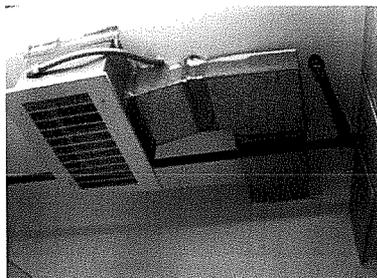
LOWER FLOOR TOILET EXHAUST FAN

Each toilet room has an individual ceiling mounted exhaust fan either controlled by the respective light switch or separate switch. The lower floor toilet room exhaust fans exhaust out the south end of the lower floor just above grade. The auditorium lobby toilet rooms discharge directly to their respective outside wall through wall caps. The second floor toilets in the addition each have ceiling exhaust fans with flexible ductwork in the attic above. A ceiling mounted exhaust fan in the second floor workout room exhausts air out through a roof cap. The adjacent second floor offices also have a ceiling mounted exhaust fan that discharges through the attic to a common roof cap. The radio offices have a small toilet room with exhaust

fan. All exhaust fans when operated appeared to be insufficient volume.

Recommend replacing the flexible ductwork with sheet metal for increased exhaust air volume and efficiency.

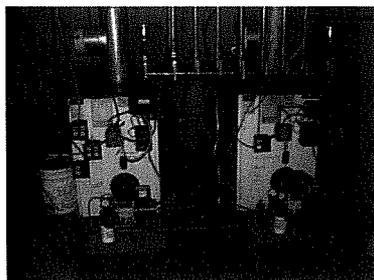
HEATING PLANT - ULTIMATE NATURAL DRAFT BOILERS

Two boilers (Ultimate Boiler PFO 9), cast-iron sectional, were installed approximately 8 years ago during a mechanical renovation. The boilers advertise a high efficiency rating in the mid 8-0% range. It was not known or evident when the burners were last adjusted for maximum efficiency. Approximately six heating zones, each with a unitized pump at the heating plan, supplies heating water to a heating loop. Each HV fan unit also has a circulating pump within its own heating coil loop to assist with water flow. Many of the heating loops experience air blockage due to piping not pitched correctly and lack off air vent valves. Some of the heating piping is insulated, roughly 50%.

Recommend renovation of heating plant for longer life. The present boilers will probably last 5-10 years more with increasingly more maintenance and replacement of parts required. The boiler manufacturer recommended replacing the burner assembly with a more efficient model in 2003. The underground storage tank is single wall and should be replaced with a double wall underground tank with leak detection/monitoring ability, or an aboveground tank.

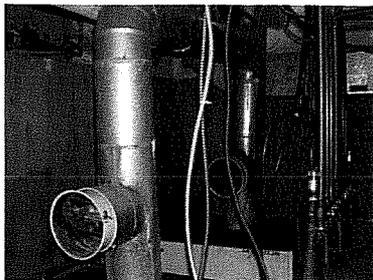
CHIMNEY BREECHING

The two natural draft boilers combustion combines in the mechanical room prior to entering the main vertical chimney. At the connection point the chimney size is not enlarged until after the tee. The chimney is double wall construction but is exposed through the two floor levels before exiting through the roof. Both of the natural draft dampers are old and appear to be partially stuck, not able to operate freely. The chimney does show evidence of past leakage with stains on the outside shell. The interior of the chimney was not investigated. The boiler model is no longer manufactured but should last 5-10 years as well as the natural draft double wall chimney.

The chimney breeching needs to enlarge at the point of the two branches and should be enclosed throughout the building in a fire rated shaft.

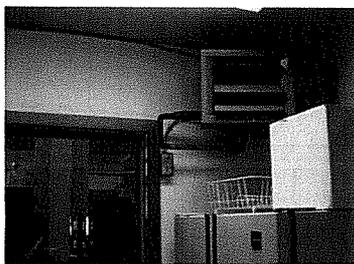
UNIT HEATER IN KITCHEN

Several areas including the main auditorium lobby meeting place has had its heating units removed and/or disconnected. Several complaints were made of lack of heating in the auditorium lobby meeting areas. Most of the baseboard heating units are of low quality residential type with many covers missing and most with damaged fins. Most sections of baseboard have individual non electric integral thermostat radiator valves for basic individual control. The integral heating valve-thermostat control of the heating units is a poor control and results in uneven temperature environment. Unit heaters are located in the kitchen and in the back stage area that operate manually. It was reported that the ventilation unit HV-3 was operated only for supplemental heating when this area got cold.

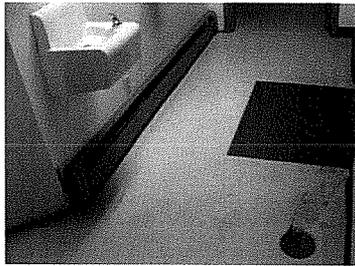
DRINKING FOUNTAIN, BASEBOARD HEATING UNIT

Note: Floor drain with continual ground water drain on right

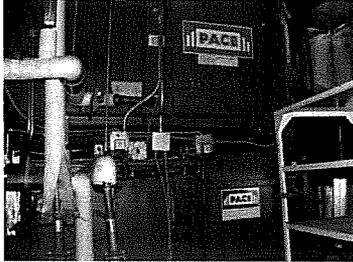
HV-1 & HV-2 CONTROLS

The fan outside and return air damper controls were not functioning and All the fan inlet doors were also observed open effectively negating outside air intake and drawing return air into the fans through the mechanical room space.

Recommend Renovation of the building heating and ventilation controls with modern Direct Digital Controls. Modern DDC type controls will be able to more efficiently operate the heating and ventilation systems and allow the user the schedule, monitor operation, and trend the building heating and ventilation systems. Therefore even though the systems when operating correctly will be heating more outside air (as required by code) these systems should be more efficient due to the DDC systems. The DDC controls should be tied into the heating circulation pump controls and possibly the boiler operating controls. The heating units should also be connected to the DDC system for monitoring and scheduling purposes.

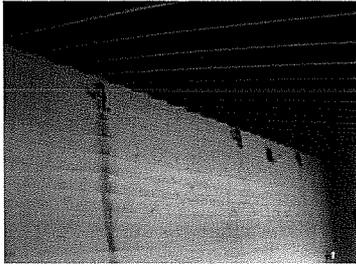
SPRINKLER EXTERIOR DRAINS

The piping has many drains, approximately 25, located around the building. These drains need to be accessed regularly for condensate draining as part of the regular maintenance of dry pipe sprinkler systems. Because of the numerous drains this probably has not done in the past. Recent problems with burst piping occurred, causing water damage, most likely a result of condensate collecting in pipe sections and without frequent drainage when the pipe is subjected to a cold spell it then freezes and breaks.
