HAINES BOROUGH, ALASKA
P.O. BOX 1209 • HAINES, ALASKA 99827
Administration 907.766.2231 • (fax) 907.766.2716
Tourism 907.766.2234 • (fax) 907.766.3155
Police Dept. 907.766.2121 • (fax) 907.766.2128
Fire Dept. 907.766.2155 • (fax) 907.766.3373

I have reviewed your letter of March 9th in which you allege that on 6 & 7 March 2015 there were violations of The Agreement Regarding Flight Operations and Practices of Commercial Ski Tours (hereafter referred to as "The Agreement") and violations of the Conditional Use Permit (CUP) issued to Big Salmon Ventures (BSV) on 14 March 2014. Specifically, you allege the following violations of the Agreement and of the CUP:

HAINES BOROUGH HELISKIING COMPLAINT FORM

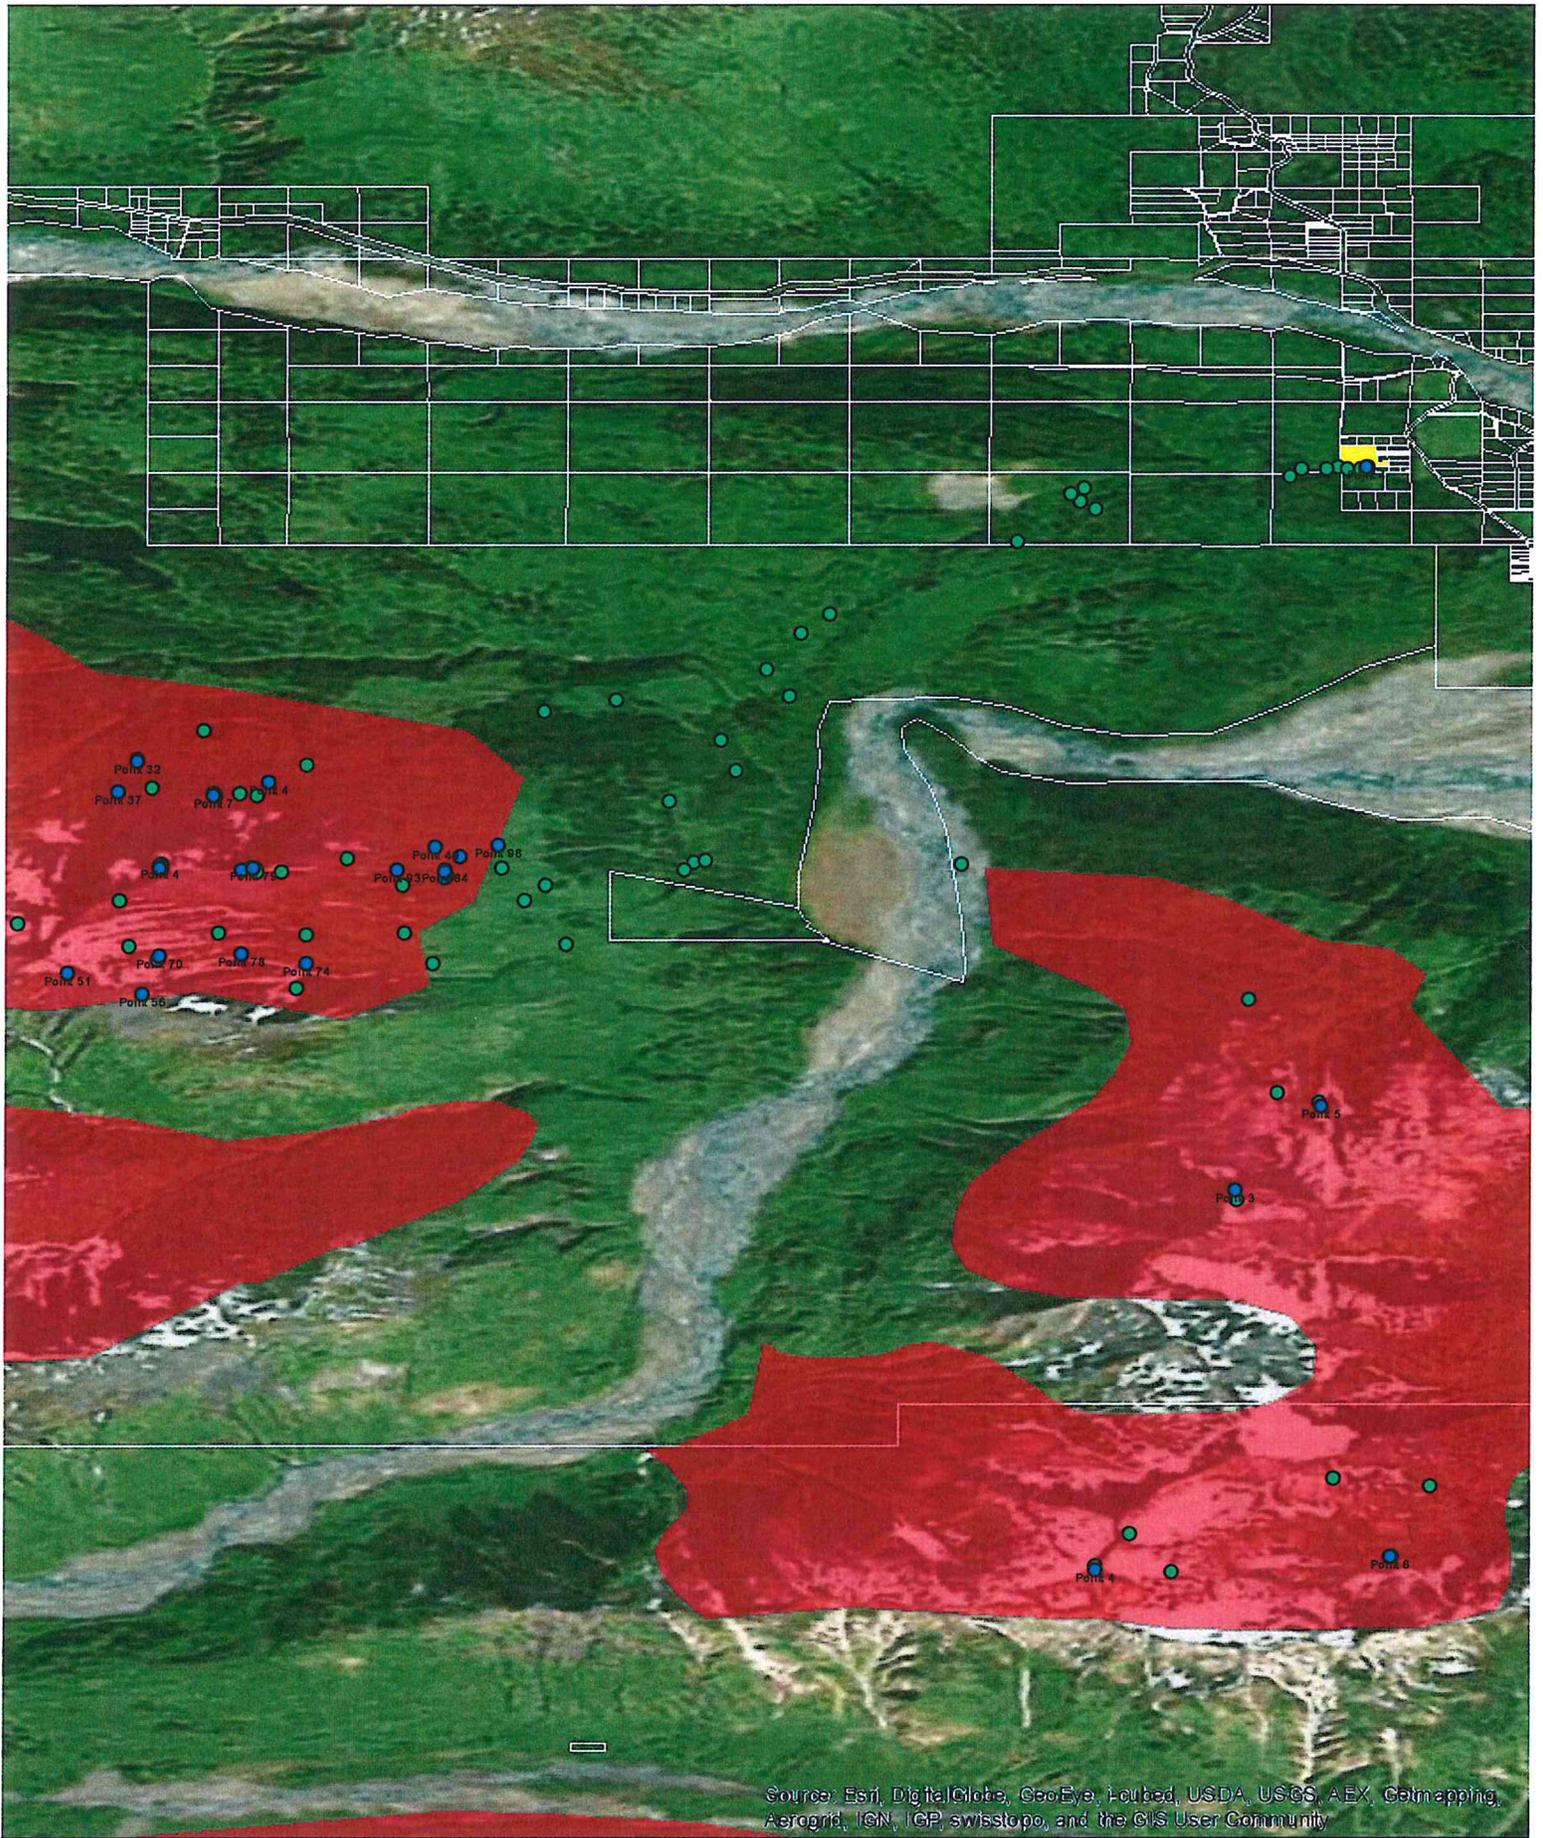
GPS Data Review: The GPS data was received as a cvs. file enabling it to be processed into a graphic for review. This graphic is labeled Graphic 1 in the supplemental information provided with this response. The data also provided information relating to the following fields: aircraft, point number, date time group in universal and local time, latitude, longitude, altitude in Above Sea Level (ASL), speed, and bearing.

For the purposes of this review it was assumed that Air Speed of 0 and a Heading of 0 (0/0) was an indication that the aircraft was on the ground. Additionally, the GPS reports data on time intervals so multiple successive time intervals of 0/0 equated to a sustained period of time on the ground. This was confirmed in conversation with Mr. Sundberg. In general

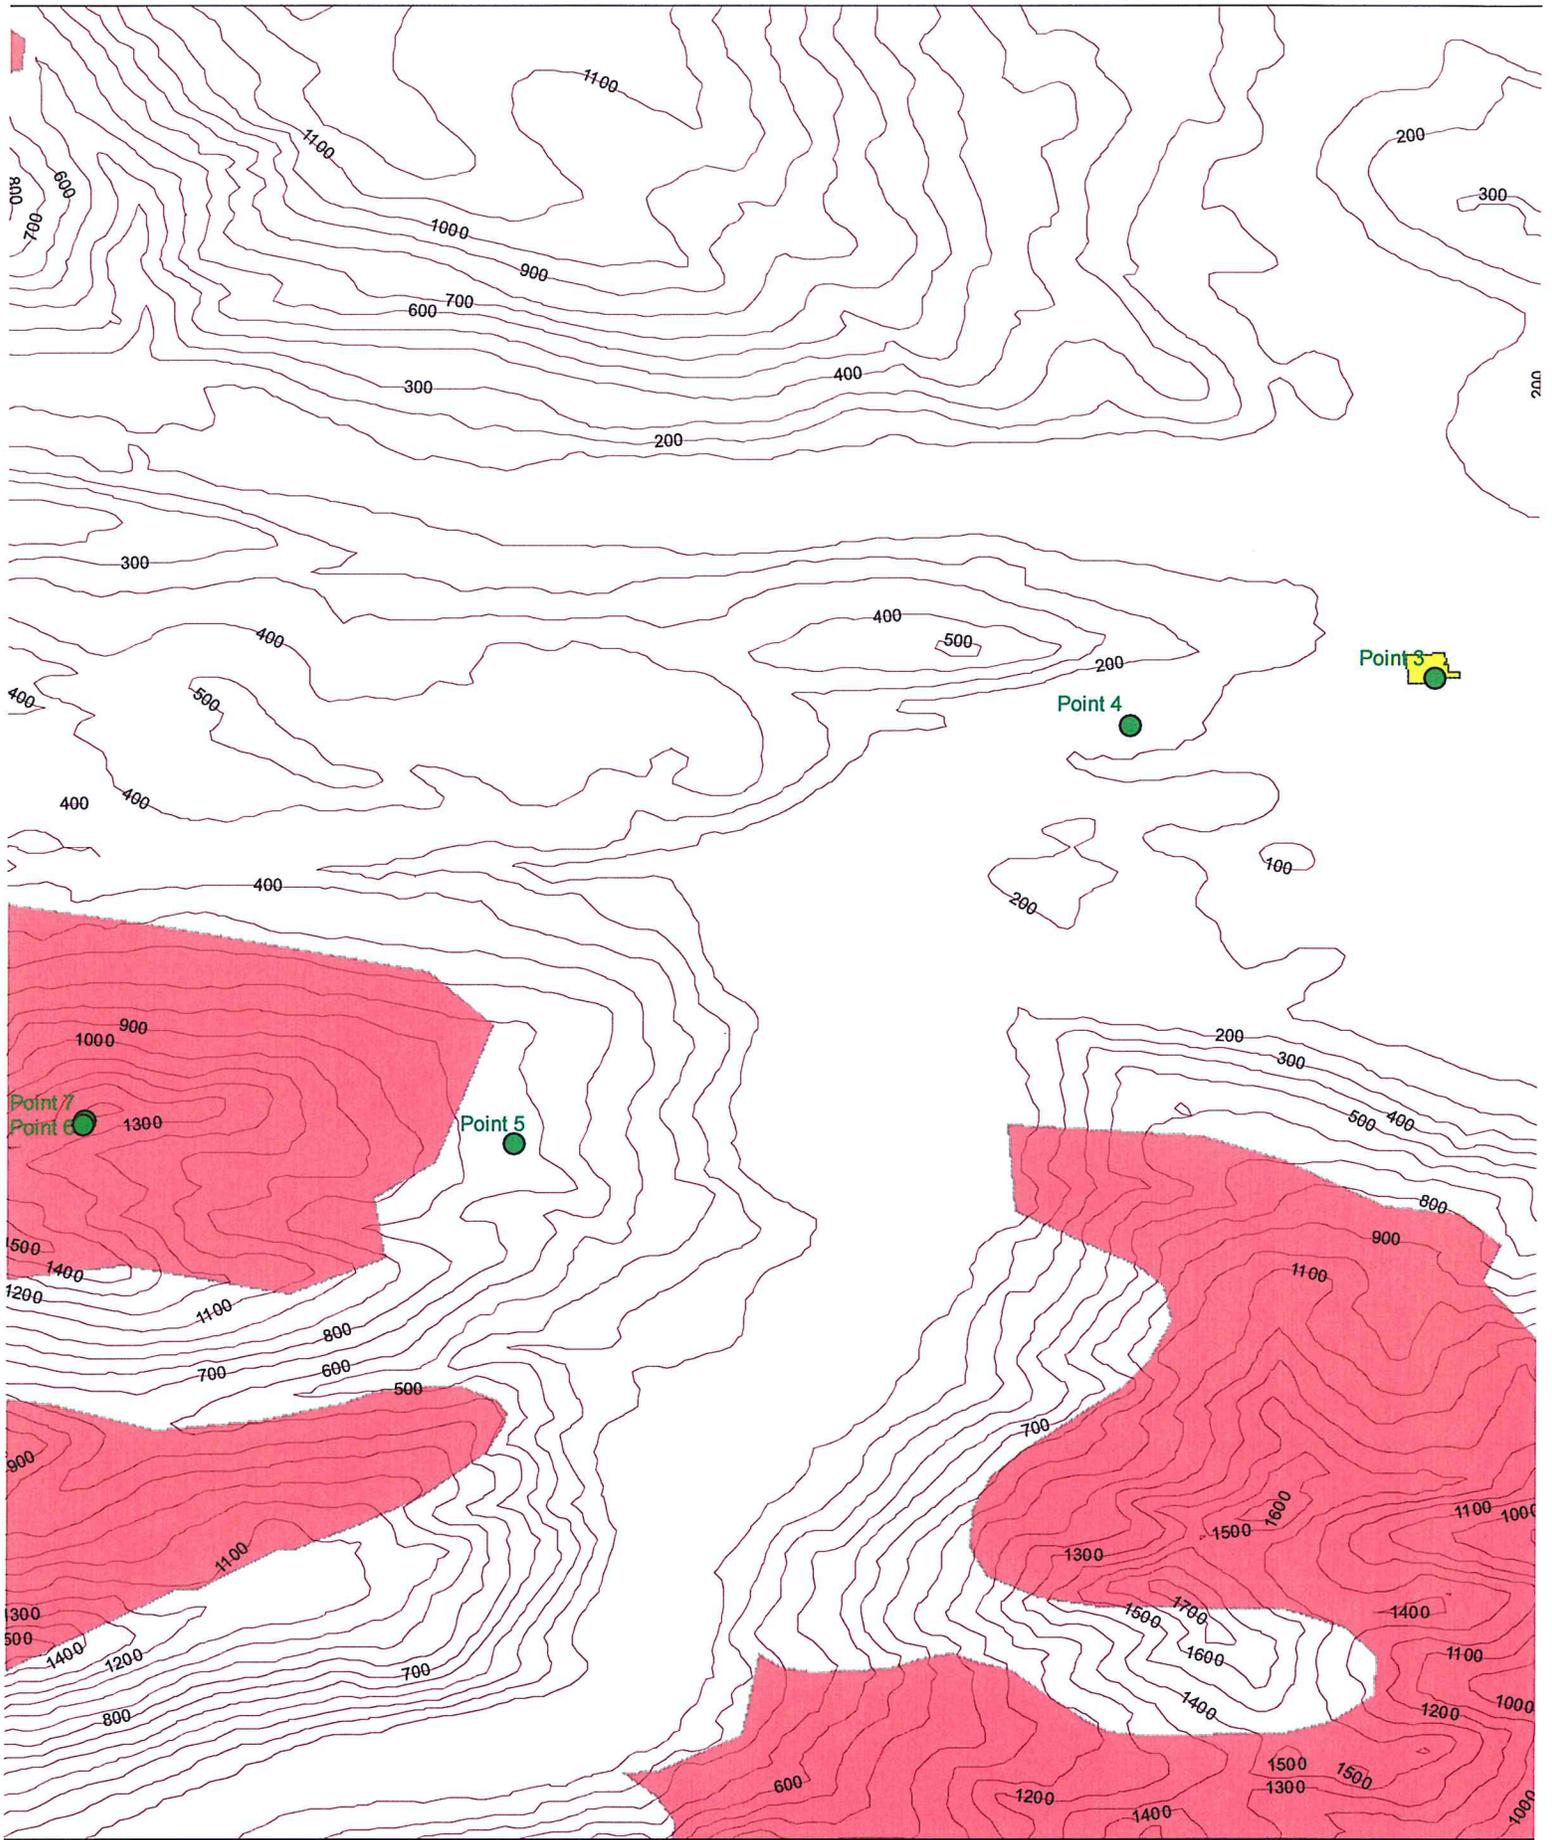
Graphic 2

An element of the complaint alleges that there were violations of the provision to remain 1500 AGL. Graphics 2 & 3 display imagery of a takeoff and a landing at the CUP LZ on 7 March 2015. The graphics denote location and elevation in ASL and also depict a 100 foot contour interval. The table below converts the information on the graphic to estimated AGL:

Graphic 2: CUP LZ to Ski Area (appx. 8.25 mi)			
Point	ASL	Contour	Estimated AGL
3	237	100	0
4	539	150	389
5	2456	750	1706
6	4800	1400	3400
7	4768	1400	0
Graphic 3: Ski Area to CUP LZ (appx. 8 mi.)			
23	4443	1300	0
24	1897	400	1497
25	450	150	300
26	286	100	0

Given the data available it was only possible to approximate the AGL by subtracting the estimated contour data from the ASL from the GPS. As reading from the GPS are in 2 minute intervals only the data for those points in time are available.

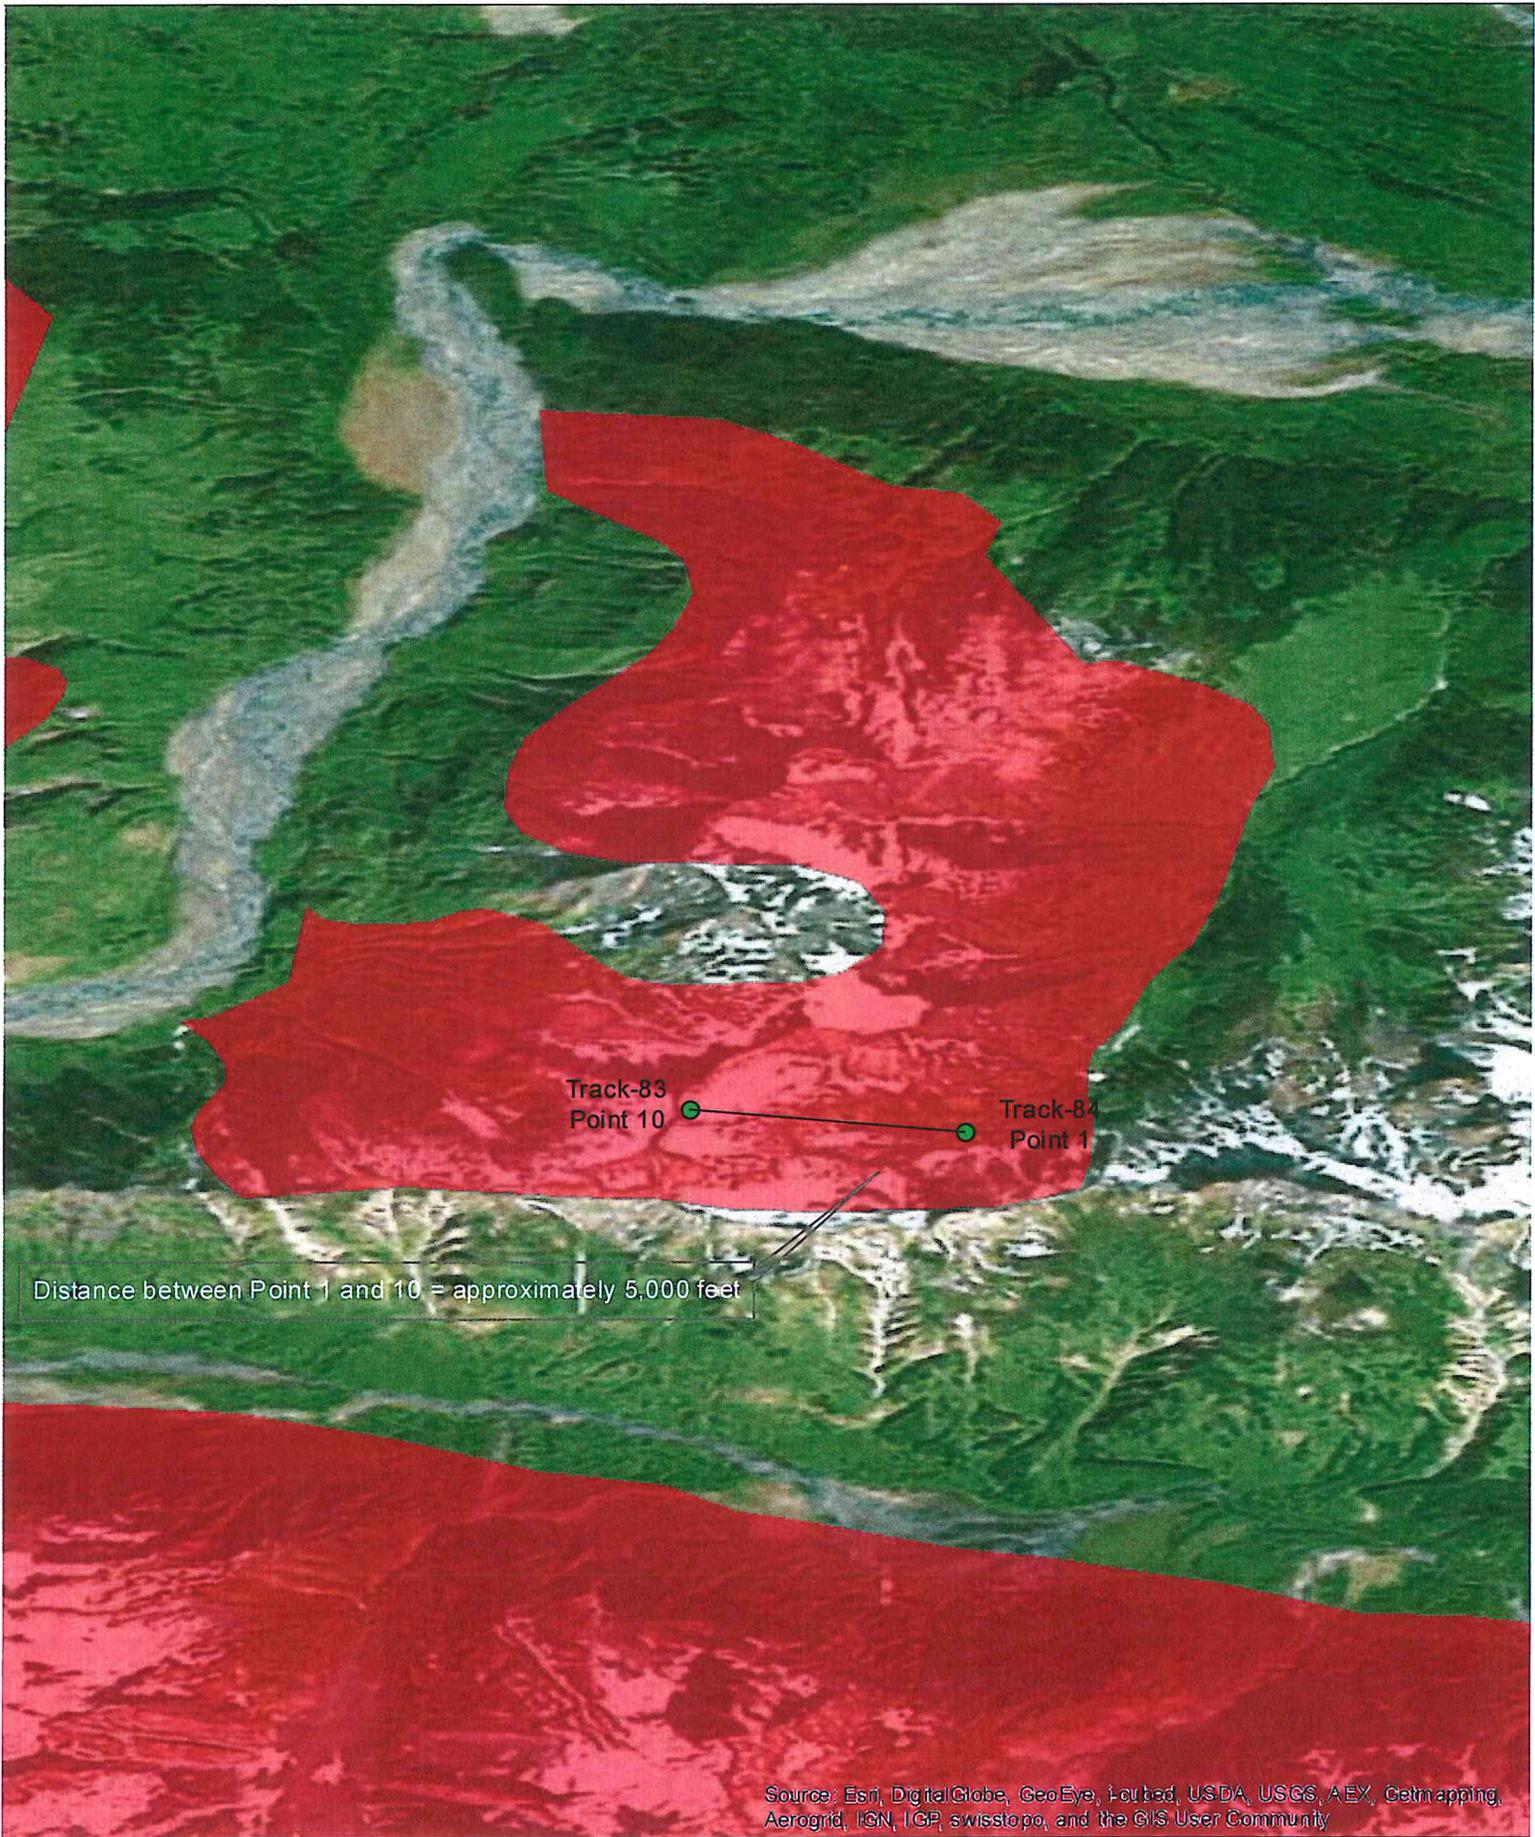
Graphic 4

6 March: On 6 March 2015 the helicopter departed the CUP LZ at 10:55 AM and returned at 1:07 PM. On the initial flight out the aircraft gained more than 2,000 feet in four minutes consistent with safe flight and ultimately gained nearly 5,000 feet of elevation before dropping passengers off at 11:07. The aircraft shut engines and "parked" in the ski area on five occasions before returning to the CUP LZ at 1:07 PM. All end points for a given Flight Track and start points for the next Flight Track give indications of Airspeed and Heading of 0/0 with the exception of Point 10 of Track 83 and Point 1 of Track 84. Point 10 of Track 83 indicates an Airspeed of 69.99943 Knots and a Bearing of 348 degrees. The Airspeed listed is an increase of 52 Knots over the previous reading for Point 9. There then follows a gap in readings of 23 minutes until the GPS readings resume during which the aircraft shifts 5,000 feet based on the Latitude and Longitude readings. This irregularity is depicted on Graphic 4.

In closing this investigation the Borough again makes note of the irregularity noted on 6 March. That still remains unexplained and the Borough will continue to investigate this aspect of the investigation while closing out the investigation of the elements noted above. Should further investigation determine that a violation occurred the Borough reserves the right to impose penalties as appropriate based on code, agreement, and policy. Finally, the Borough recommends that tour operators provide copies of the Agreement and any applicable CUP's to aircraft operators to ensure there is a clear understanding of restrictions and requirements.
