Memo To: Aaron Banks, C.P.G. 2925-5.3
R&M Consultants, Inc.

**Subject: Phase 2 Test Pit and Laboratory Testing Results
Haines Beach Road Landslide – NTP2 Task 5.3
PSA Agreement No. 25213018, IRIS No. SDRER00317**

TEST PIT SITE MAP
JUNE 2021
BEACH ROAD LANDSLIDE
HAINES, ALASKA

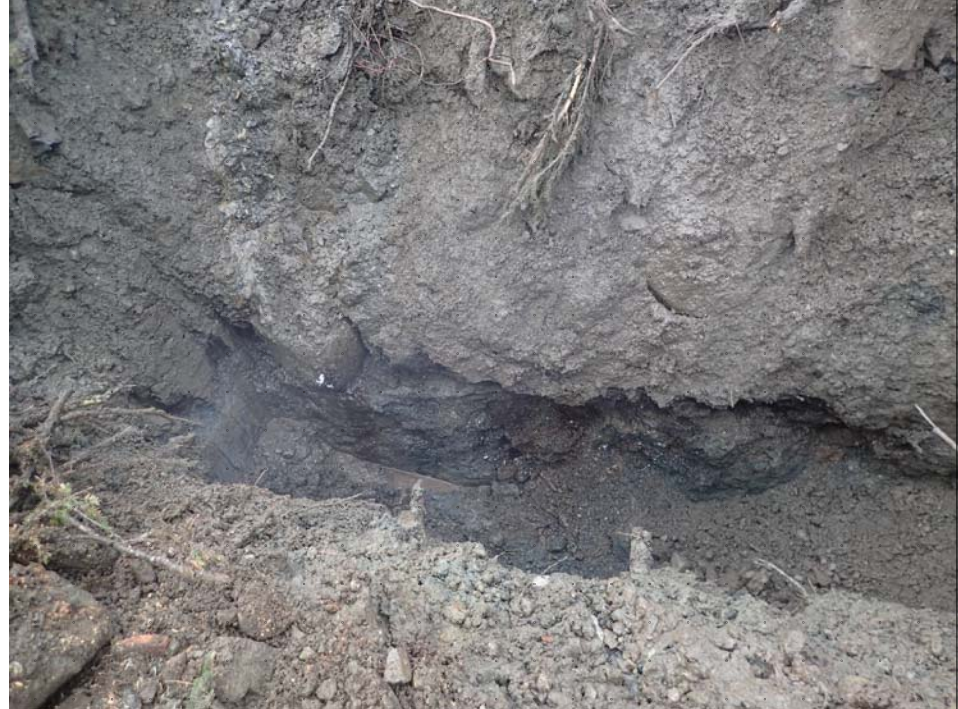
TEST PIT NO.: TP-5
 START TIME: 0600 FINISH TIME: 0630
 DATE: 6/24/21 DATE: 6/24/21

SURFACE CONDITIONS:
 Downed trees intermixed with Slide Debris.

0-8 feet: LOOSE, brown, silty SAND; numerous angular, gravel- to boulder-sized rock fragments up to 8 feet, scattered woody debris and roots, wet (SLIDE DEBRIS)

8 - 9 feet: LOOSE, dark brown, ORGANICS; wet (ORIGINAL GROUND)

9-10 feet: VERY STIFF, gray, slightly sandy, slightly clayey to clayey SILT; moist (GLASCIOLACUSTRINE/MARINE SEDIMENTS)

10-11 feet: HARD (R4), dark gray, moderately weathered, Ultramafic Rock

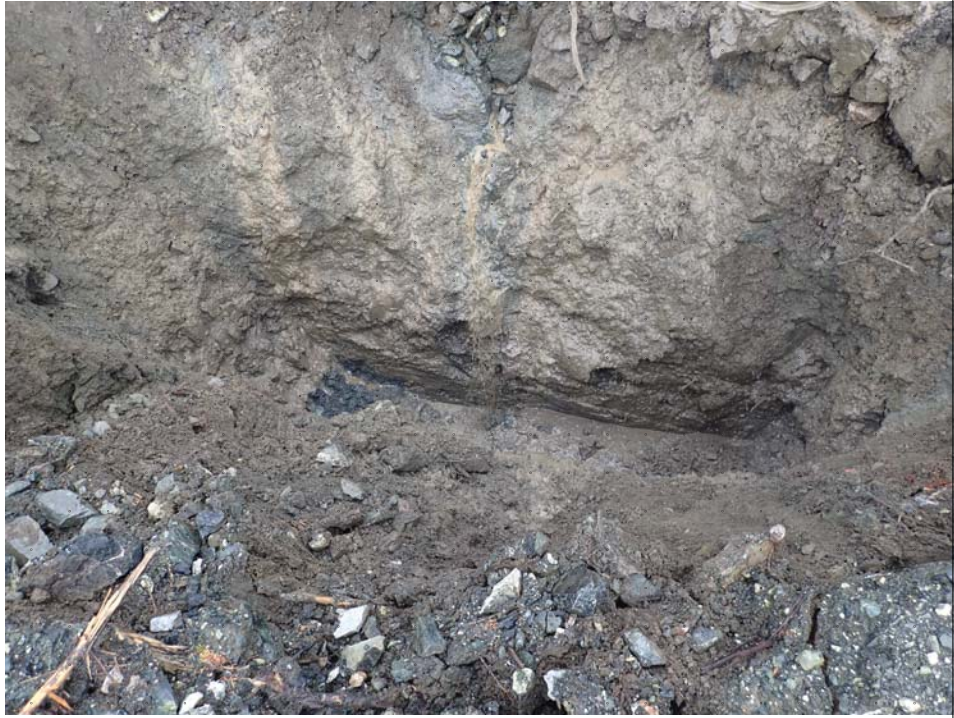
TEST PIT NO.: TP-6
START TIME: 0635
FINISH TIME: 0655
DATE: 6/24/21 DATE: 6/24/21

SURFACE CONDITIONS:
Scattered tree limbs, numerous boulders up to 6 feet max dimension.

0-12 feet: LOOSE, brown, silty SAND; numerous angular, gravel- to boulder-sized rock fragments up to 8 feet, scattered woody debris and roots, wet (SLIDE DEBRIS)

11-12 feet: LOOSE, dark brown, ORGANICS; wet (ORIGINAL GROUND)

12-13 feet: VERY STIFF, gray, slightly sandy, slightly clayey to clayey SILT; moist (GLASCIOLACUSTRINE/MARINE SEDIMENTS)

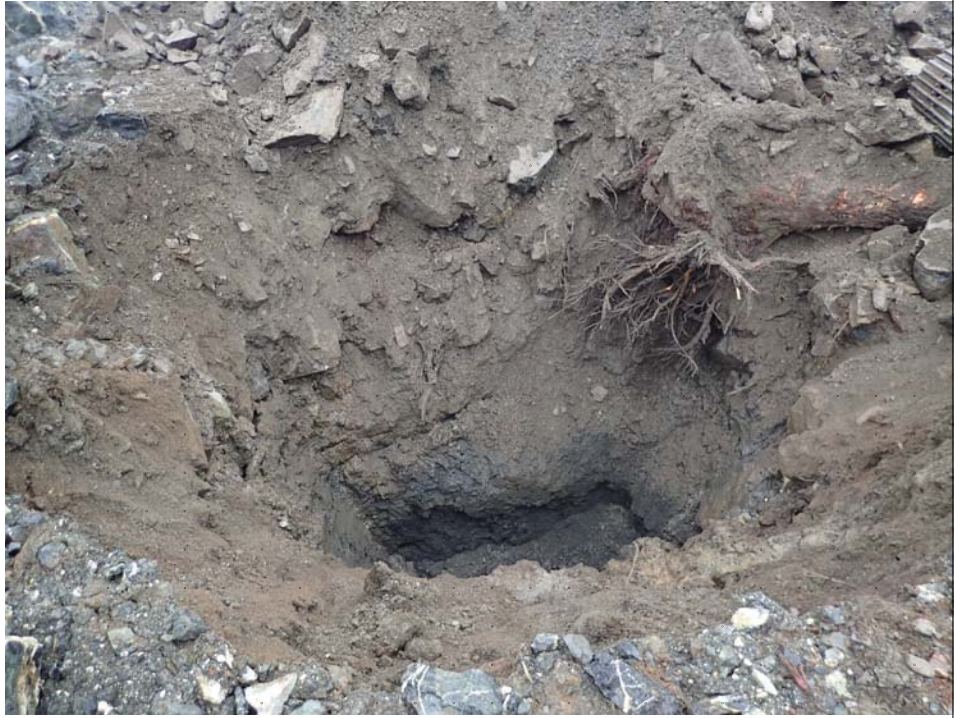
SURFACE CONDITIONS:
 Scattered tree limbs, numerous boulders up to 3 feet max dimension.

0-12 feet: LOOSE, brown, silty SAND; numerous angular, gravel- to boulder-sized rock fragments up to 8 feet, scattered woody debris and roots, wet (SLIDE DEBRIS)

12-17 feet: LOOSE, dark gray, silty SAND; micaceous (biotite) grains, (WEATHERED ULTRAMAFICS)

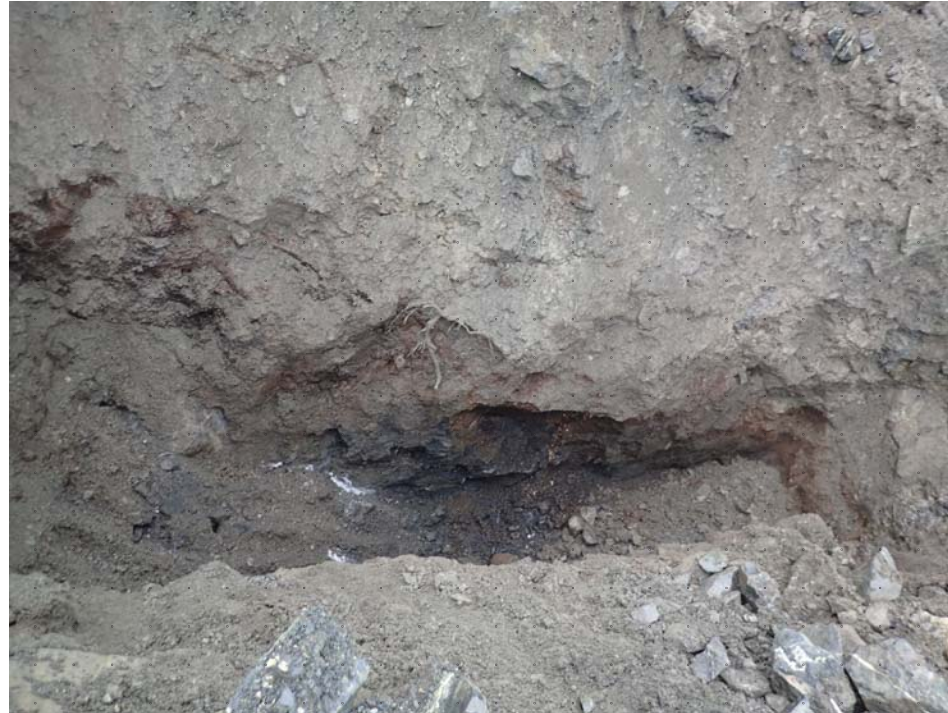
SURFACE CONDITIONS:
Numerous boulders up to 3 feet max dimension.

0-5 feet: LOOSE, brown, silty SAND; numerous angular, gravel- to cobble-sized rock fragments; scattered woody debris and roots, moist (SLIDE DEBRIS)

5 feet: HARD (R4), dark gray, moderately weathered, Ultramafic Rock; biotite rich

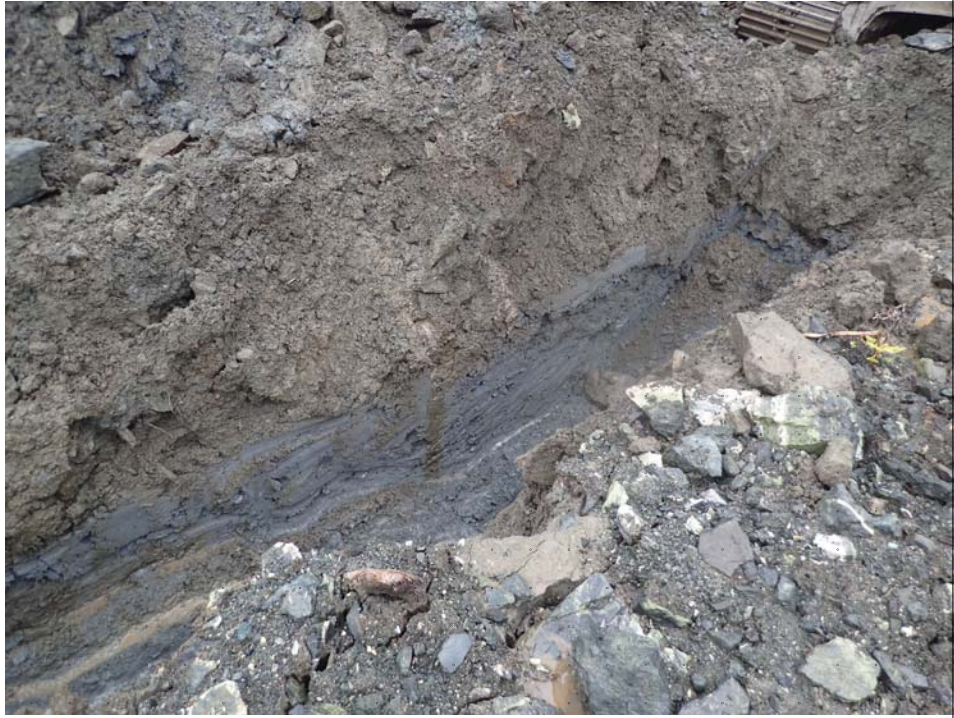
SURFACE CONDITIONS:
Numerous boulders up to 3 feet max dimension.

0-3.5 feet: LOOSE, brown, silty SAND; numerous angular, gravel- to boulder-sized rock fragments, scattered woody debris and roots, wet (SLIDE DEBRIS)

3.5-8 feet: VERY STIFF, gray, slightly sandy, slightly clayey to clayey SILT; moist (GLASCIOLACUSTRINE/MARINE SEDIMENTS)

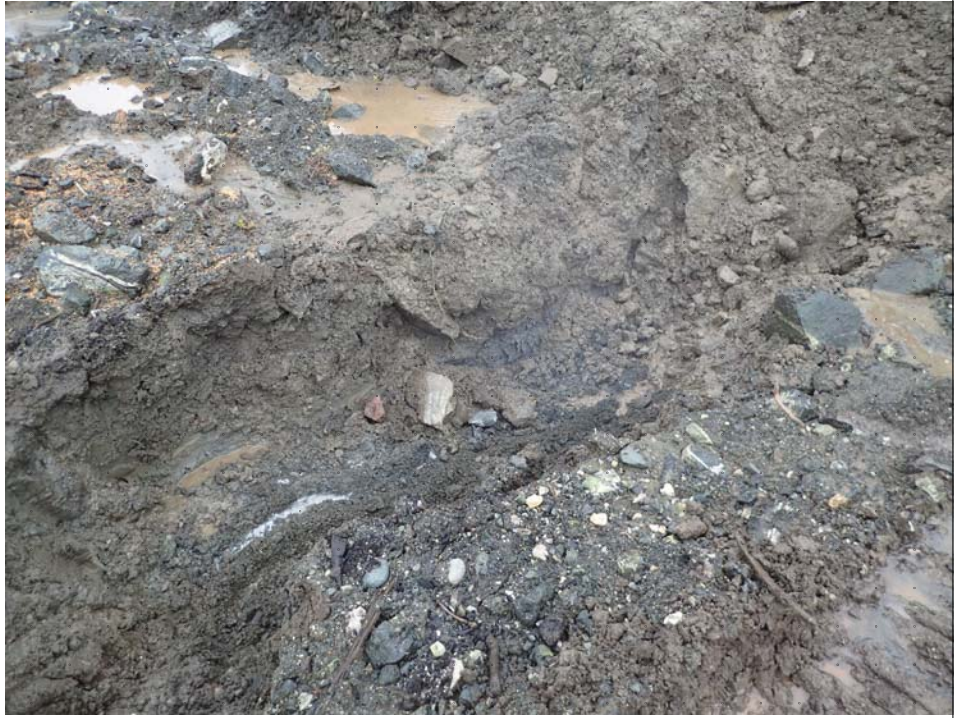
SURFACE CONDITIONS:
 Standing water, silty SAND with scattered gravel- and cobble-sized

rock fragments
 0-2 feet: LOOSE, brown, silty SAND; numerous angular, gravel- to cobble-sized rock fragments, scattered woody debris and roots, wet (SLIDE DEBRIS)
 2-4 feet: VERY STIFF, gray, slightly sandy, slightly clayey to clayey SILT; moist (GLASCIOLACUSTRINE/MARINE SEDIMENTS)
 4-5 feet: HARD (R4), dark gray, moderately weathered, Ultramafic Rock; biotite rich

Notes:
 - Refusal assumed to be on bedrock.
 - Water flowing into pit from the surface.

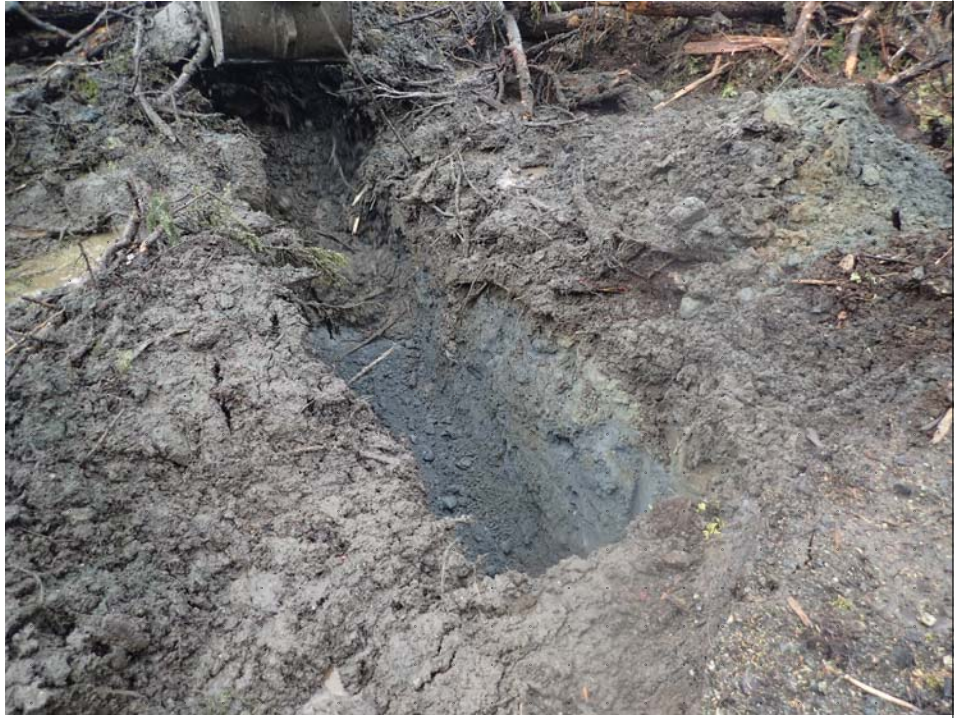
SURFACE CONDITIONS:
 5-6 foot thick layer of 2-3 foot diameter downed trees, standing water

Notes:
 - Refusal assumed to be on bedrock.
 - Sample at 2 feet.

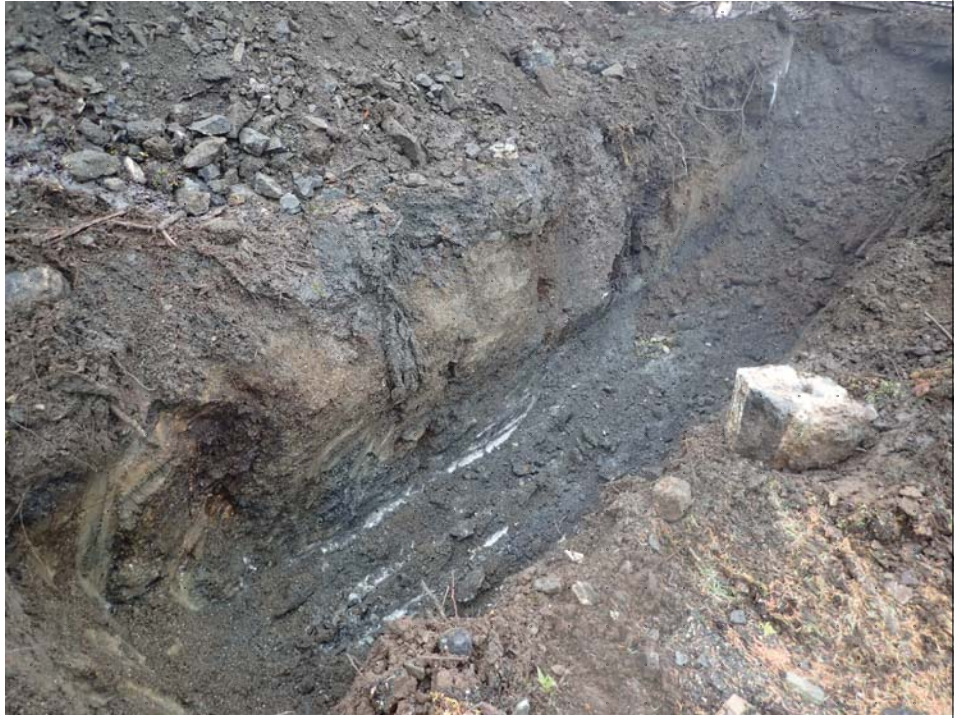
SURFACE CONDITIONS:
 Numerous woody debris with logs up to 2 foot in diameter

0-2 feet: LOOSE, brown, silty SAND; numerous angular, gravel- to cobble-sized rock fragments, moist (SLIDE DEBRIS)

2-4 feet: LOOSE, brown and gray, silty SAND; micaceous (WEATHERED TOP OF ROCK)

4 feet: HARD (R4), gray, moderately weathered, Ultramafic Rock; biotite rich

Notes:
 - Refusal assumed to be on bedrock.
 - Sample at 2 feet.

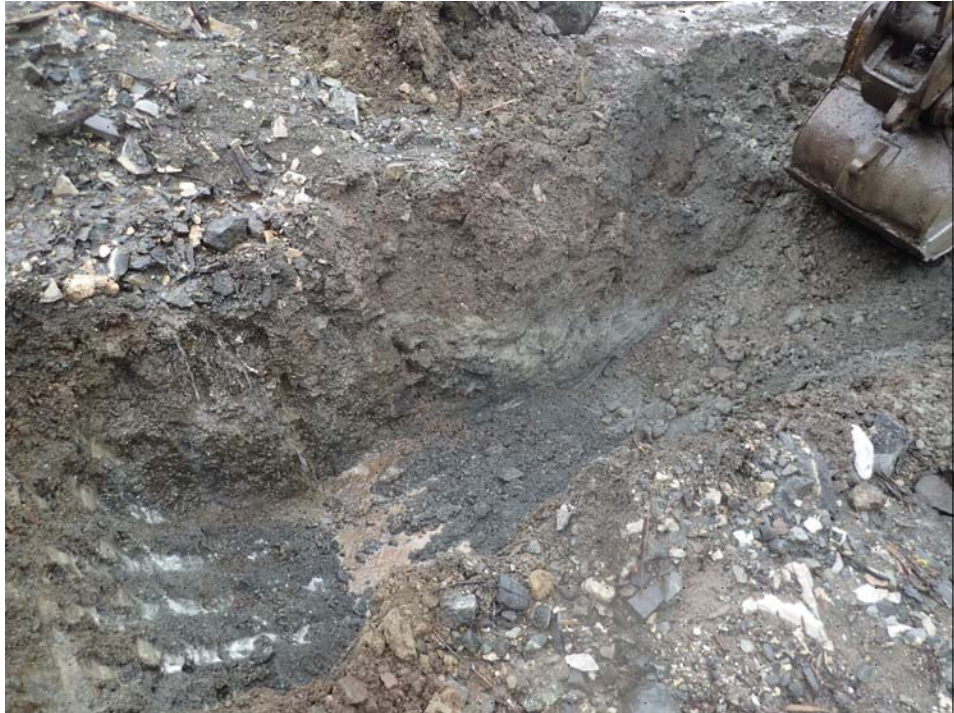
SURFACE CONDITIONS:
 LOOSE, brown, silty SAND with numerous cobbles (SLIDE DEBRIS)

0-2 feet: LOOSE, brown, silty SAND; numerous angular, gravel- to cobble-sized rock fragments, moist (SLIDE DEBRIS)

2-5 feet: LOOSE, brown and gray, silty SAND; micaceous (WEATHERED TOP OF ROCK)

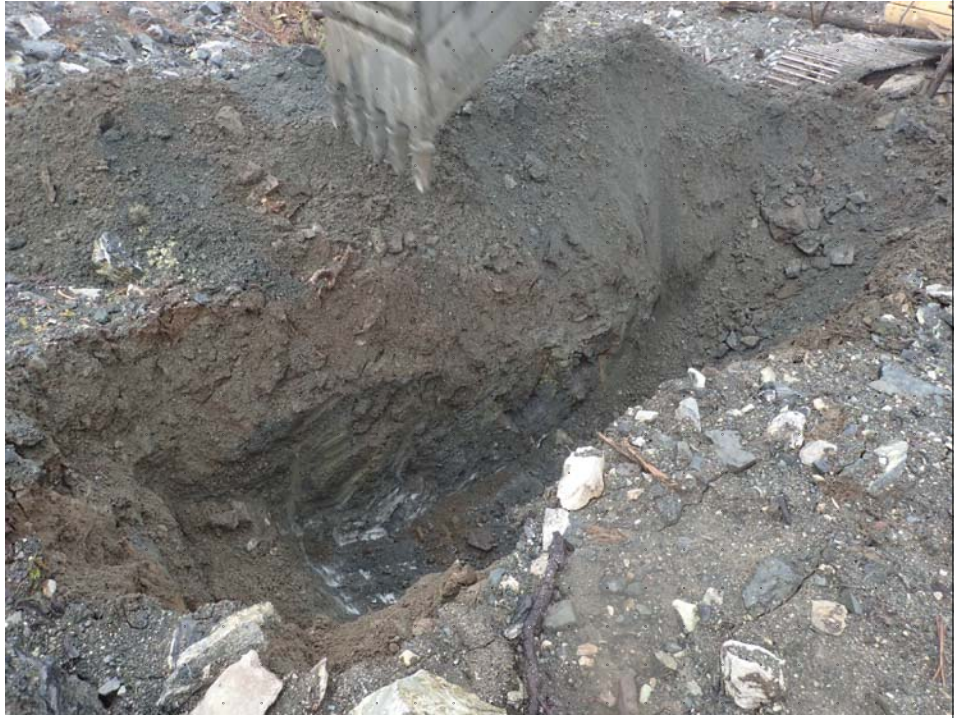
SURFACE CONDITIONS:
LOOSE, brown, silty SAND with scattered woody debris (SLIDE DEBRIS)

(DEBRIS)
0-3 feet: LOOSE, brown, silty SAND; numerous angular, gravel- to cobble-sized rock fragments, moist (SLIDE DEBRIS)
3-9 feet: DENSE, brown and gray, silty SAND; micaceous (WEATHERED TOP OF ROCK)
9 feet: HARD (R4), gray, moderately weathered, Ultramafic Rock; biotite rich

Notes:
- Refusal assumed to be on bedrock.
- Sample from 3 to 9 feet.

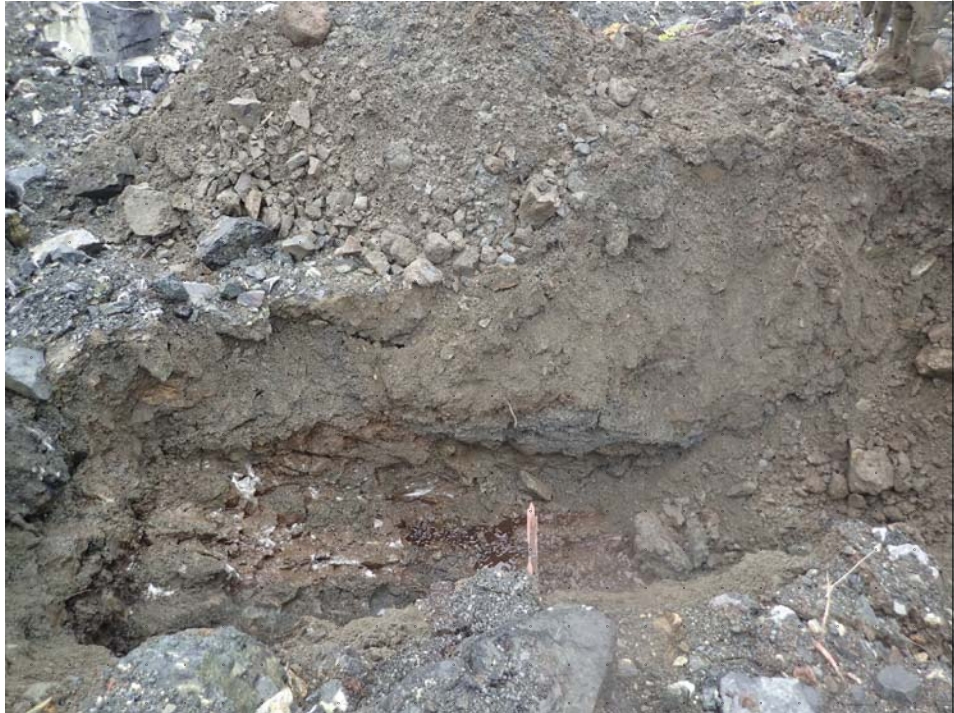
SURFACE CONDITIONS:
 LOOSE, brown, silty SAND (SLIDE DEBRIS)

0-3 feet: LOOSE, brown, silty SAND; numerous angular, gravel- to cobble-sized rock fragments, moist (SLIDE DEBRIS)

3-9 feet: DENSE, brown grading into gray, silty SAND; micaceous (WEATHERED TOP OF ROCK)

9 feet: HARD (R4), gray, moderately weathered, Ultramafic Rock; biotite rich

Notes:
 - Refusal assumed to be on bedrock.
 - Water flowing < 1 gpm at 2 feet.

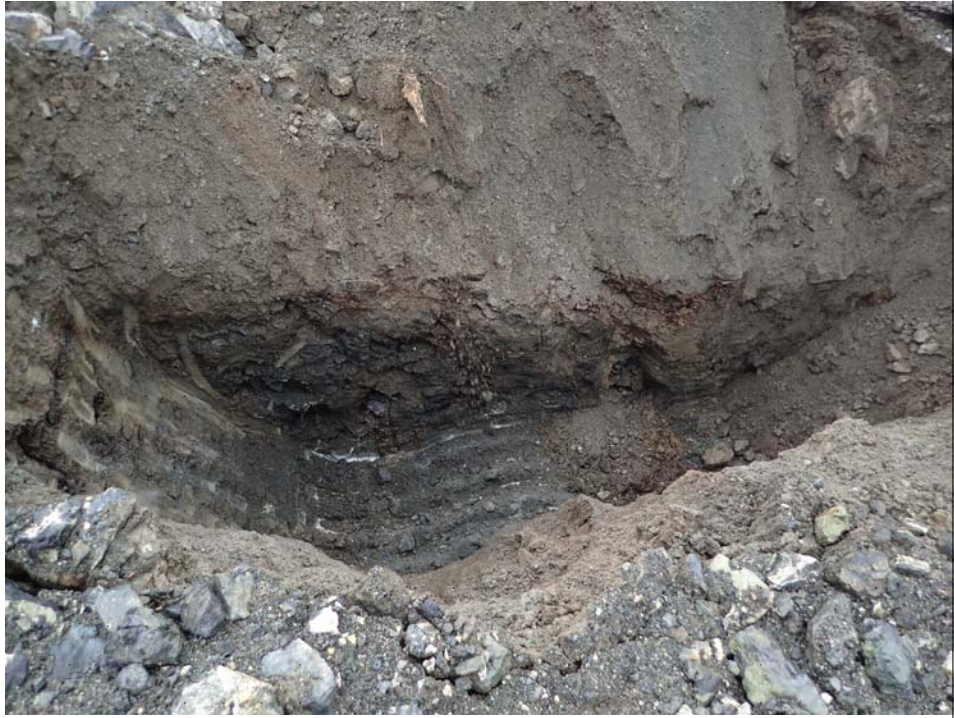
SURFACE CONDITIONS:
 LOOSE, silty SAND with boulders up to 2 feet (SLIDE DEBRIS)

20 foot boulder adjacent to test pit

0-2 feet: LOOSE, brown, silty SAND; numerous angular, gravel- to cobble-sized rock fragments, moist (SLIDE DEBRIS)

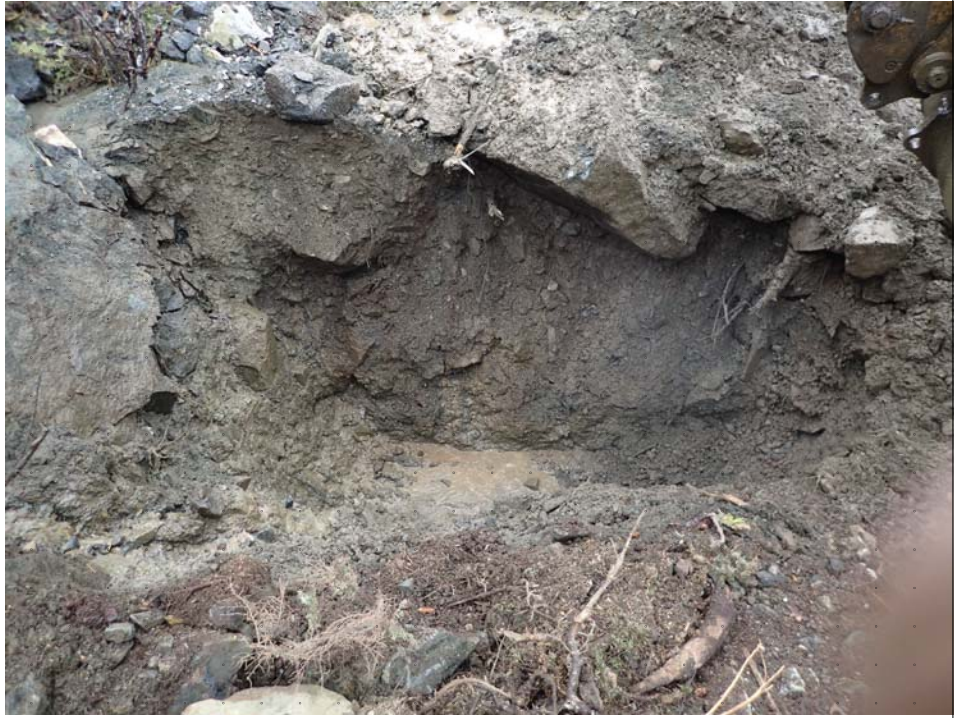
SURFACE CONDITIONS:
LOOSE, silty SAND with boulders up to 10 feet (SLIDE DEBRIS)

Water flowing on the surface at 10-15 gpm adjacent to pit.

0-7 feet: LOOSE, brown, silty SAND; numerous angular, gravel- to cobble-sized rock fragments, wet (SLIDE DEBRIS)

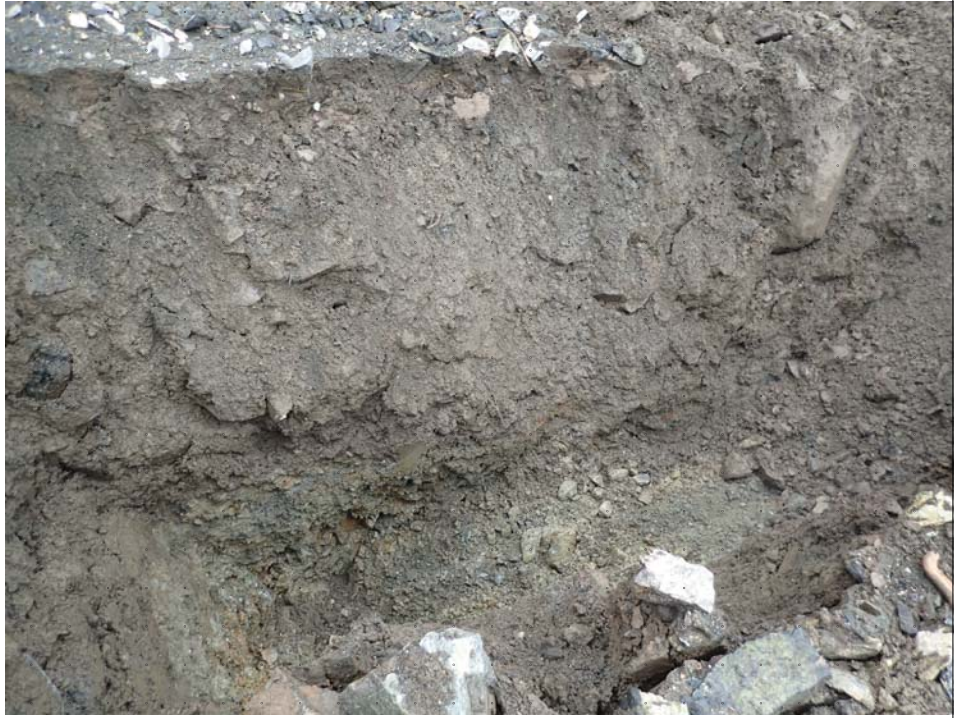
SURFACE CONDITIONS:
 LOOSE, silty SAND with boulders up to 5 feet (SLIDE DEBRIS)

0-5 feet: LOOSE, brown, silty SAND; numerous angular, gravel- to cobble-sized rock fragments, wet (SLIDE DEBRIS)

5-8 feet: DENSE, brown and gray, silty SAND; moist, micaceous (WEATHERED TOP OF ROCK)

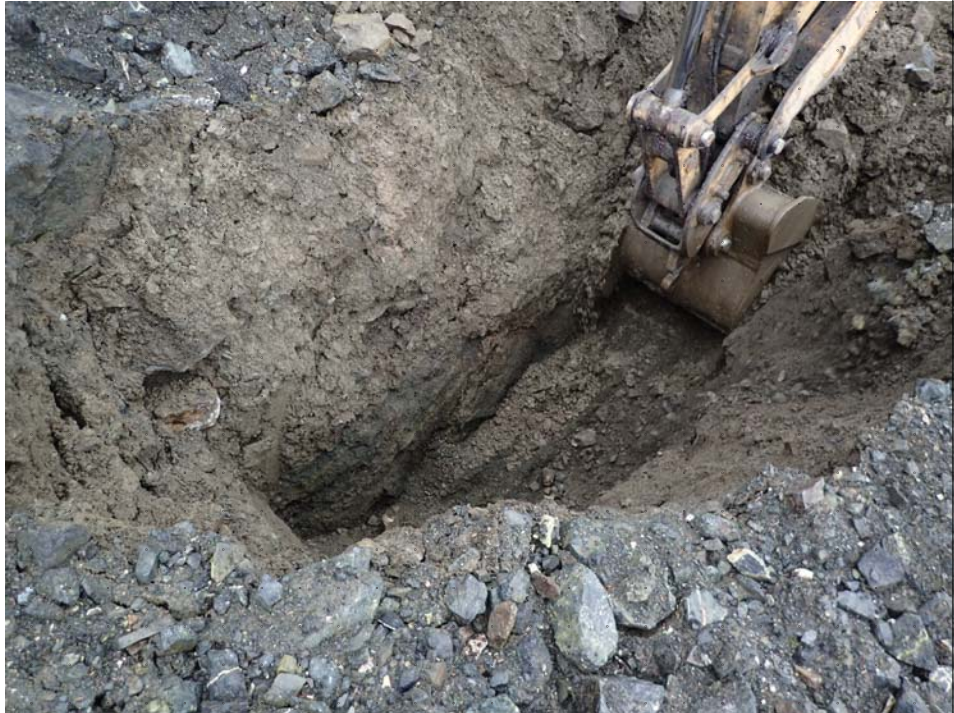
SURFACE CONDITIONS:
 LOOSE, silty SAND with boulders up to 5 feet (SLIDE DEBRIS)

0-5 feet: LOOSE, brown, silty SAND; numerous angular, gravel- to cobble-sized rock fragments, moist (SLIDE DEBRIS)

5-12 feet: DENSE, brown and gray, silty SAND; moist, micaceous (WEATHERED TOP OF ROCK)

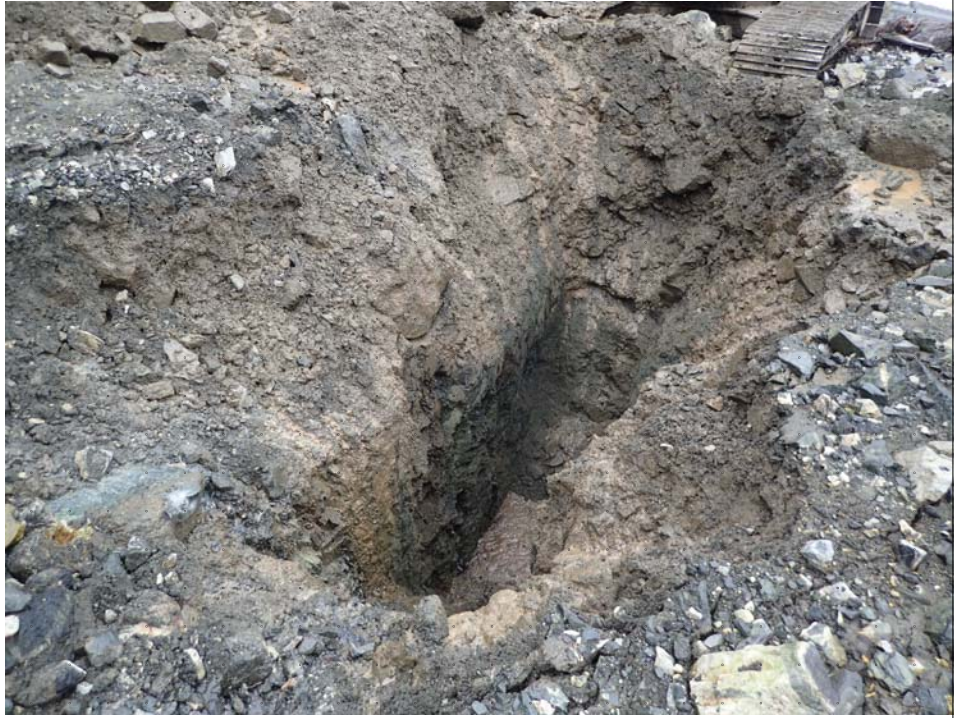
SURFACE CONDITIONS:
 LOOSE, silty SAND with running water on surface (SLIDE DEBRIS)

0-6 feet: LOOSE, brown, silty SAND; numerous angular, gravel- to cobble-sized rock fragments, wet (SLIDE DEBRIS)

6-18 feet: DENSE, brown and gray, silty SAND; moist, micaceous (WEATHERED TOP OF ROCK)
 ... numerous cobble-sized rock fragments starting at 10 feet

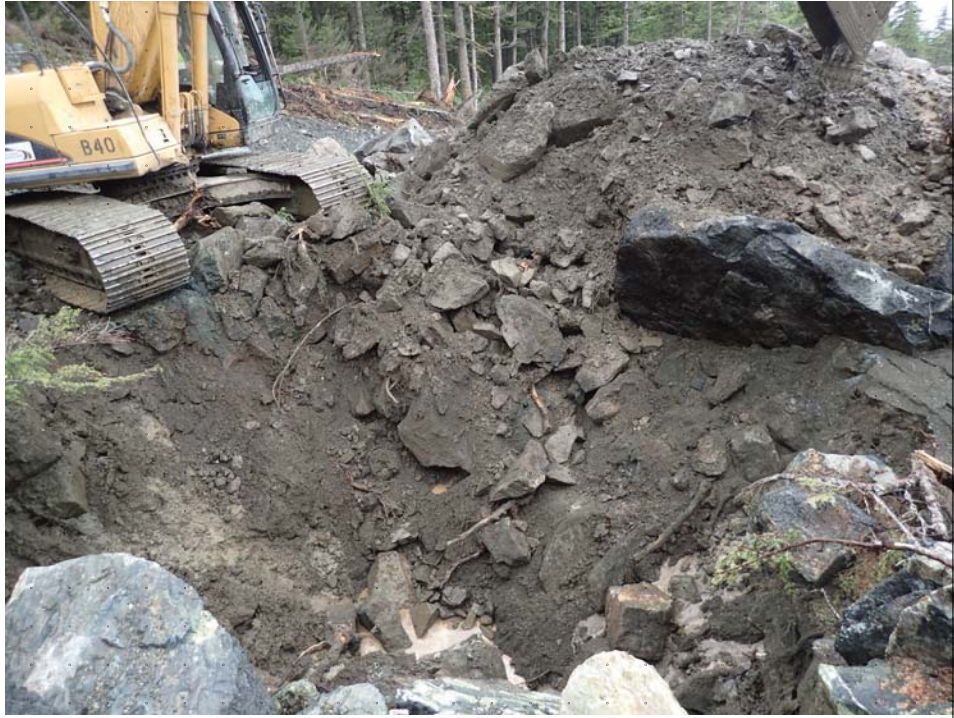
SURFACE CONDITIONS:
 LOOSE, silty SAND with boulders up to 10 feet (SLIDE DEBRIS)

0-16 feet: LOOSE, brown, silty SAND; numerous angular, gravel- to cobble-sized rock fragments, wet (SLIDE DEBRIS)

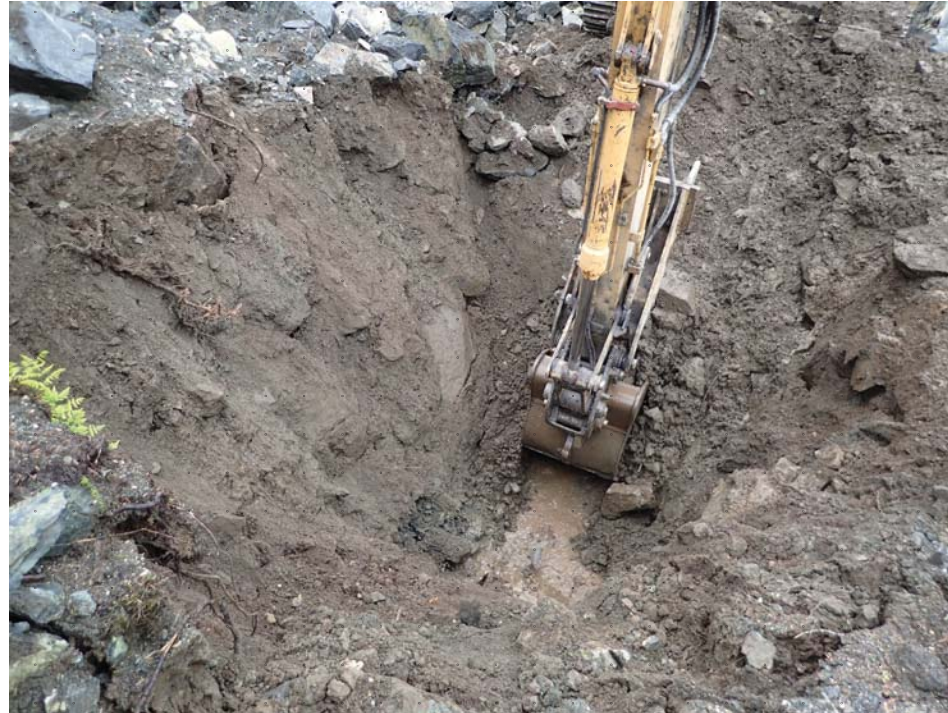
SURFACE CONDITIONS:
 LOOSE, silty SAND with boulders up to 15 feet and logs up to 3 feet

(SLIDE DEBRIS)
 0-5 feet: LOOSE, brown, silty SAND; numerous angular, gravel- to cobble-sized rock fragments, moist (SLIDE DEBRIS)
 12-16 feet: DENSE, brown and gray, silty SAND; moist, woody debris at 12 feet, micaceous (WEATHERED TOP OF ROCK)
 16 feet: HARD (R4), gray, moderately weathered, Ultramafic Rock; biotite rich

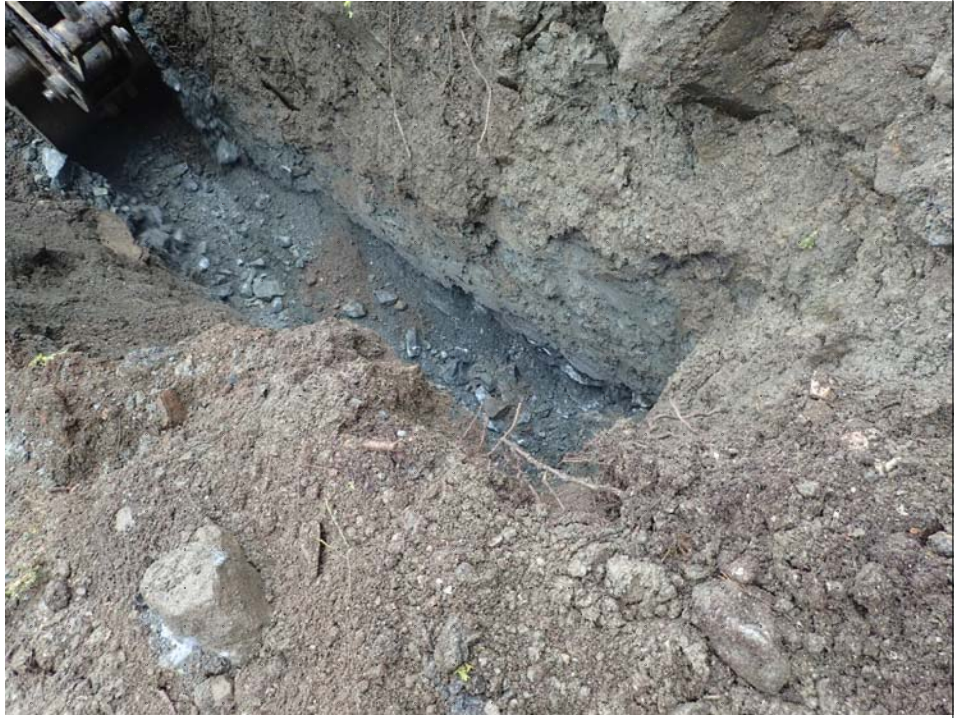
SURFACE CONDITIONS:
LOOSE, silty SAND with boulders up to 6 feet (SLIDE DEBRIS)

0-3 feet: LOOSE, brown, silty SAND; numerous angular, gravel- to cobble-sized rock fragments, moist (SLIDE DEBRIS)

3-12 feet: DENSE, brown grading to gray, silty SAND; moist, micaceous (WEATHERED TOP OF ROCK)

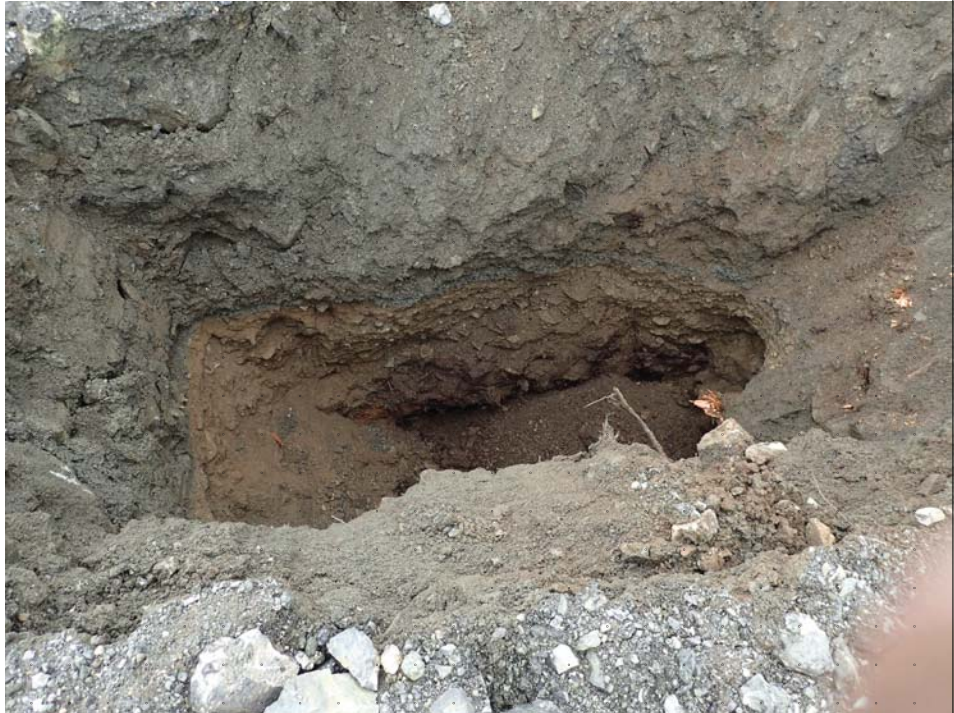
SURFACE CONDITIONS:
 LOOSE, silty SAND with boulders up to 2 feet (SLIDE DEBRIS)

0
 2
 4
 5-6 feet: DENSE, gray, sandy, GRAVEL; moist (DRIVEWAY SURFACING MATERIAL)
 6-10 feet: DENSE, brown, silty, SAND AND GRAVEL; moist (FILL)
 10-12 feet: Woody debris (CORDUROY)

Notes:
 - Halted excavation at 12 feet.
 - Exposed utilities at 10 feet.

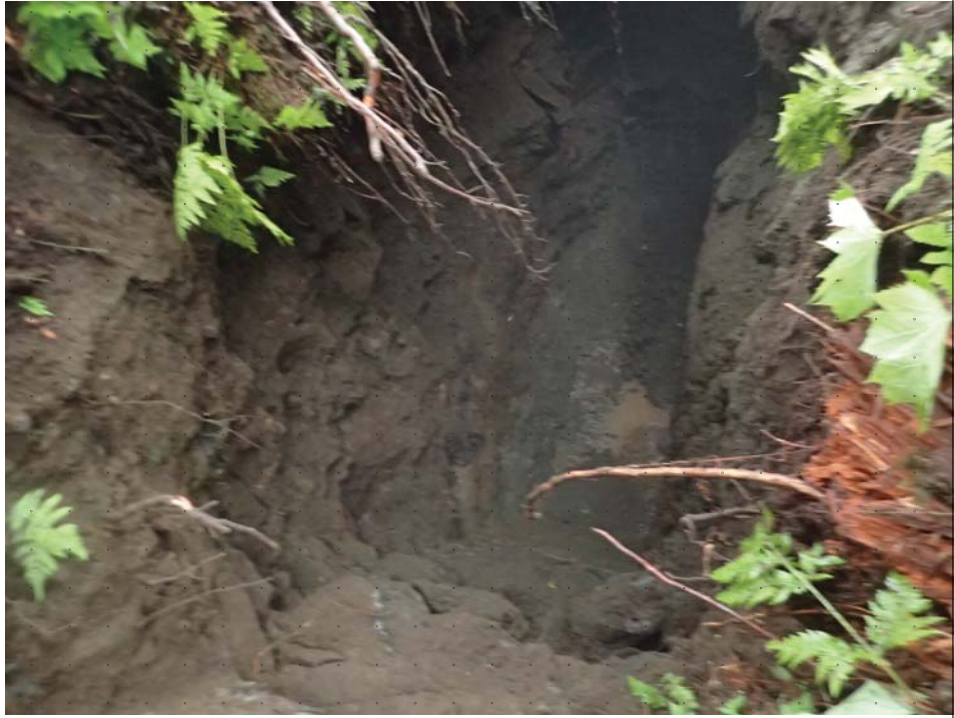
SURFACE CONDITIONS:
 Thick vegetation (ferns and devil's club), trees up to 6 foot diameter

0-1 feet: SOFT, brown, sandy, SILT; moist, numerous roots (TOP SOIL)

1-18 feet: MEDIUM DENSE, brown, silty SAND; moist, scattered angular cobbles and boulders up to 3 feet (COLLUVIUM)

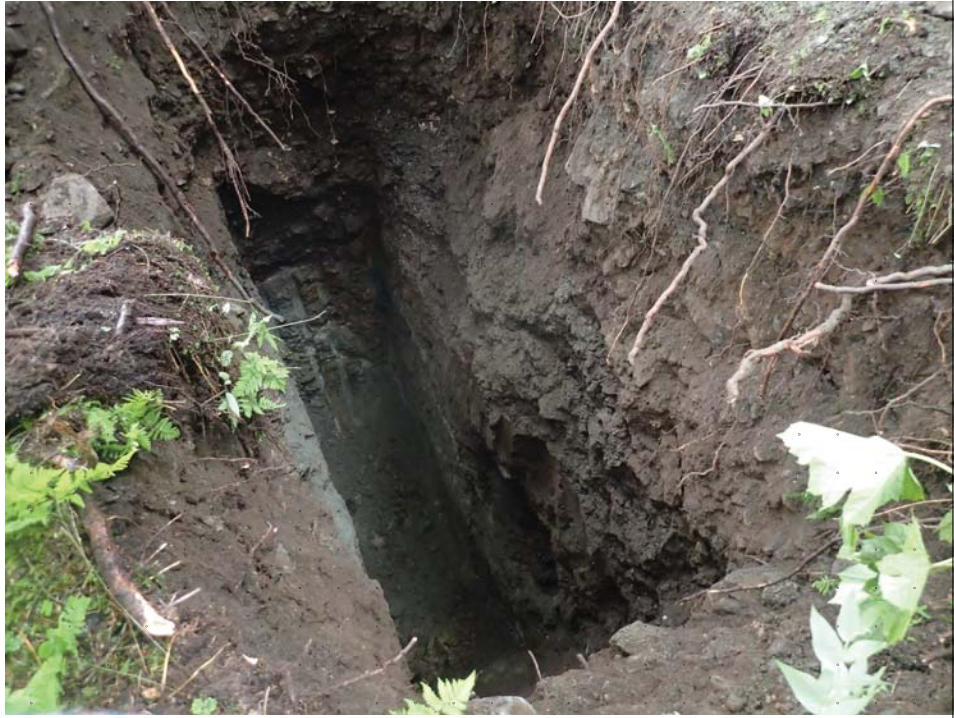
SURFACE CONDITIONS:
 Thick vegetation (ferns and devil's club), trees up to 6 foot diameter

0-1.5 feet: SOFT, brown, slightly clayey, sandy, SILT; moist, numerous roots (TOP SOIL)

1.5-12 feet: MEDIUM DENSE, brown, silty SAND; moist, occasional boulders up to 2 feet, scattered cobbles (COLLUVIUM)

12-12.5 feet: STIFF to VERY STIFF, black, clayey, SILT; organic ordor, moist (PALEO TOP SOIL)

12.5-18 feet: MEDIUM DENSE, gray, silty, SAND; moist becoming wet, scattered cobbles to coarse gravel sized angular rock fragments (COLLUVIUM)
