HAINES BEACH ROAD LANDSLIDE

WINTER SURVEY RECONNAISSANCE

SURVEY REPORT

Prepared by:
AJ Griffin, PLS
R&M Consultants, Inc.
March 18, 2021

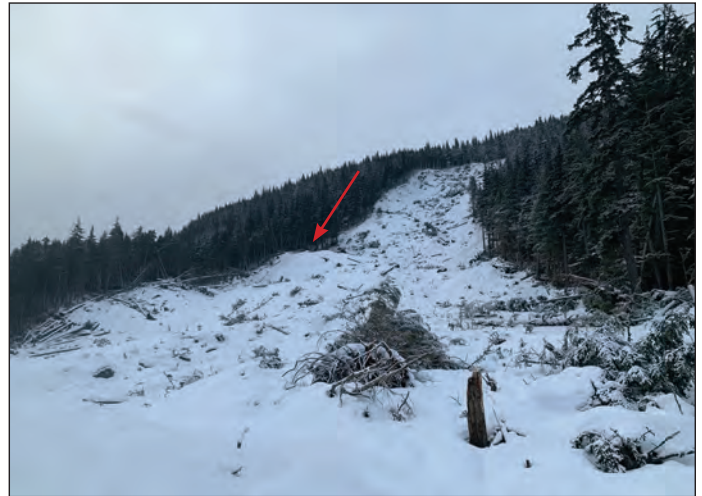
Potential robotic total station location

If possible, once power is restored to Beach Road, the ability to power the site from the grid would be ideal. We anticipate a good spot for the total station is on the outcrop about halfway up the slide area on the lookers left (see photo above). This spot should leave the instrument and structure safe from any future events. There are many different targets that can be placed on rocks, trees, poles, etc. Protecting them from the weather will be challenging. A hood constructed over the prism or monitoring point will help and is easily installed and commercially available. The potential for sideways snow sticking to targets may hamper monitoring operations. This option is also limited by weather conditions such as fog, mist, rain and snow. We cannot guarantee we will be able to obtain measurements all the time. It is possible to use more targets to enable better coverage of monitoring locations, even though some could be obscured from view. The area around the slide has good cellular service, so the ability to transfer data in real time exists.

Long-term monitoring of the existing slide path and associated landslide features poses many challenges. Utilizing a robotic total station to monitor line of sight targets along the slide path will allow for active monitoring of the slide area. The instrument will need to be housed in a structure that provides protection from the elements, while providing an unobstructed 360° view. Backsight locations will have to be located away from the path and at a minimum, be built on a concrete pedestal, if not housed in their own structure. With the slide area having an open view of the sky, using solar panels to power the system and associated equipment seems reasonable. Battery back-up power would most likely be needed to get through the months of October through February.

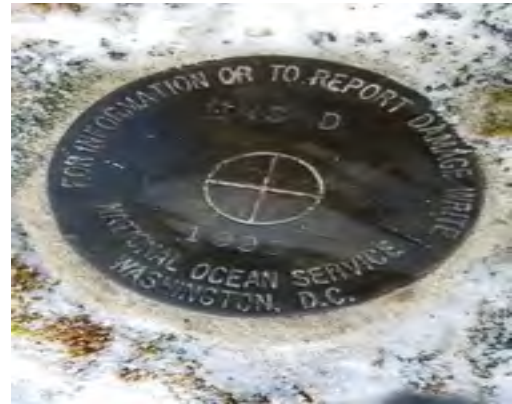
Close-up View

PID: AI4905
Designation: HNS D
Stamping: HNS D 1999
Stability: Most reliable; expected to hold position well
Setting: In rock outcrop or ledge
Mark Condition: G
Description:
Observed: 2020-12-15T21:44:00Z more obs 2016-01-20
Source: OPUS - page5 2008.25

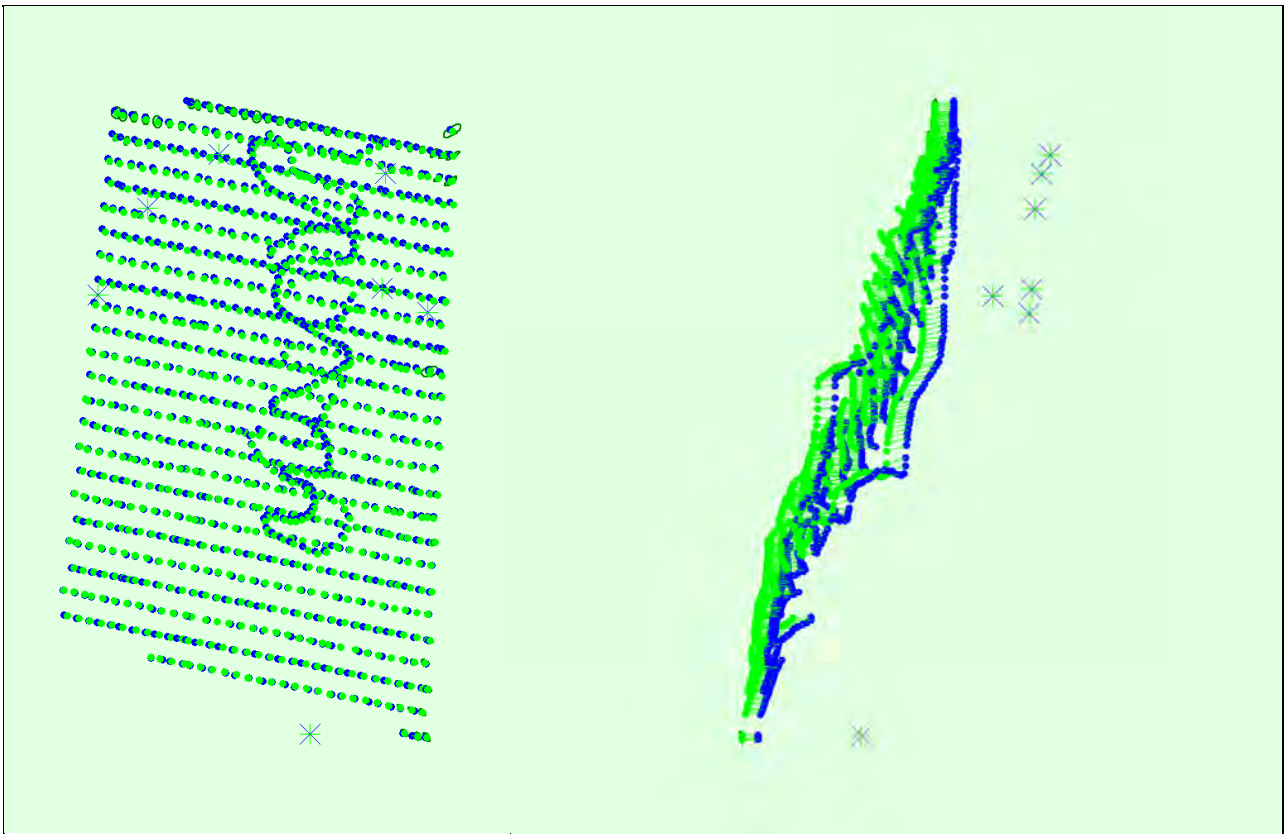
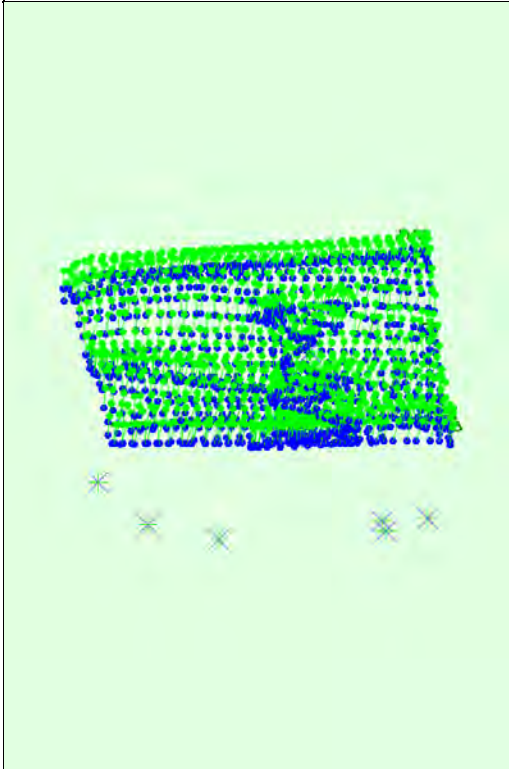
Uncertainty ellipses 100x magnified

Figure 3: Offset between initial (blue dots) and computed (green dots) image positions as well as the offset between the GCPs initial positions (blue crosses) and their computed positions (green crosses) in the top-view (XY plane), front-view (XZ plane), and side-view (YZ plane). Dark green ellipses indicate the absolute position uncertainty of the bundle block adjustment result.
