Appendix D: Laboratory Testing

Project: DOT_SC Haines Beach Road Landslide

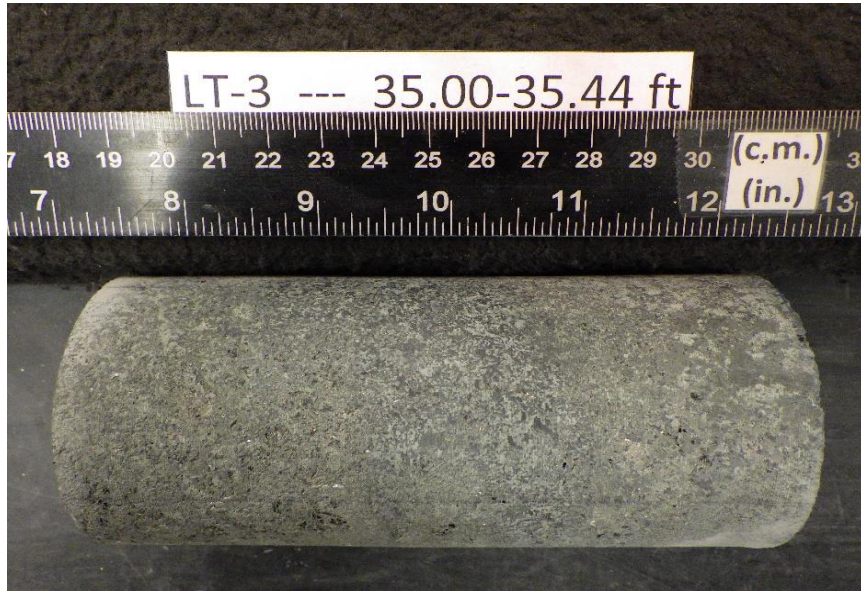
After cutting and grinding

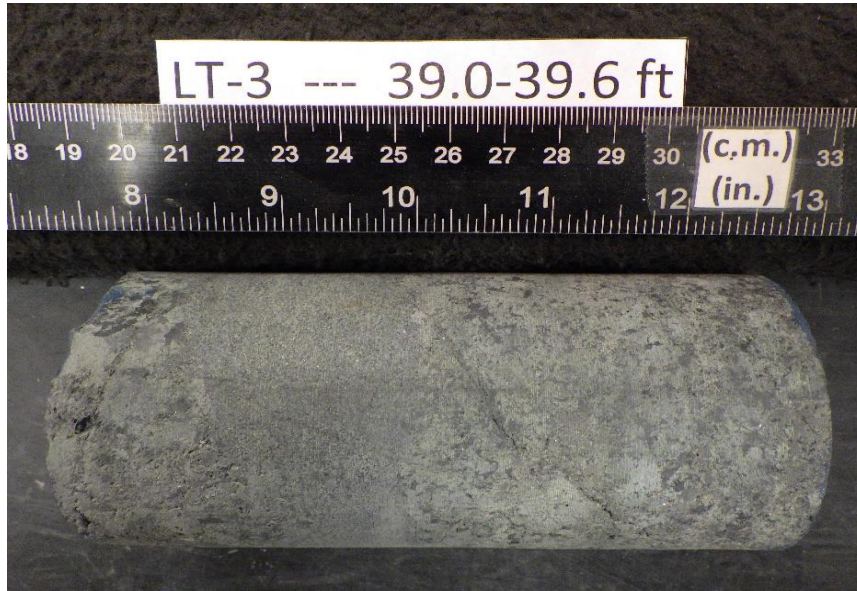
After cutting and grinding

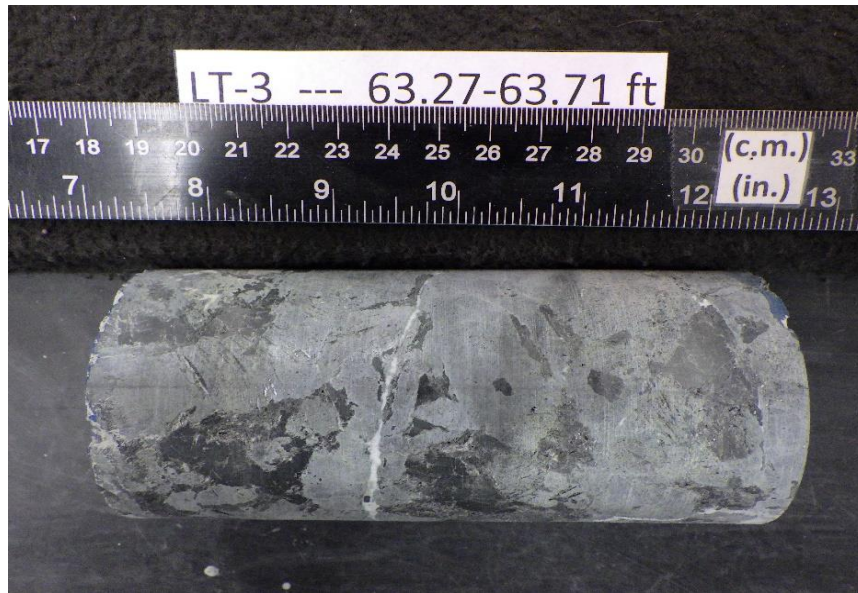
After cutting and grinding

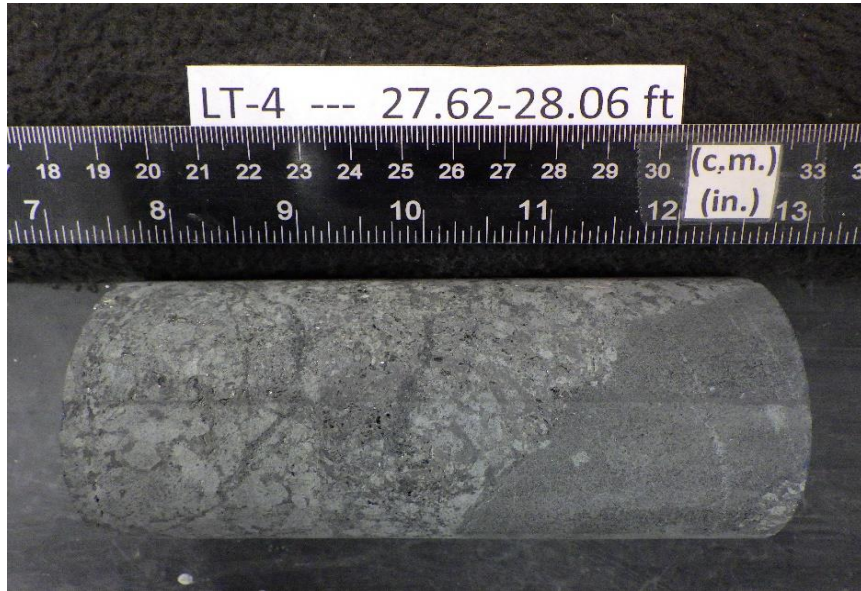
After cutting and grinding

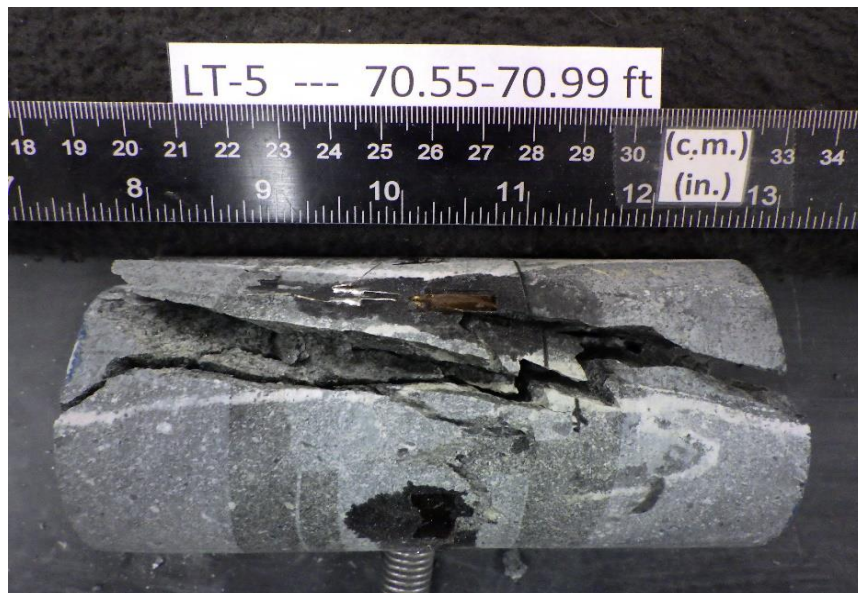
After break

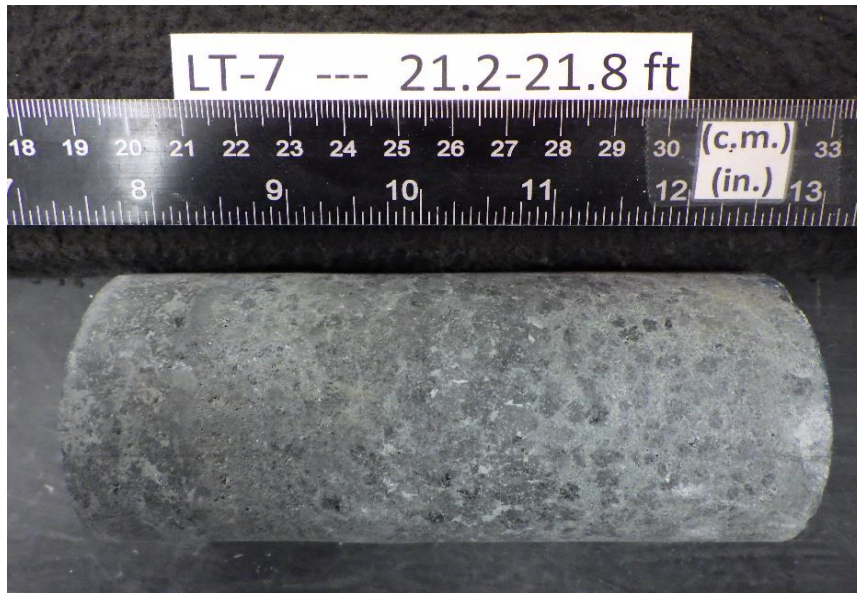
After cutting and grinding

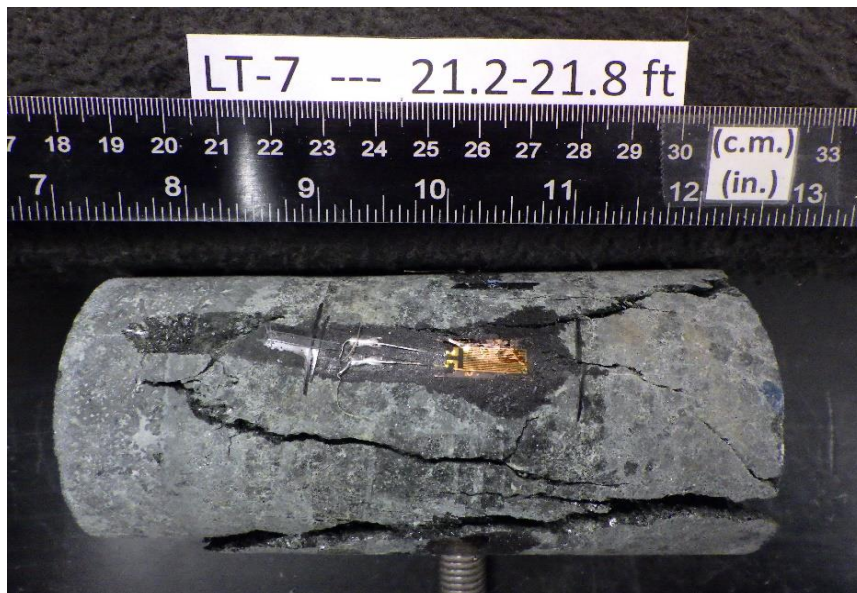
After break

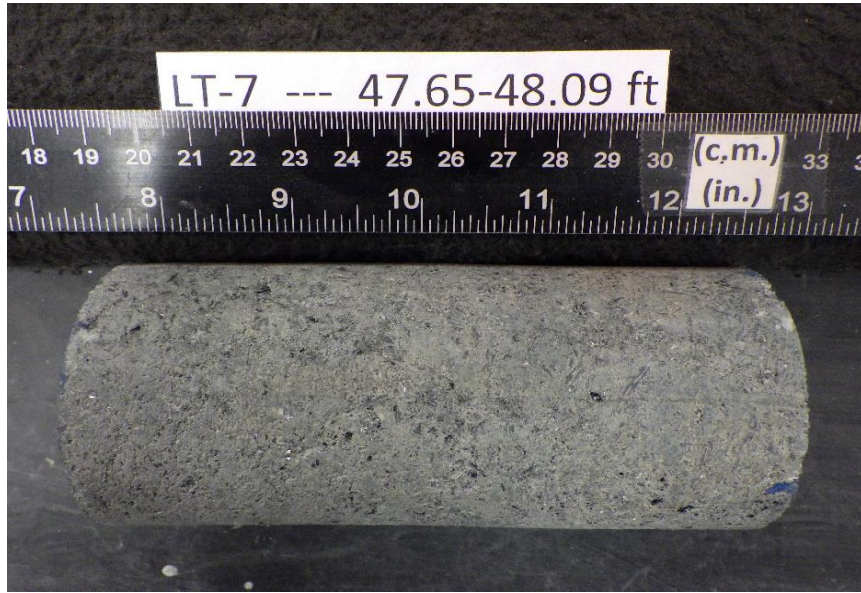
After cutting and grinding

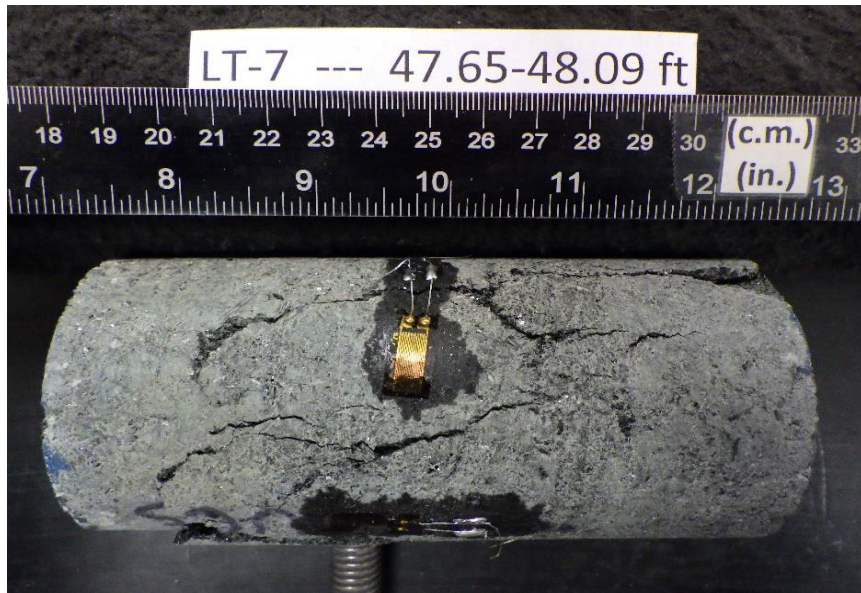
After break

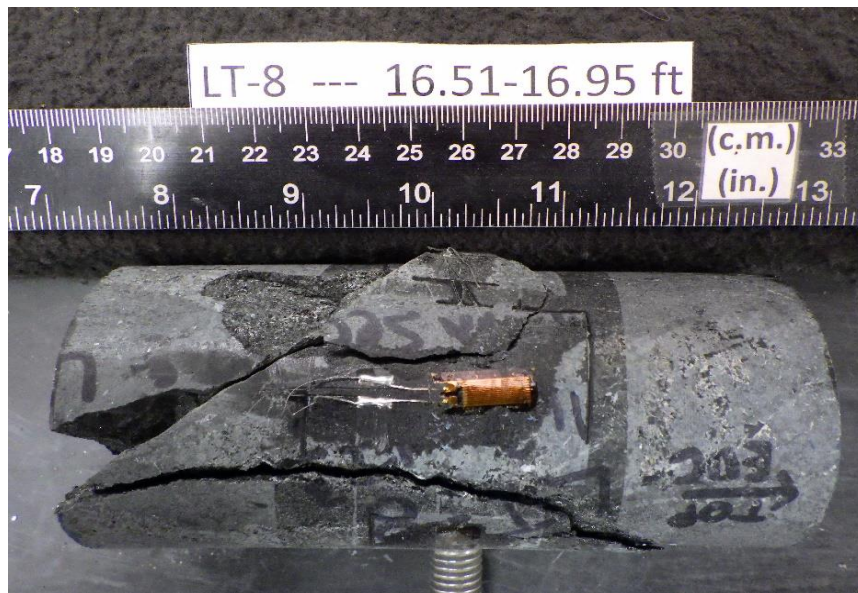
After break

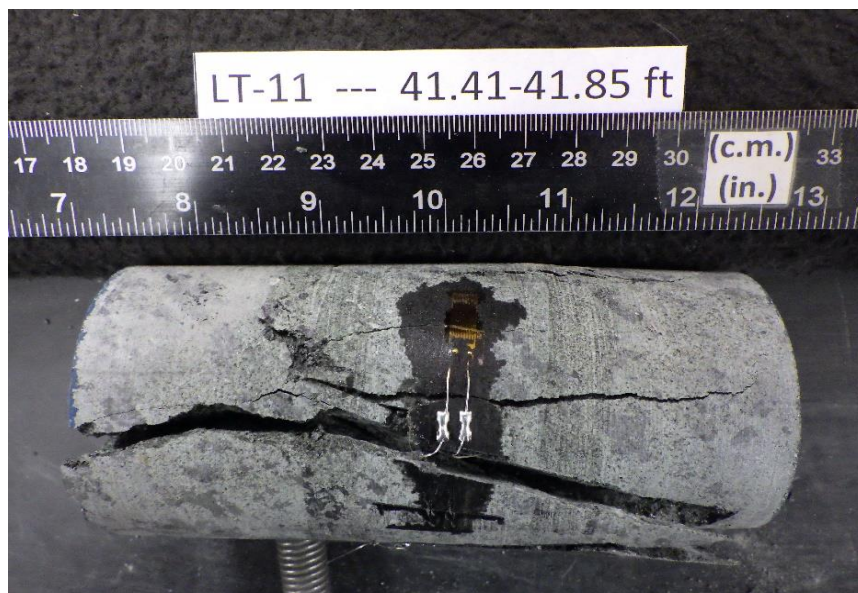
After break

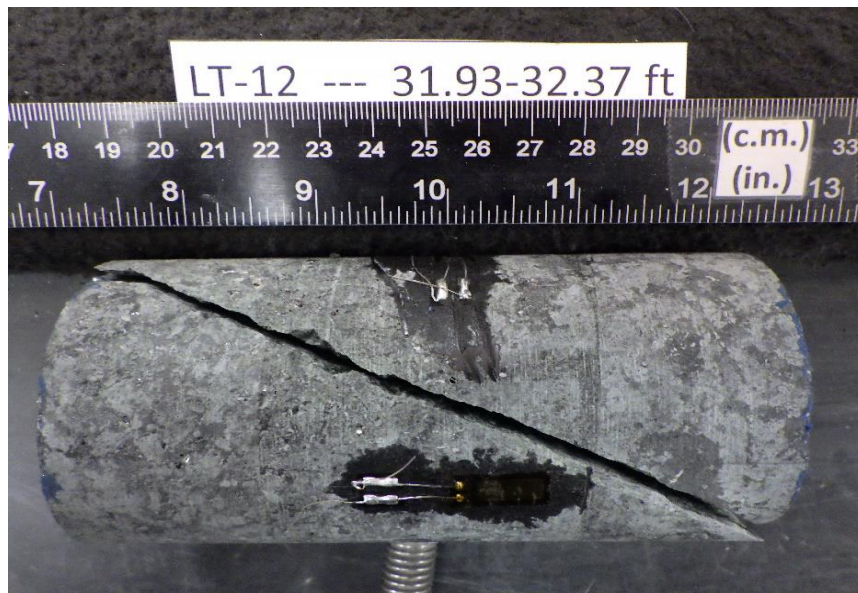
After break

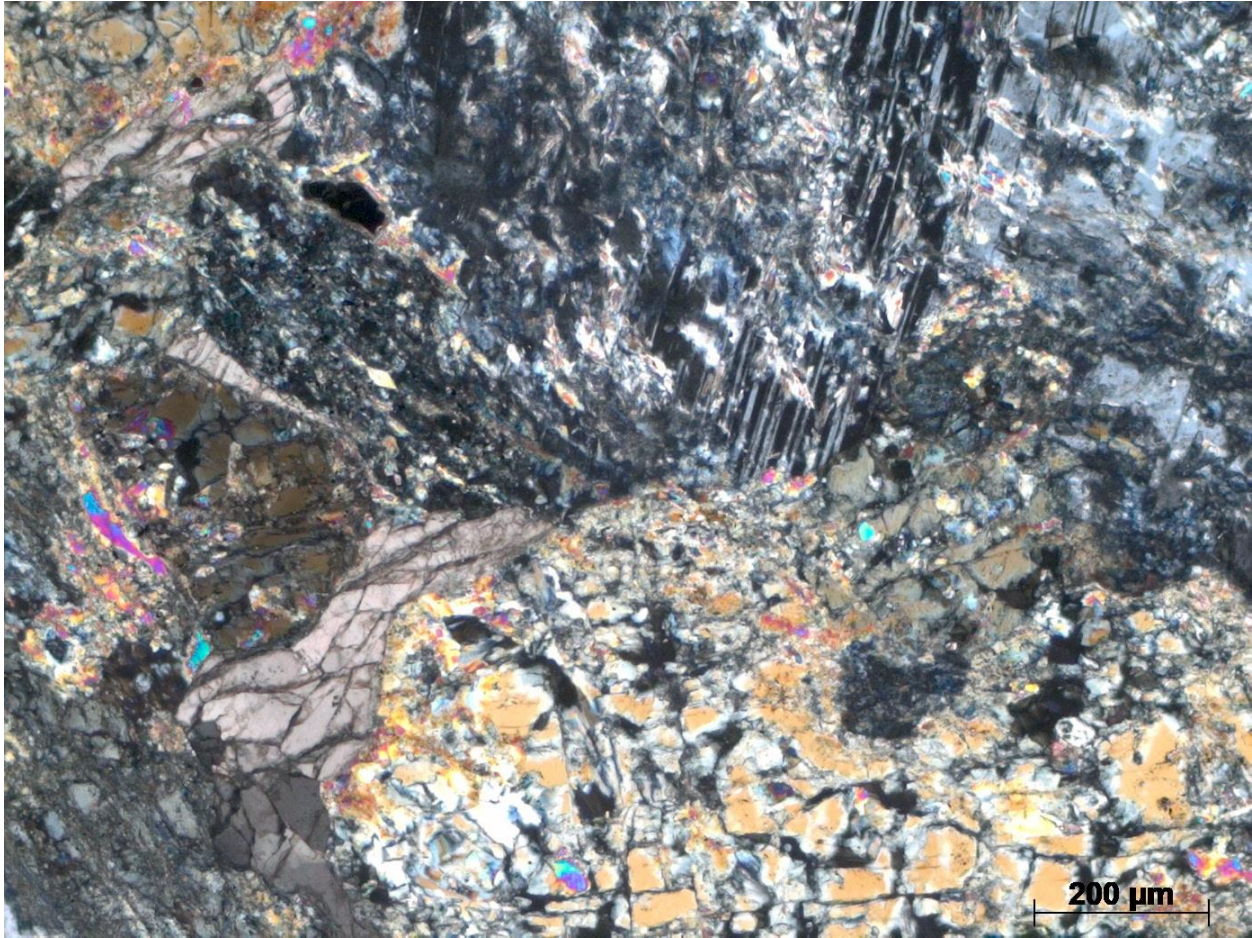
Thin Section Image 15. Greater detail of the gabbro reveals partially intact plagioclase feldspar (white, Fp) and sericite alteration (medium gray). Surrounding pale-green augite-clinopyroxene (CPX) is partially altered to serpentine (colorless). At left, high-relief calcite cement (cal) indicates hydrothermal alteration. 10x Magnification. Field of View 1.46 mm. Scale bar = 200 microns or 0.2 mm.

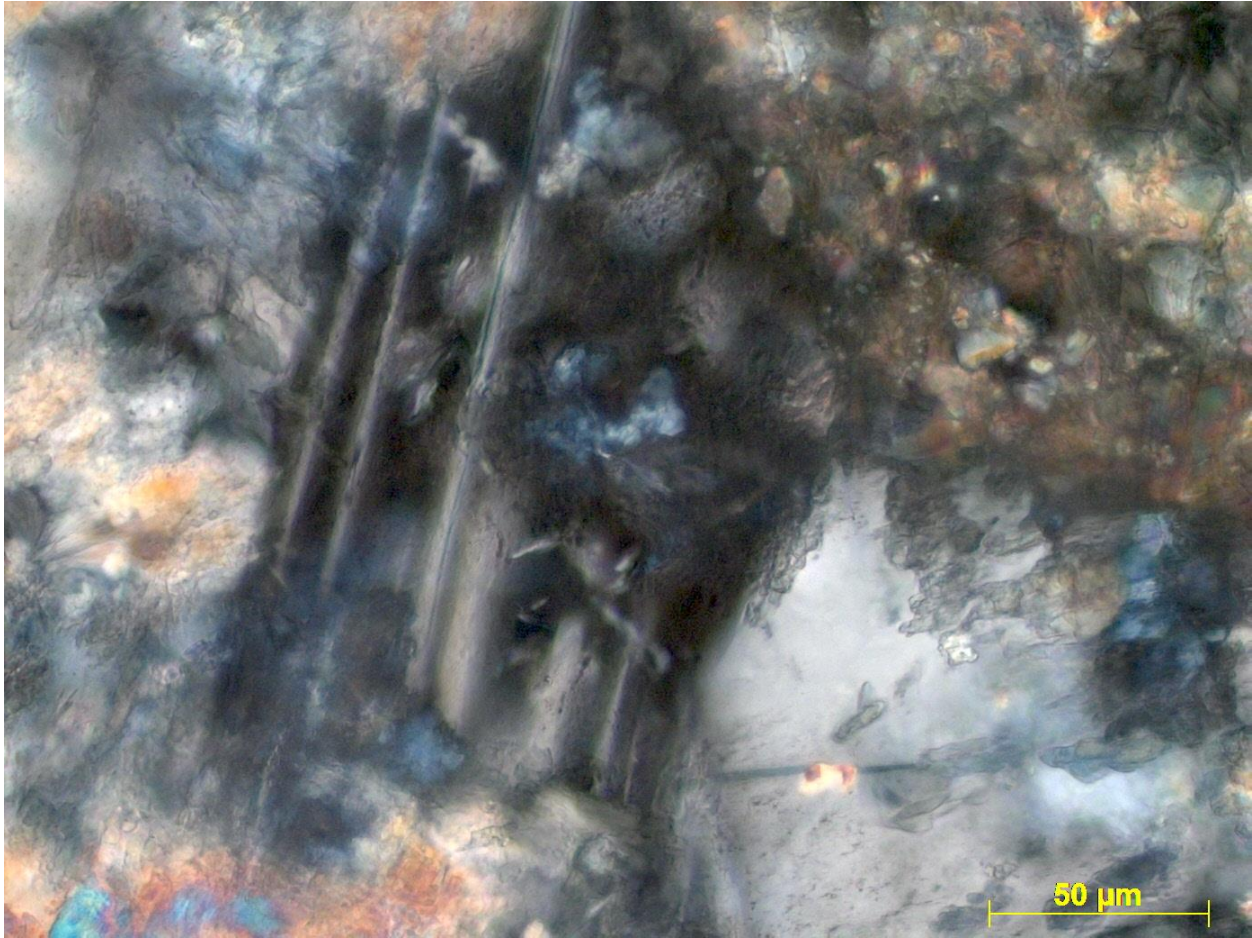
Thin Section Image 19. Highest magnification view of low-relief, plagioclase feldspar at center (Fp), higher-relief sericite replacement at lower-left, and serpentine-and-chlorite alteration of augite-clinopyroxene (white to pale-green) at upper-right. Plane-polarized light. 50x Magnification. Field of View 0.28 mm. Scale bar = 50 microns or 0.05 mm.

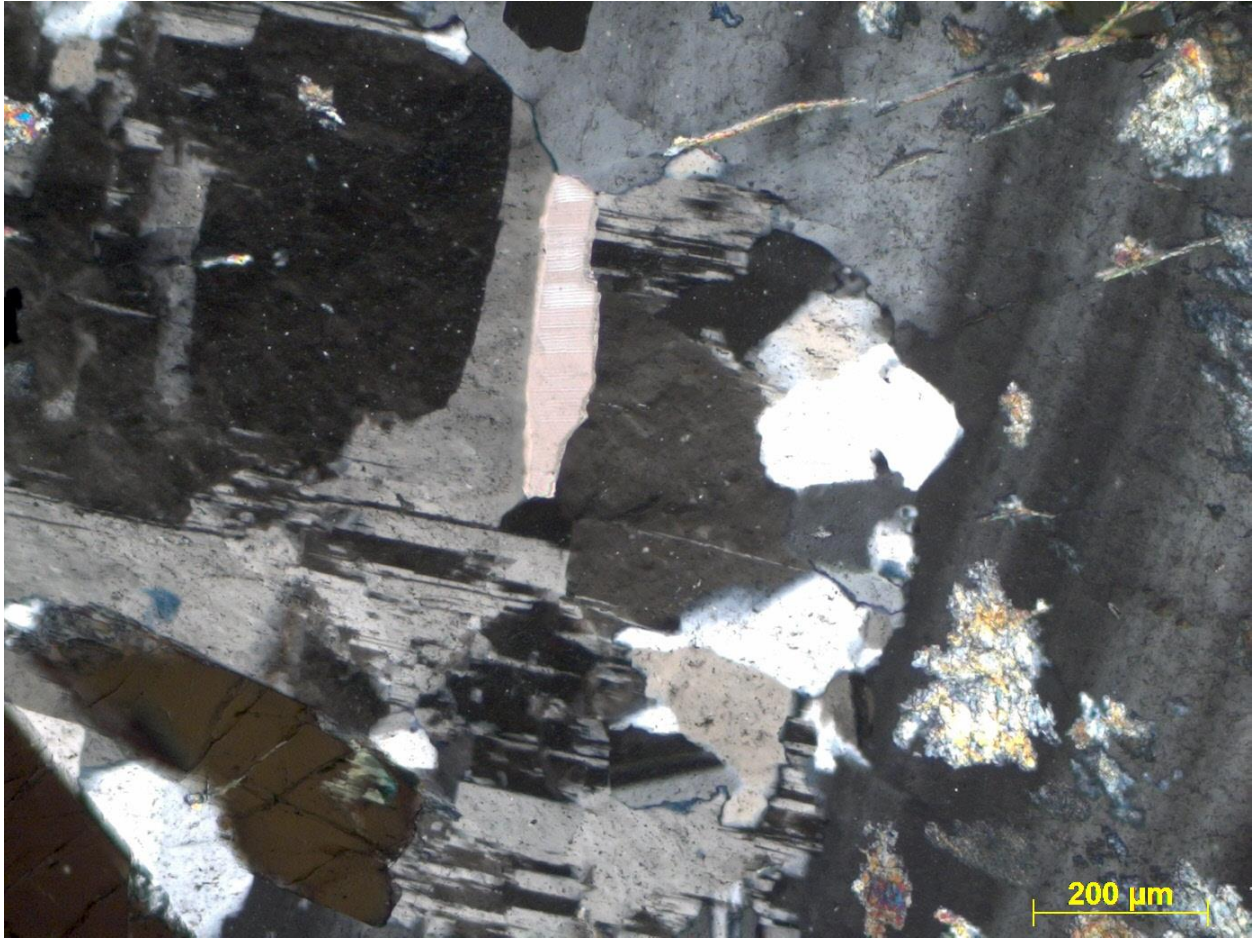
LT-3_6317-63_26_10x_xpl_026	Clinopyroxenite
-----------------------------	-----------------

Thin Section Image 26. The same view as in thin section 15 but taken under crossed-polarized light to show the uneven albite and pericline twinning of plagioclase feldspar. The clinopyroxene inclusions exhibit bright white, yellow, yellow, and blue middle second-order interference colors. Cross-polarized light. 10x Magnification. Field of View 1.46 mm. Scale bar = 200 microns or 0.2 mm.

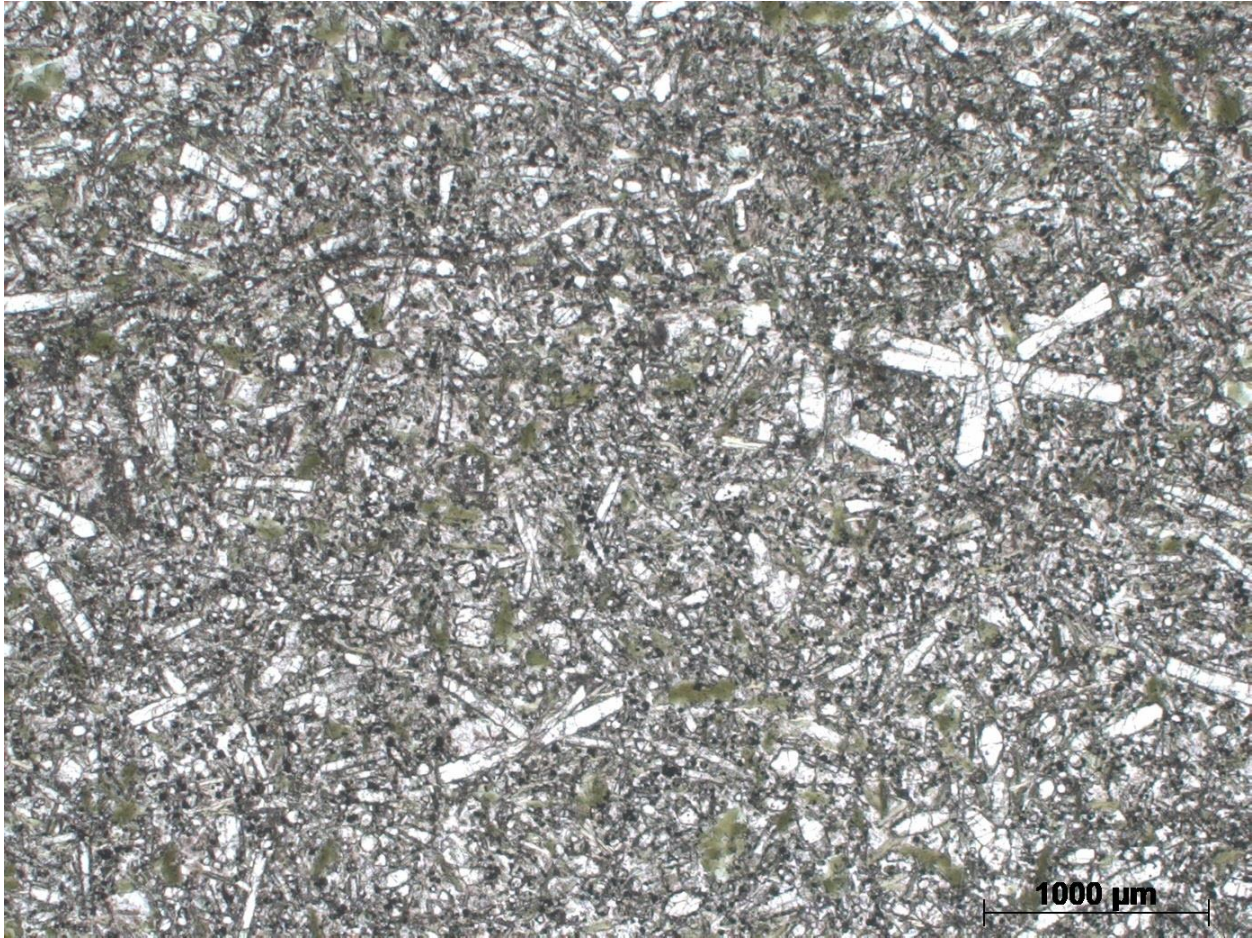
Thin Section Image 30. The same image as thin section image 29 but under crossed-polarized light reveals bright, second-order interference colors in both the augite-clinopyroxene and the biotite/phlogopite. Cross-polarized light. 50x Magnification. Field of View 0.28 mm. Scale bar = 50 microns or 0.05 mm.

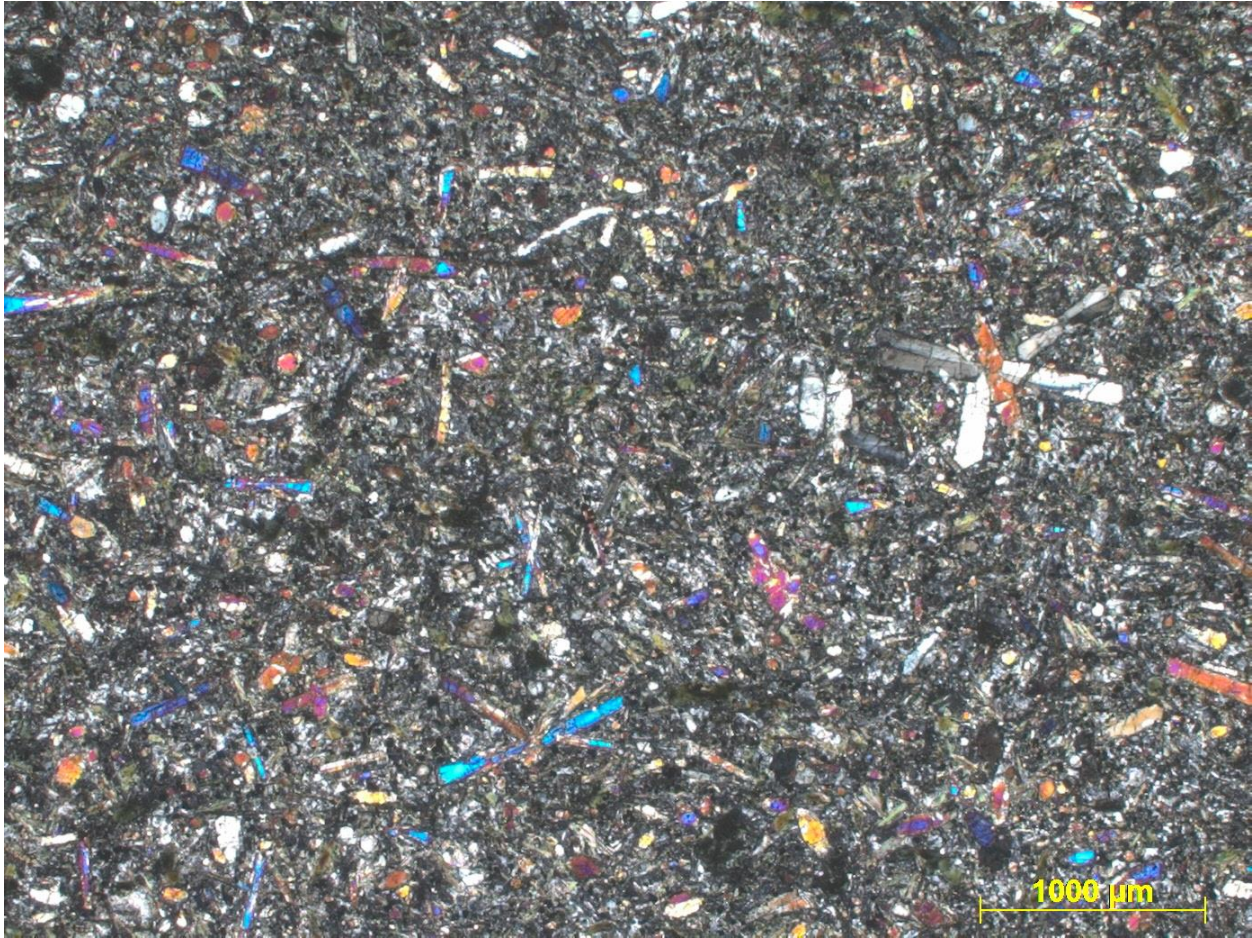
Thin Section Image 31. Low magnification overview of an alkaline lamprophyre, with a composition between a camptonite and a fourchite, shows fine-grained, long, prismatic crystals of clinopyroxene (white), green biotite and hornblende, and opaque magnetite hosted by a groundmass of sericite- and serpentine-replaced plagioclase feldspar. Plane-polarized light. 2.5x Magnification. Field of View 5.5 mm. Scale bar = 1000 microns or 1 mm.

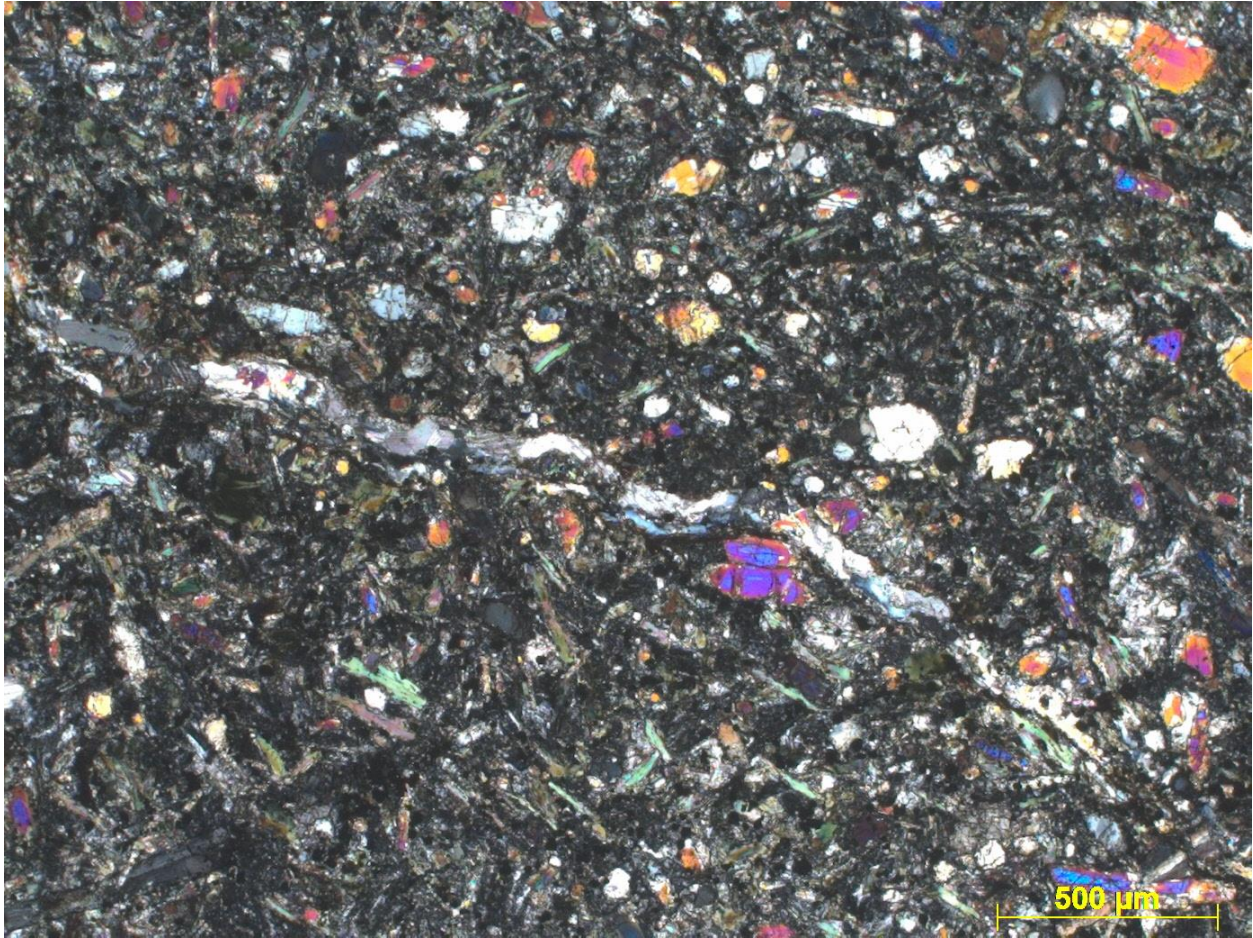
LT-6_24_72-24_8_5x_xpl_034	Alkaline Lamprophyre
----------------------------	----------------------

Thin Section Image 34. The same image as thin section image 33 but taken under crossed-polarized light reveals high, second-order interference colors of clinopyroxene with vibrant purple, orange, blue, and yellow. Green and pink biotite is noticeable at lower-left-center. The groundmass appears darker with a serpentine, chlorite, uralite, and sericite composition. Cross-polarized light. 5x Magnification. Field of View 2.82 mm. Scale bar = 500 microns or 0.5 mm.

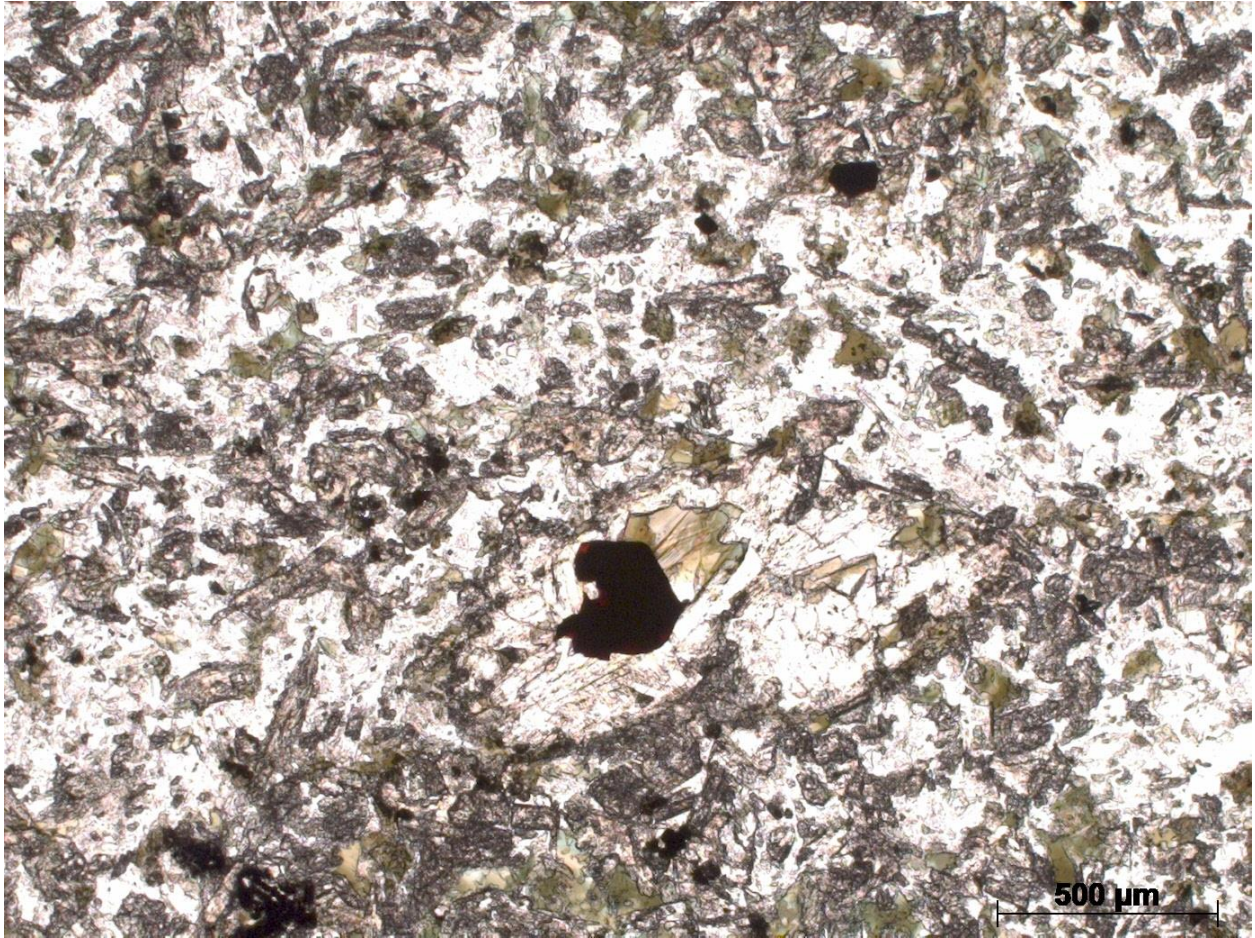
LT-7_11_13-11_22_5x_ppl_043	Alkaline Lamprophyre
-----------------------------	----------------------

Thin Section Image 43. Increased magnification view of the alkaline lamprophyre reveals white plagioclase feldspar phenocrysts among dark gray, high-relief augite-clinopyroxene phenocrysts. Green hornblende admixed with pleochroic biotite, as well as opaque magnetite are widely dispersed among the matrix. Plane-polarized light. 5x Magnification. Field of View 2.82 mm. Scale bar = 500 microns or 0.5 mm.

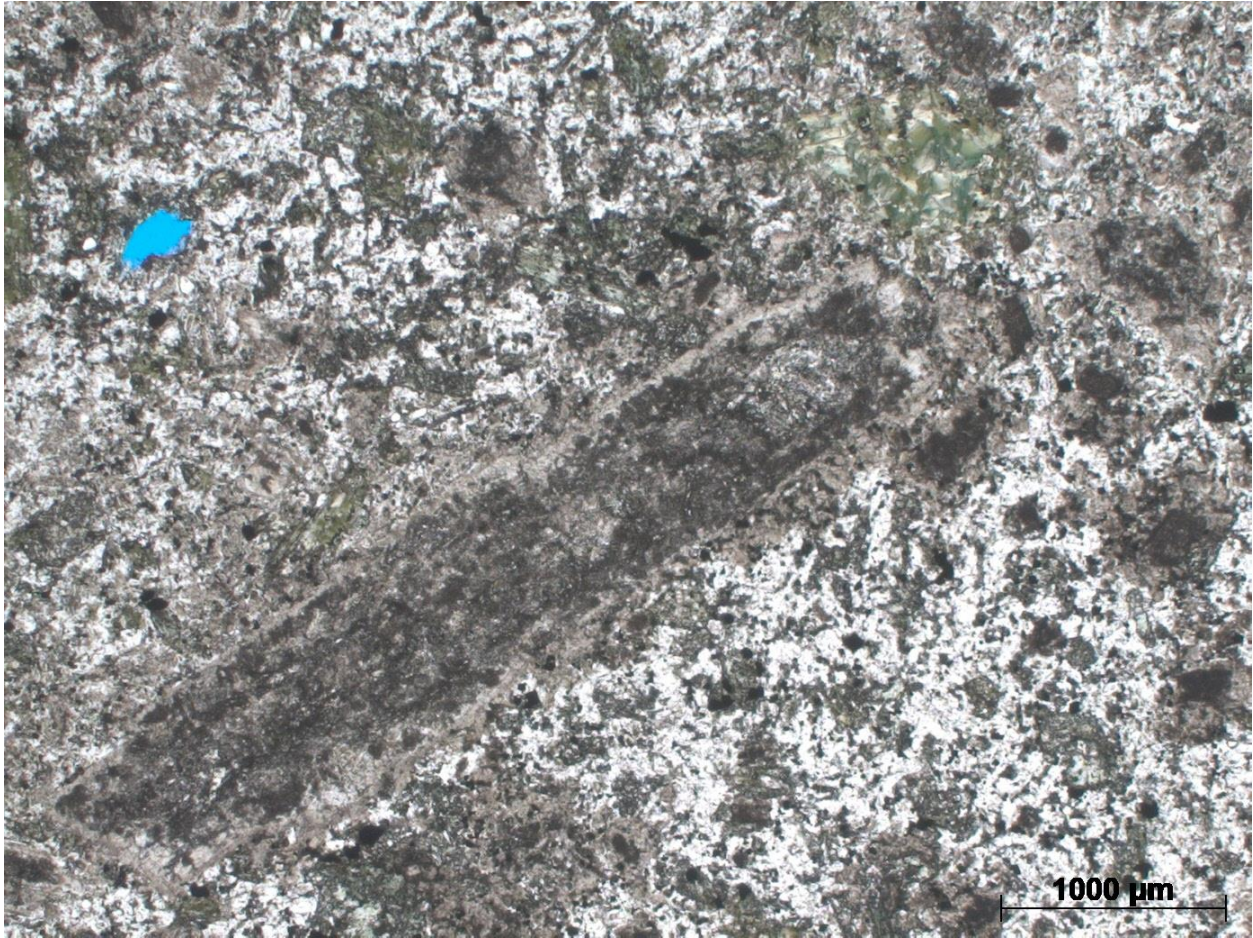
LT-8_55_85-55_94_2_5x_ppl_061	Dolerite or Diabase
-------------------------------	---------------------

Thin Section Image 61. Low magnification view of a dolerite/diabase reveals abundant white, finely-crystalline laths of plagioclase feldspar that host fine-to-coarsely-crystalline augite-clinopyroxene that is mostly altered to uralite (gray) and serpentine (green). Plane-polarized light. 2.5x Magnification. Field of View 5.5 mm. Scale bar = 1000 microns or 1 mm.

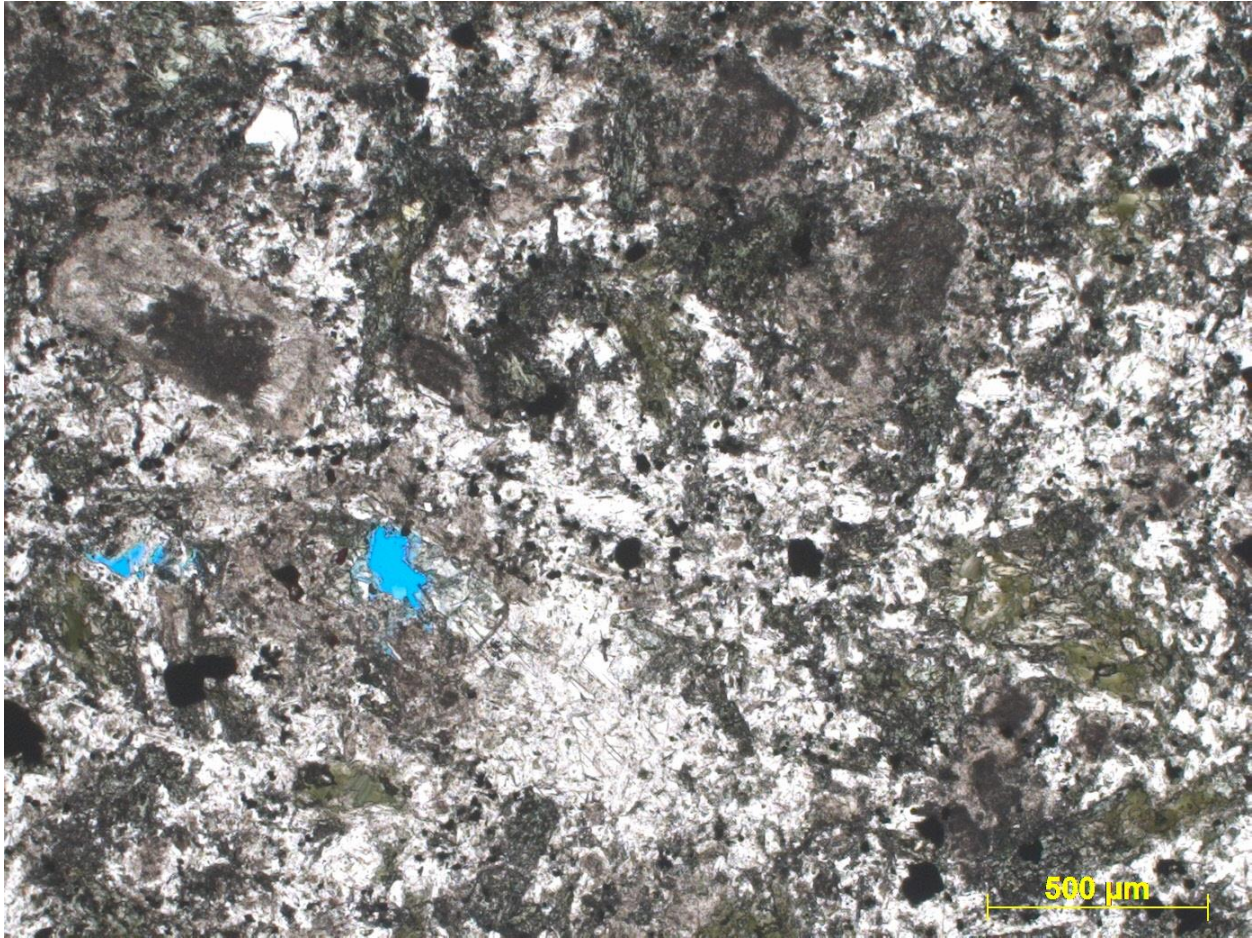
LT-8_55_85-55_94_5x_ppl_06	Dolerite or Diabase
----------------------------	---------------------

Thin Section Image 63. Increased magnification view of a dolerite/diabase exhibits abundant, finely-crystalline plagioclase feldspar and clinopyroxene that are partially altered to sericite (gray). Minor augite-clinopyroxene is mostly replaced with uralite and serpentine (green). However, some of the dark green phenocrysts are hornblende or biotite. Plane-polarized light. 5x Magnification. Field of View 2.82 mm. Scale bar = 500 microns or 0.5 mm.

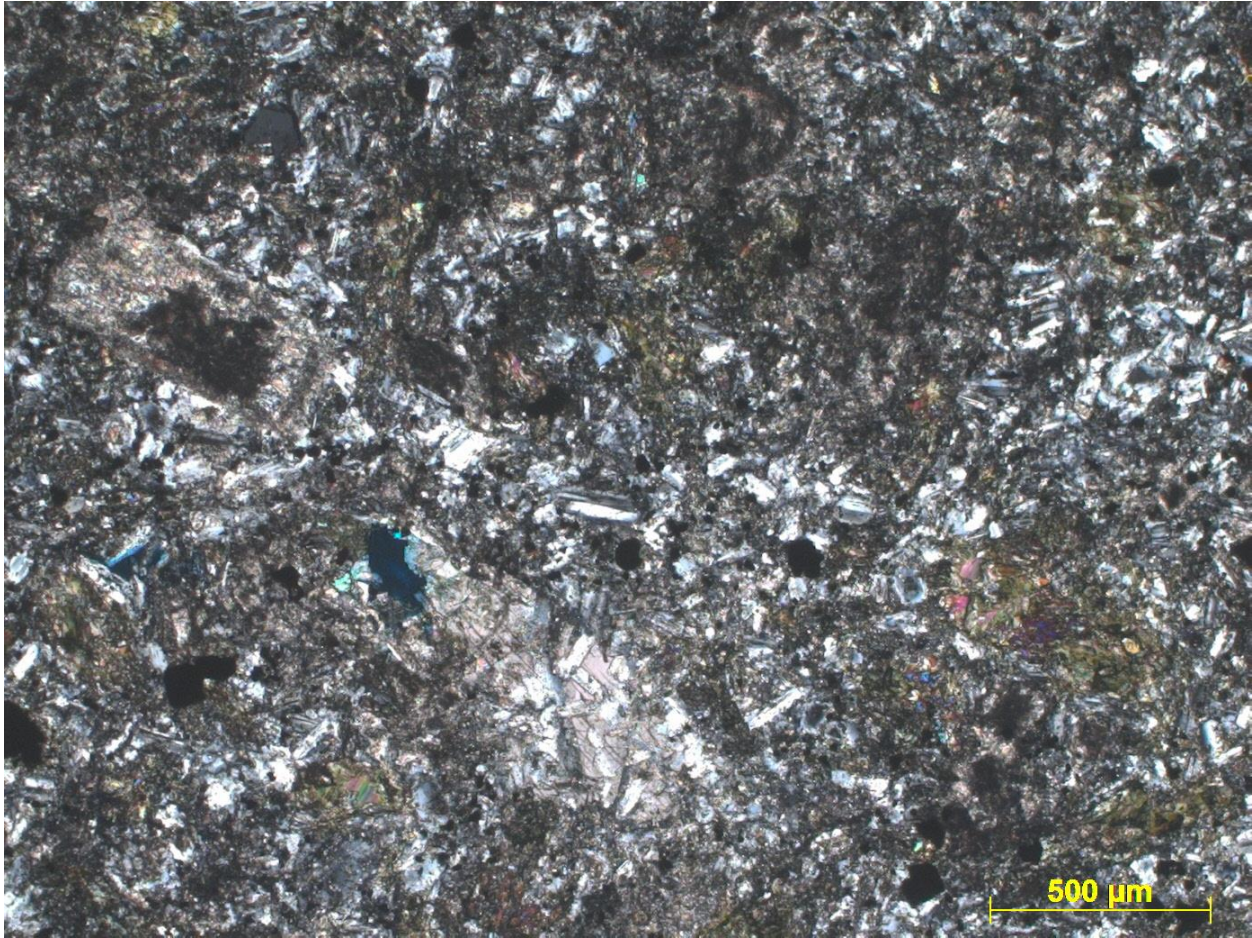
LT-8_55_85-55_94_5x_xpl_064	Dolerite or Diabase
-----------------------------	---------------------

Thin Section Image 64. The same image as thin section image 63 but taken under cross-polarized light illustrates simple and polysynthetic twinning of plagioclase feldspar, as well as second-order interference colors of augite-clinopyroxene that is altered to green serpentine. At lower-center is bright calcite that encloses feldspar crystals in a poikilitic texture. Cross-polarized light. 5x Magnification. Field of View 2.82 mm. Scale bar = 500 microns or 0.5 mm.

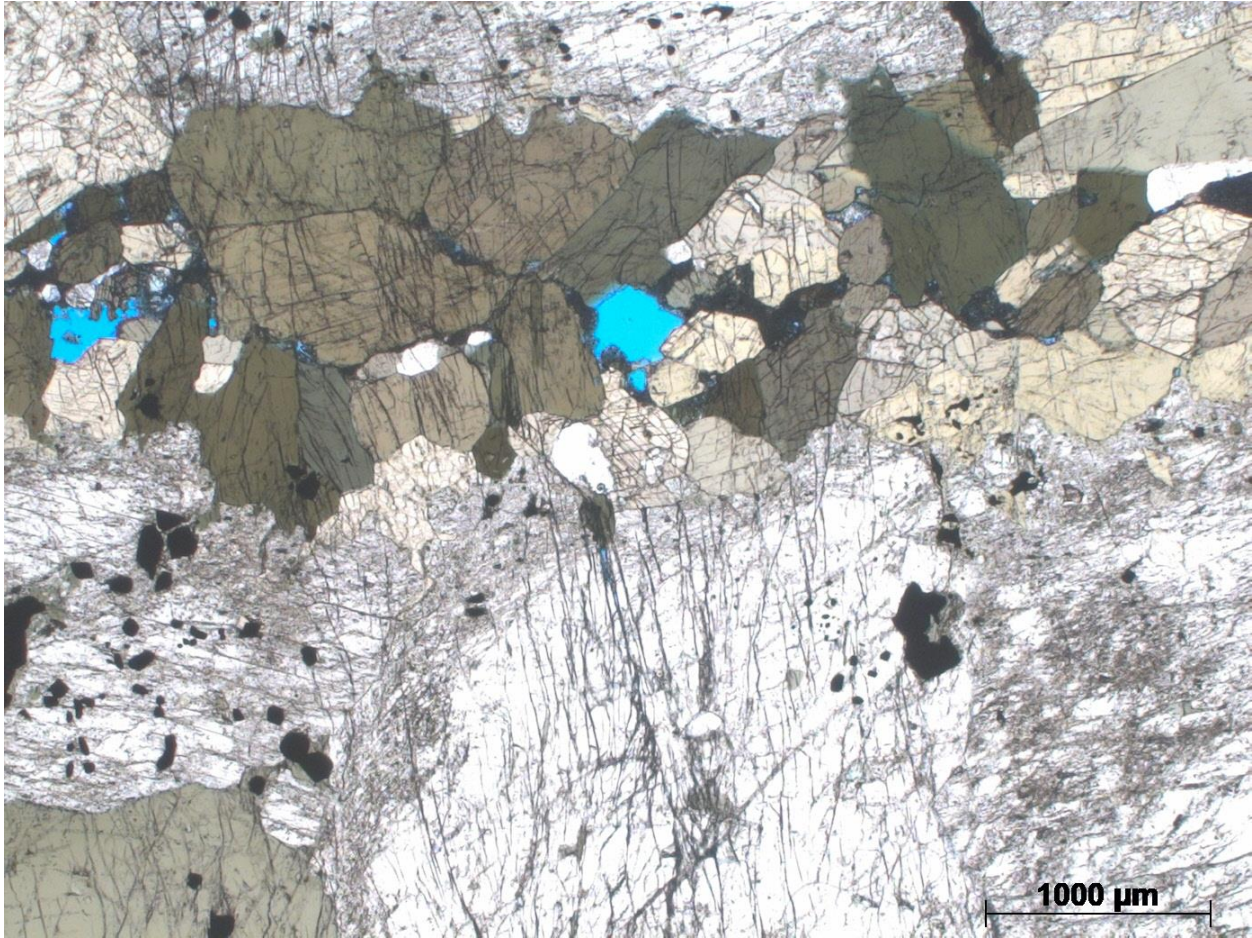
LT-9_93_48-93_56_2_5x_ppl_071	Clinopyroxenite
-------------------------------	-----------------

Thin Section Image 71. Low magnification view of a clinopyroxenite shows coarsely crystalline augite clinopyroxene (colorless) and green, pleochroic hornblende along a vein. Subhedral, opaque magnetite are widely scattered throughout the rock. Plane-polarized light. 2.5x Magnification. Field of View 5.5 mm. Scale bar = 1000 microns or 1 mm.

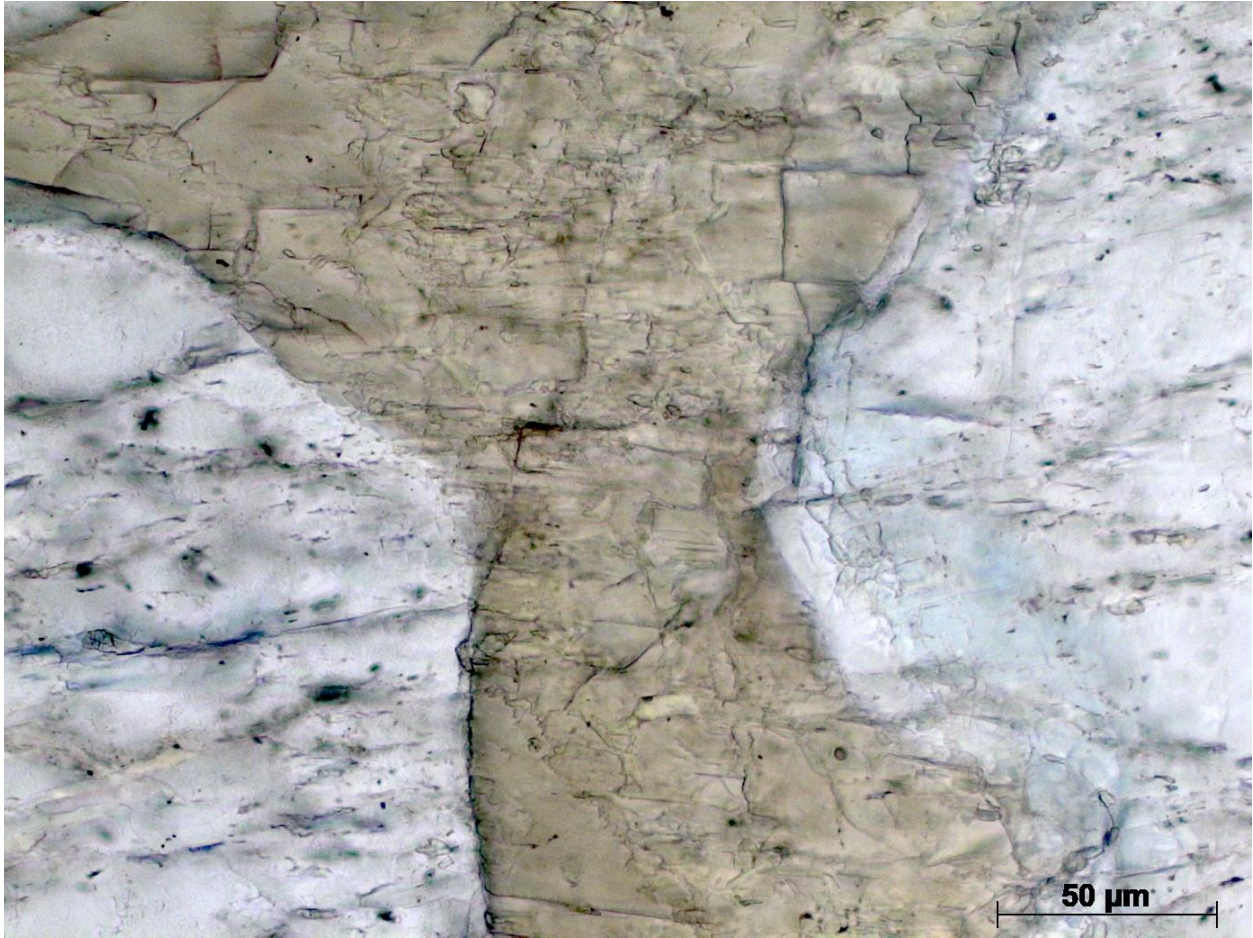
LT-9_93_48-93_56_50x_ppl_079	Clinopyroxenite
------------------------------	-----------------

Thin Section Image 79. Highly magnified view of the clinopyroxenite reveals high-relief augite throughout the image from colorless to pale-green. Plane-polarized light. 50x Magnification. Field of View 0.28 mm. Scale bar = 50 microns or 0.05 mm.

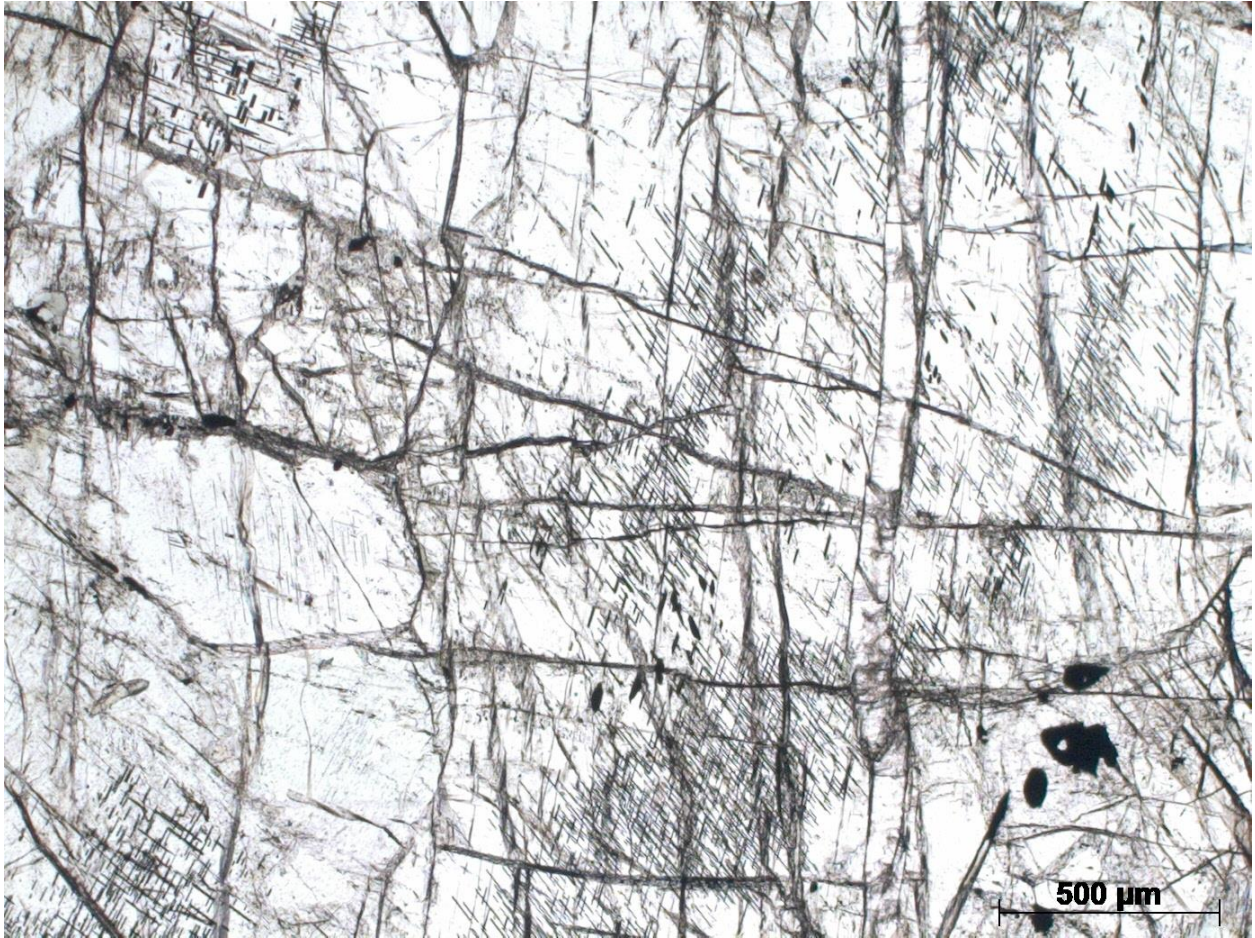
LT-11_28_58-28_67_5x_ppl_083	Clinopyroxenite
------------------------------	-----------------

Thin Section Image 83. Increased magnification view of colorless, high-relief augite-clinopyroxene that hosts numerous fractures and low-relief serpentine fracture-fill. Plane-polarized light. 5x Magnification. Field of View 2.82 mm. Scale bar = 500 microns or 0.5 mm.
