Bettisworth North Architects and Planners Inc.
2600 Denali St. Ste 710
Anchorage, Alaska 99503

Haines Community Safety and Training Center Geotechnical Report

PND Engineers, Inc.
9360 Glacier Highway, Suite 100
Juneau, Alaska 99801

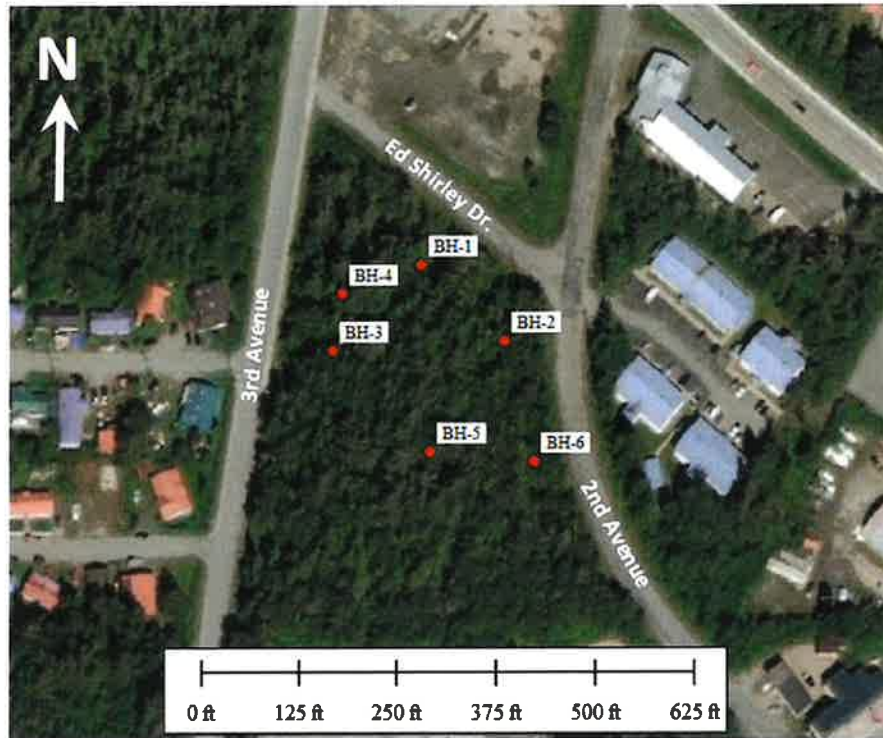
Figure 3-1: Borehole Location Map

Borehole	Latitude	Longitude	Collar Elevation (ft)	Total Depth (ft bgs)
BH-1	59.230500	135.447783	48.6	101.5
BH-2	59.230233	135.447233	49.1	101.5
BH-3	59.230200	135.448383	53.4	91.5
BH-4	59.230400	135.448317	49.3	32
BH-5	59.229850	135.447733	54.5	20
BH-6	59.229817	135.447033	55.5	32

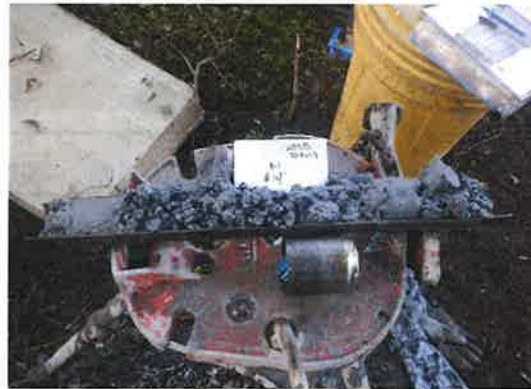
Figure 4-1: Very dense clayey sand with gravel encountered 100 feet bgs in BH-1.

The soil lithology at the project site generally consists of surficial organics underlain by soft silty clay and lean clay to depths of about 85 feet bgs. Below about 85 feet bgs, the soil is dense to very dense clayey sand with gravel and stiff sandy clay.

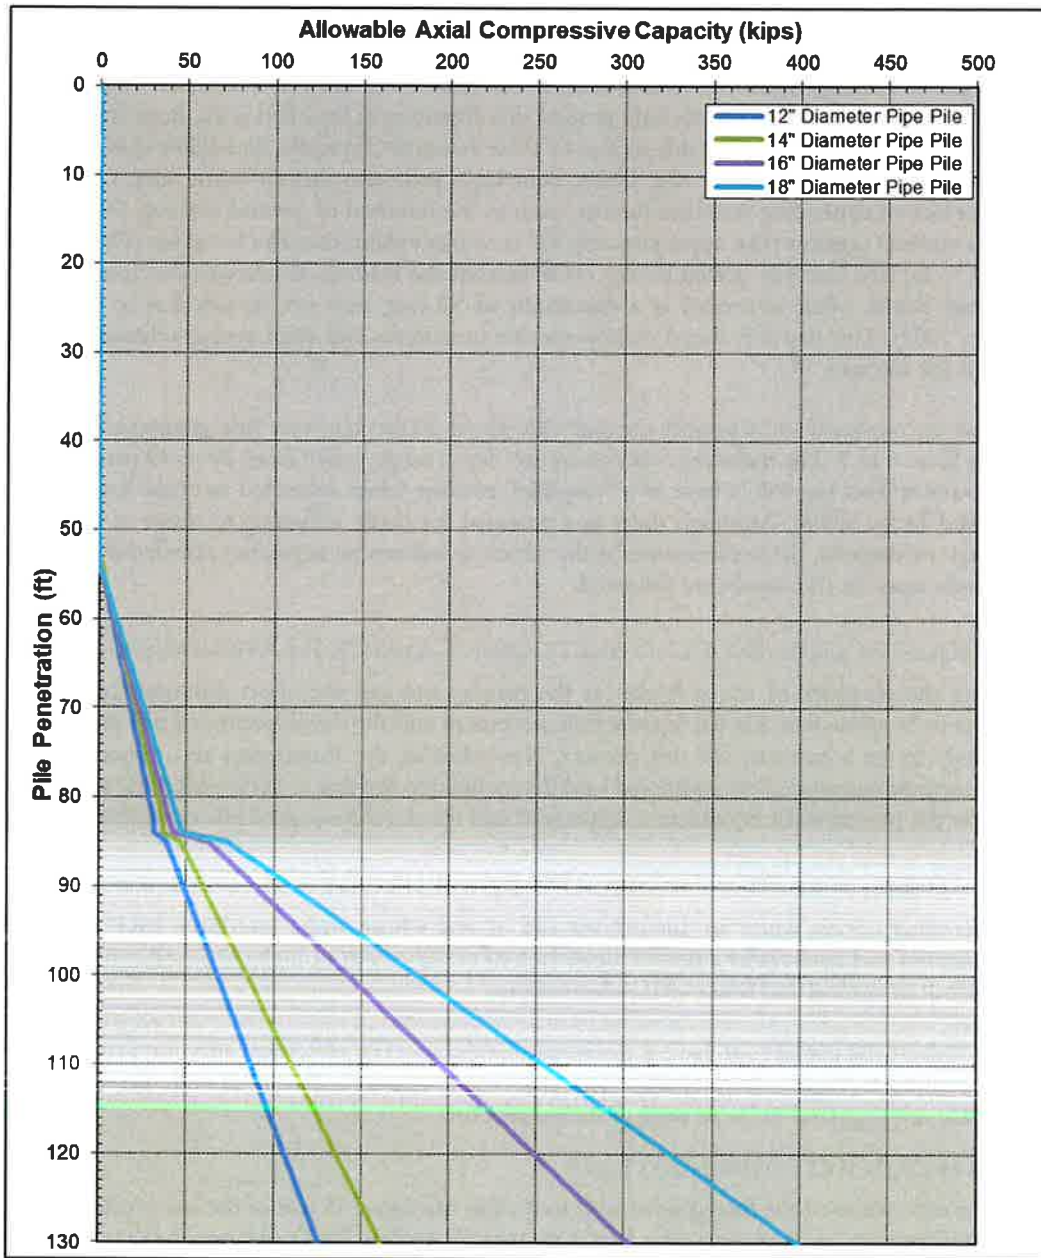
Figure 6-1: Allowable Compressive Capacities for Open-Ended Pipe Piles Under Seismic Conditions

Allowable axial pile capacities were calculated for ½-inch wall thickness open- and closed-ended pipe piles ranging from 12 to 18 inches in diameter. For all axial compressive capacity calculations, the soil strength between 3 and 50 feet bgs was neglected for load transfer considerations. This neglect also applies to a seismic condition in which the soil has softened and would not likely contribute to structural resistance.

The capacities shown in these figures are allowable capacities that incorporate a factor of safety of 1.5. The capacities do not account for pile group effects. Per ASCE 7-16 section 12.13.8.8, pile group effects must be accounted for in the calculation of vertical capacities if the nearest neighboring pile is less than a distance of three pile diameters away. If closed-ended pipe piles are selected, PND recommends that the structural design team specify conical tips, as opposed to plug plates, for all foundation piles. Piles should be driven to a minimum tip elevation of approximately – 40 feet MLLW, or deeper, to ensure that all piles are bearing
