Haines Borough Pool Condition Survey Haines, Alaska

June 2007

EXECUTIVE SUMMARY

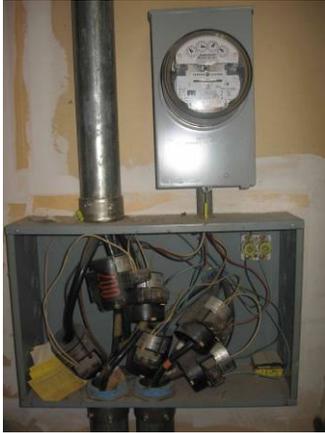
Meter with CTs

The pool building is fed power from the existing high school. The current renovation project at the high school includes refeeding the pool building from the new main distribution panel in the High School with two 150 amp, three phase circuit breakers. Each of these feeds one panel in the pool building with existing conduit and feeder conductors. The feeders are routed through current transformers in the pool first floor storage room allowing the feeders to be metered. The two panels; A1 and A2 provide power for the pool building. The pool is used as a separate facility from the high school. It should have main disconnects for each of it's panels.

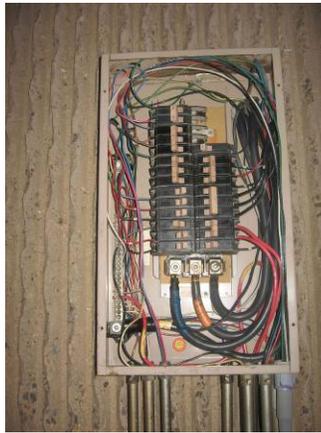
Panel A1 has 42 circuits and panel A2 has 30 circuits; both are rated at 200 amps.. Each panel has six spaces for additional circuit breakers. The pool ventilation and circulation pumps were not running during the inspection, so an accurate load measurement was not possible. However, based upon the size of the feeder conductors and the panel ratings, they are adequate for the building load with growth for future. However, due to their age, both the panels and their feeders have exceeded their service life and should be replaced. Panel A2 should be replaced with a 42 circuit panel to increase space for future loads.

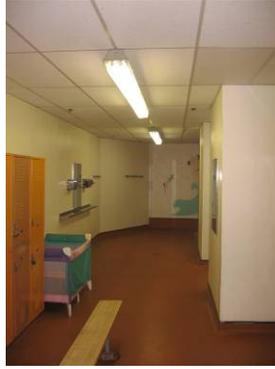
Locker room and office lighting

All of the lighting is original with magnetic ballasts. The ballasts have started to fail. With luminaires this old, the ballasts need to be replaced. The cost to relamp and ballast luminaires with energy efficient ballasts and lamps is very close to the cost of new luminaires that have less glare. This would also solve the lens attachment problem with the existing luminaires. The pool lighting should be replaced based upon the wrong type of lighting in that space alone.

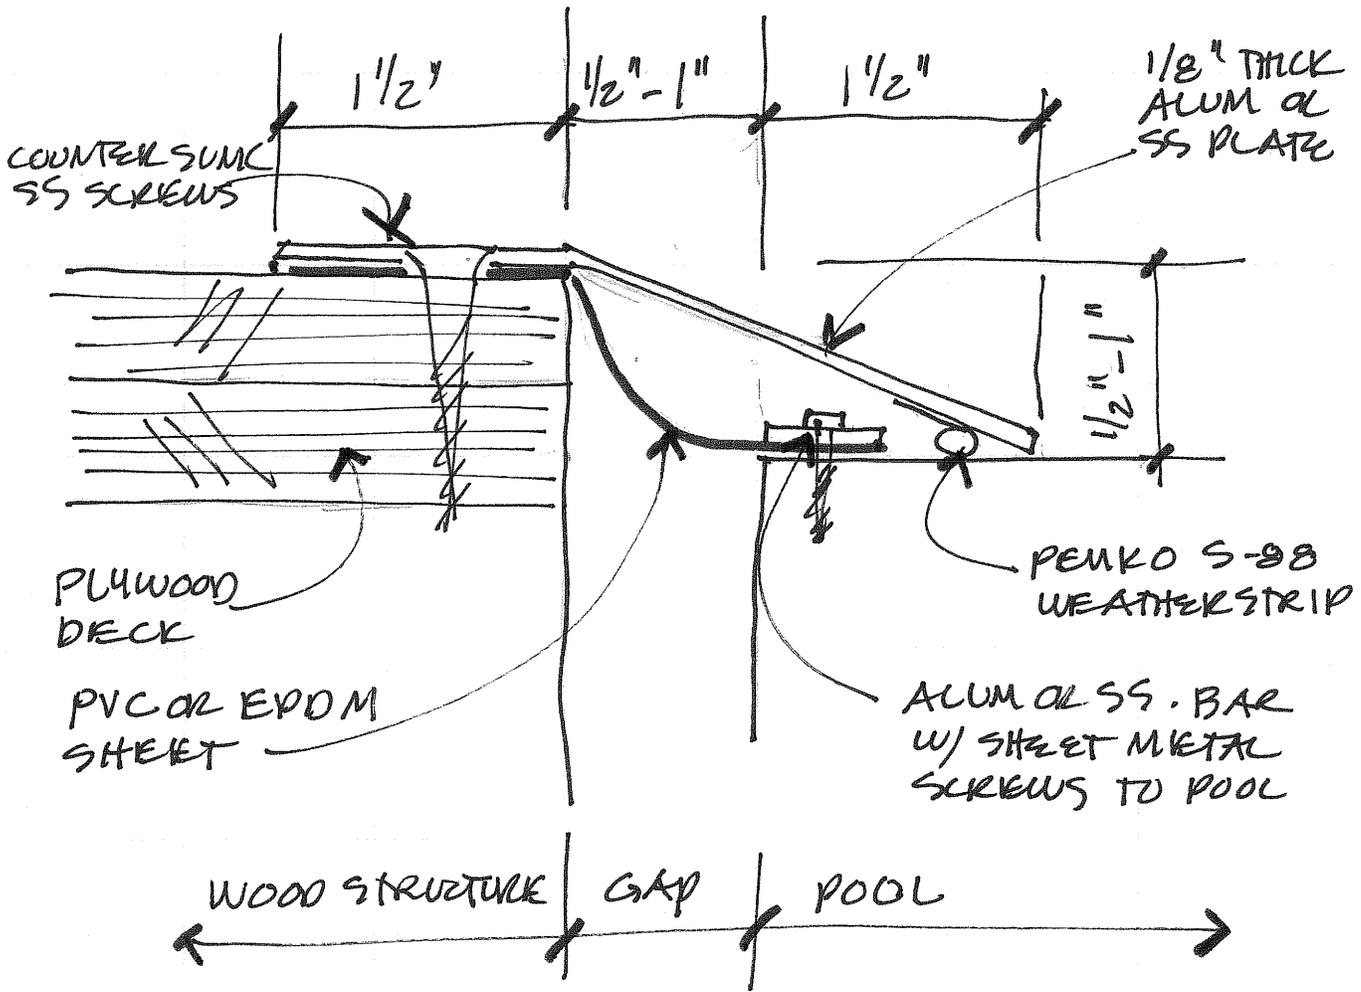
SCALE DECK/POOL JOINT

5. **Interior Construction:** The building appears to be well maintained, but due to its age is showing signs of deterioration due to “wear and tear.” The sheet flooring in the locker rooms and on the pool deck is showing wear at high traffic areas and should be monitored. The metal toilet partitions and lockers in the locker rooms are rusted near the floor. The suspended acoustic ceiling system in the locker rooms is deteriorating. There is a joint between the pool deck and the aluminum pool. The joint varied in width from about ½” to 1” and the deck was also ½” to 1” higher than the pool. The pool was empty at the time of the survey. Reportedly the joint width closes somewhat when the pool is full and the tank expands. This joint has been filled with liquid sealant in the past.

Recommendation: *Replace sheet vinyl flooring in locker rooms and pool deck. Clean and paint toilet partitions in locker rooms. Clean and paint or replace lockers. Replace suspended acoustic ceiling in locker rooms. Install a stainless steel or aluminum joint cover across the joint between pool deck and aluminum tank with a rubber membrane to seal water from entering the joint from the pool.*
