Winter Reconnaissance - Preliminary Findings Report Beach Road Landslide, Haines, Alaska

**WINTER RECONNAISSANCE
PRELIMINARY FINDINGS REPORT**

**BEACH ROAD LANDSLIDE
HAINES, ALASKA**

April 8, 2021

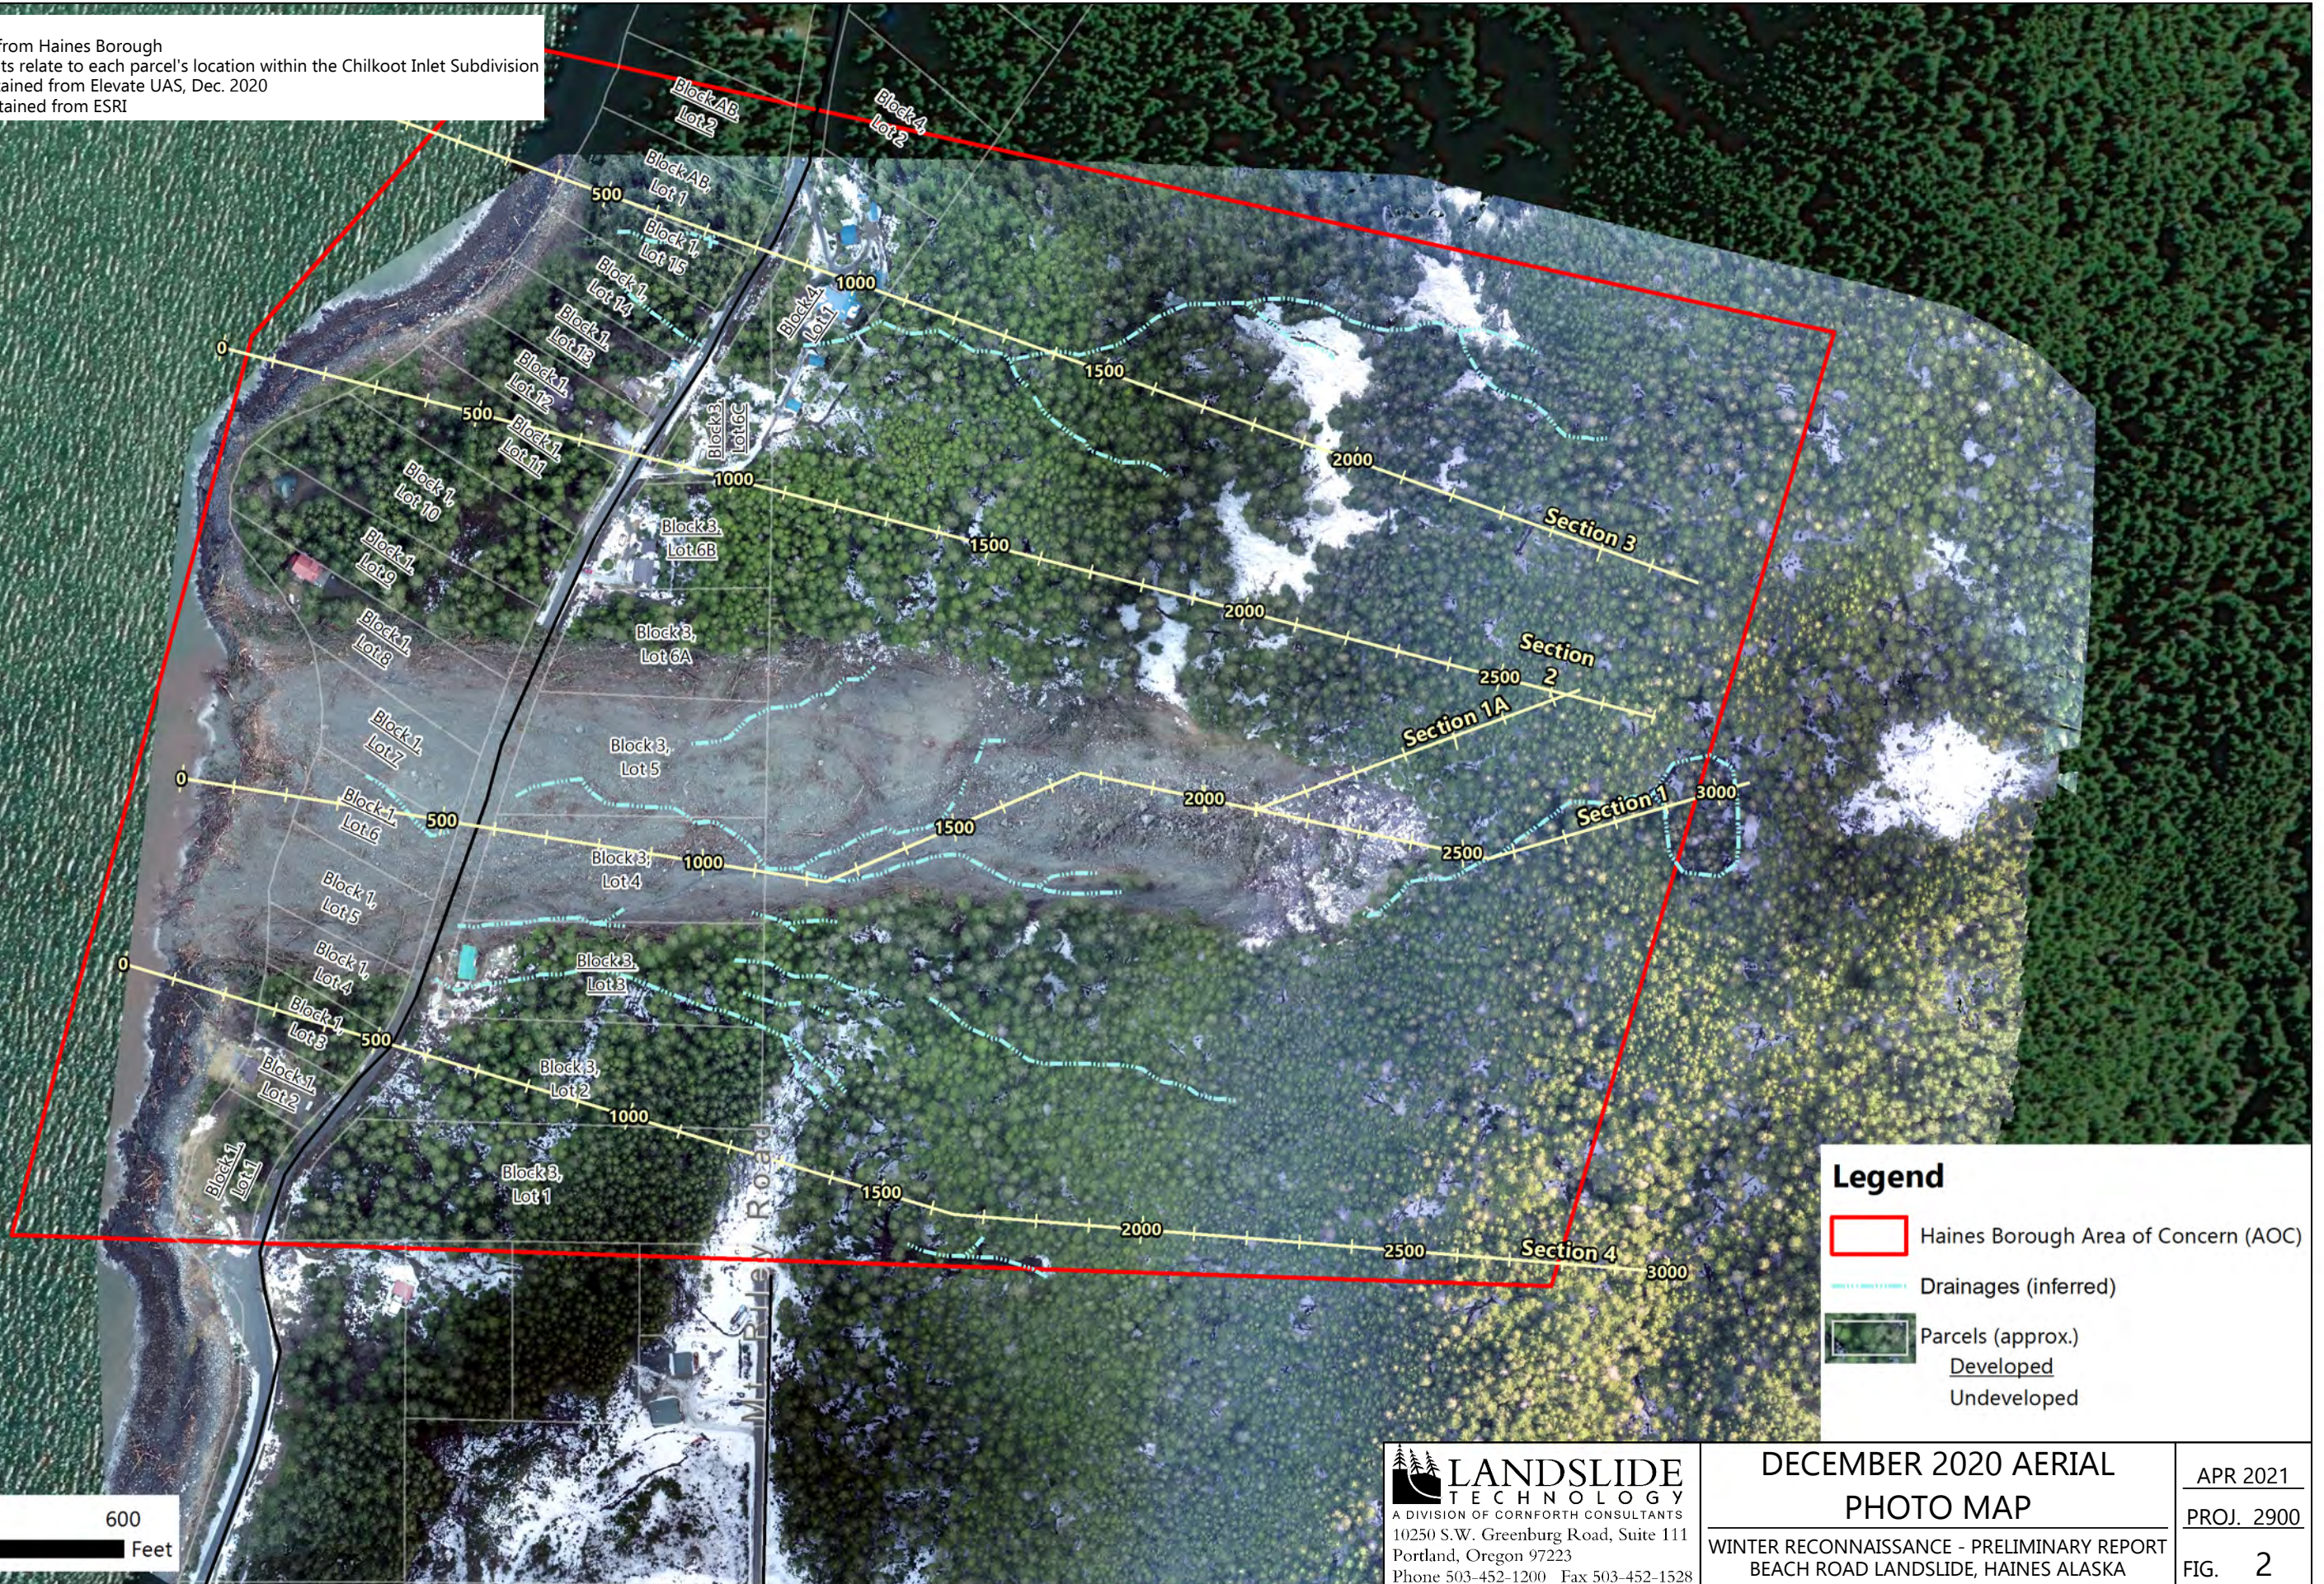
APR 2021
 PROJ. 2900
 FIG. 2

An ortho-aerial photo was developed from the December post-slide photography to assess the landslide and adjacent hillside slopes. Figure 2 shows the aerial photo, which includes the approximate locations of private properties and roads. The extent of sliding and impacts to the terrain were visible. The length of the landslide was determined to be 2,300 feet from the headscarp to the shoreline. The width of the upper landslide area was approximately 300 to 400 feet, and the width along the road and shoreline was approximately 650 feet. Locations of large rock blocks and clusters of boulders on the surface of the slide debris were evident in the aerial photo. Drainage channels on the slide debris were also identified on the aerial photo. A “linear” feature was identified relatively parallel to the west flank of the landslide, comprised of a canopy of spruce trees.

Haines Borough adopted a DGGS map delineating the AOC, which showed the properties included in the evacuated zone (December 18, 2020). The AOC was defined as an area that “could be impacted by a potential landslide originating at the fracture site” and that this area “remains an area of elevated concern with unknown stability.” The approximate boundary of the AOC is shown on Figure 2.

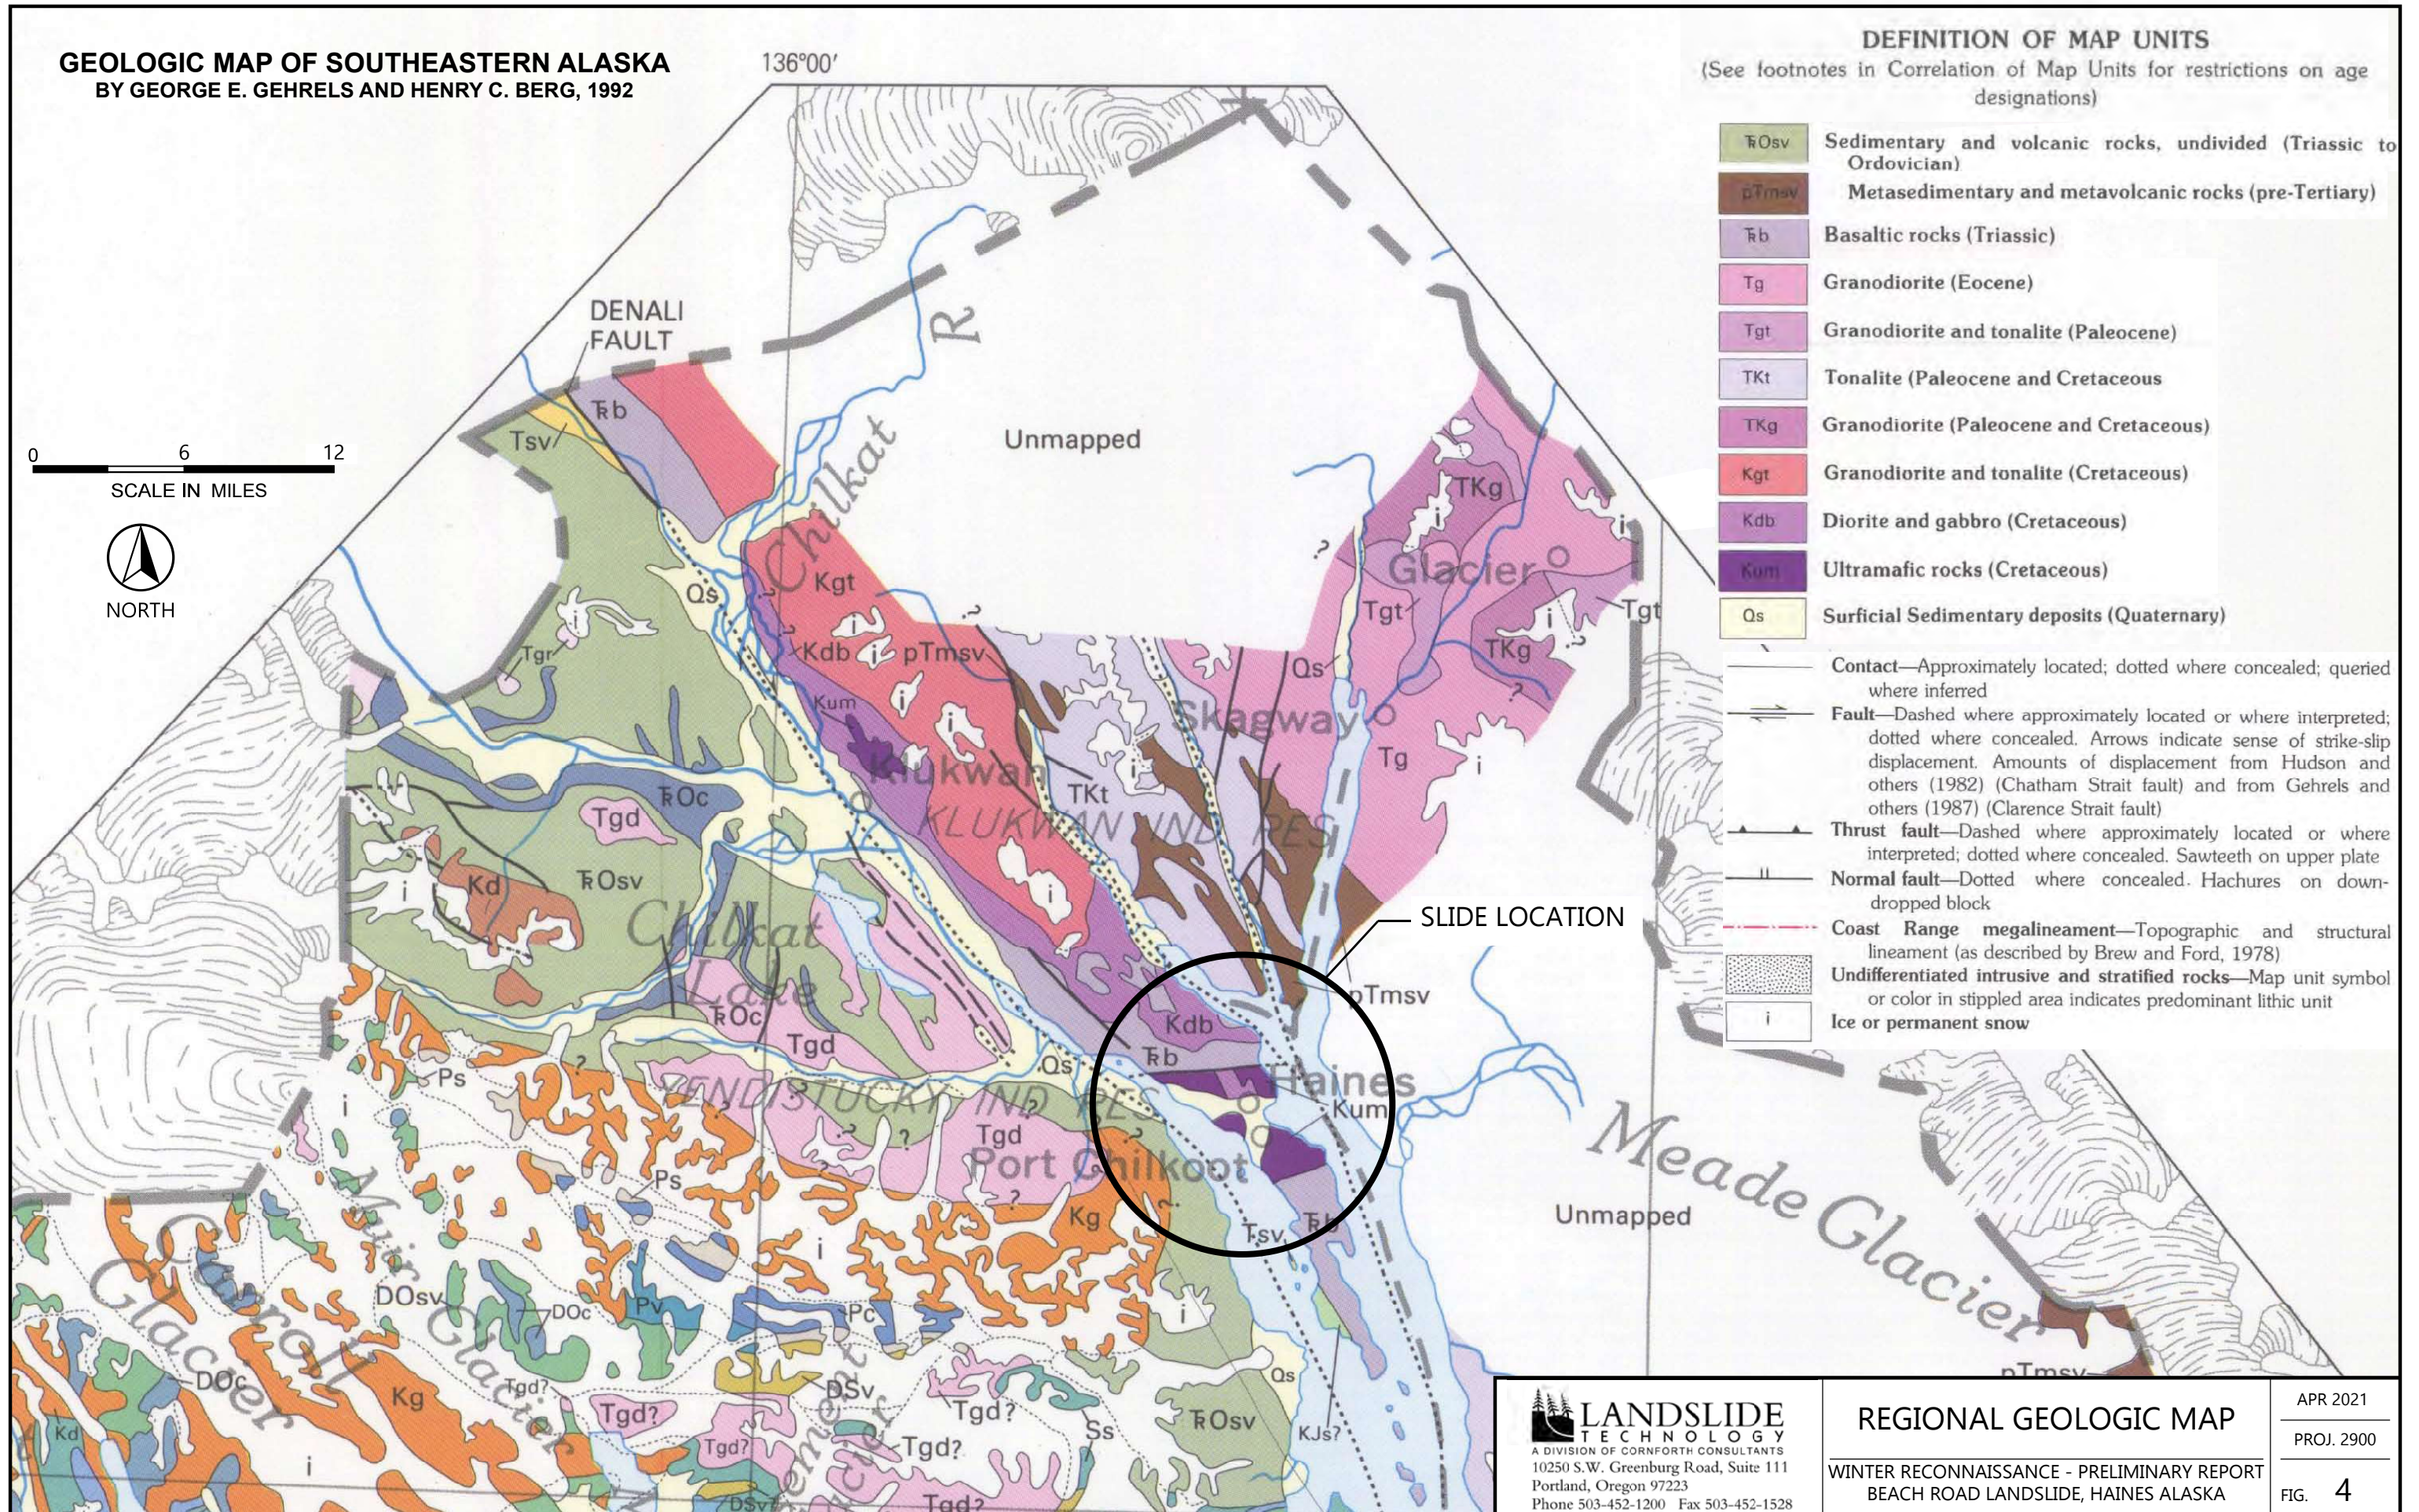
APR 2021
 PROJ. 2900
 FIG. 4

The Chilkat Peninsula and the southeast region of Alaska has undergone numerous changes in geologic time. There has been accretion of terranes onto the western margin of the ancient North American tectonic plate, metamorphism of these terranes, igneous intrusions causing deformation, faulting and significant uplift, and most recently the advancement and retreat of continental glaciation. These processes have combined to form the complex geology and structural elements through the region. A regional geologic map is provided on Figure 4.

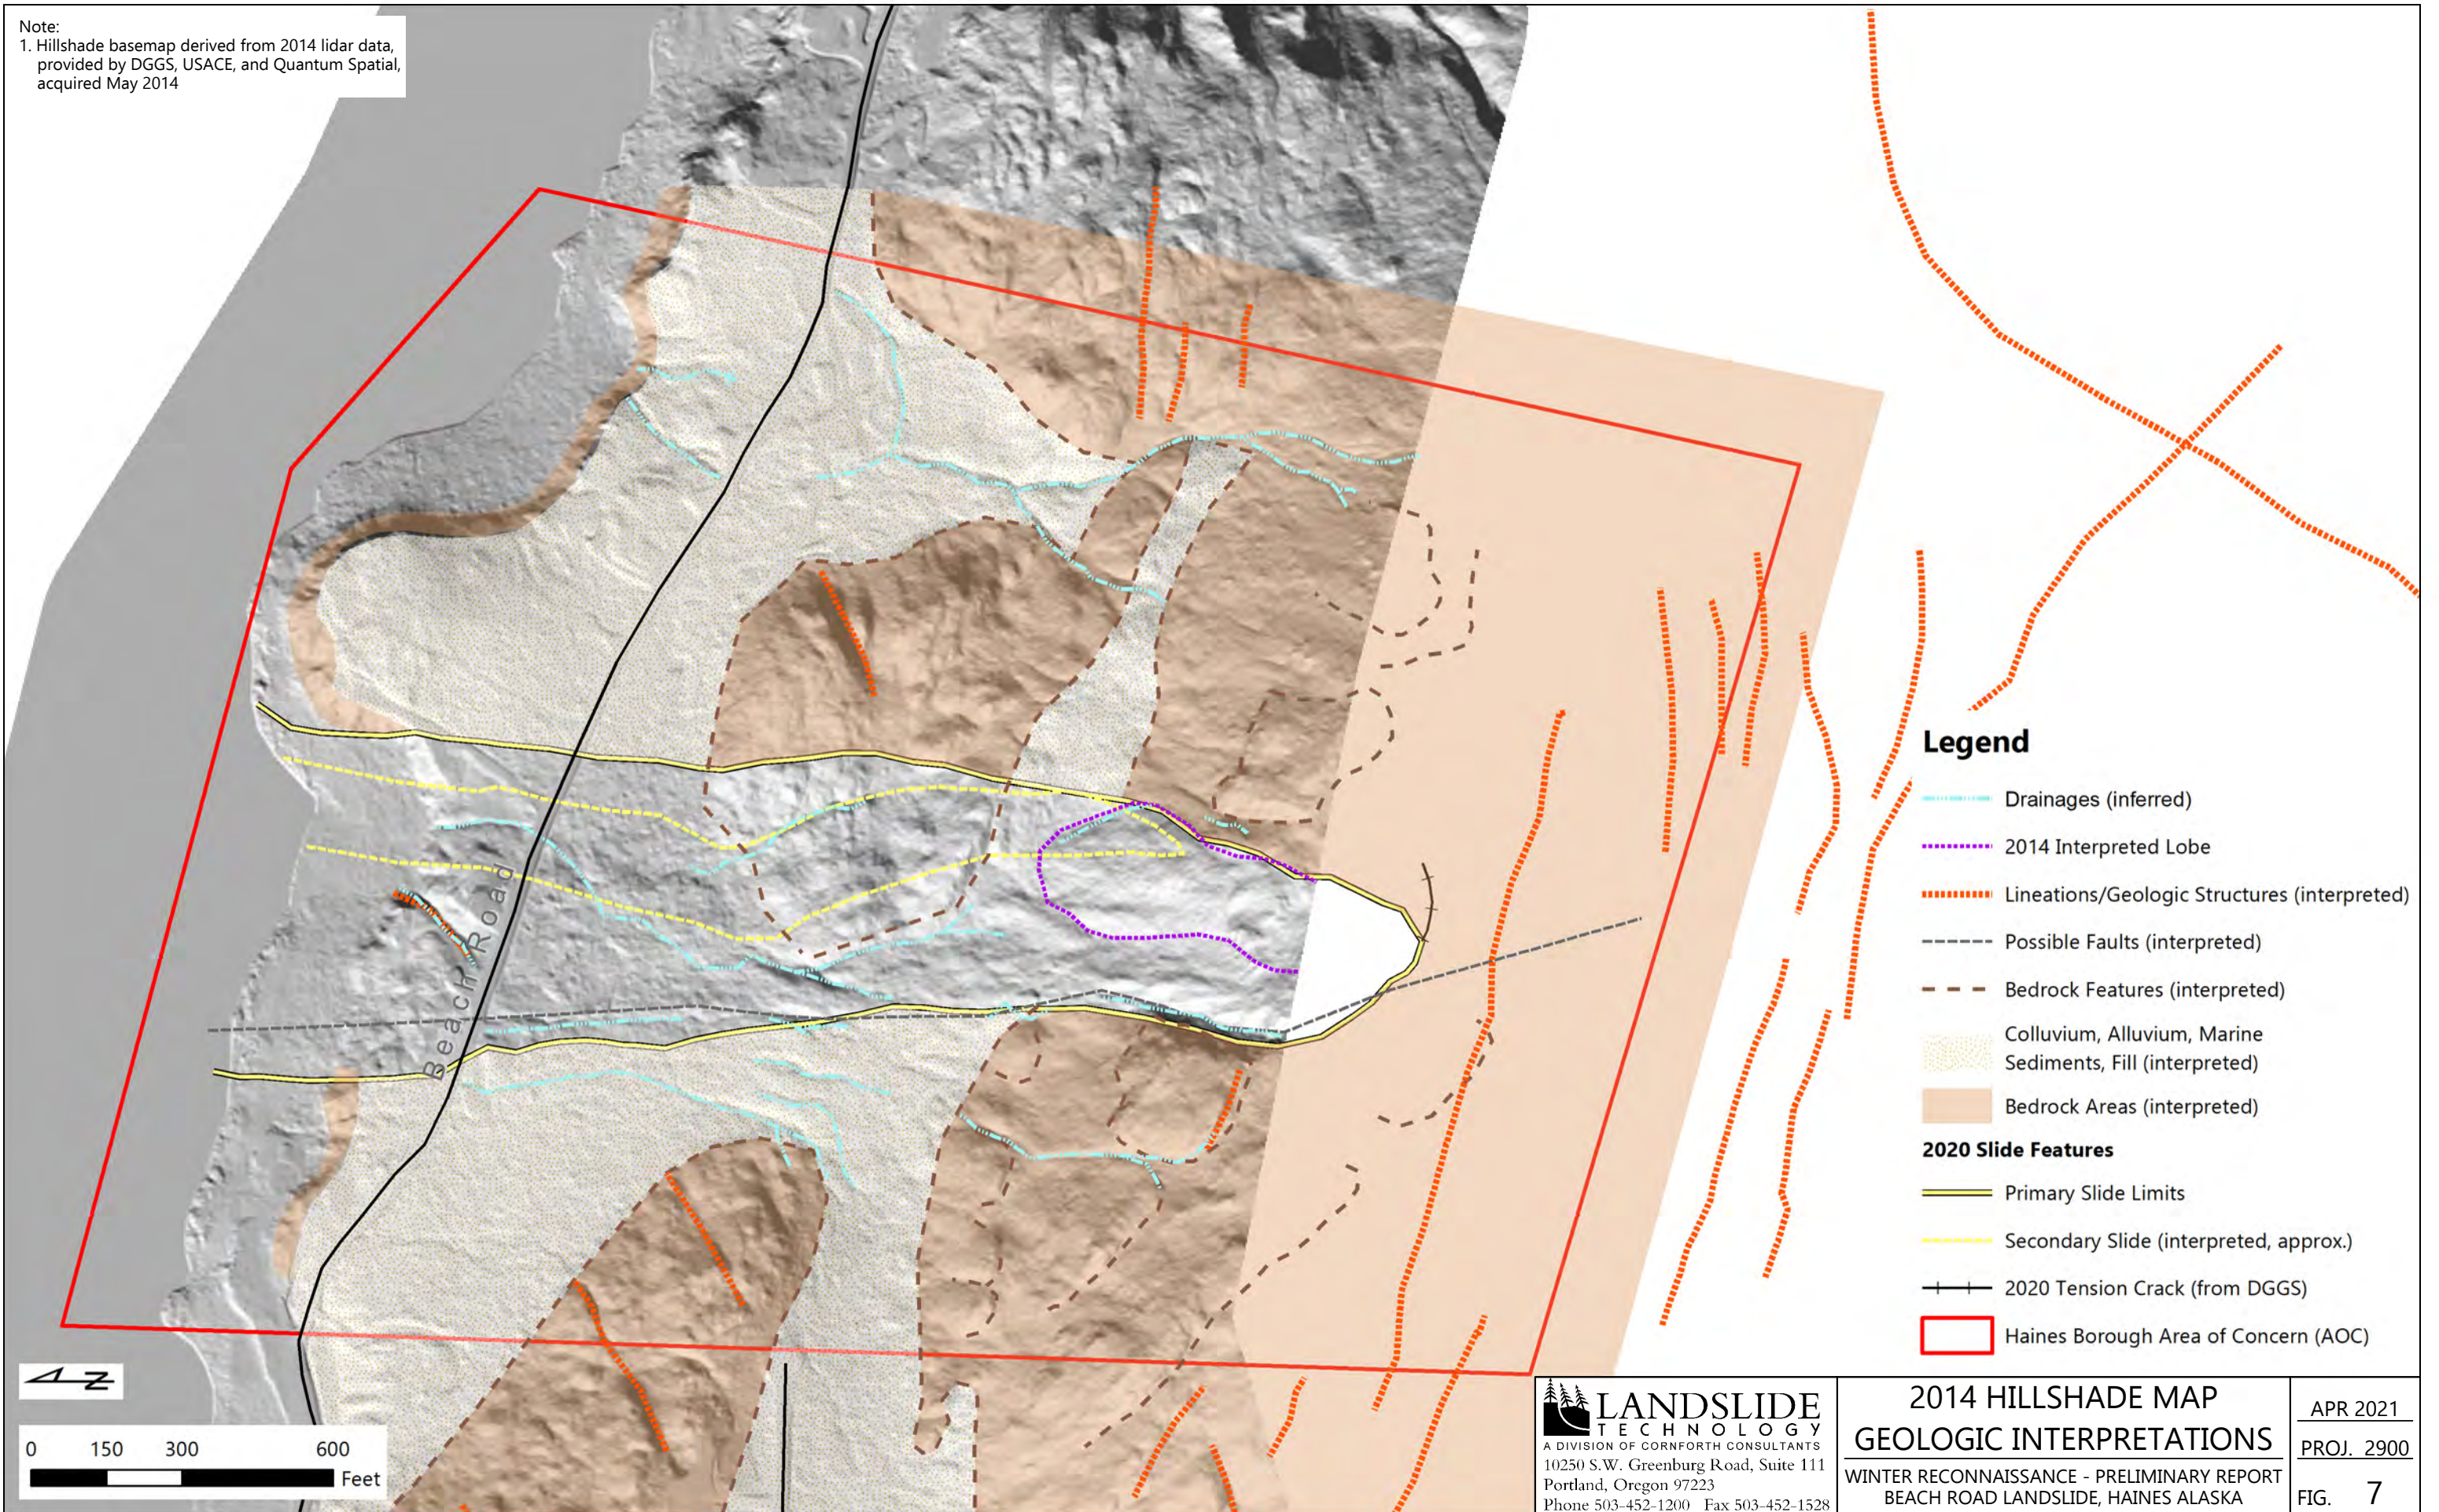
APR 2021
 PROJ. 2900
 FIG. 7

A feature only observed in the 2014 LiDAR includes a lobe-like shape of material downslope of the headscarp of the landslide from approximate elevations 380 to over 780 feet (see Figures 7 and 8). The upslope southern limit of the lobe feature is not known due to the limited coverage of the 2014 LiDAR data. The lobe feature may have extended upslope to the 2020 headscarp, or it may have extended to slope features that were removed by the 2020 mass wasting event. The western and eastern limits of the lobe feature are wholly within the extents of the upper landslide. Conditions outside of the landslide extents to the west and east of the landslide have been mapped as bedrock areas. In general, slopes of the upper hillside are relatively steep, almost 45° in inclination; whereas, the upper area of the landslide exhibits slopes of 35 to 38° inclination indicating weaker materials. These differing slope features appear to be a result of major contributors to rock slope weathering and the 2020 mass wasting event.

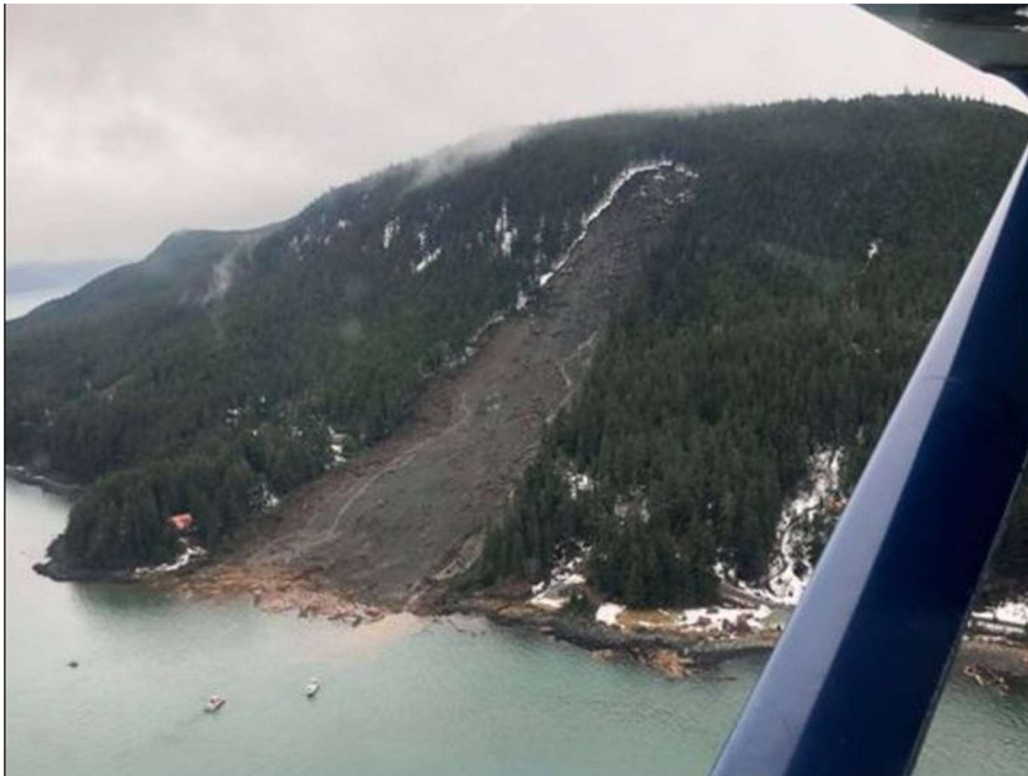
Aerial view looking southeast at landslide (from DGGS, taken 12/10/2020).

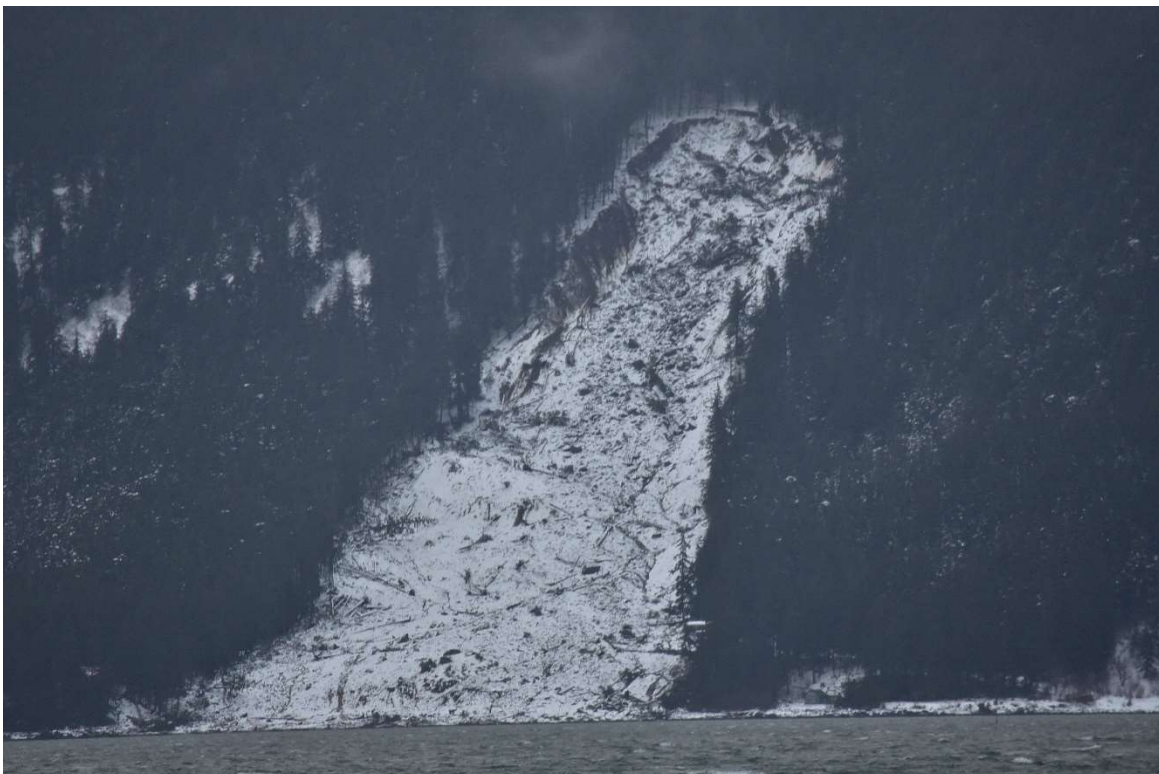
View looking approximately south at landslide from the inlet (from Haines Avalanche Center, taken 12/6/2020).

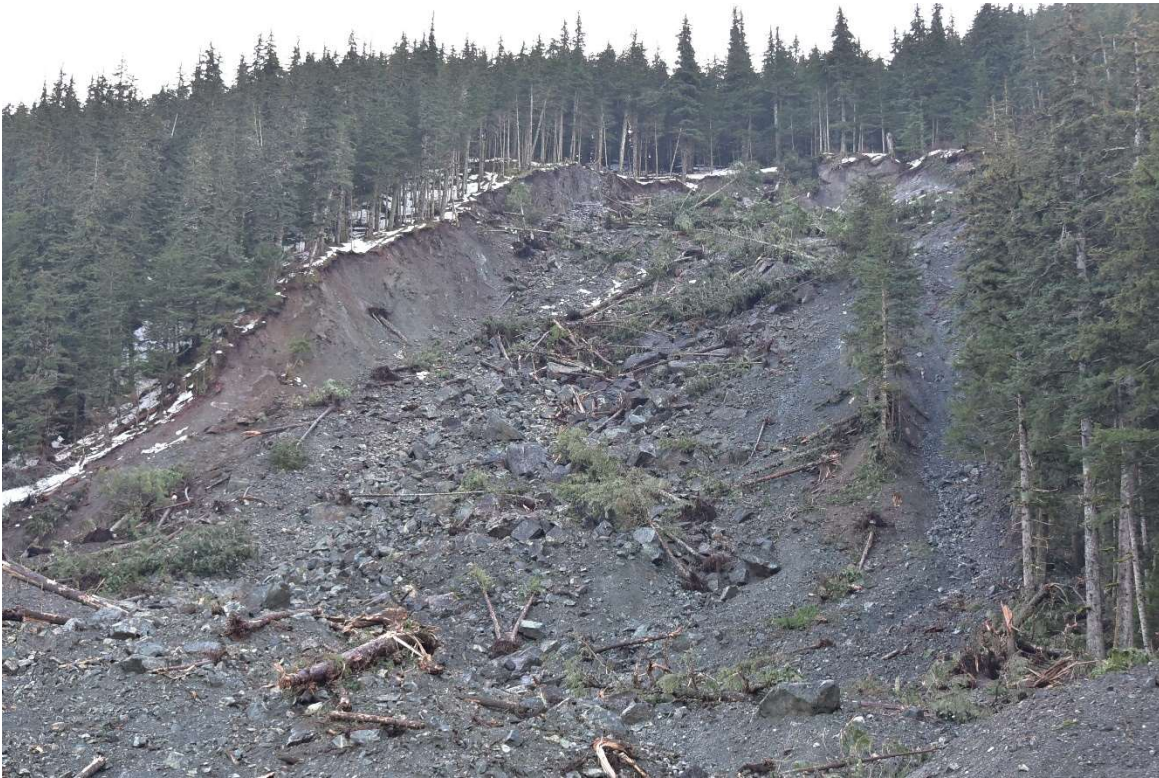
View looking southeast at upper portion of the landslide and the eastern lateral scarp (from Haines Avalanche Center, taken 12/9/2020).

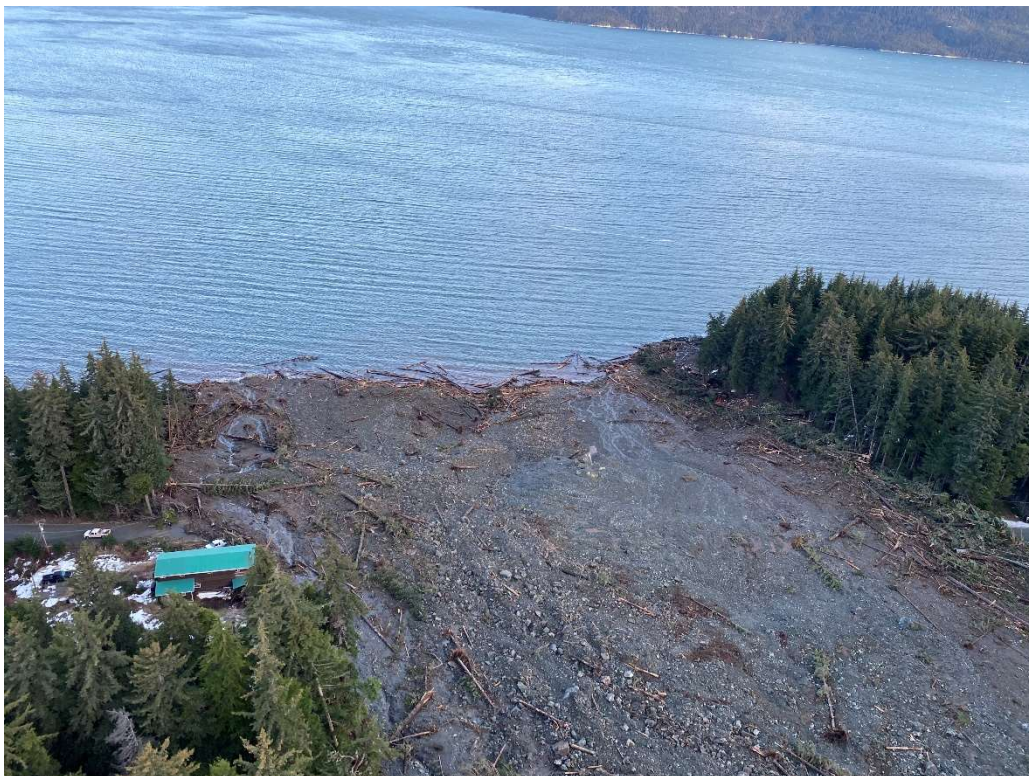
Aerial view looking northeast at lower portion of the landslide (from DGGs, taken 12/10/2020).

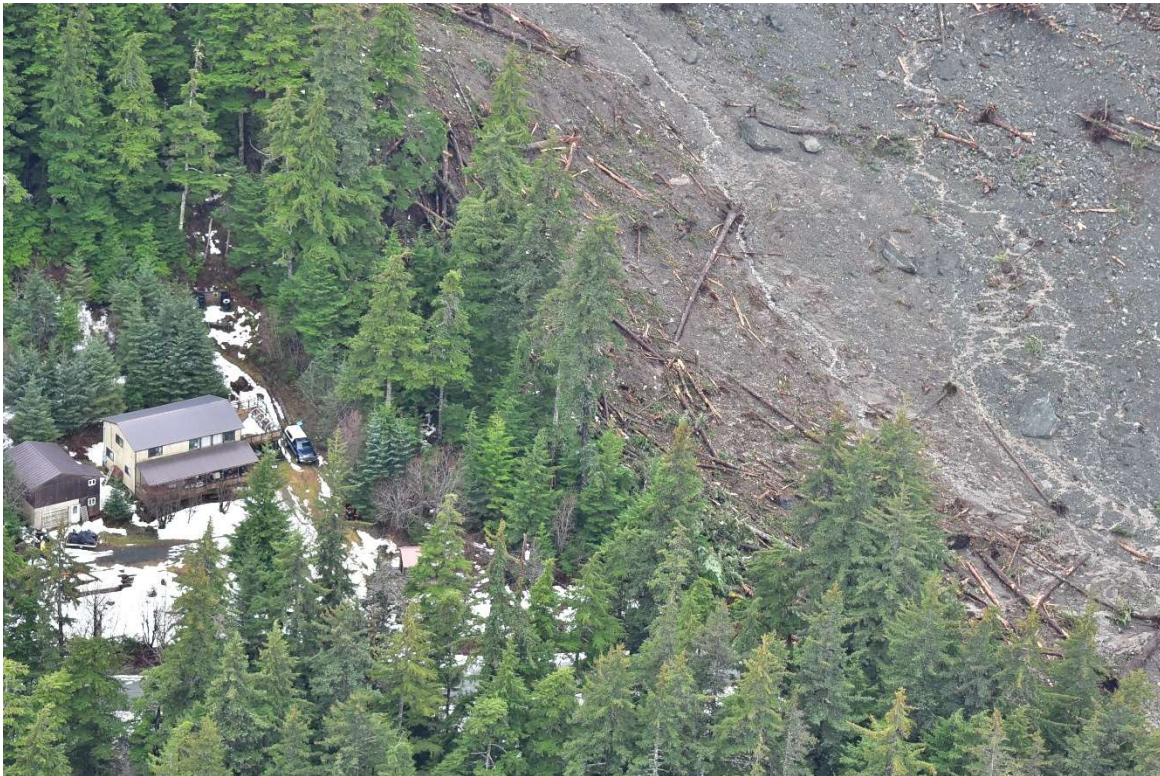
Aerial view looking southwest at eastern portion of the landslide near the Keller property (from Haines Avalanche Center, taken 12/8/2020).

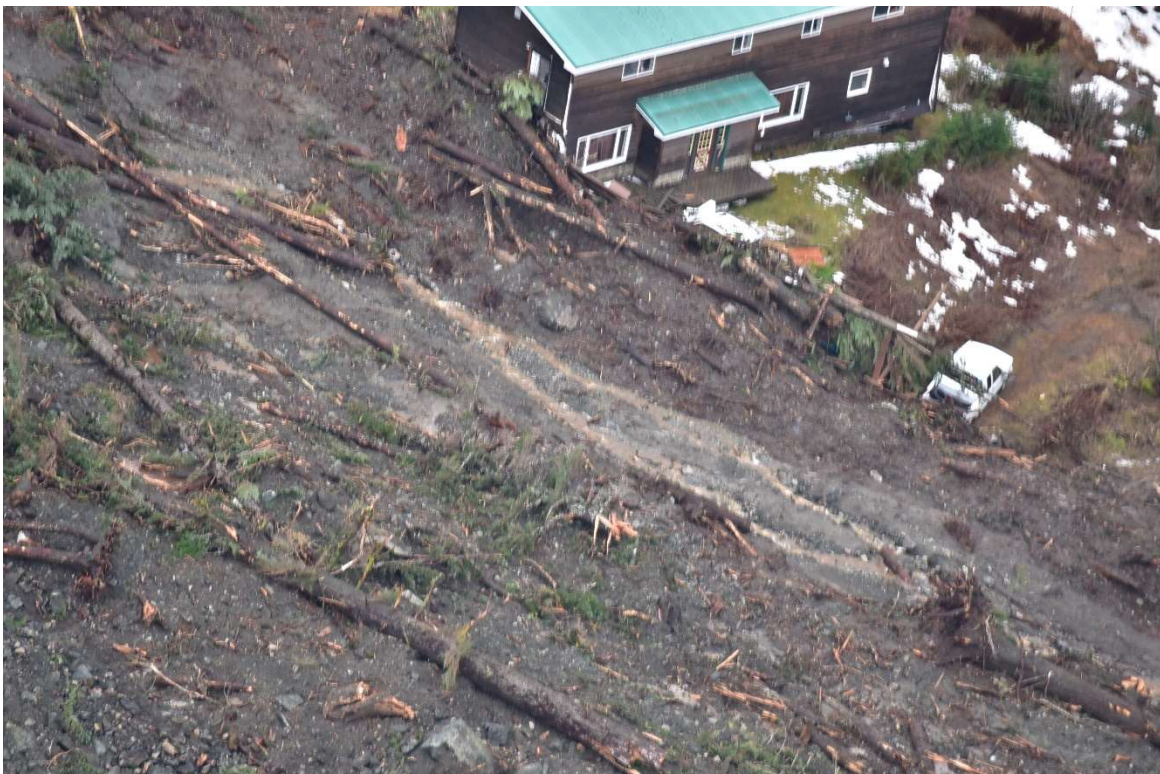
Aerial view southwest at western portion of the landslide on the Messano property (from Haines Avalanche Center, 12/8/2020).

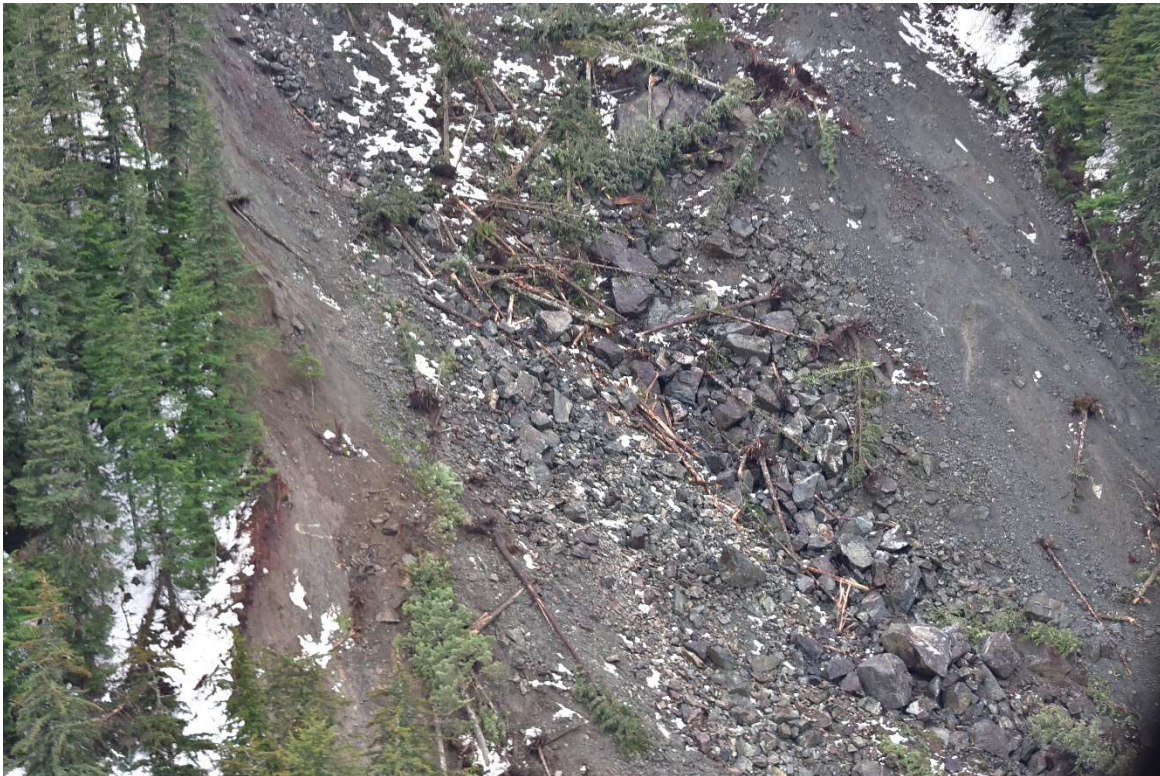
View looking south at landslide debris in upper portion of landslide (from Haines Avalanche Center, taken 12/8/2020).

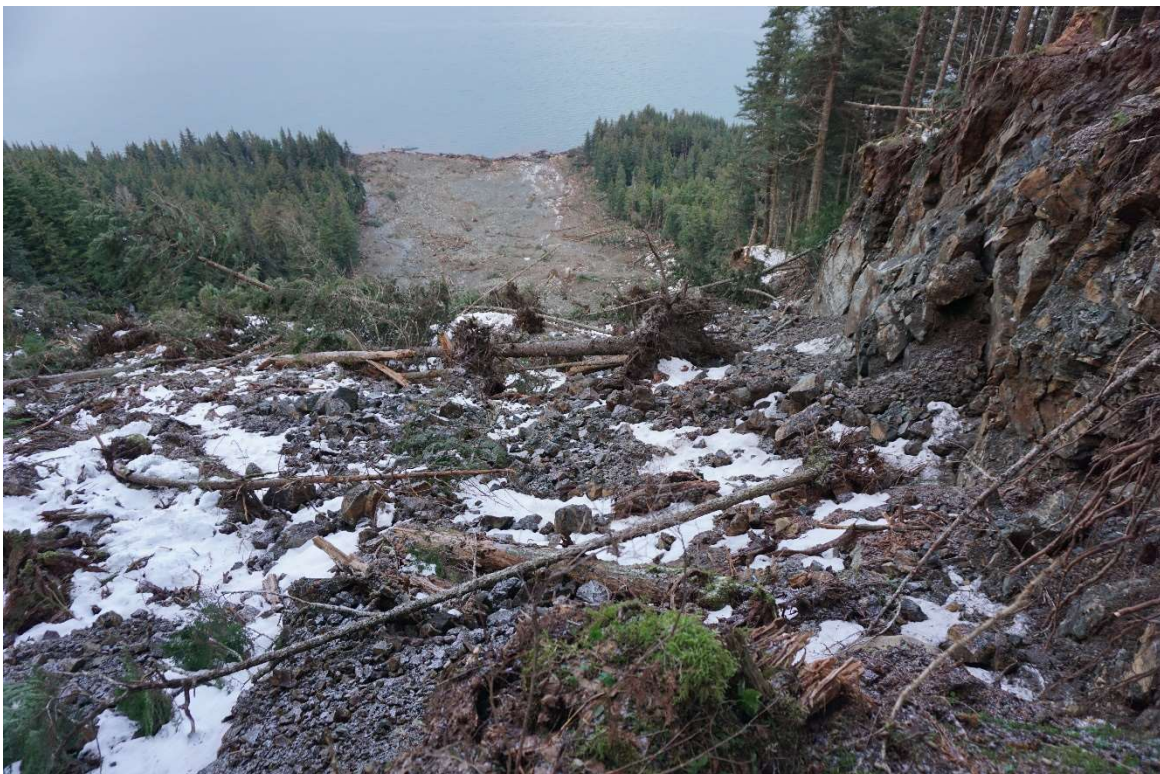
View looking north at landslide debris from the headscarp area (from DGGs, taken 12/11/2020).

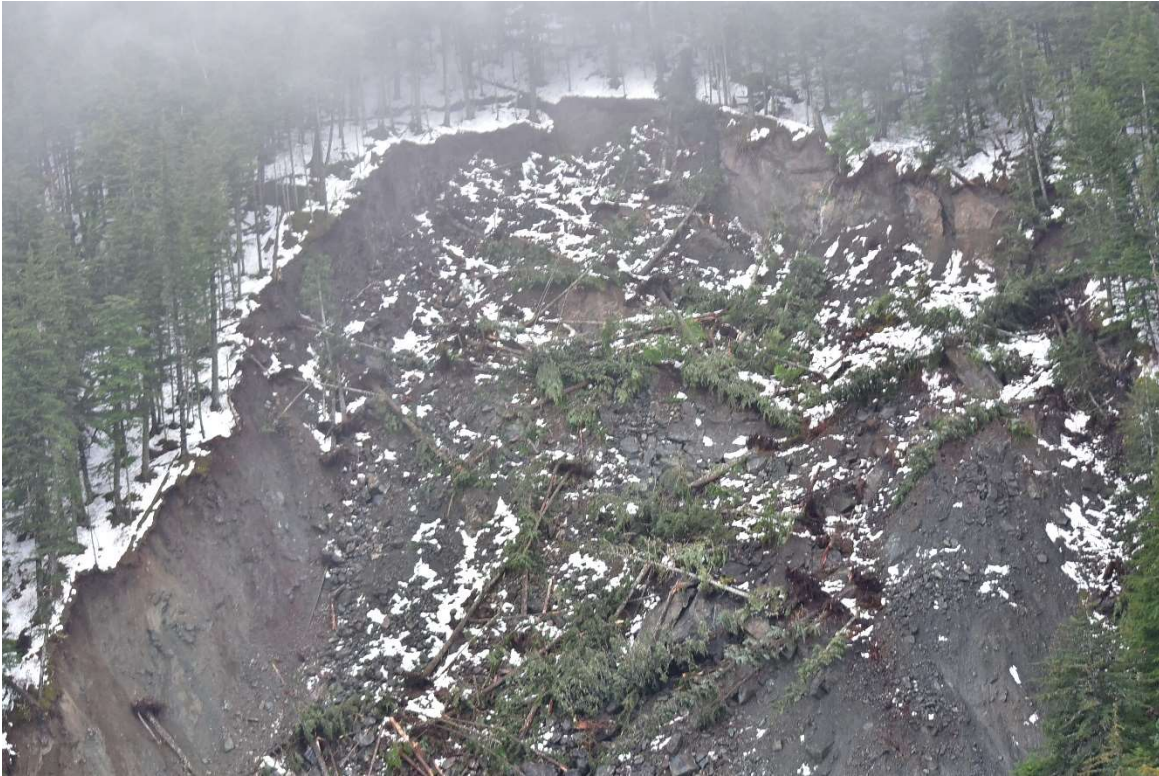
Aerial view looking southeast at headscarp area and the upper eastern lateral scarp (from Haines Avalanche Center, taken 12/8/2020).

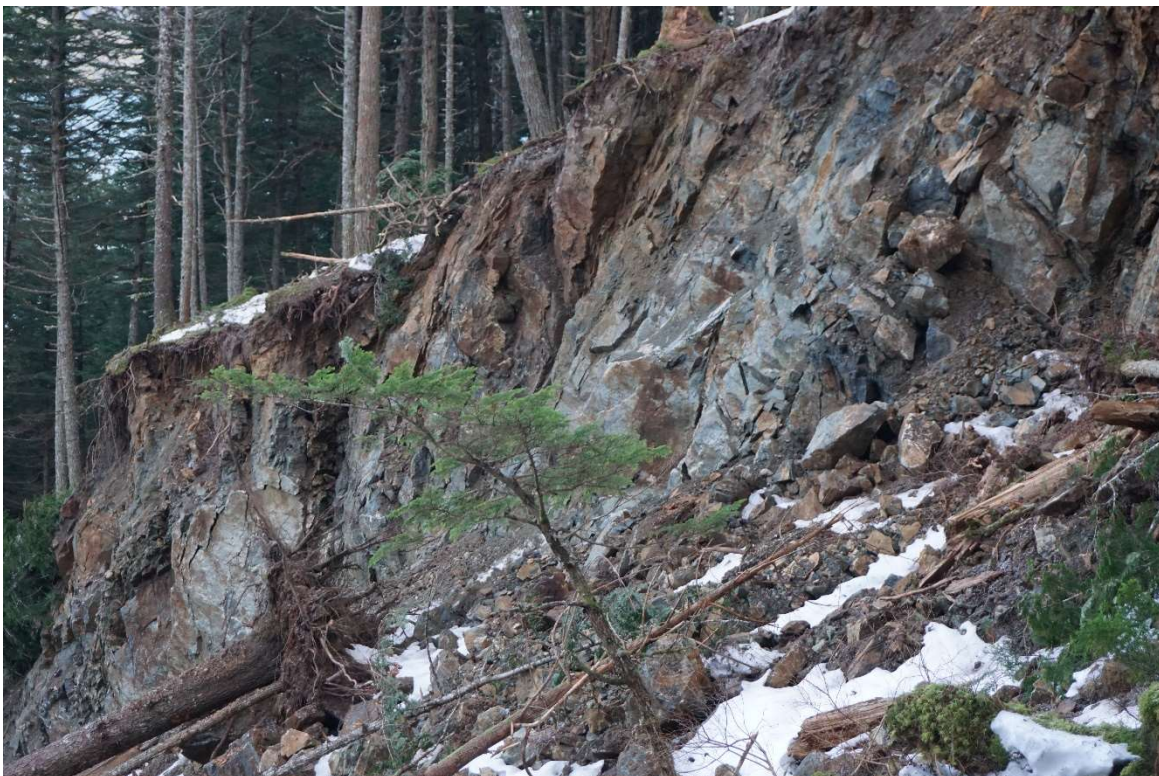
View looking east at bedrock exposed in the upper eastern lateral scarp (from DGGs, taken 12/12/2020).

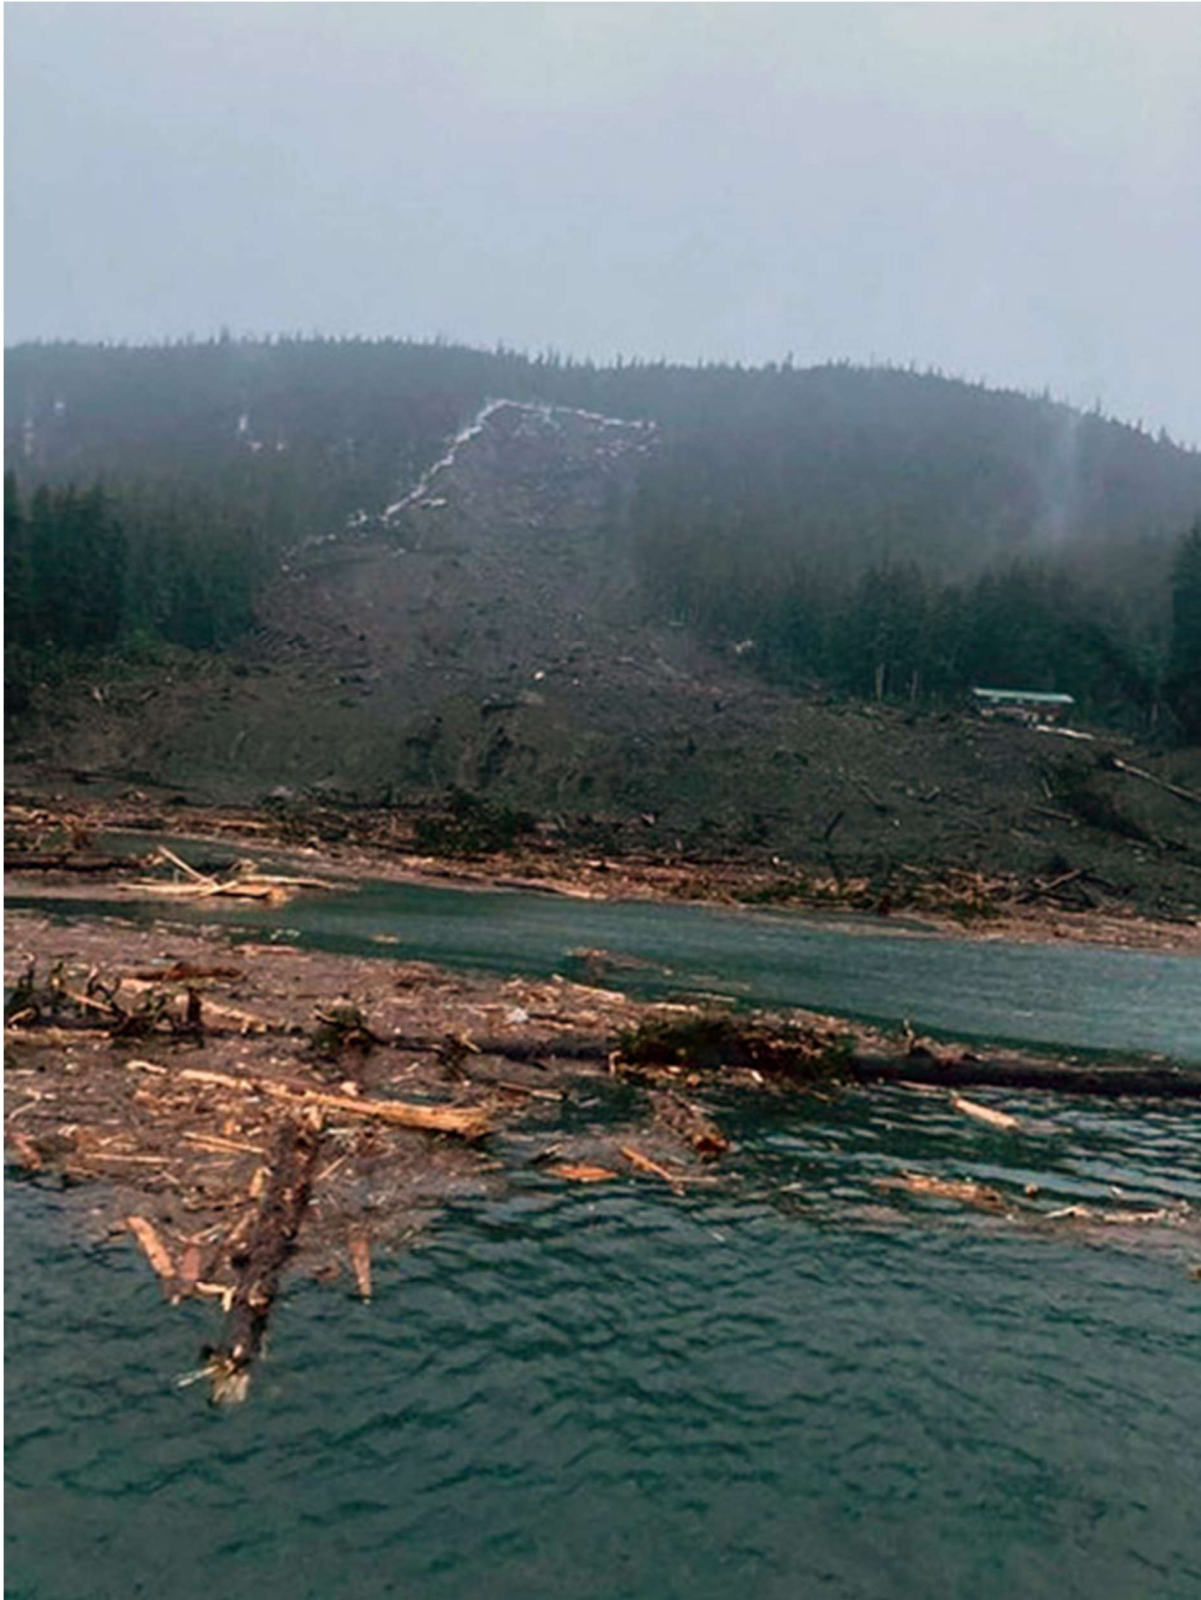
View looking south at landslide from the inlet (from DGGs).
