Winter Reconnaissance - Preliminary Findings Report Beach Road Landslide, Haines, Alaska

**WINTER RECONNAISSANCE
PRELIMINARY FINDINGS REPORT**

**BEACH ROAD LANDSLIDE
HAINES, ALASKA**

April 8, 2021

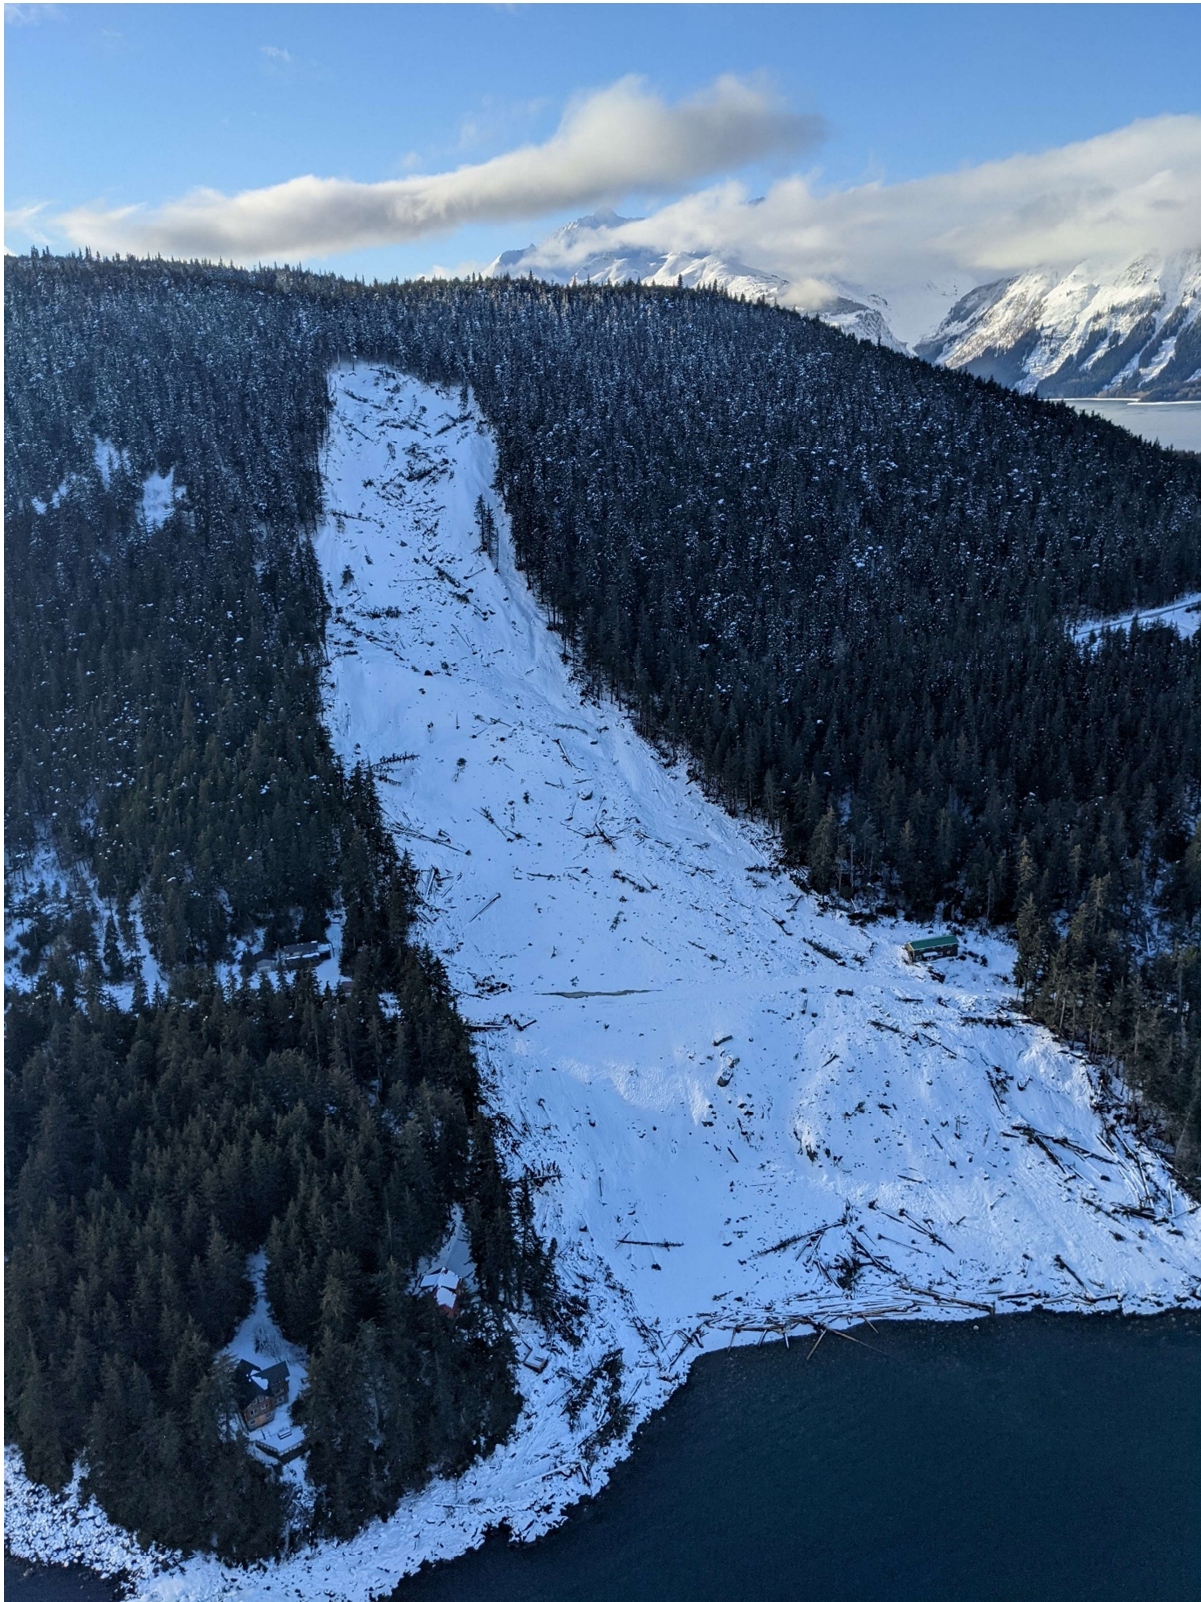
Aerial view looking south-southwest at the slide area during the winter reconnaissance (taken 2/23/2021).

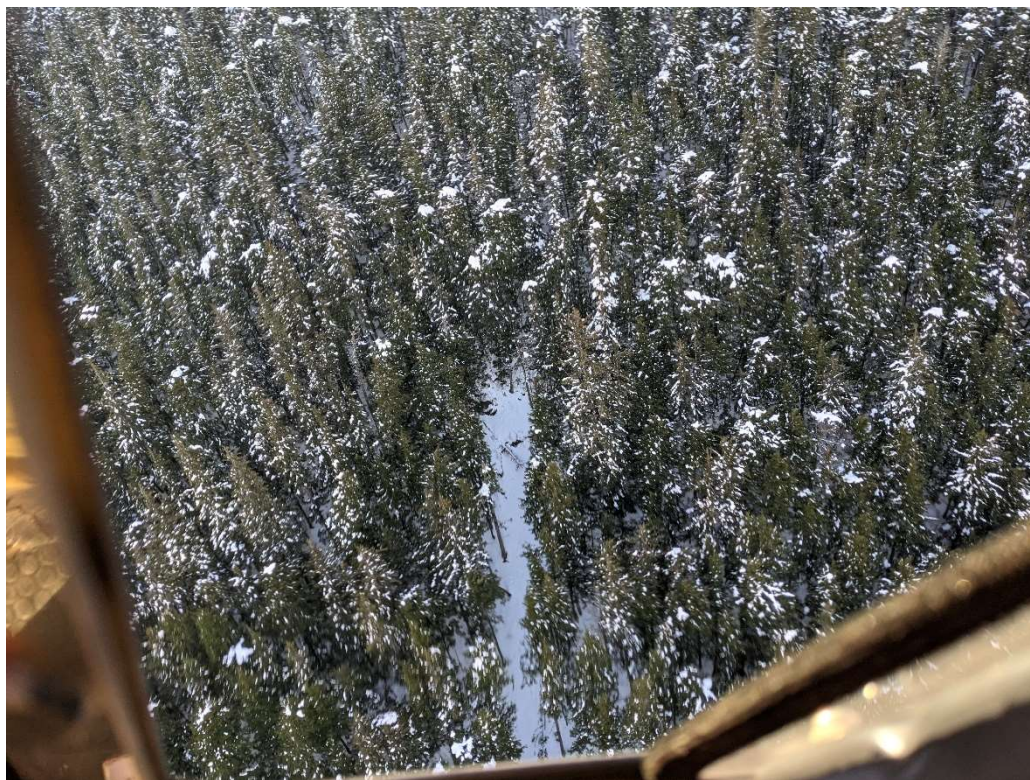
Aerial view looking south at a localized slide on the western edge of EOC "Area of Concern" (taken 2/23/2021).

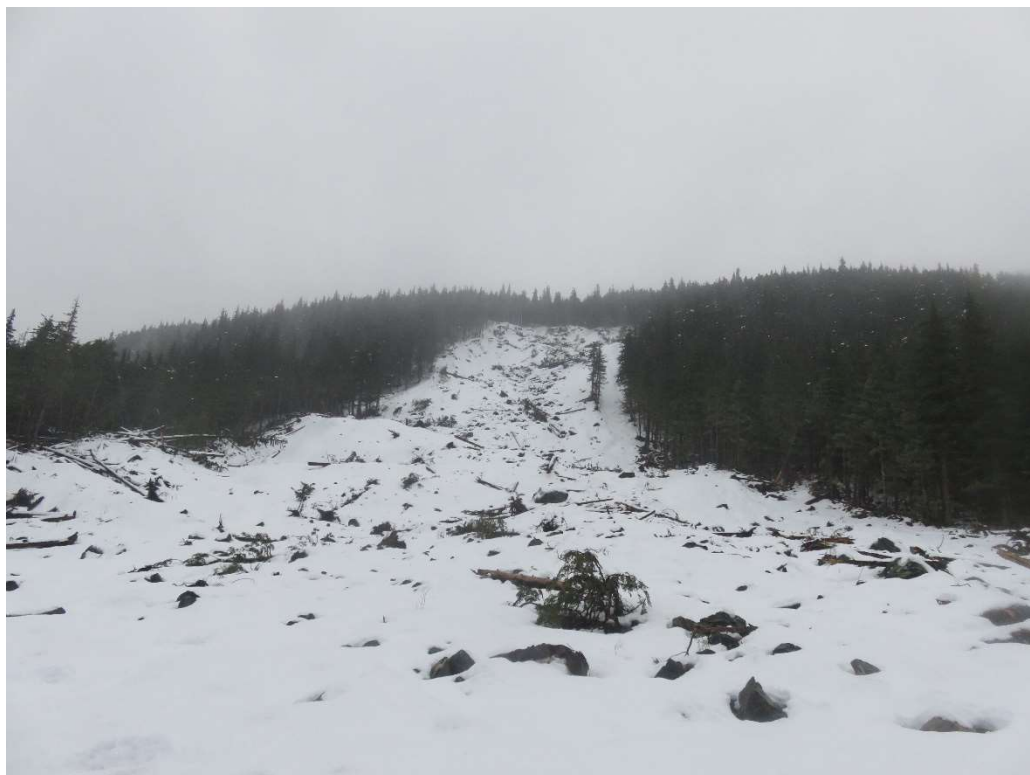
View from temporary access road looking south at the headscarp of the slide.

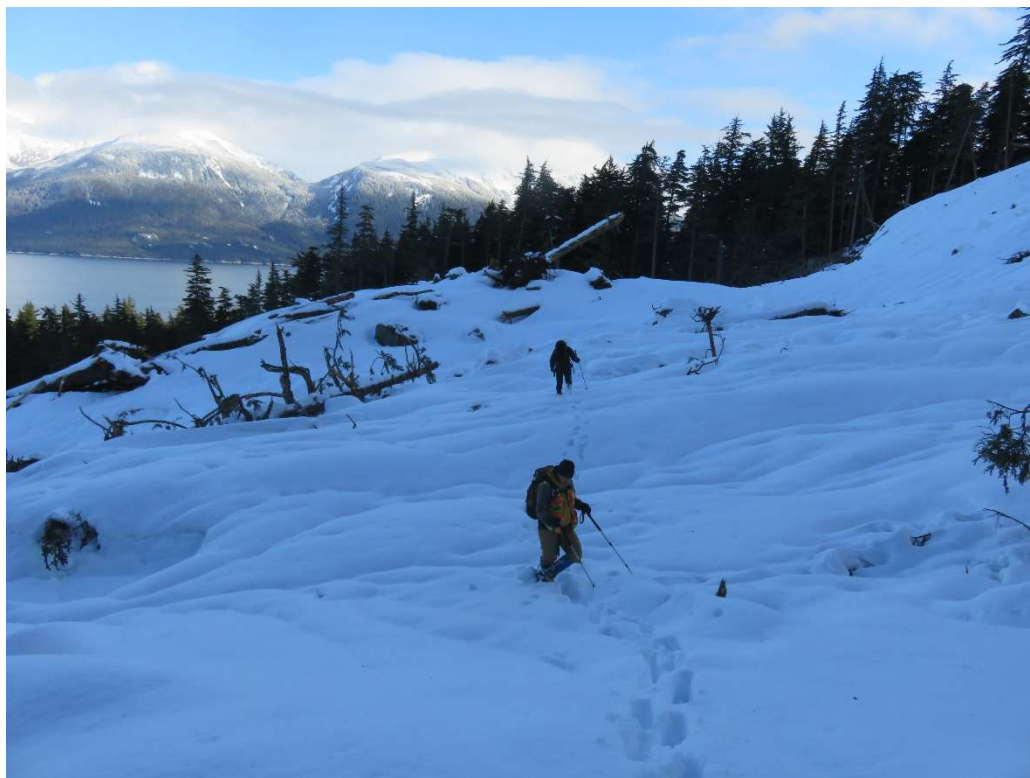
View looking west across the middle of the slide near elevation 400 feet (taken 2/23/2021).

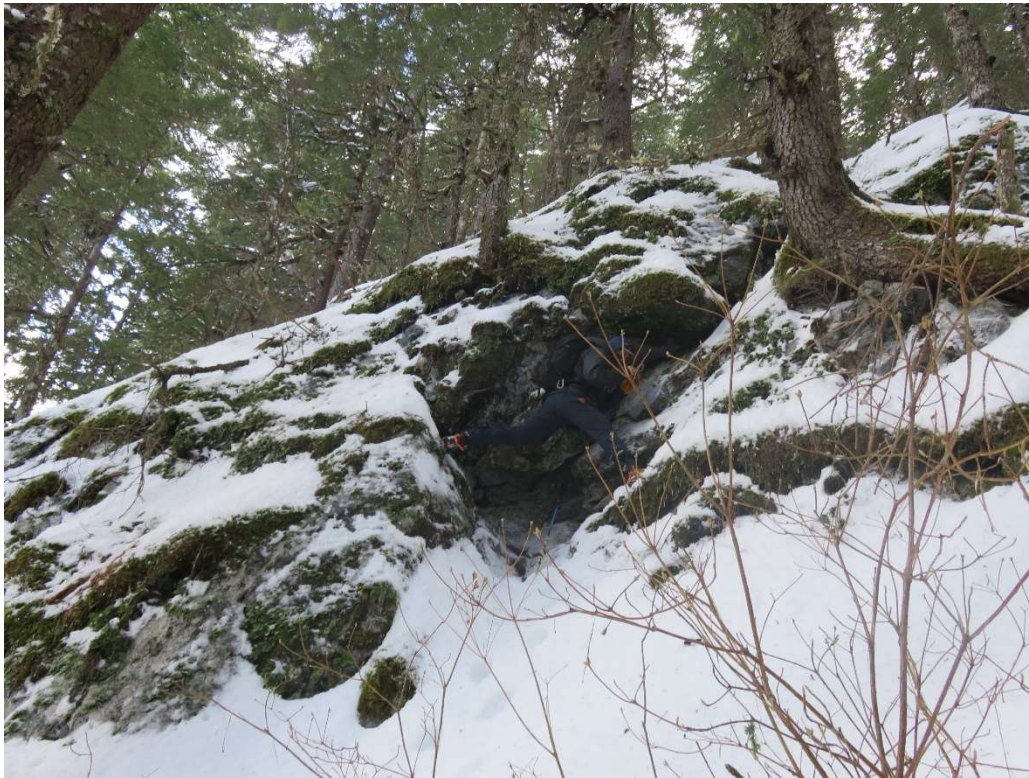
View looking southeast at rock outcrop on the western flank of the slide near elevation 550 feet (taken 2/23/2021).

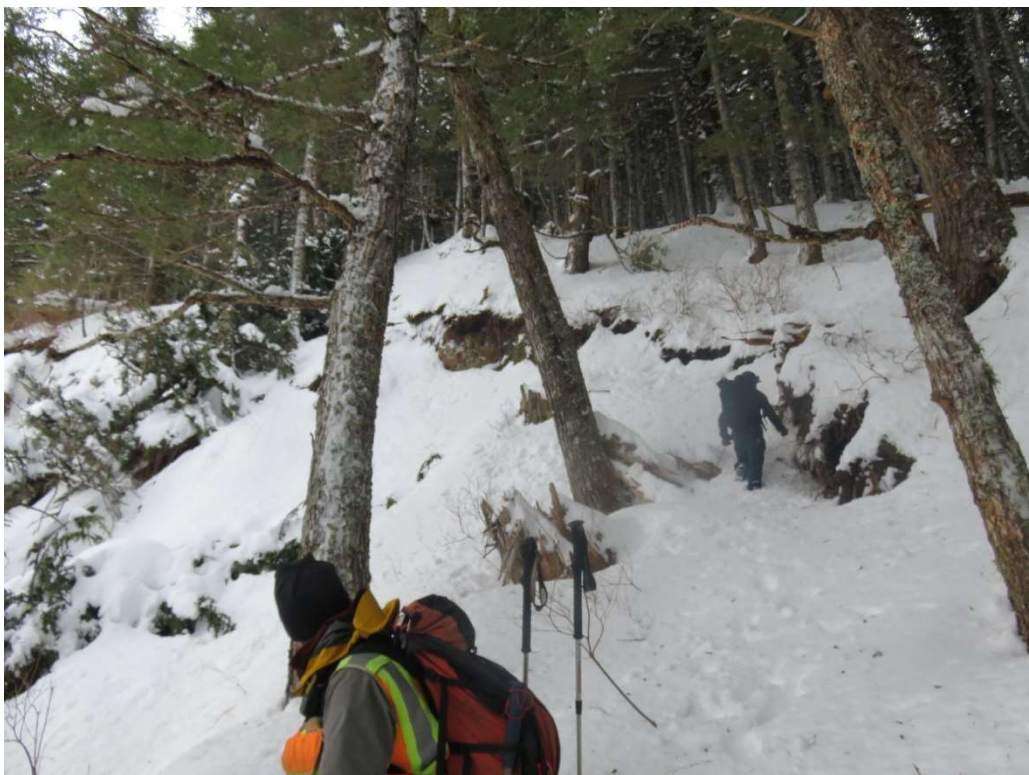
View looking east at the headscarp along the western flank of the slide near elevation 850 feet (taken 2/23/2021).

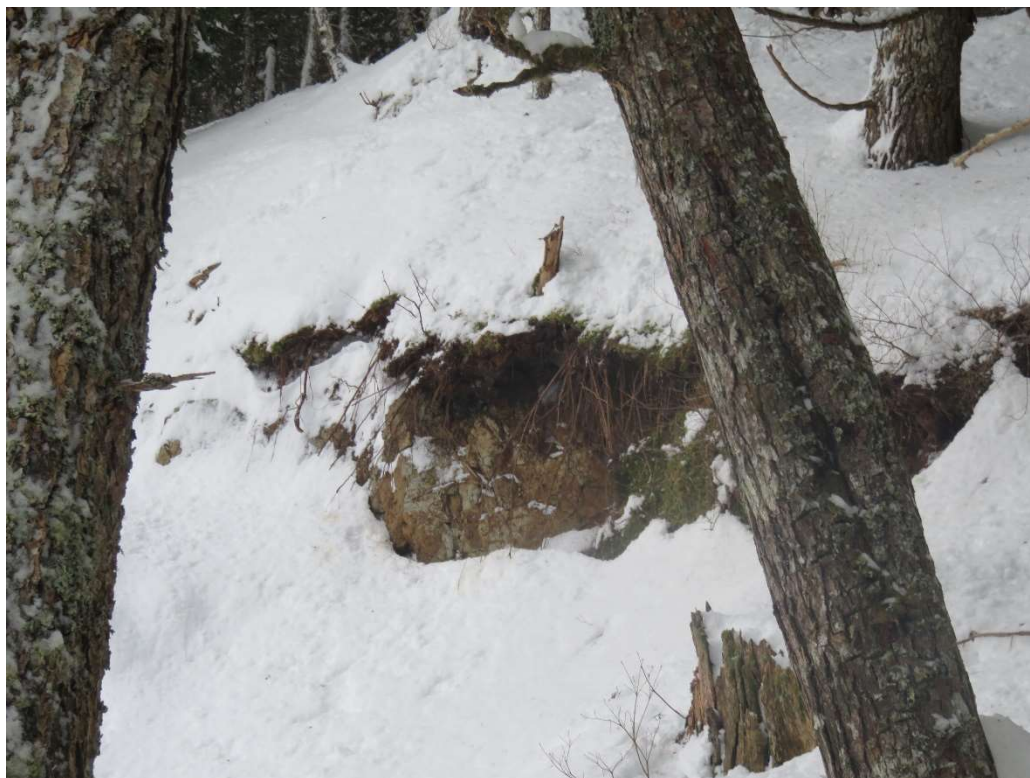
View of rock exposed in the western portion of the headscarp of the slide (taken 2/23/2021).

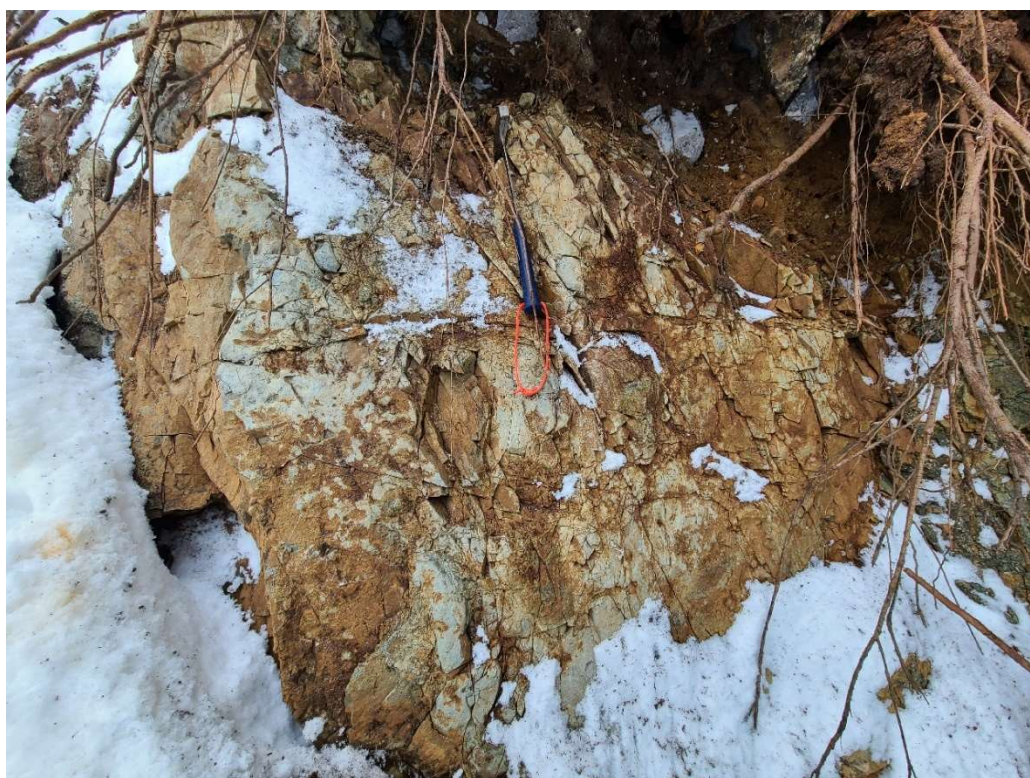
Close up view of the rock exposed in the western portion of the headscarp. Note altered nature of the rock surface (taken 2/23/2021).

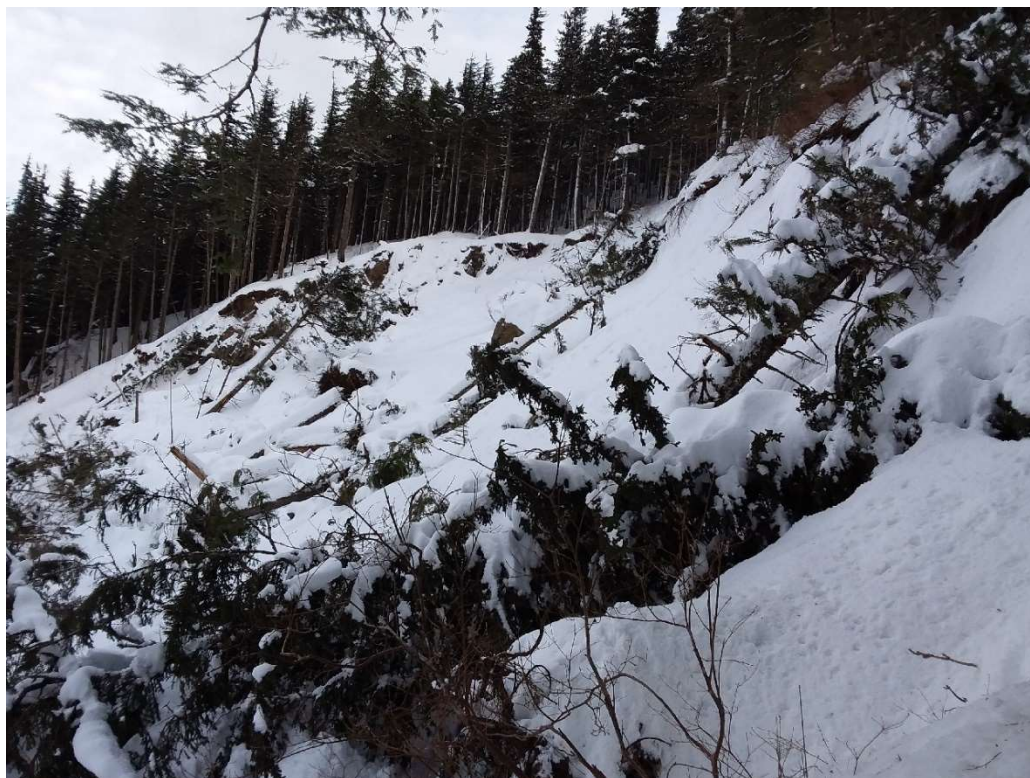
View looking east at the headscarp area (taken 2/24/2021).

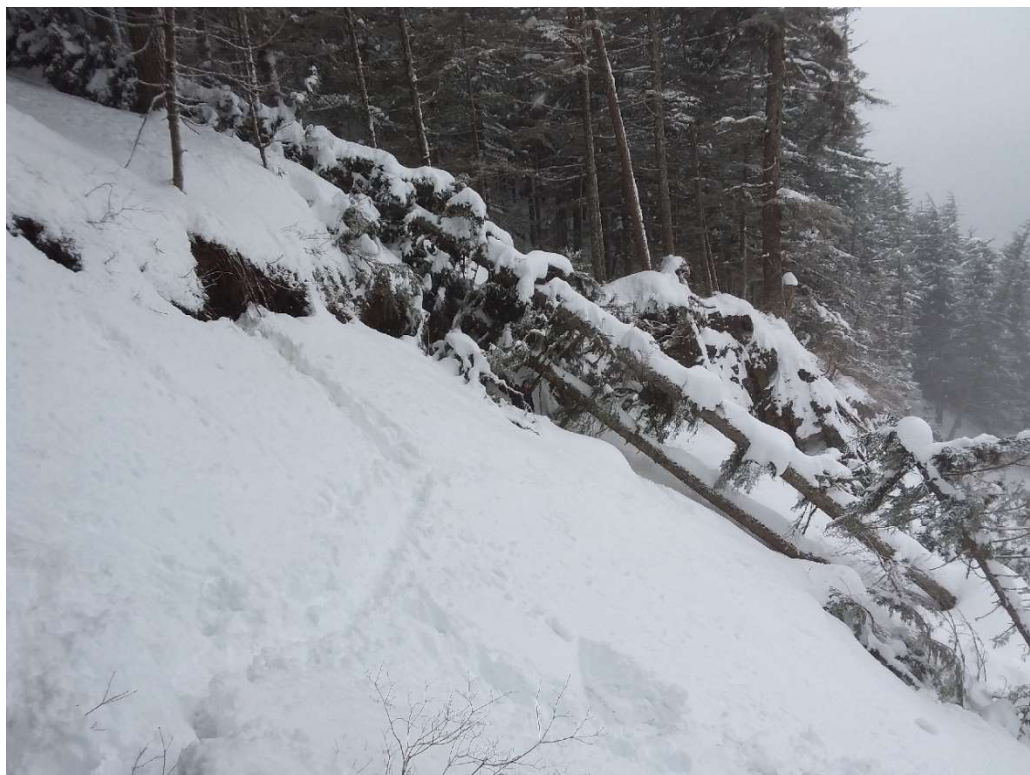
View looking west at the headscarp area (taken 2/24/2021).

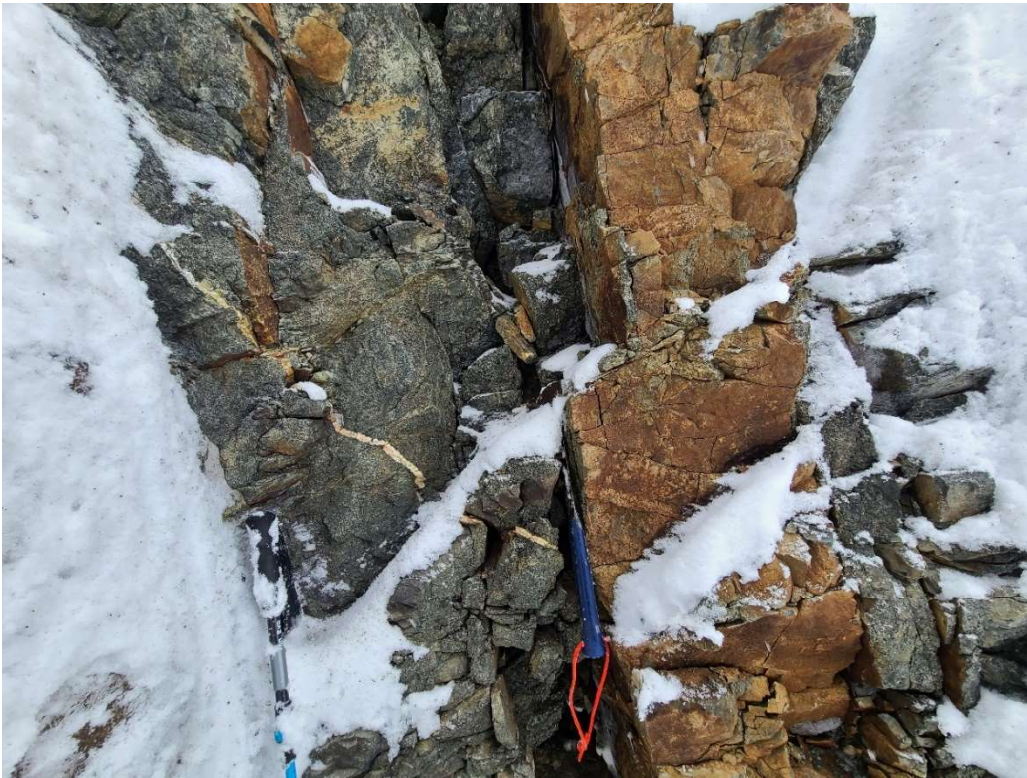
Close up view of rock exposed in the eastern portion of the headscarp. Note altered nature of the rock surface (taken 2/24/2021).

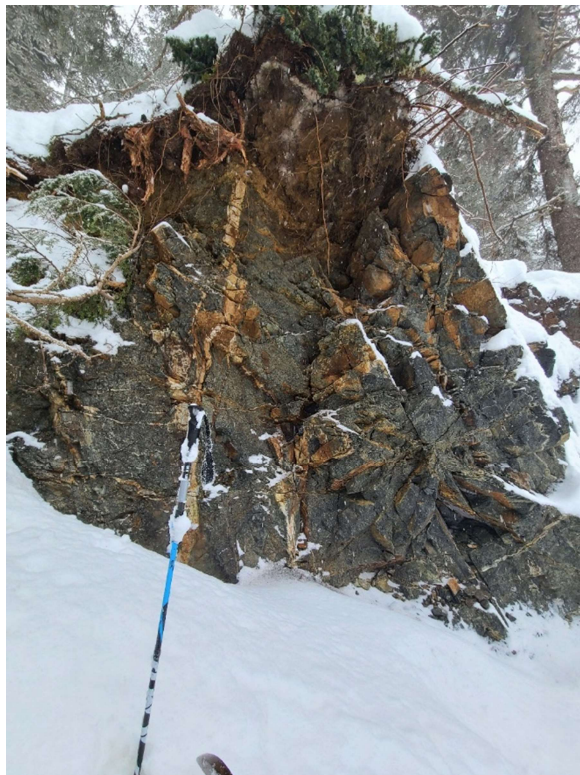
Close up view of rock exposed in the eastern portion of the headscarp. Note altered nature of the rock surface (taken 2/24/2021).

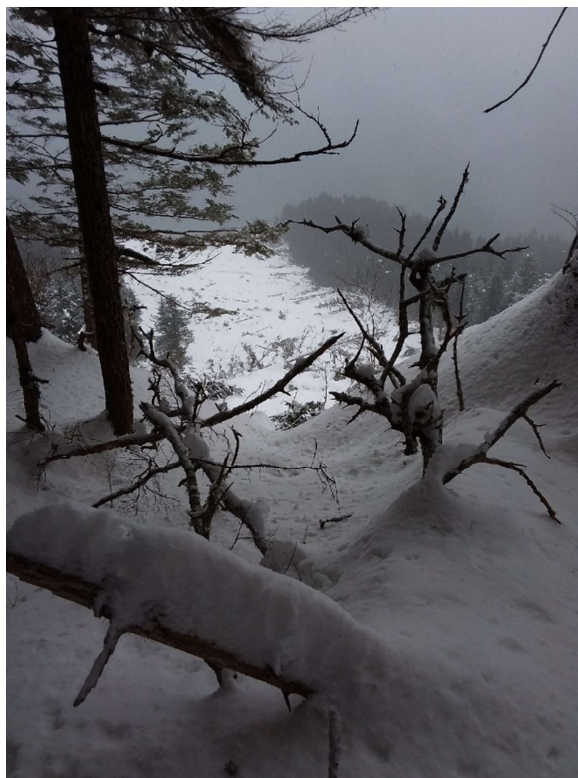
View looking north above the headscarp area. This area appears to be where concentrated surface water flowed into the headscarp area during the slide event (taken 2/24/2021).

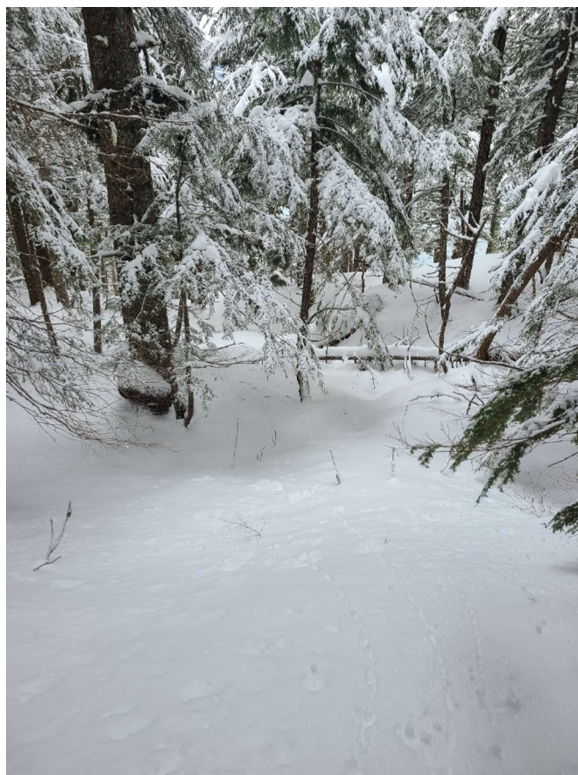
View looking north further up the slope above the headscarp area. This area is the drainage path that channeled surface water flow toward the headscarp area during the slide event (taken 2/25/2021).

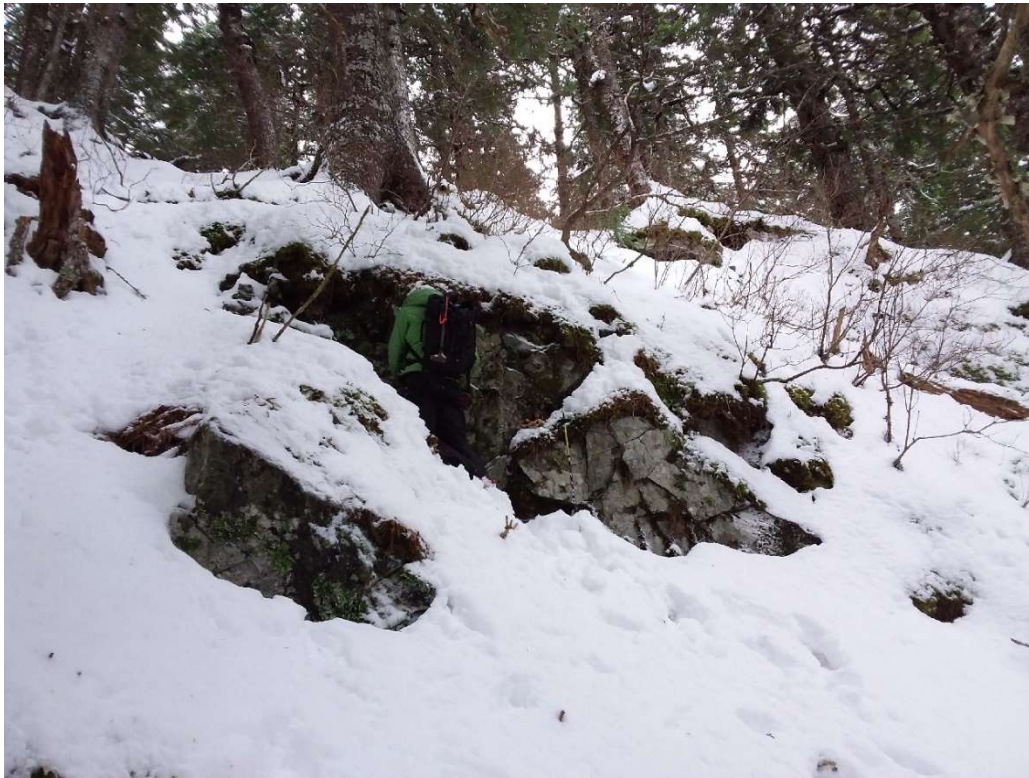
View looking southwest at rock outcrop above the prominent rock knob just east of the slide. The rock appears to be in place (taken 2/26/2021).

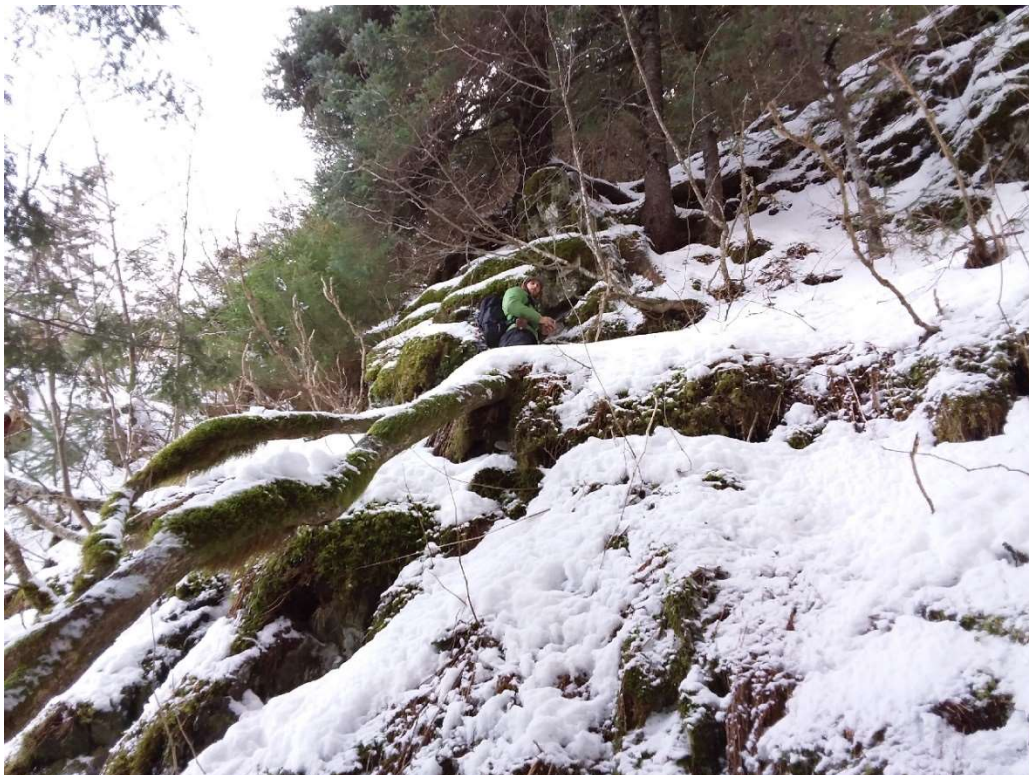
View looking southeast at rock outcrop at the base of the prominent rock knob just east of the slide. The rock appears to be in place (taken 2/26/2021).

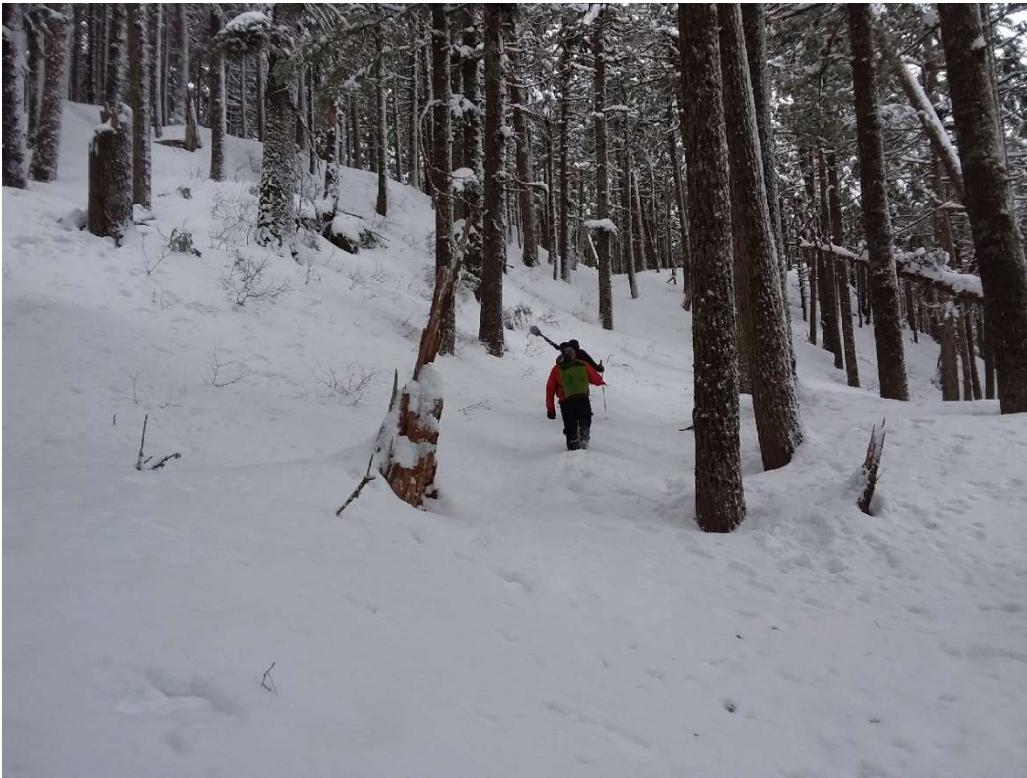
View looking west at a bench feature above and further east the eastern most prominent rock knob (east of the slide area). The elevation of this feature is approximately 900 feet (taken 2/25/2021).

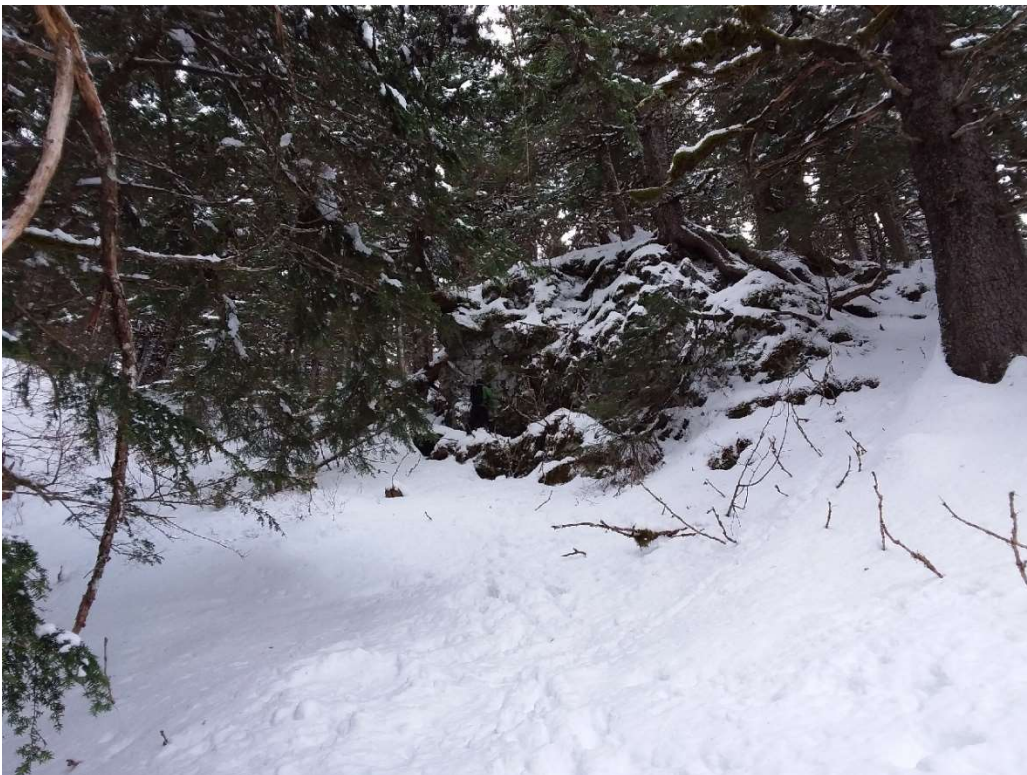
View looking southeast at a rock outcrop at the top eastern most prominent rock knob (east of the slide area; taken 2/26/2021).

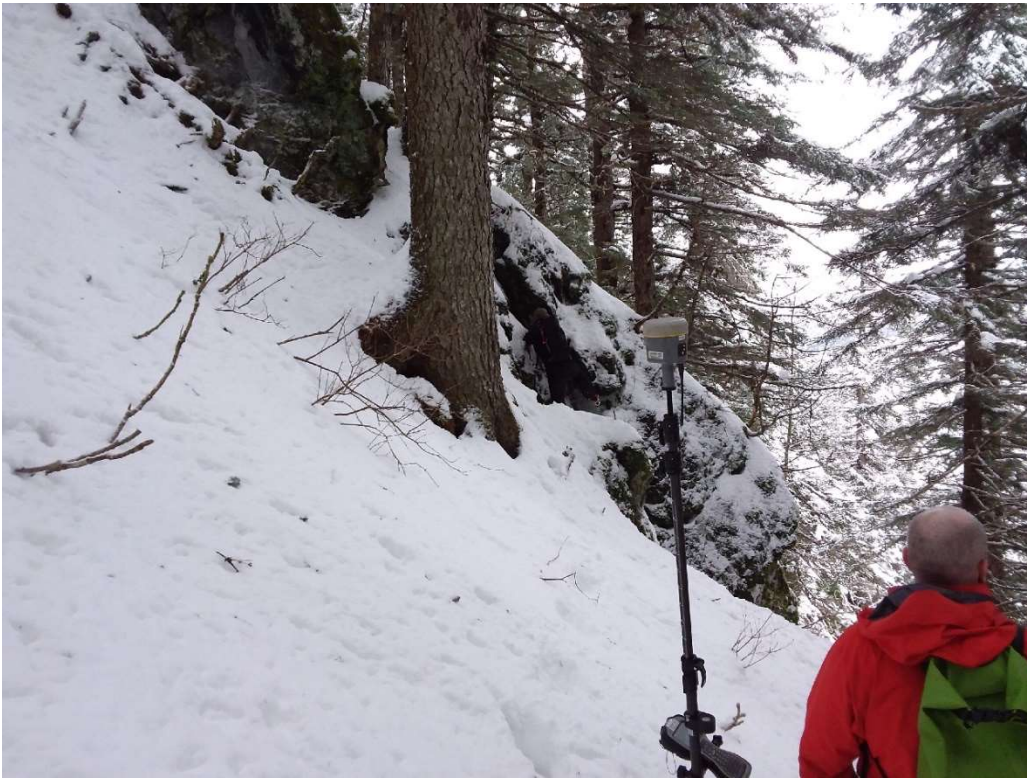
View looking east at the base of the eastern most prominent rock knob (east of the slide area; taken 2/25/2021).

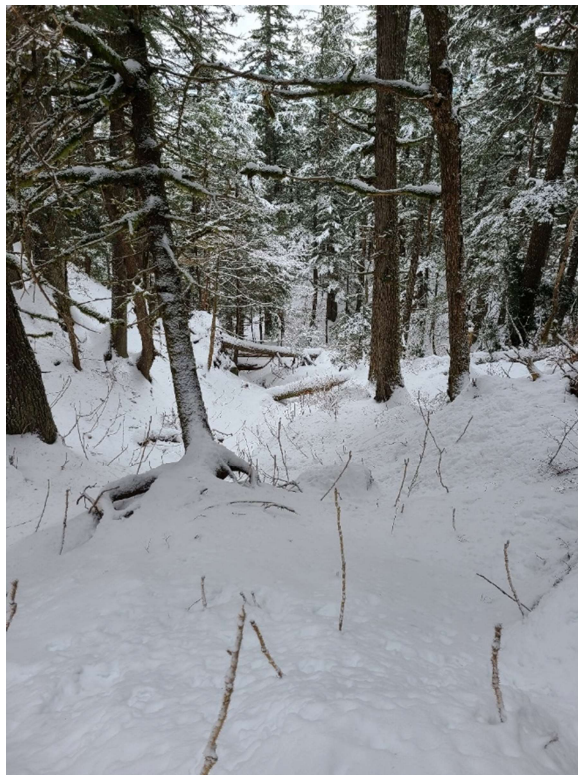
View looking north at the major drainage channel located on the eastern edge of the "Area of Concern" (taken 2/25/2021).

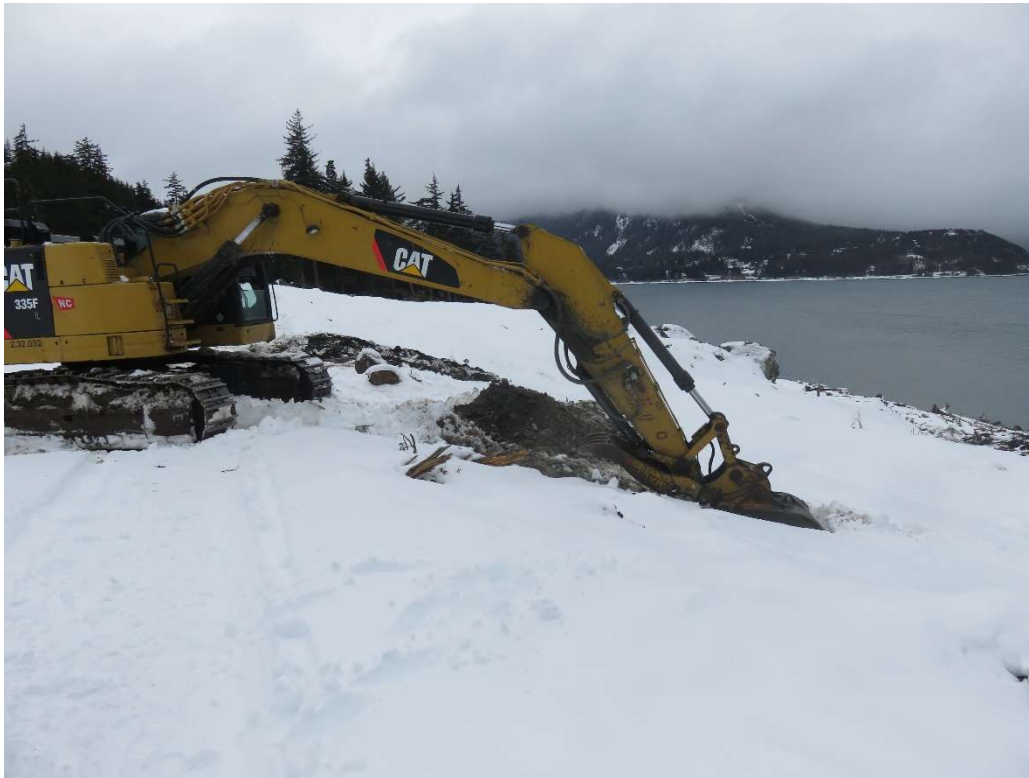
View of excavator excavating a test pit (TP-2) on the east end of the temporary access road (taken 2/27/2021).

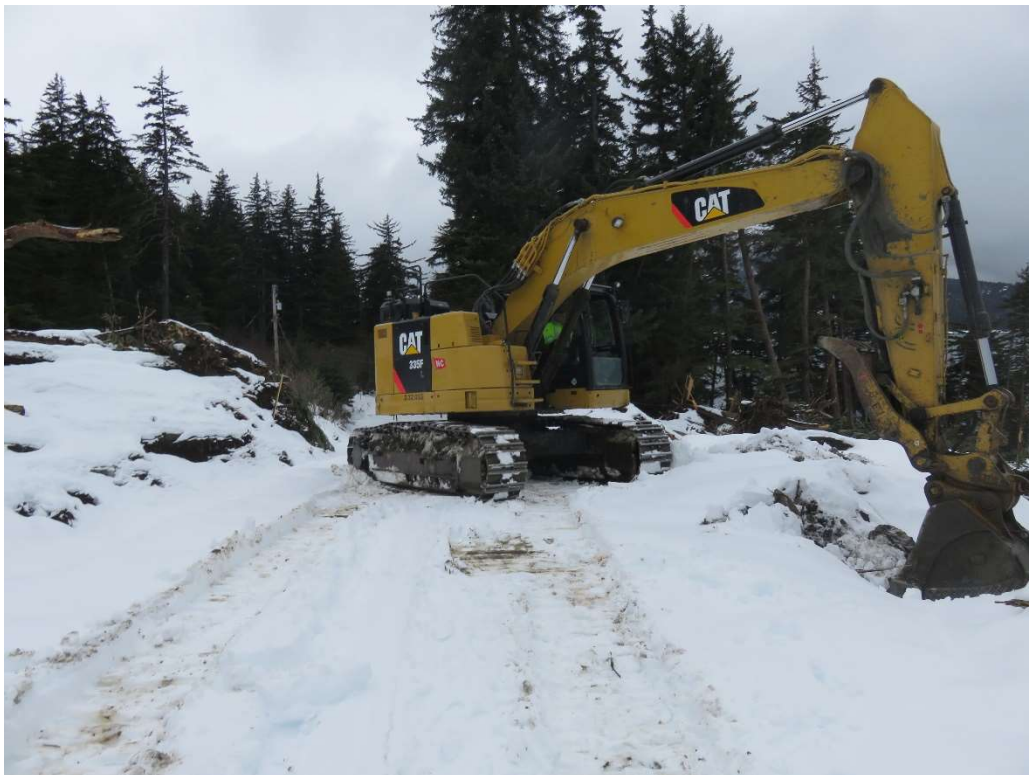
View of excavator excavating a test pit (TP-4) on the west end of the temporary access road (taken 2/27/2021).

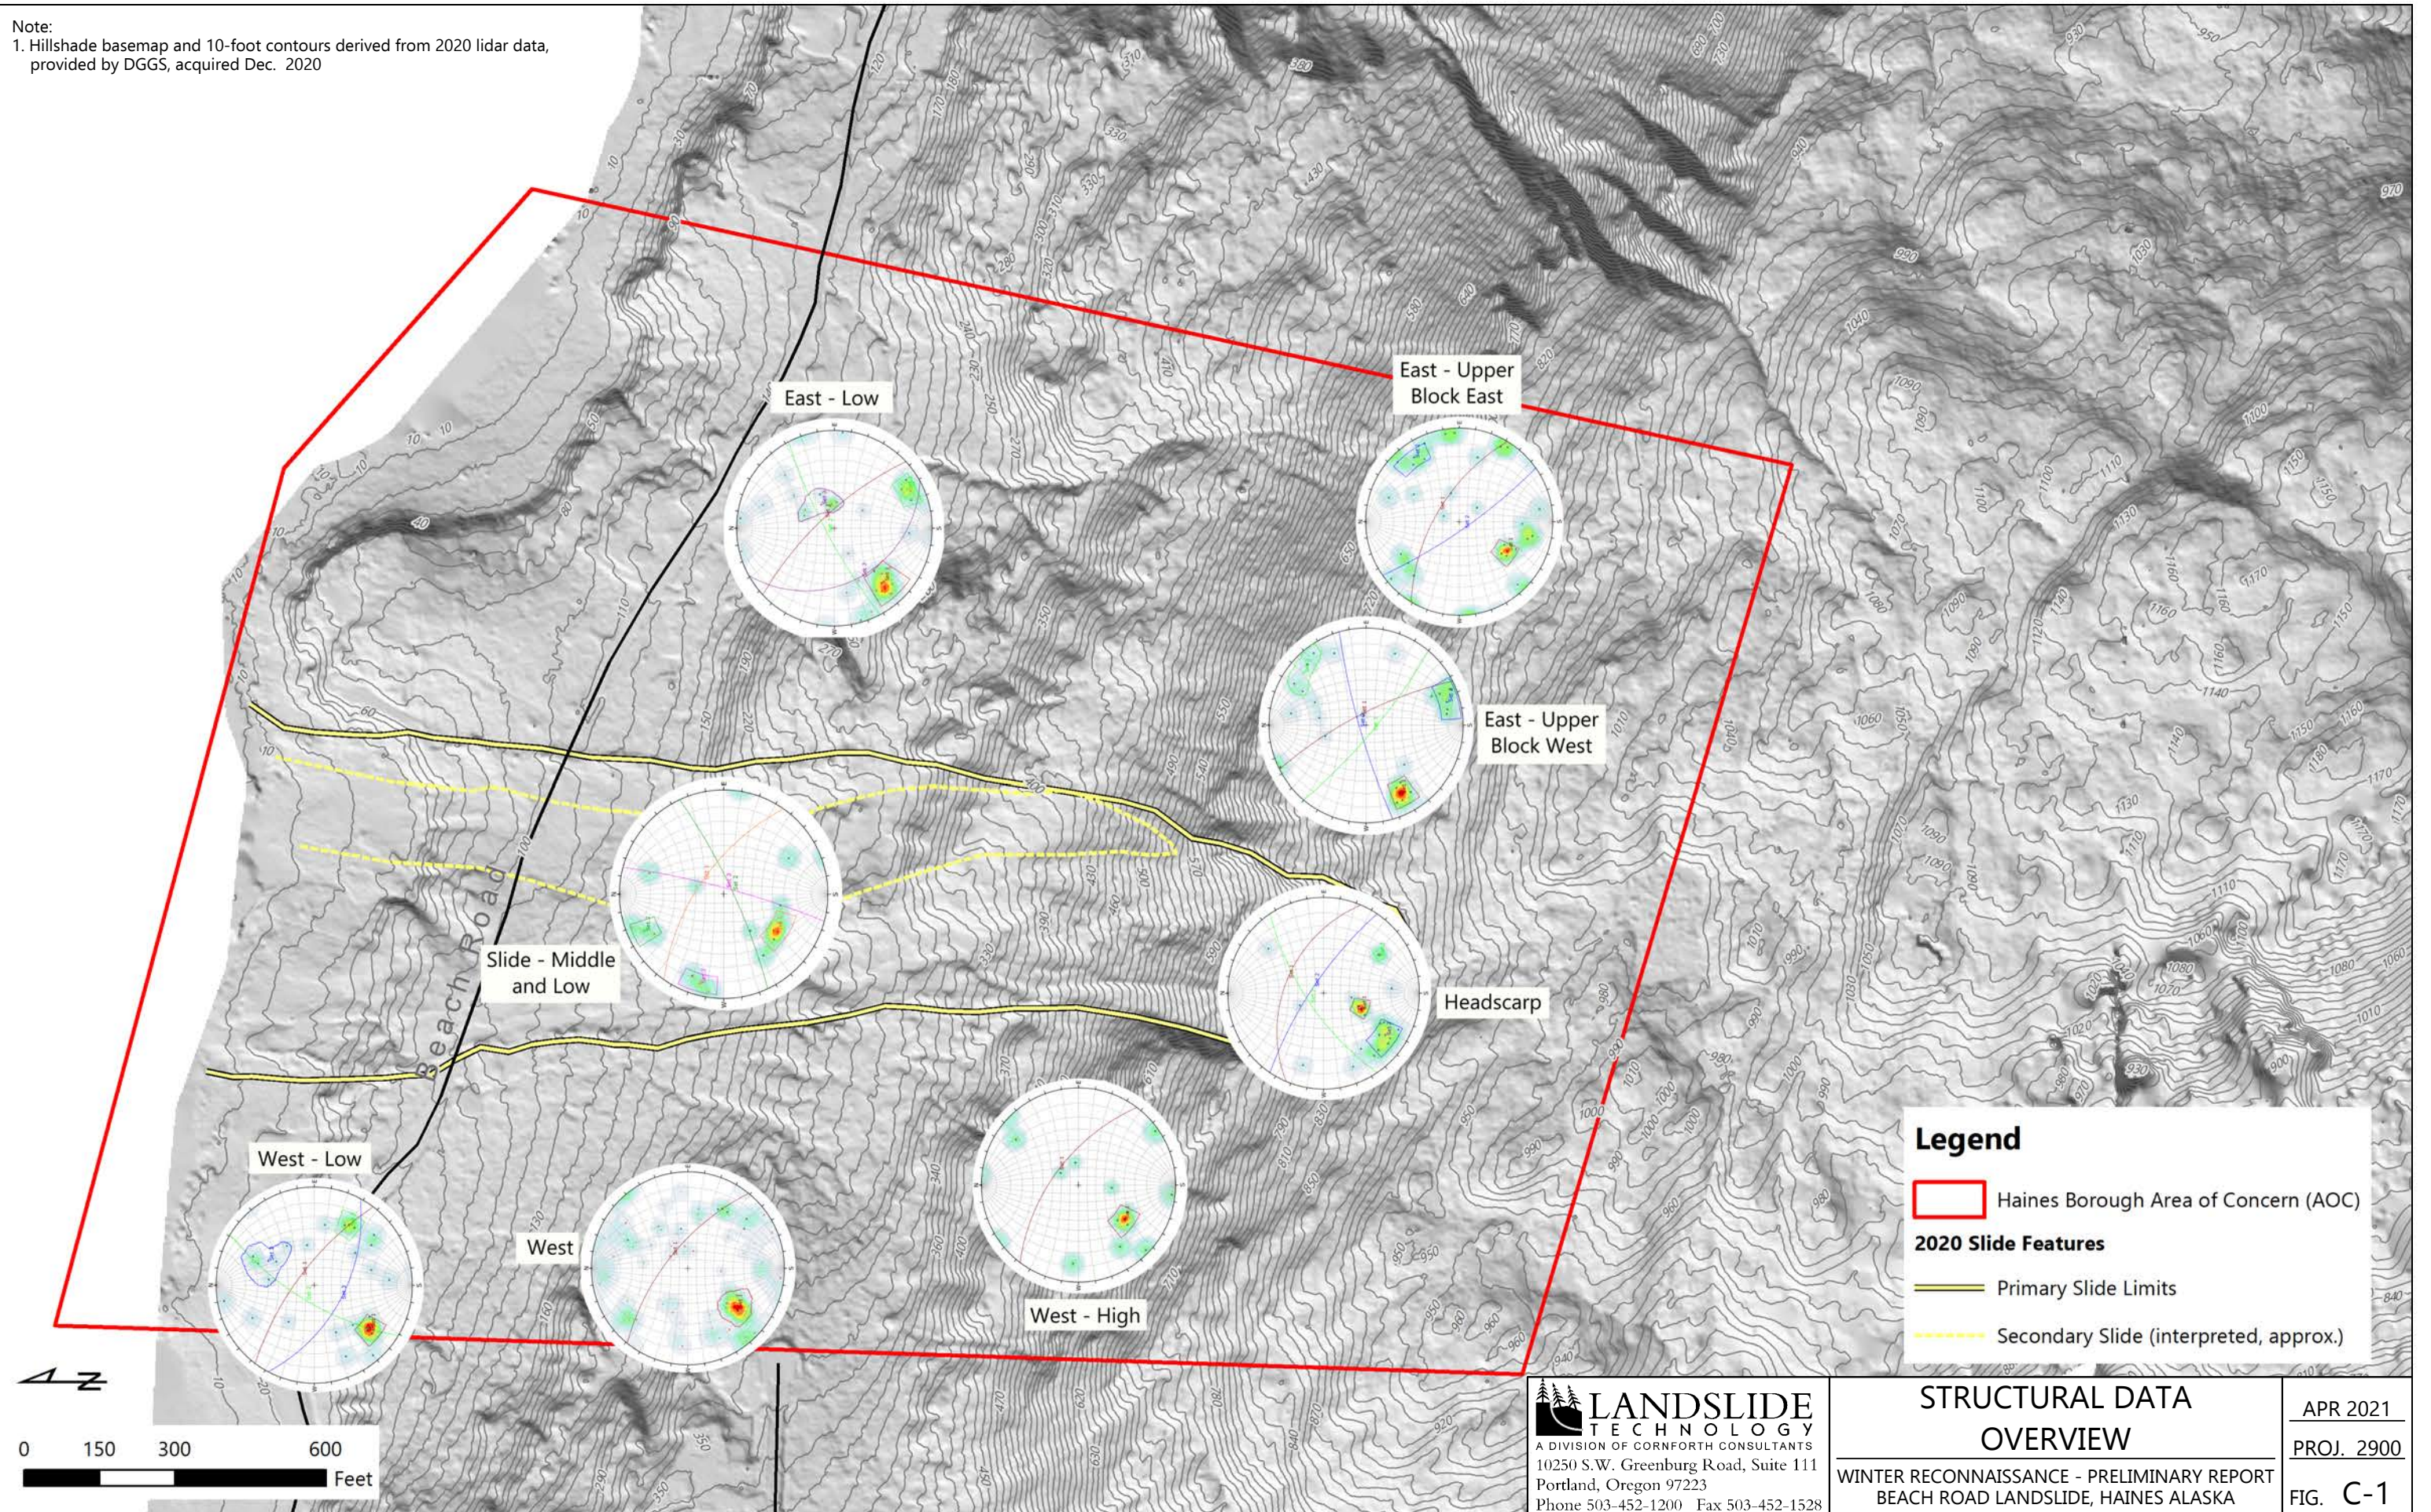
APR 2021
 PROJ. 2900
 FIG. C-1

The spatial distribution of the geologic conditions across the site are illustrated on a Figure found in this Appendix C. Joint Set 1 can be seen in all of the stereonet across the site. Sets 2, 3, and 4 were not seen as consistently as Set 1. However, at least one of these sets were present at all of the data collection locations.

The kinematic analyses considered slope angles from 35 to 52 degrees at slope dip directions from 008 to 024 degrees, depending on the locations data was collected (see attached Figure C-1). A friction angle of 40 degrees was used for all analyses. With the estimated slope geometry and friction, the kinematic analyses suggested that direct toppling would be the most prevalent potential failure mode. Planar sliding, wedge sliding and flexural toppling were all shown to have a very low potential. Stereonets showing the kinematic analyses are provided in this Appendix C.

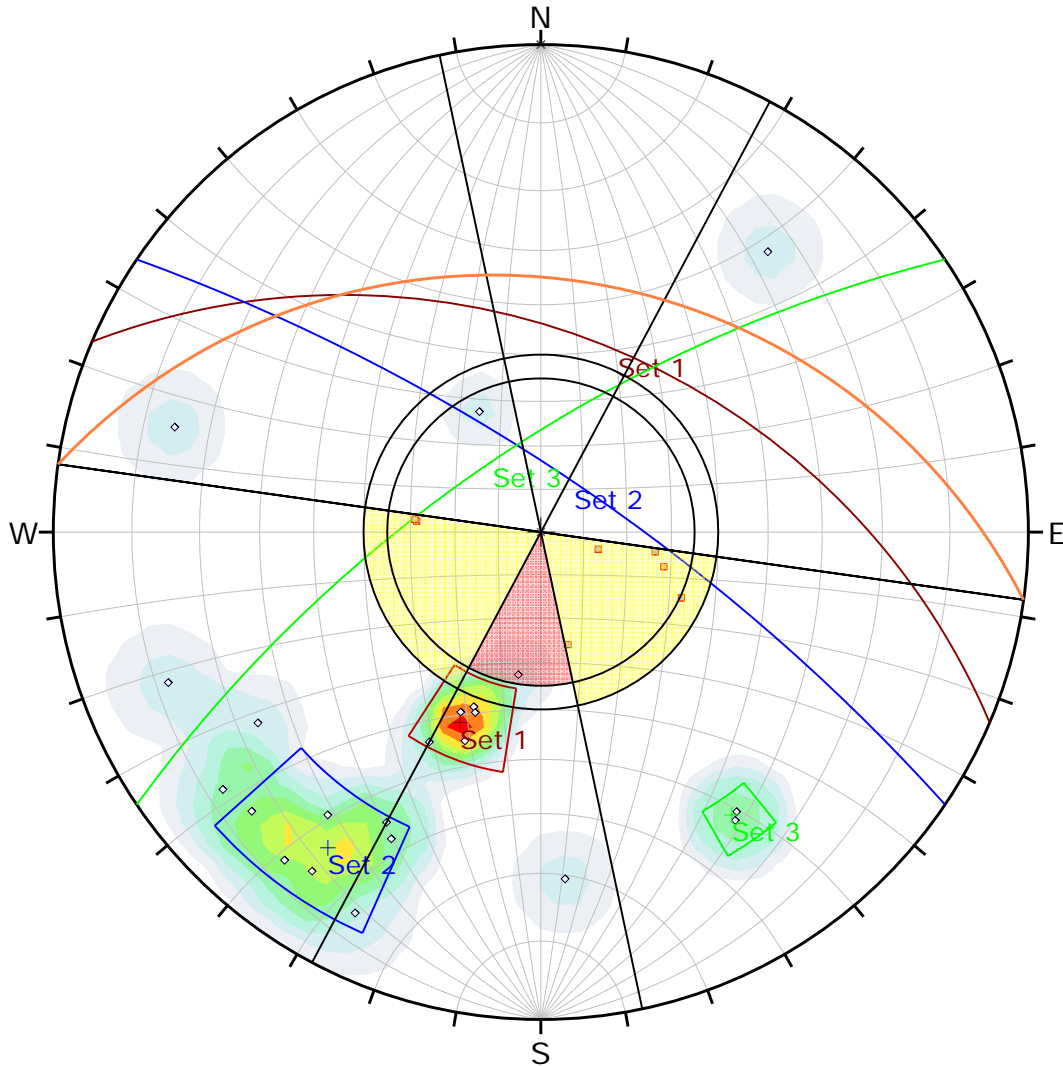
Project	Haines Slide Emergency Response		
Analysis Description	East - Upper West Block - Wedge Analysis		
Drawn By	SWD	Company	LT
Date	3/16/2021	File Name	East_UpperBlock_West_Wedge.dips8
