Winter Reconnaissance - Preliminary Findings Report Beach Road Landslide, Haines, Alaska

**WINTER RECONNAISSANCE
PRELIMINARY FINDINGS REPORT**

**BEACH ROAD LANDSLIDE
HAINES, ALASKA**

April 8, 2021

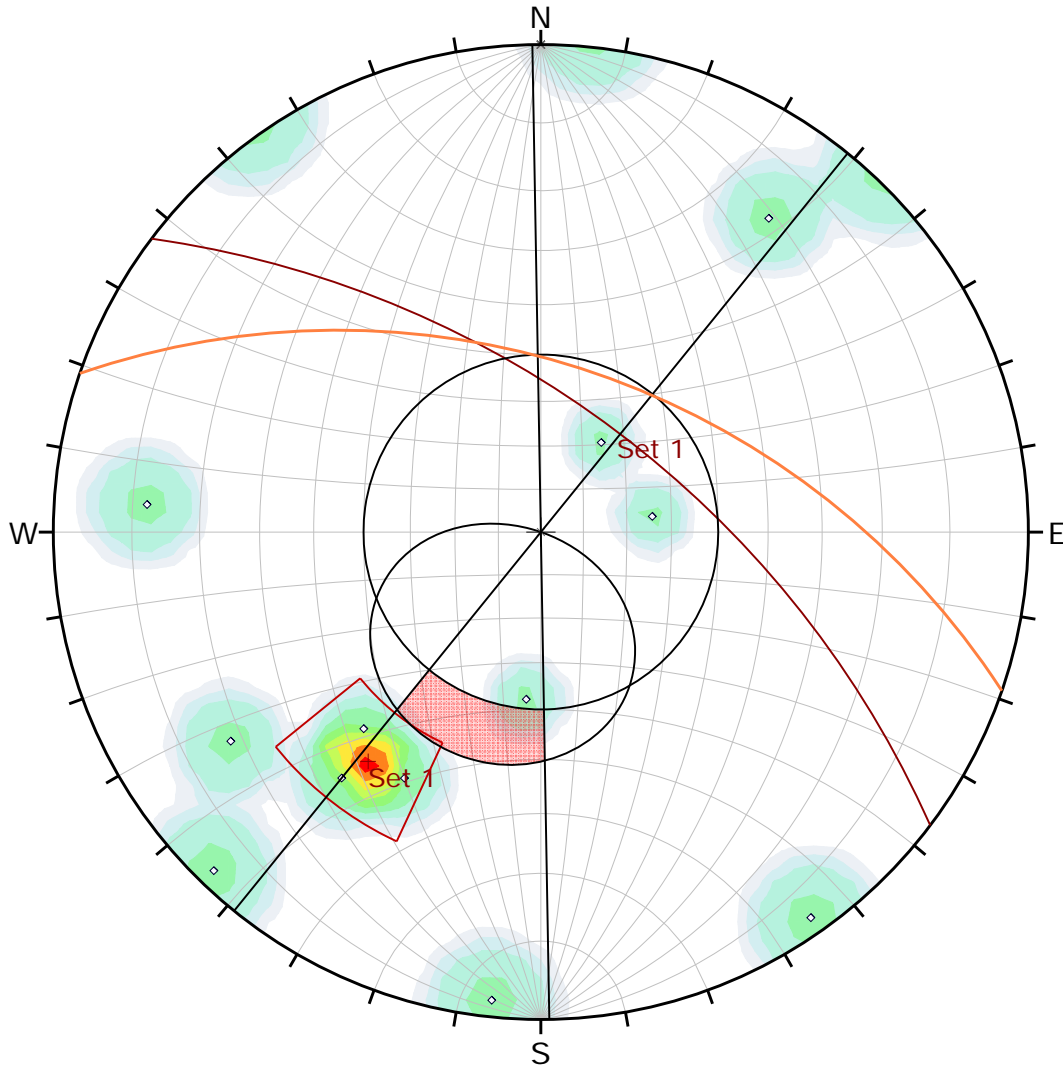
Project	Haines Slide Emergency Response		
Analysis Description	West - High - Flexural Toppling Analysis		
Drawn By	SWD	Company	LT
Date	3/16/2021	File Name	West_High_FlexuralToppling.dips8

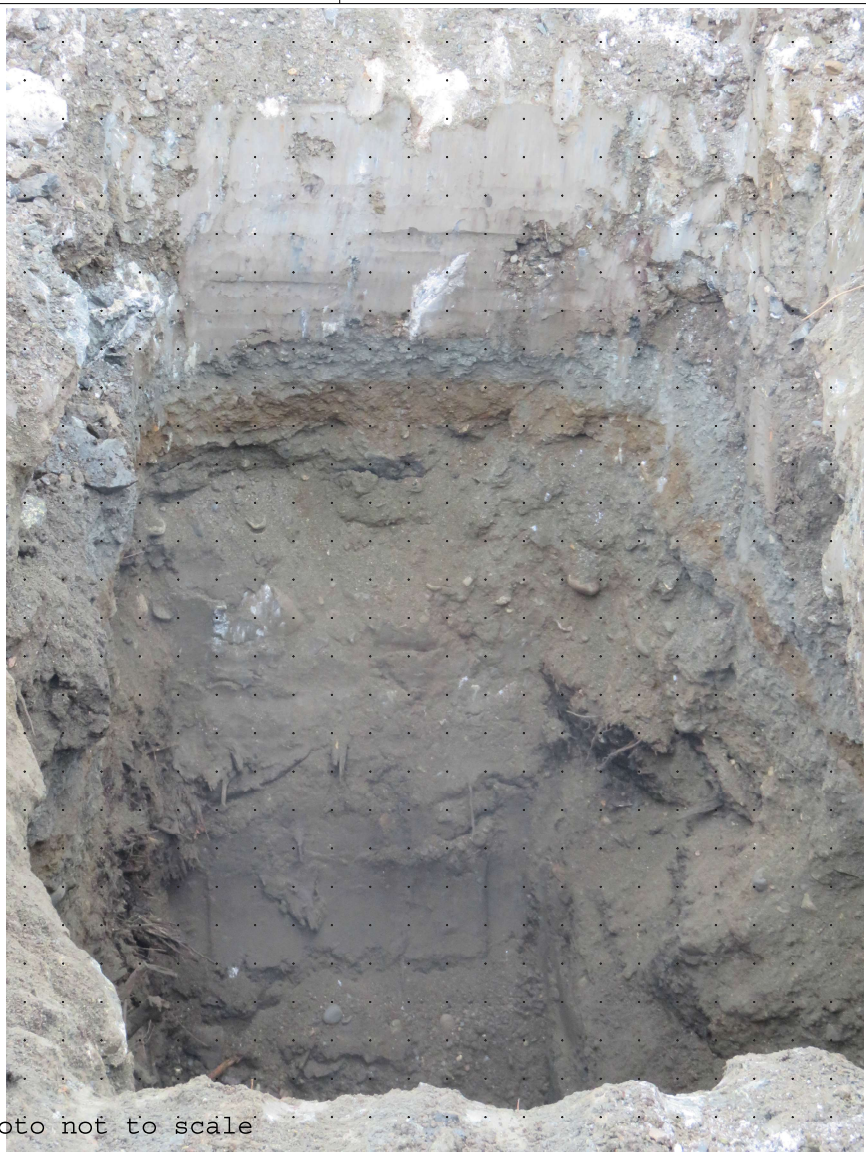
FIG. D-2

~2 ft snow (pit dug on down slope side of interim road).
Top of TP is 2 ft below interim road grade elevation.
~1 ft frozen ground.
Difficult excavation due to rocky conditions.
0 - 9 ft Very dense, grey, silty sand with angular rock fragments, gravel-sized to 2.5 ft boulders; scattered woody debris and roots, moist (Landslide Debris).
9 ft (6 to 9 in) Grey, crushed rock, 1-in minus (Original Road Surface)
Underlain by (9 in to 1 ft) brown, sl. silty sand with scattered rounded gravels (Road Base - Fill). This material is underlain by 1 to 1.5 ft of woody debris (Corduroy Road)
11.5 to 14 ft Loose to medium dense, brown, gravely sand, with round cobbles and boulders up to 3 ft in size, moist (Delta Deposits/Till?)
Refusal at 14 ft (Rock/Boulder?)

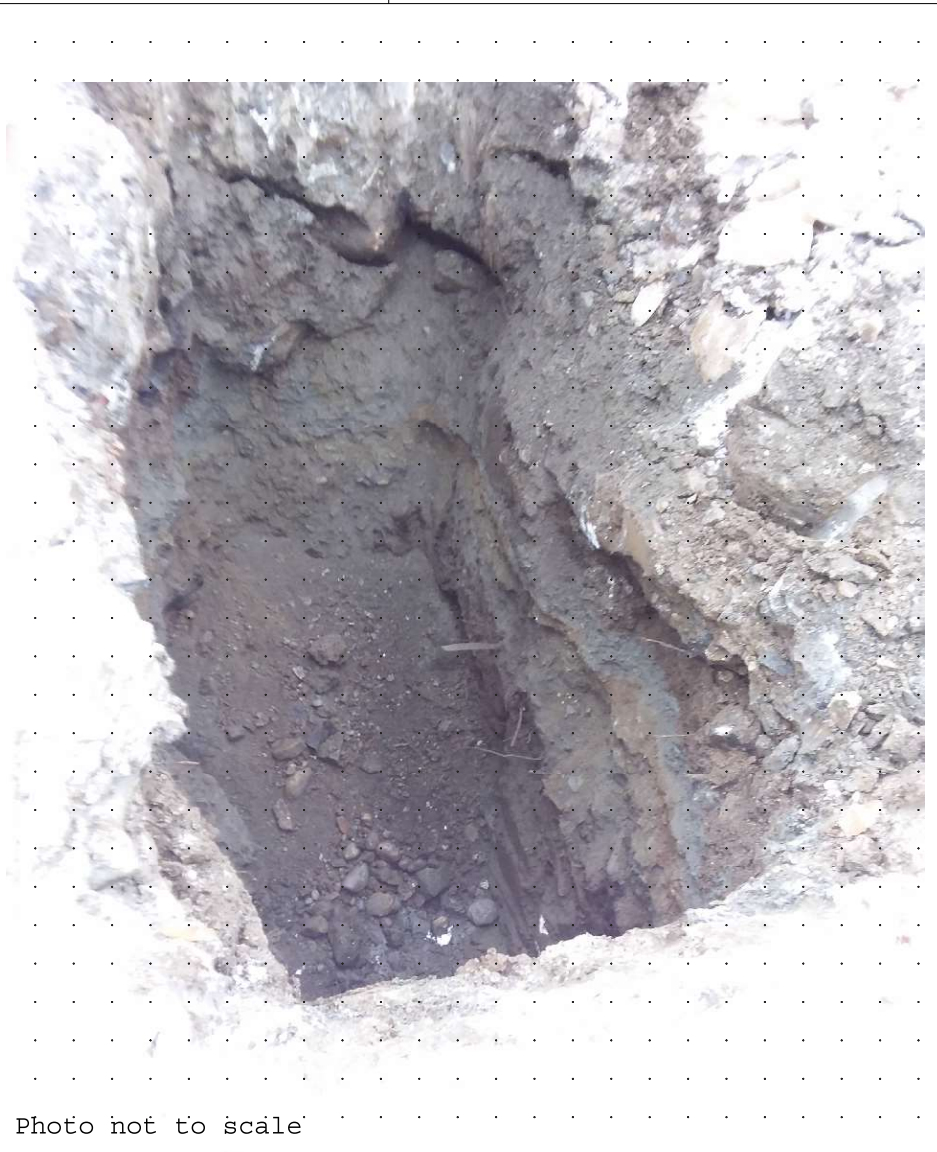
Top of TP is 3 ft below interim road grade elevation.
~2 ft frozen ground.
~Easy excavation.
0 - 9 ft Medium dense, grey, silty sand with angular rock fragments, gravel-sized up to 2 ft boulders; scattered woody debris and roots, moist (Landslide Debris).

9 ft (6 to 9 in) Grey, crushed rock, 1-in minus (Original Road Surface)
Underlain by (9 to 12 in) brown, sl. silty sand with scattered rounded gravels (Road Base - Fill). This material is underlain by 1 to 1.5 ft. of woody debris (Corduroy Road)
11.5 to 14 ft Loose to medium dense, brown, gravely sand, with round cobbles and boulders up to 3 ft in size, moist (Delta Deposits/Till?)
14 to 17 ft Very stiff, grey, slightly sandy, slightly clayey to clayey silt; scattered rounded gravel up to 3", moist, slight lenses to no observable structure, no observable organics but organic smell (Glacial Lacustrine/marine clay?)
17 to 18 ft Hard excavation. Gravel- to cobble-sized angular rock fragments. Refusal on rock and out of reach at 18 feet.

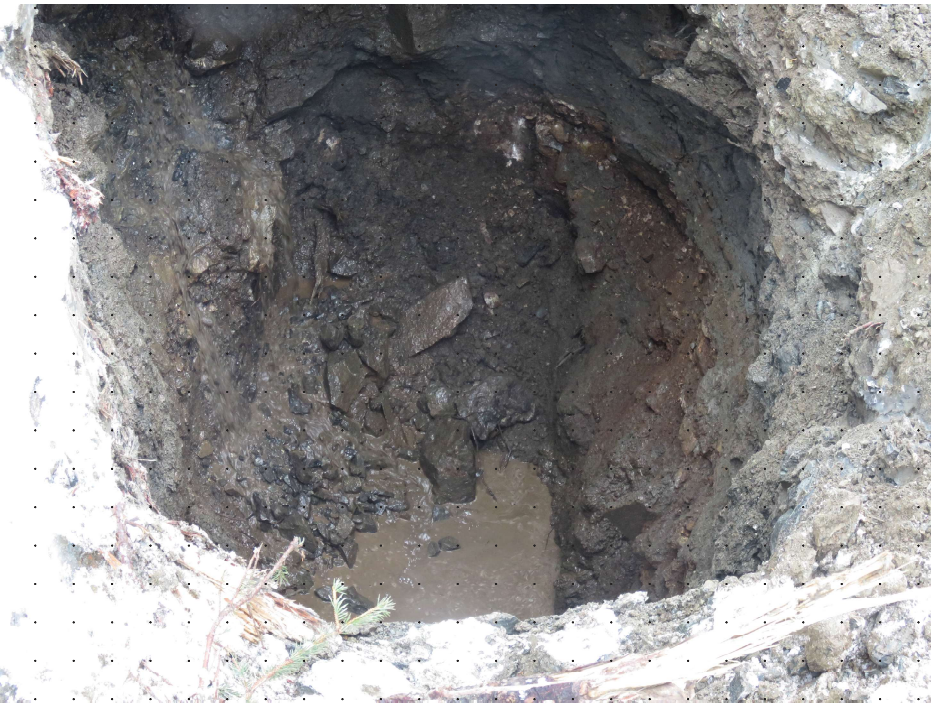
Top of TP is 3 ft below interim road grade elevation.
 ~1 ft frozen ground.
 ~Difficult excavation due to rocky material
 0 - 5 ft Dense to very dense, grey, silty sand with angular rock fragments gravel-sized up to 3 ft boulders; scattered woody debris and roots, saturated (Landslide Debris).
 At 5 ft seeping water into south side of the test pit. Believe water source was from ponding water in ditch on uphill side of interim road. Observed level of water in ditch drop.
 A grey and brown layer underlain by woody debris was observed in the pit below 5 ft. It is unclear if this the original road surfacing.
 Pit was saturated and caving due to inflow of surface or near surface water. Pit was excavated to a depth of 18 ft. Due to caving conditions, it is unclear what material was encountered at depth.
 Most of the material appeared grey, silty sand with angular and sub-rounded rock fragments (Landslide Debris or Delta Deposits/Till?)

Terminated pit due to lack of reach and caving conditions.

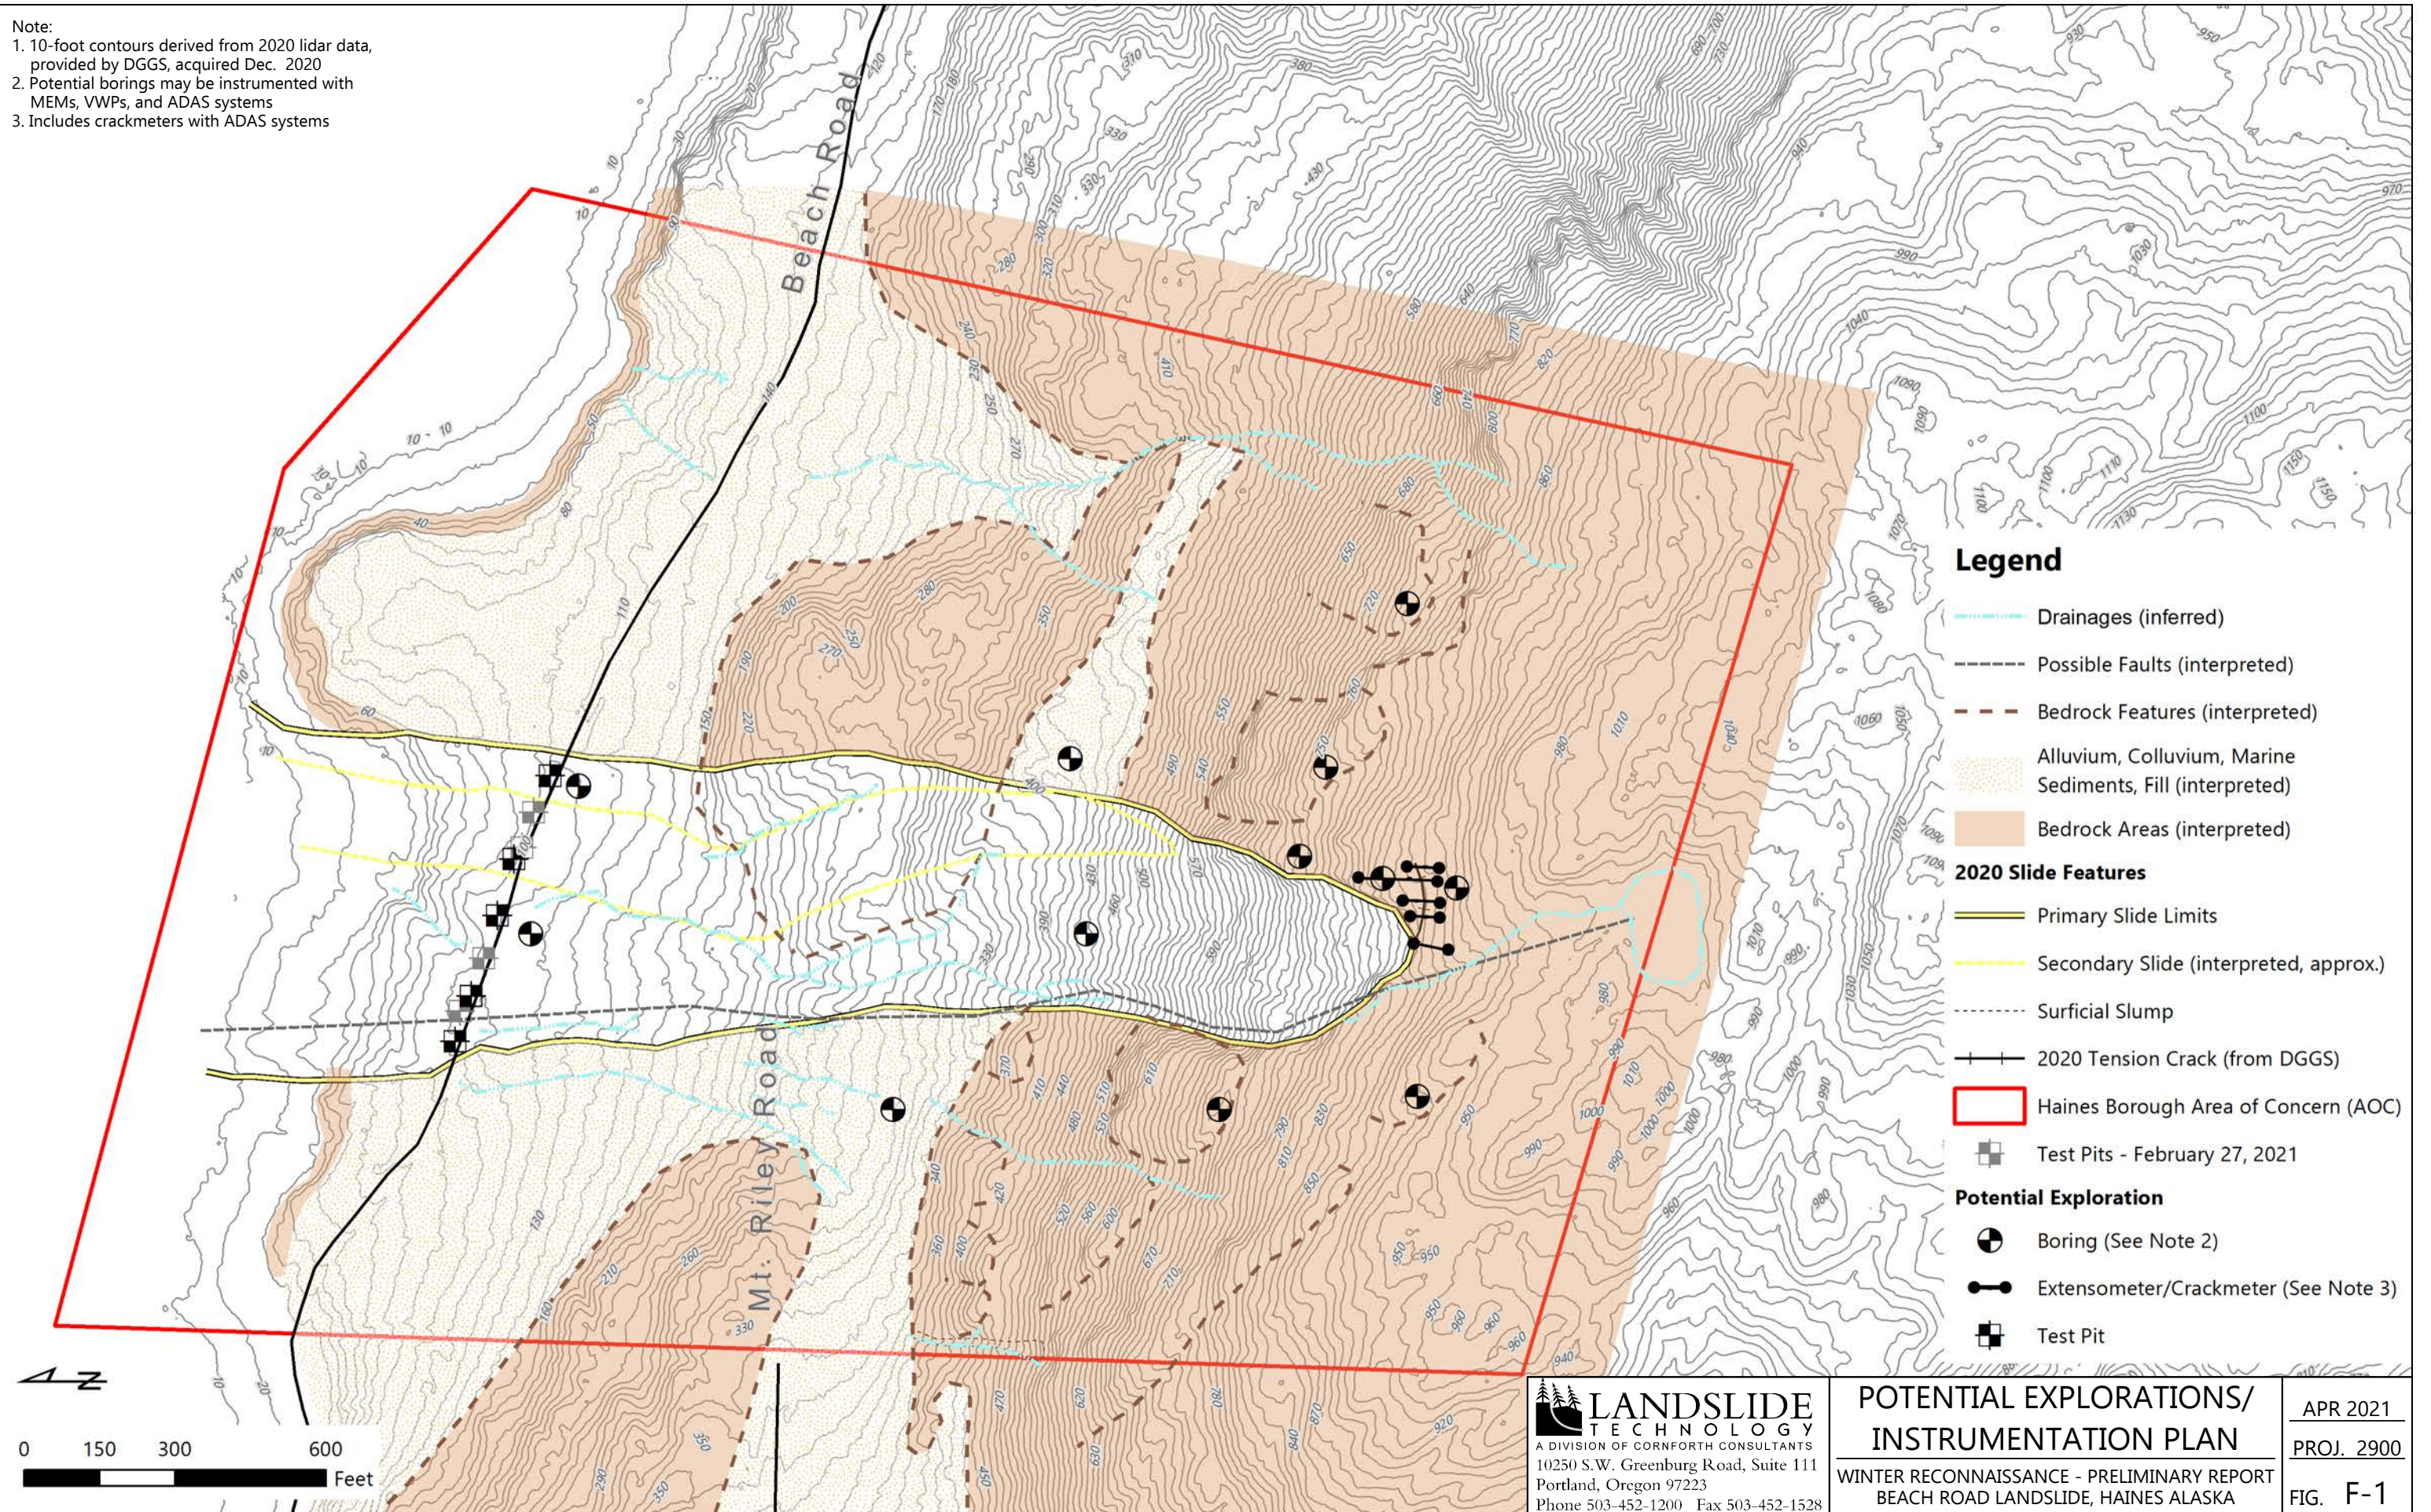
- Note:
1. 10-foot contours derived from 2020 lidar data, provided by DGGs, acquired Dec. 2020
 2. Potential borings may be instrumented with MEMs, VWP's, and ADAS systems
 3. Includes crackmeters with ADAS systems

4. Surface extensometers could be used to determine if the ground downslope of the east tension crack displaces. The surface extensometers consist of long-range displacement digital transducers with wire cables extending from fixed positions upslope of tension cracks to positions downslope areas within suspected slide blocks or marginally-stable slopes.
5. Tell-tale stakes could be established upslope of the headscarp along lines to roughly visualize and measure the amount of scarp calving over time (landslide retrogression). The stakes and distances of retrogression would be periodically monitored and measured manually.
6. All digital instruments should utilize automated data acquisition methods, which would need power supplies and telemetry.
