RE: DR-4585 PW 13 - FEMA Questions for Porcupine Road (EHP RFI)
Response to 9/20/2023 Request for Information

Completed Work, Phase I (Scope of Work Details):

Attachment A – Start/Stop GPS Points for Third-Party and Porcupine Trail Road Phase I Work

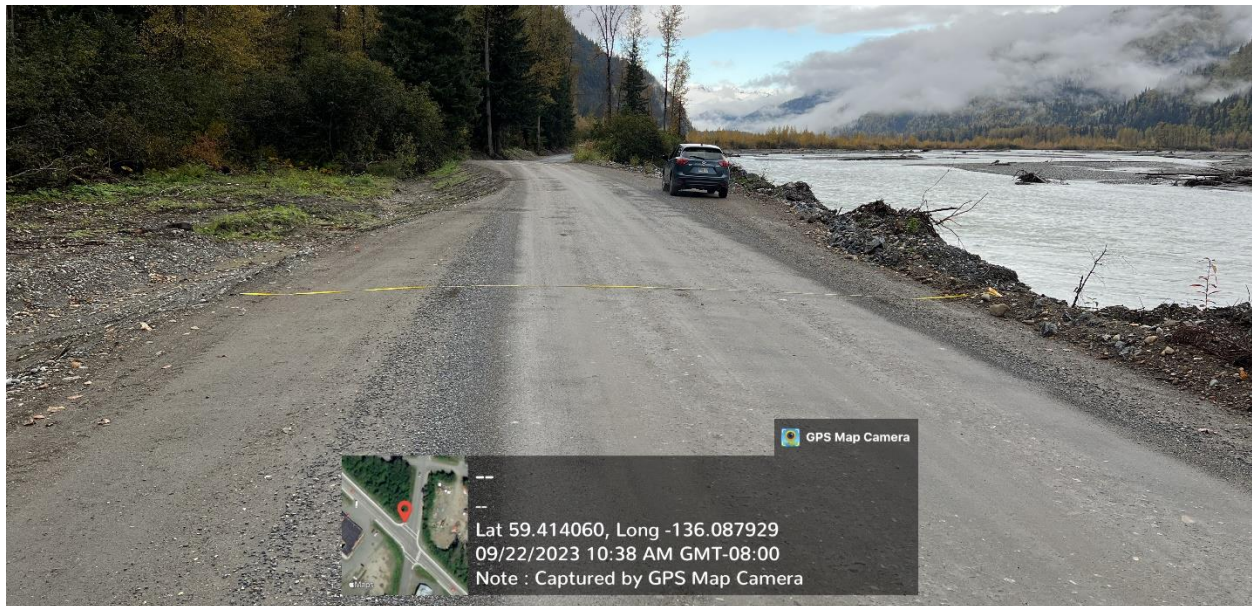
Figure C.6 – Cross section of third-party work site 2 fill area on Porcupine Trail Road, outside of Phase I work limits. Edge of shoulder to edge of shoulder width is 28' at this location (including pullout), and width to outside edges of travel lanes (driving surface) is 16'. Third-party work at this site was placement of 3' fill only – no gravel surfacing or riprap materials were placed. Fill was placed within the limits of the existing roadway corridor shoulders/berms. Photos of measurements can be provided upon request.

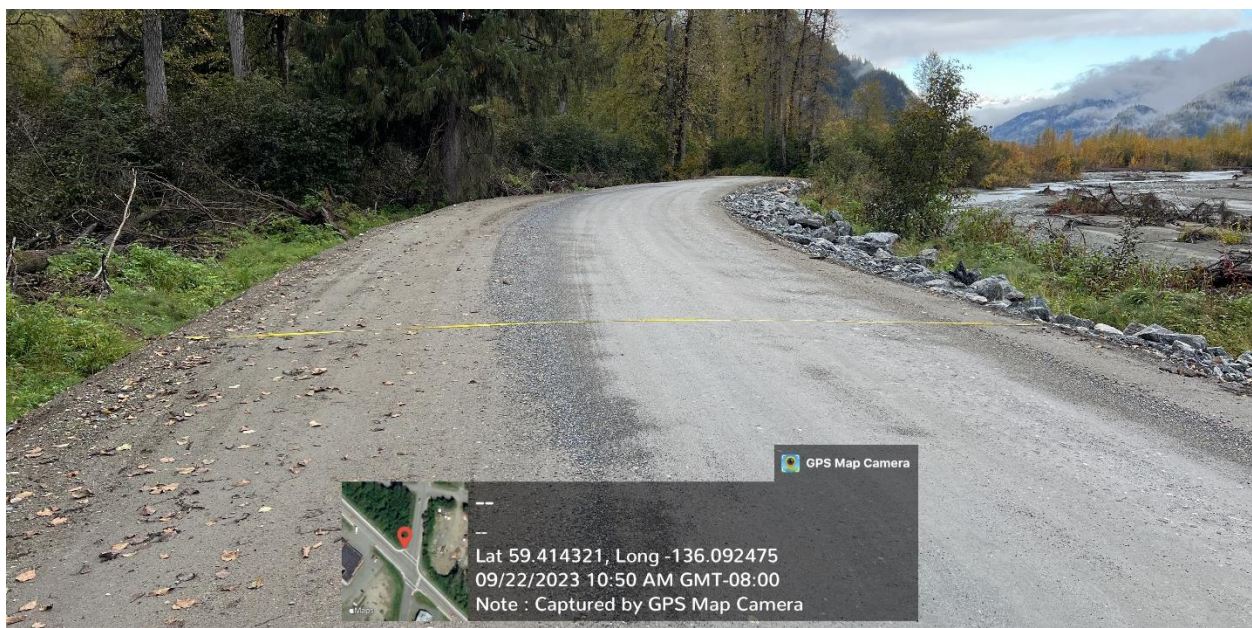
Figure C.7 – Cross section of third-party work site 3 fill area on Porcupine Trail Road, outside of Phase I work limits. Edge of shoulder to edge of shoulder width is 28' at this location (including pullout), and width to outside edges of travel lanes (driving surface) is 15.7'. Third-party work at this site was placement of 3' fill and some riprap above ordinary high water – no gravel surfacing materials were placed. Fill was placed within the limits of the existing roadway corridor shoulders/berms. Photos of measurements can be provided upon request.

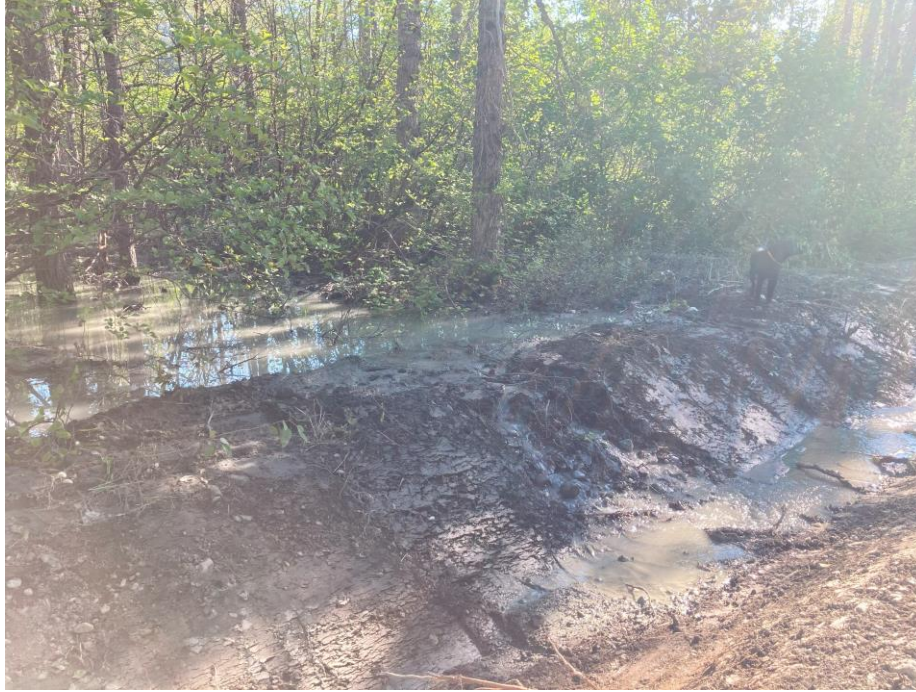
Water coming into the cleaned ditches

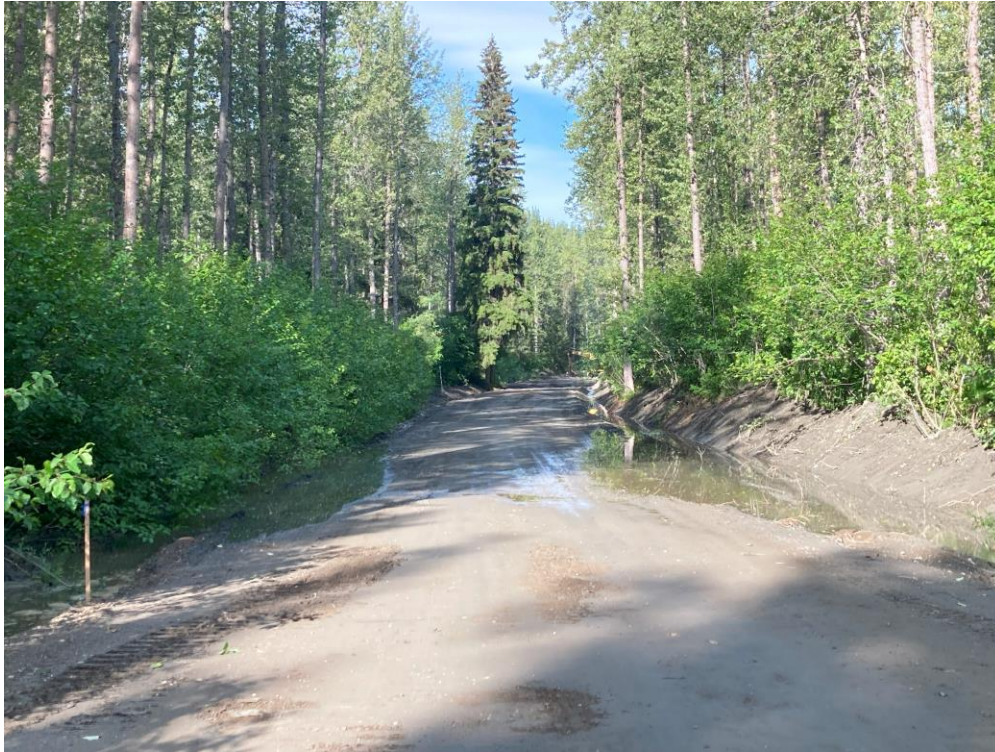
The one area today that overflow exceeded ditch line

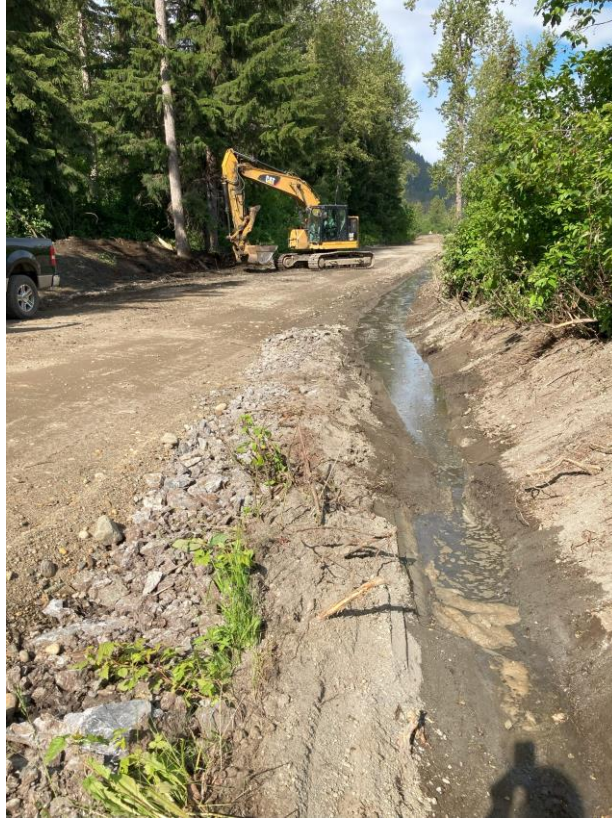
Water level down in ditch, from yesterday

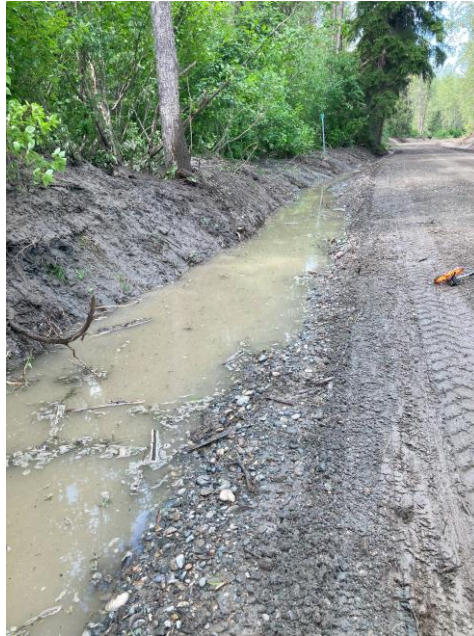
2 mi. marker ditch line with water

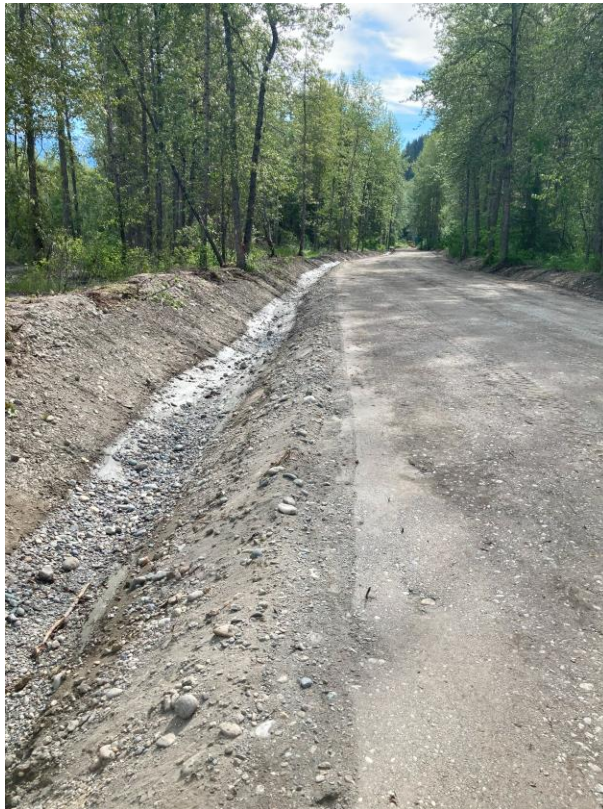
Water line from yesterday

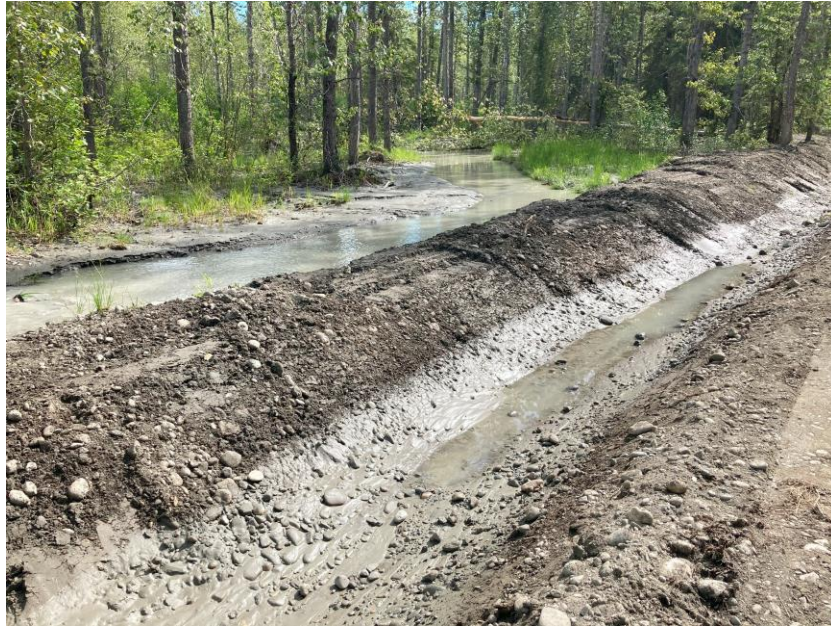
Water flow above the right ditch

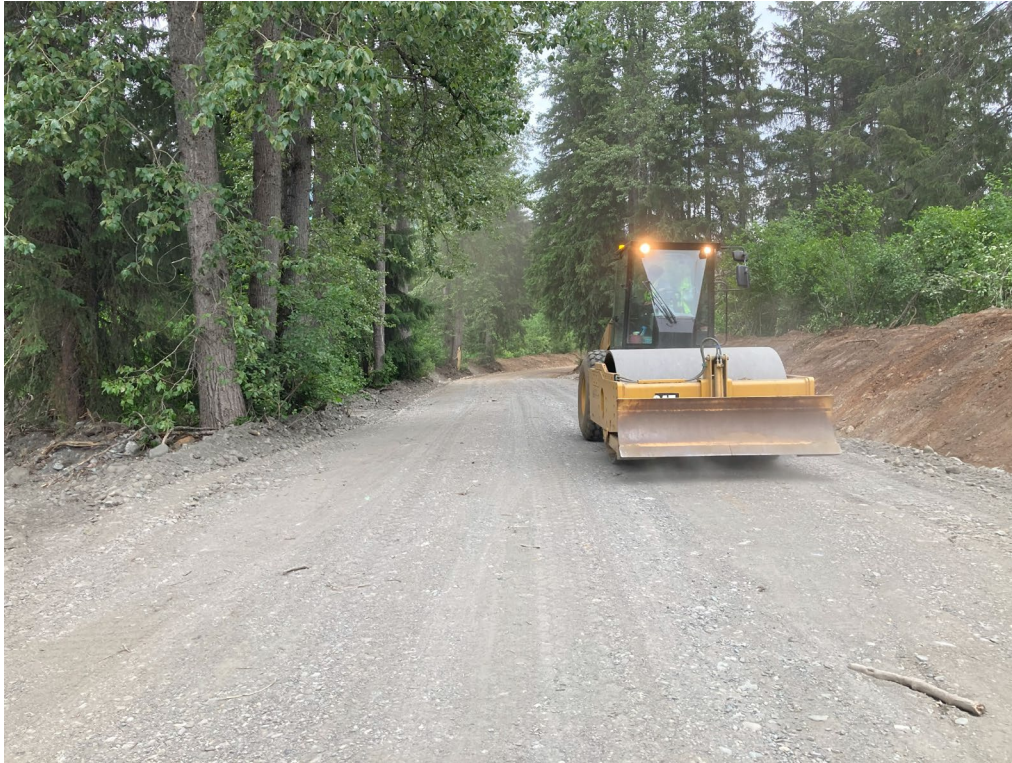
Last day of Reconditioning, Roadbed and Shoulders

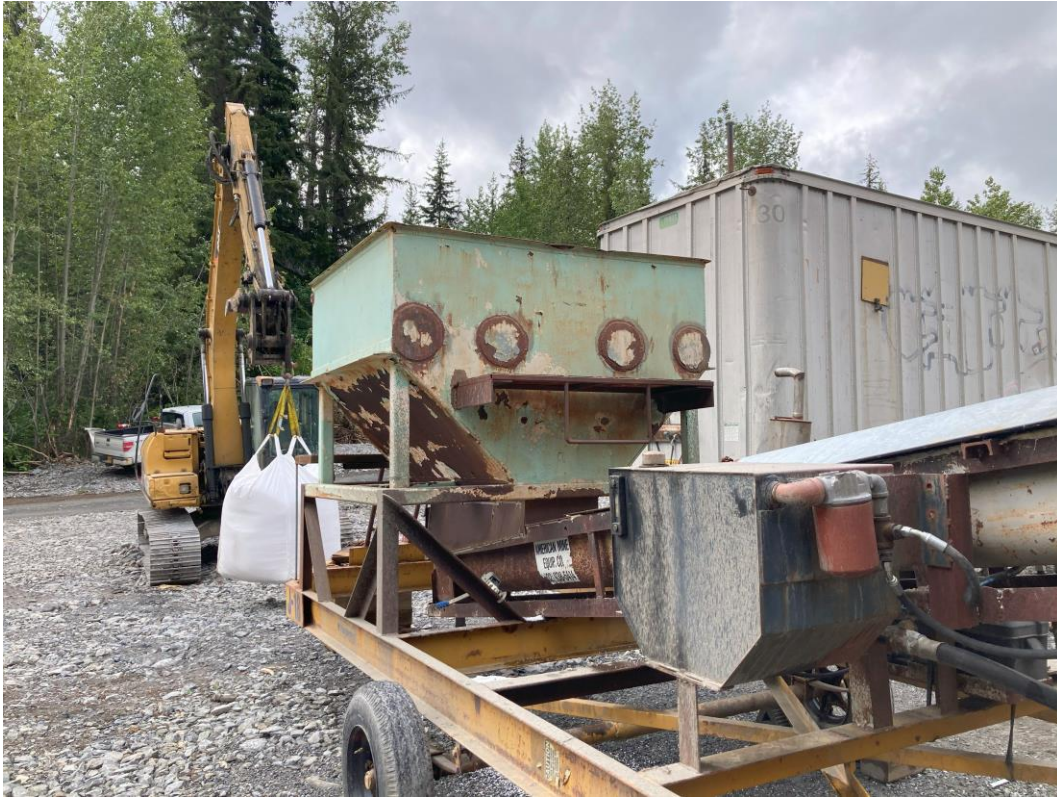
Calcium Chloride added to belt through screw feeder

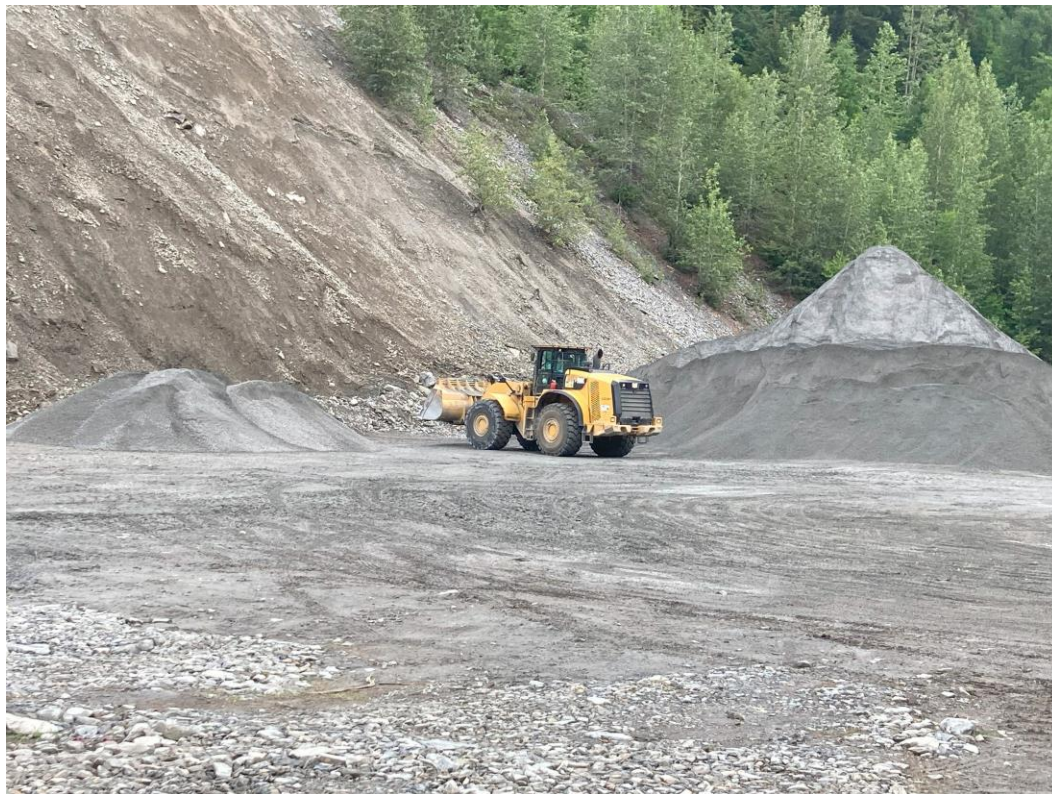
10 am E1 stockpile with Calcium Chloride

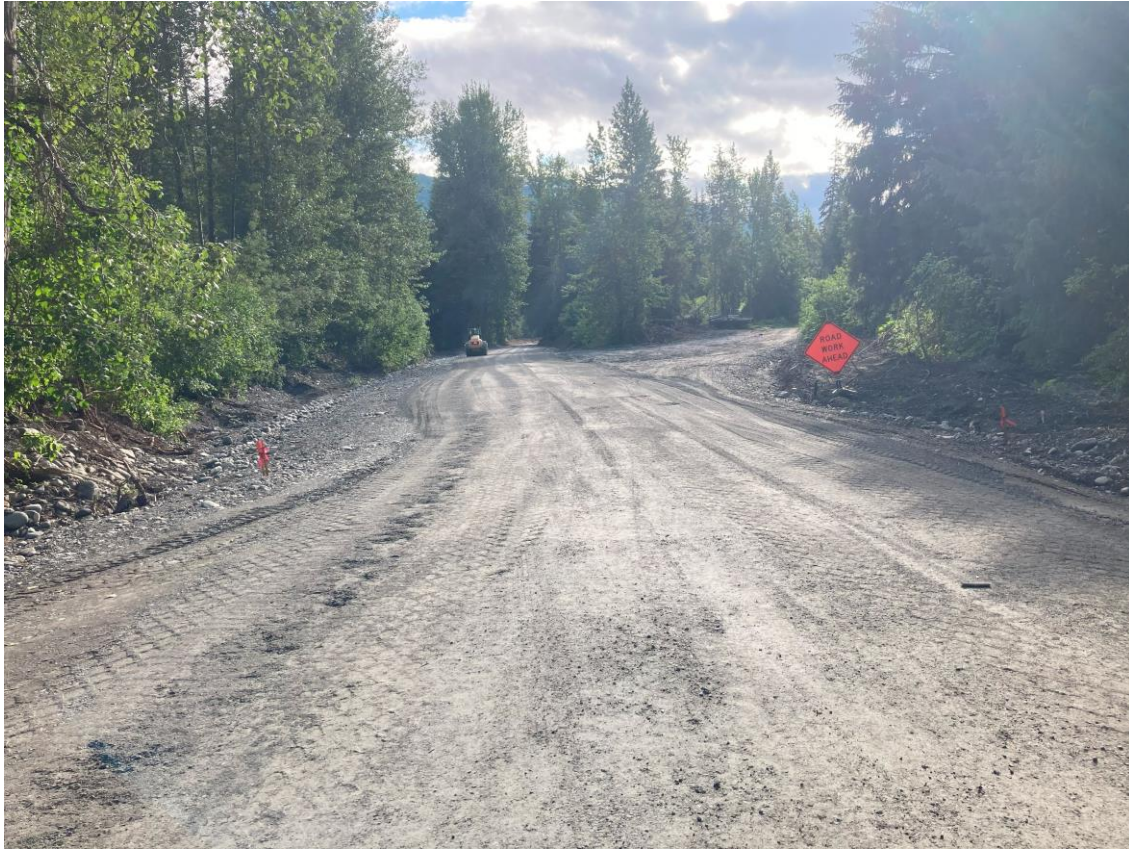
Cat 663E Roller finishing up the first lift of E1

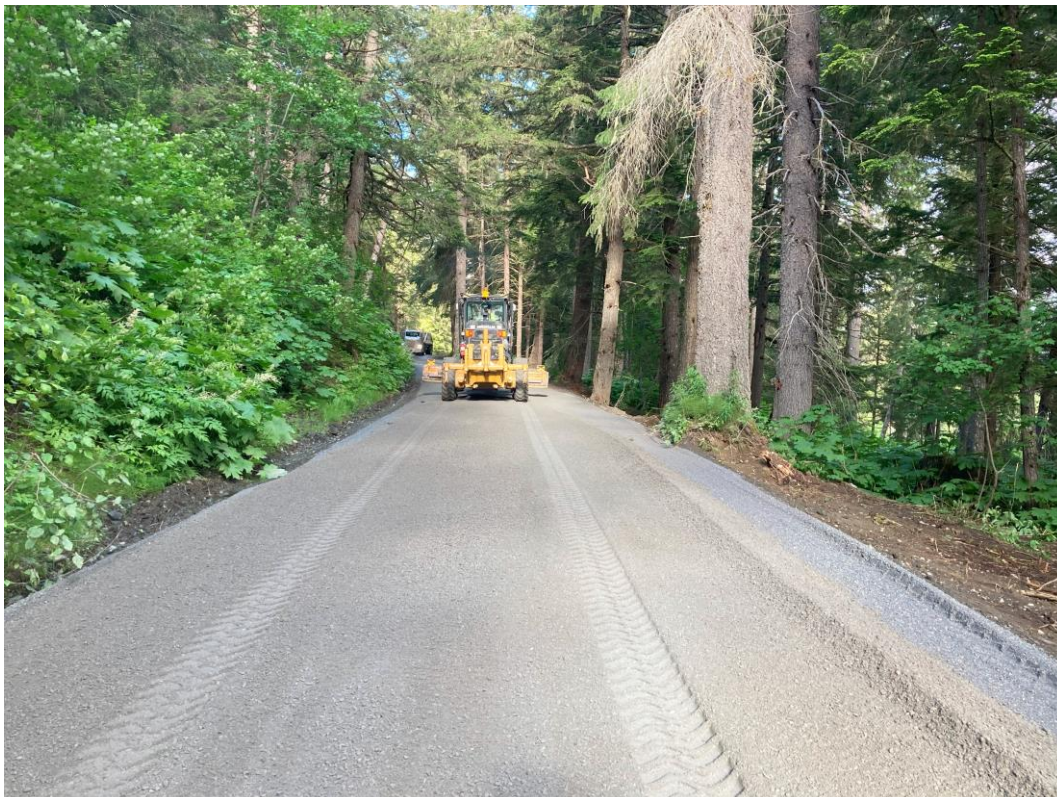
Cat 12 Grader set back to beginning of last section to start the 2nd lift with Calcium Chloride

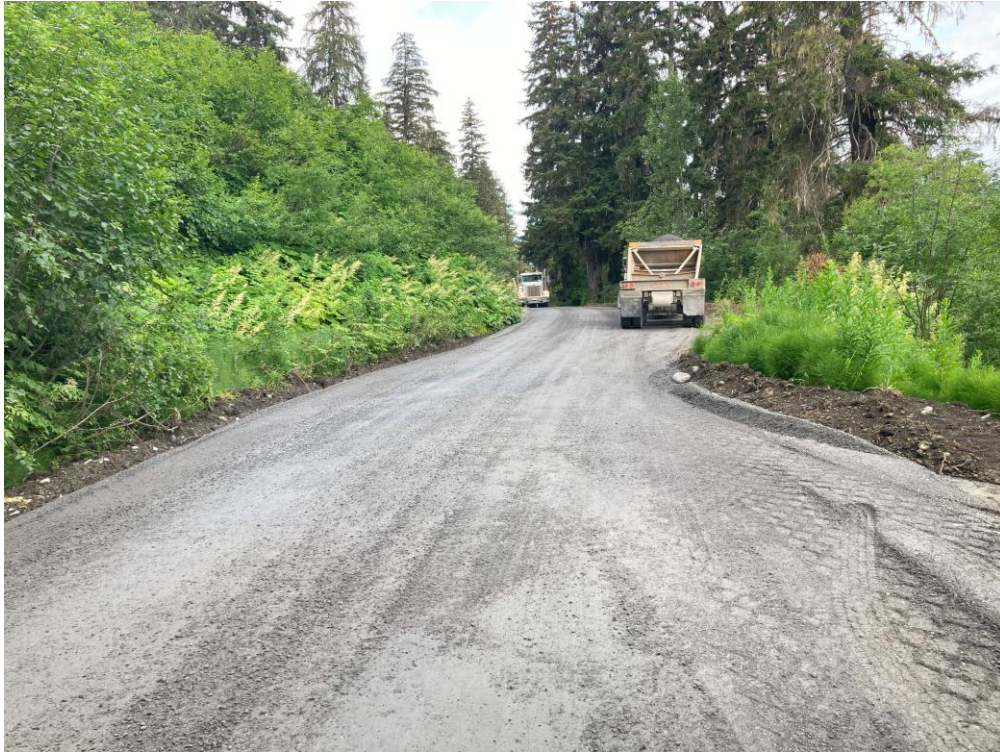
5.9 mile from B□P Calcium Chloride material haul

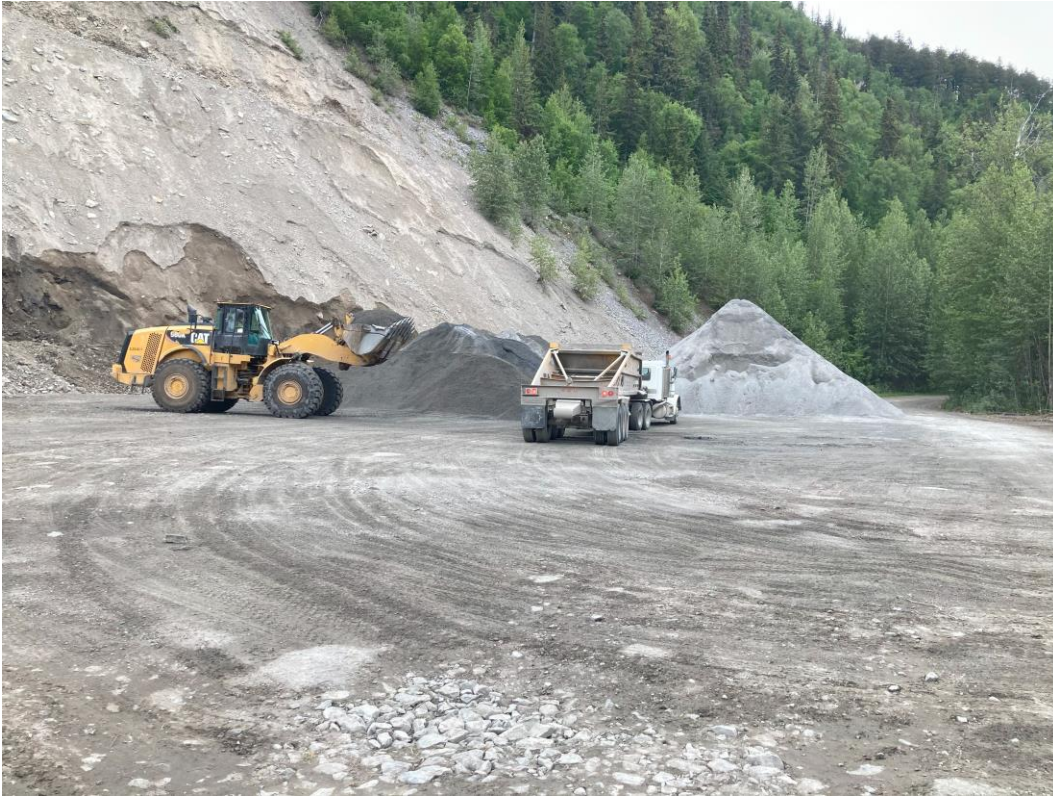
Calcium Chloride material stockpile is running low.

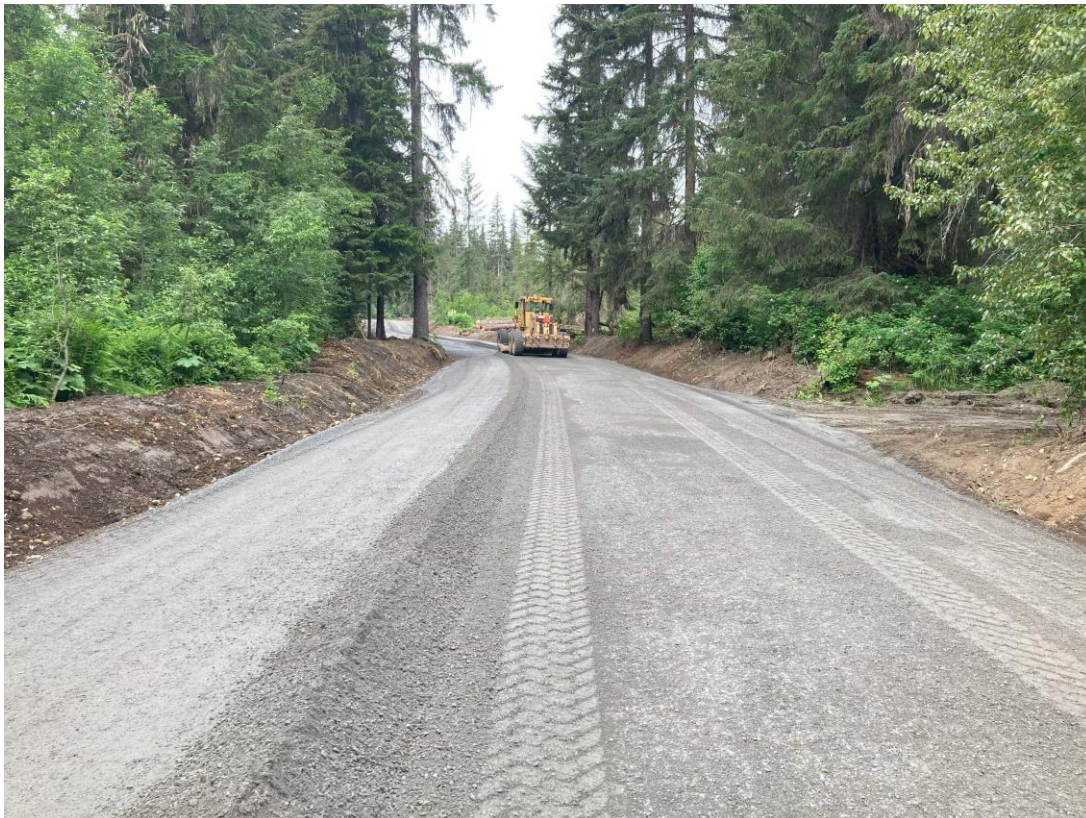
Cat 14G Grader started finish grading. 6.3 miles from B□P

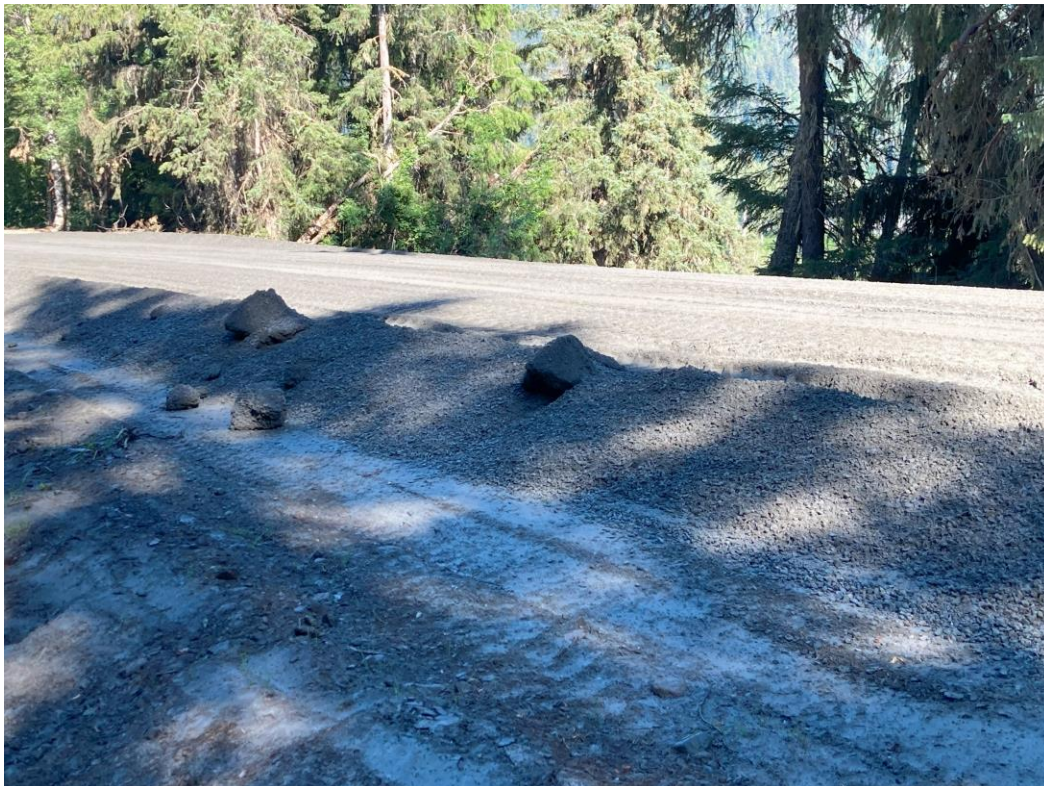
Worst of the clumps of Calcium Chloride

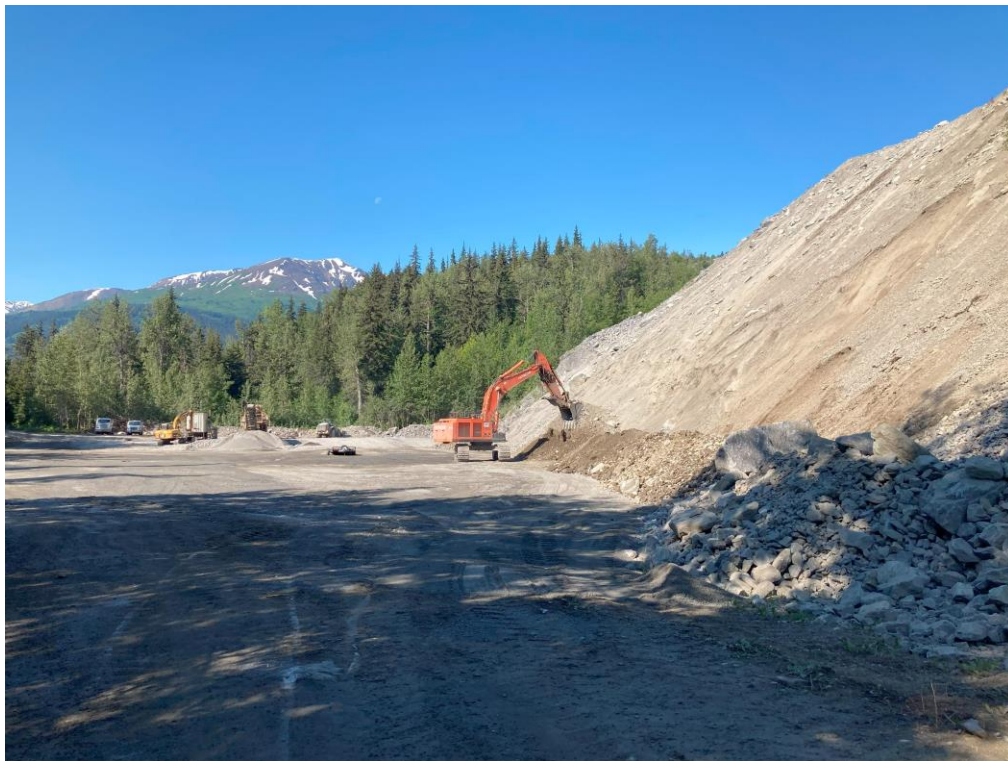
Pit final clean up.

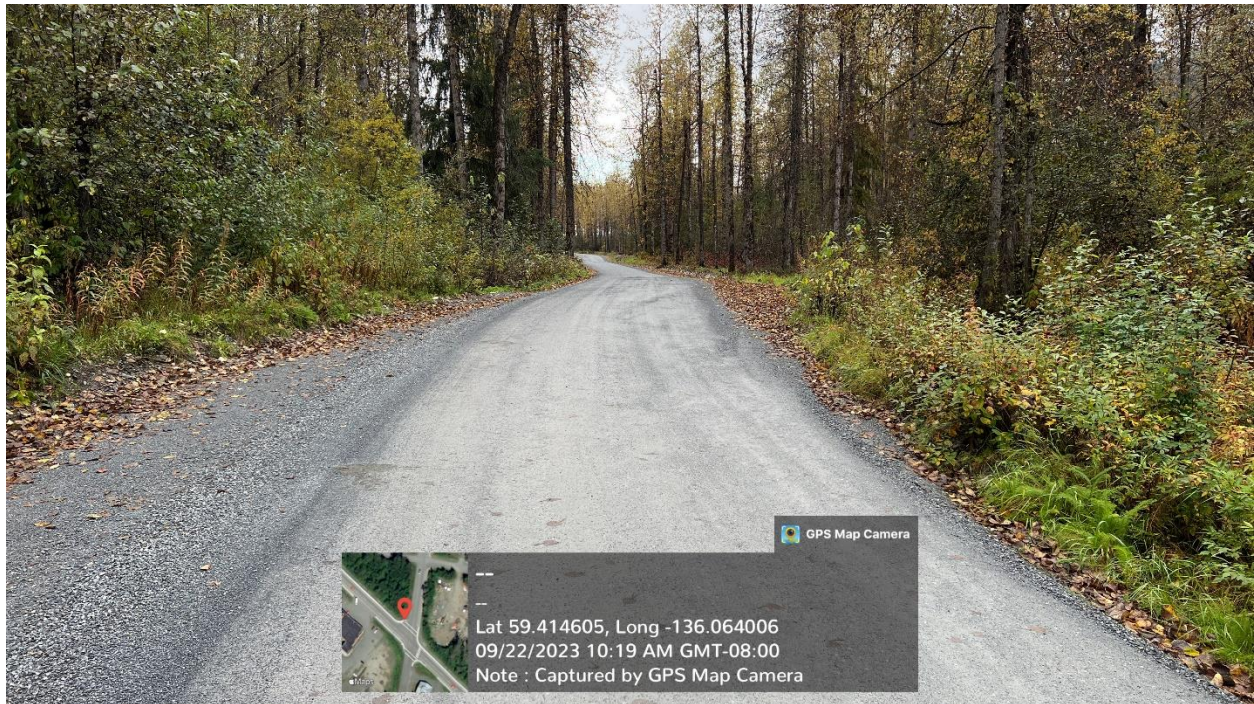
Figure E.1 – Phase I gravel surfacing work at Herman Creek, culvert crossing at photo center, photo facing end of road.

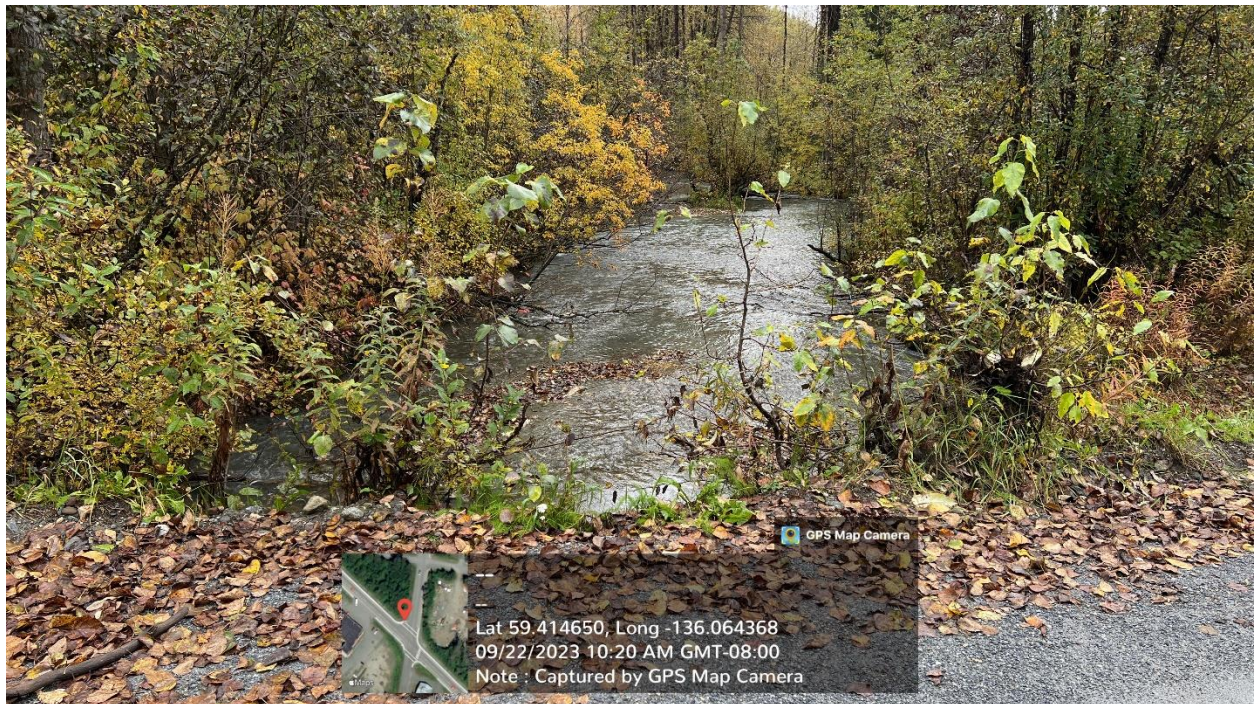
Figure E.3 – Porcupine Trail Road crossing at Herman Creek, photo facing downstream.

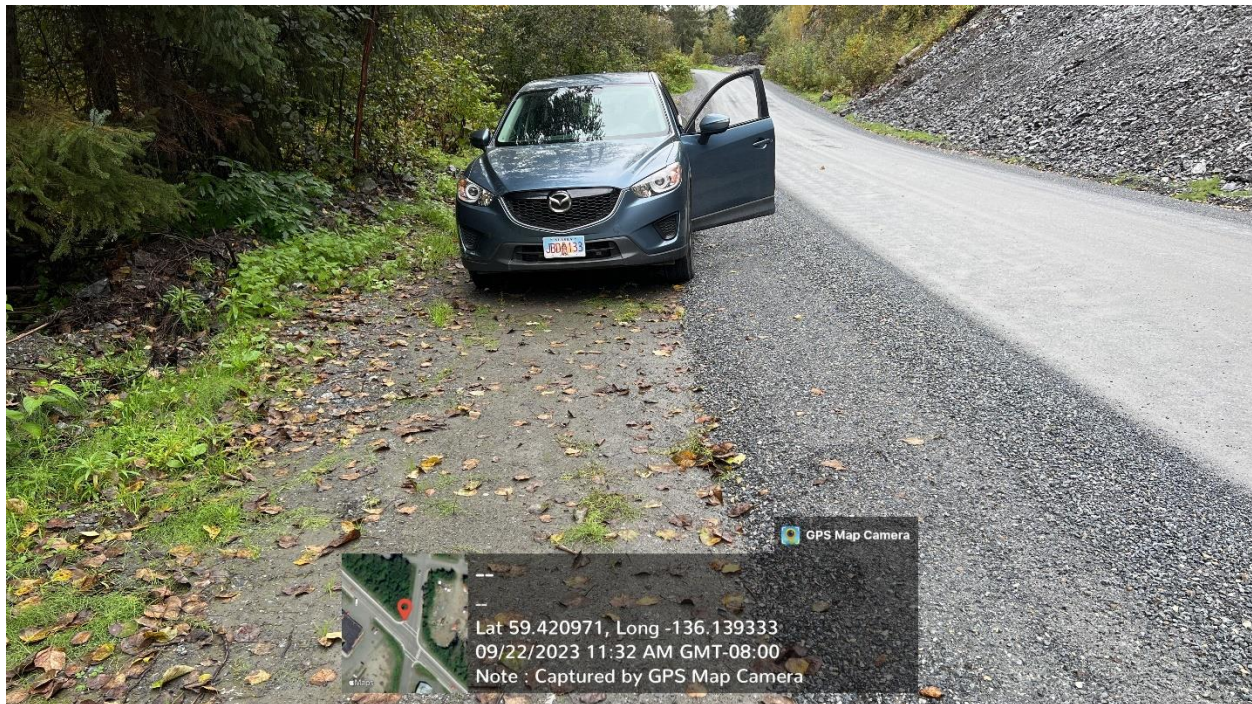
Figure F.2 – Typical existing pullout on Porcupine Trail Road within the Phase I work limits where gravel surfacing was placed per Plan and did not extend to the limits of the existing roadway.

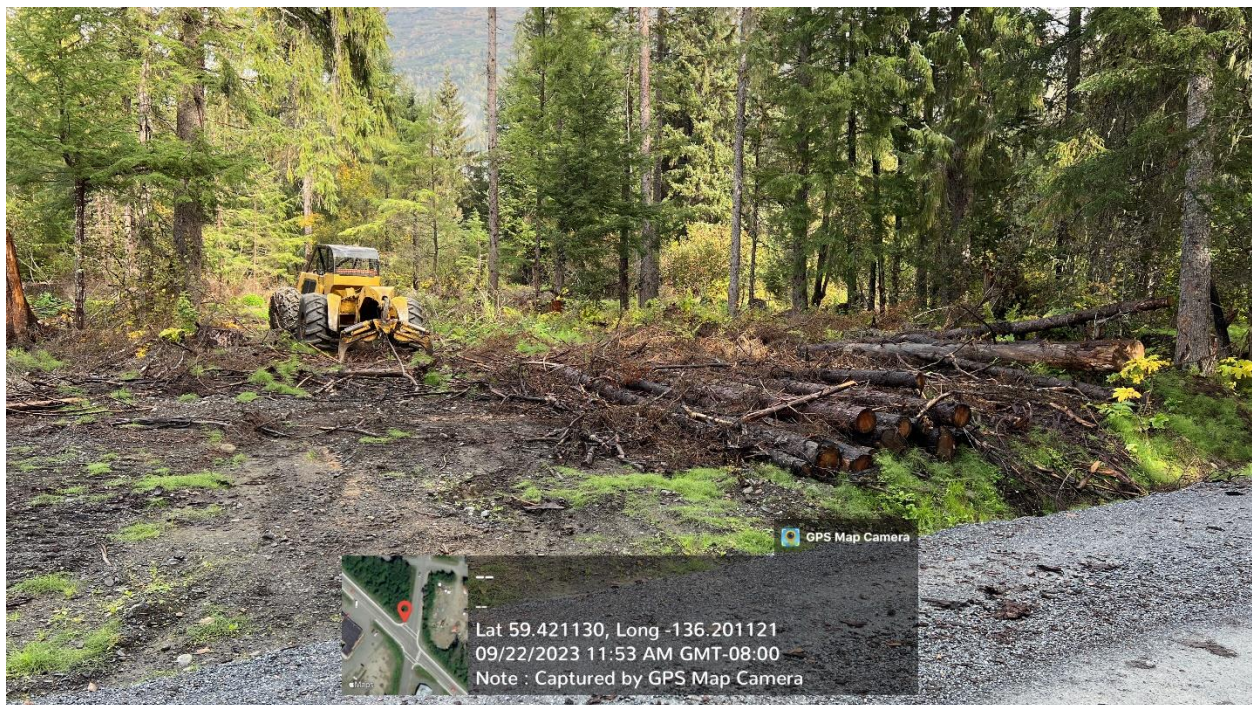
Figure F.7 – Unrelated resource extraction operation adjacent to Porcupine Trail Road corridor. Have included documentation to make clear decked timber and disturbances in daily reports for this area of project was performed by Others outside the Phase I project limits for unrelated purposes.

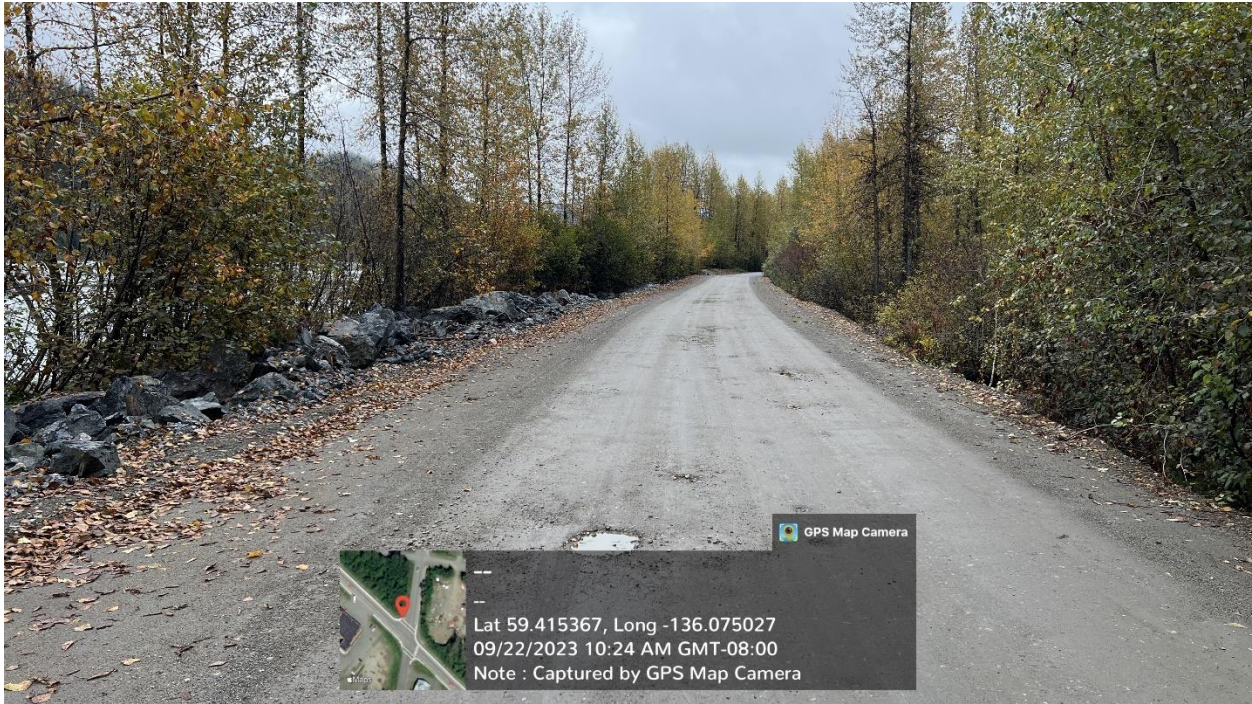
Figure H.1 – Riprap on left was placed in 2022 as described in FH22-I-0090. This is the same location as 2023 Third-Party Work Site 1. Third-party work placed 3’ of road fill up against backside of riprap berm placed in 2022.

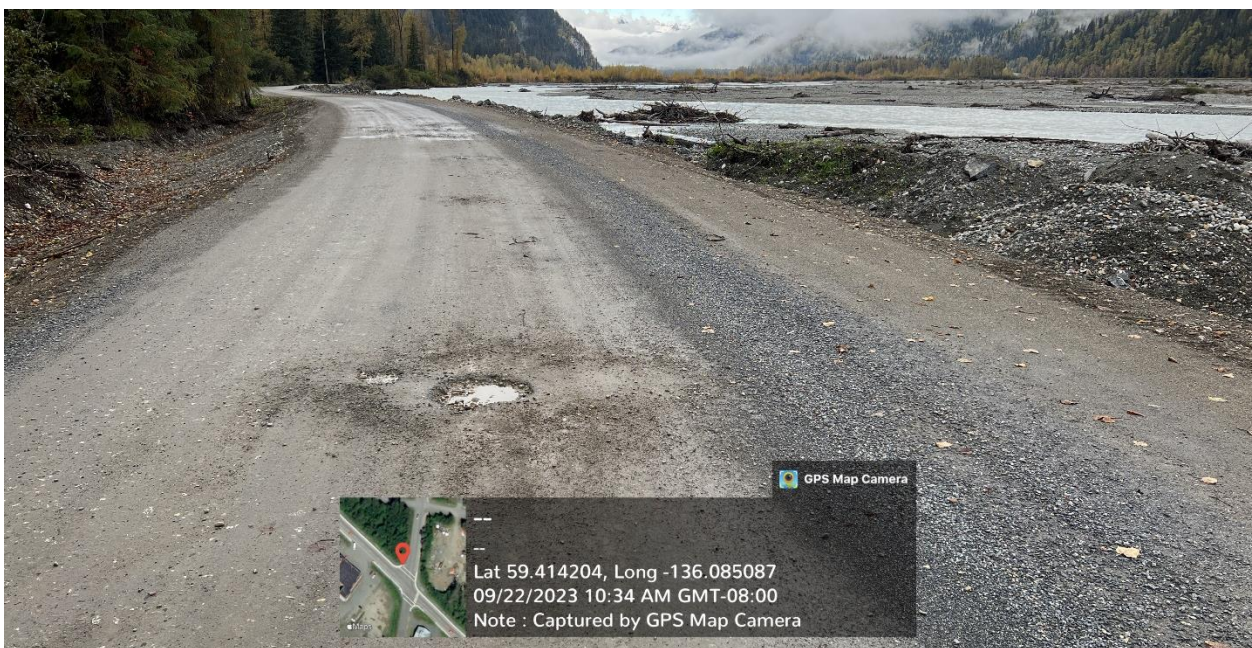
Figure H.2 – Berm on right was placed in 2022 as described in FH22-I-0090. This is the same location as 2023 Third-Party Work Site 2. Third-party work placed 3’ of road fill up against backside of berm placed in 2022.

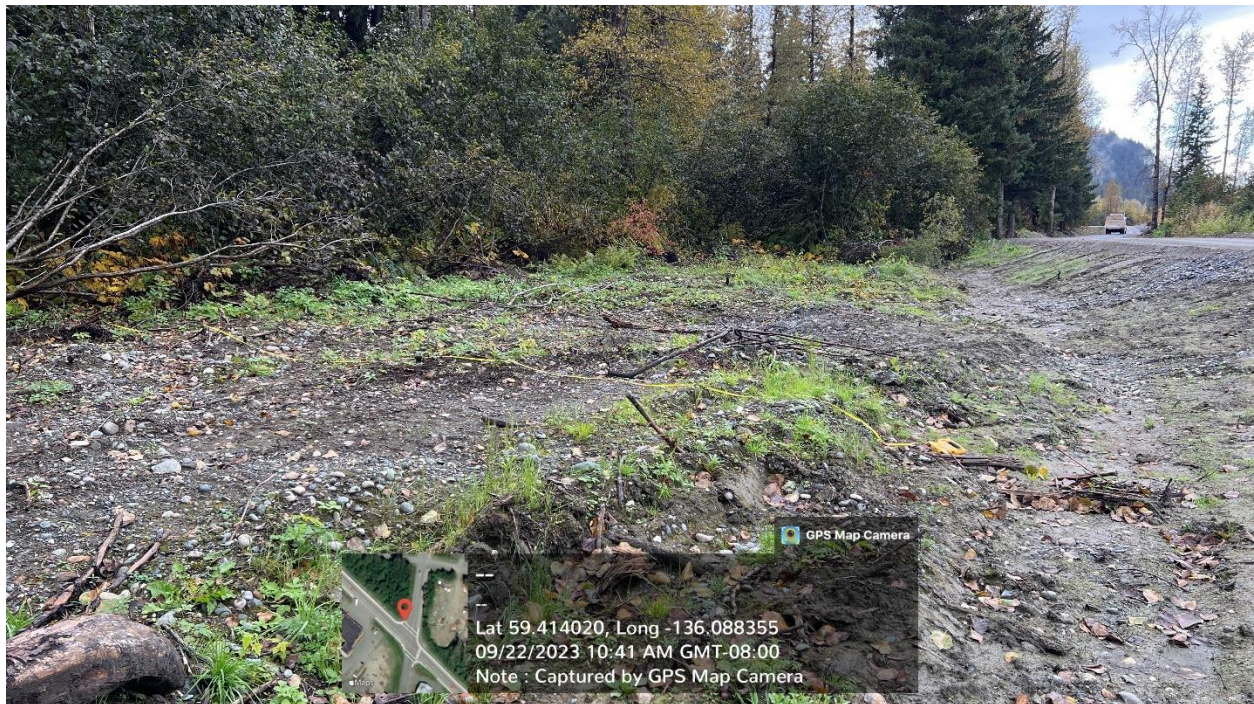
Figure H.5 – Area adjacent to Porcupine Trail Road and Third-Party Work Site 2 where a significant amount of gravel and debris were deposited during flood events. Area appears to be disturbed because it was used as a source of material to construct gravel/debris berms described herein and FH22-I-0090.
