# Updated Findings Report

## Beach Road Landslide, Haines, Alaska

**GEOTECHNICAL INVESTIGATION, UPDATED FINDINGS REPORT  
BEACH ROAD LANDSLIDE, HAINES, ALASKA**

March 18, 2022

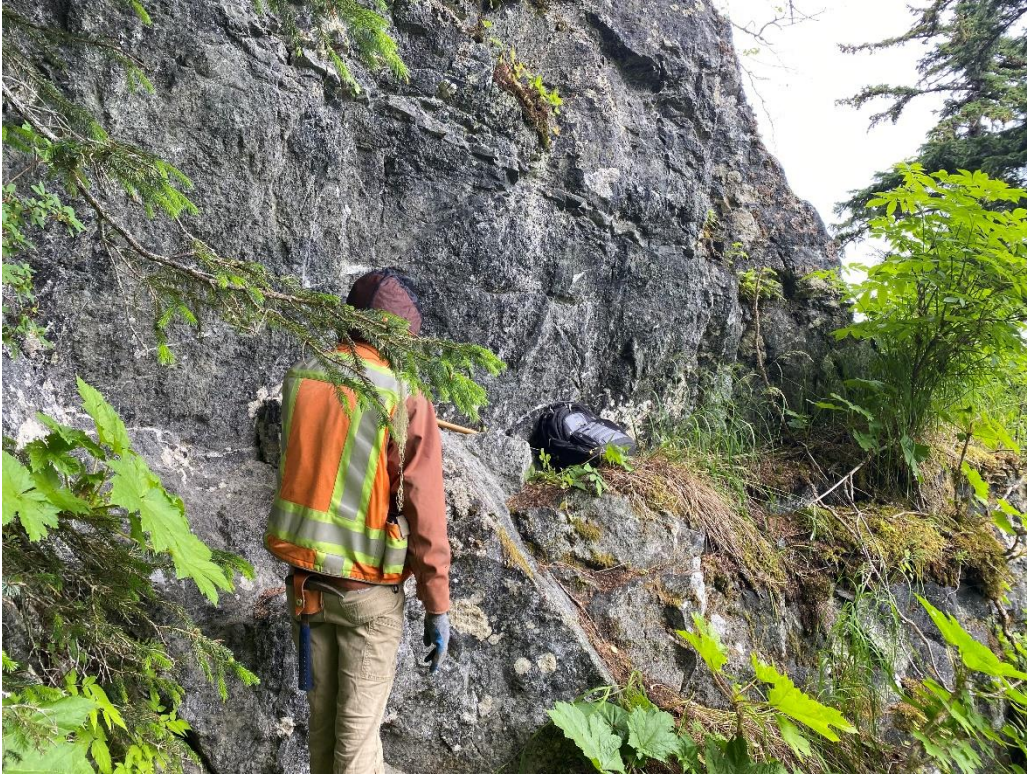
A: Rock 1 located at elevation 750 feet approximately 1,000 feet east of the 2020 landslide.

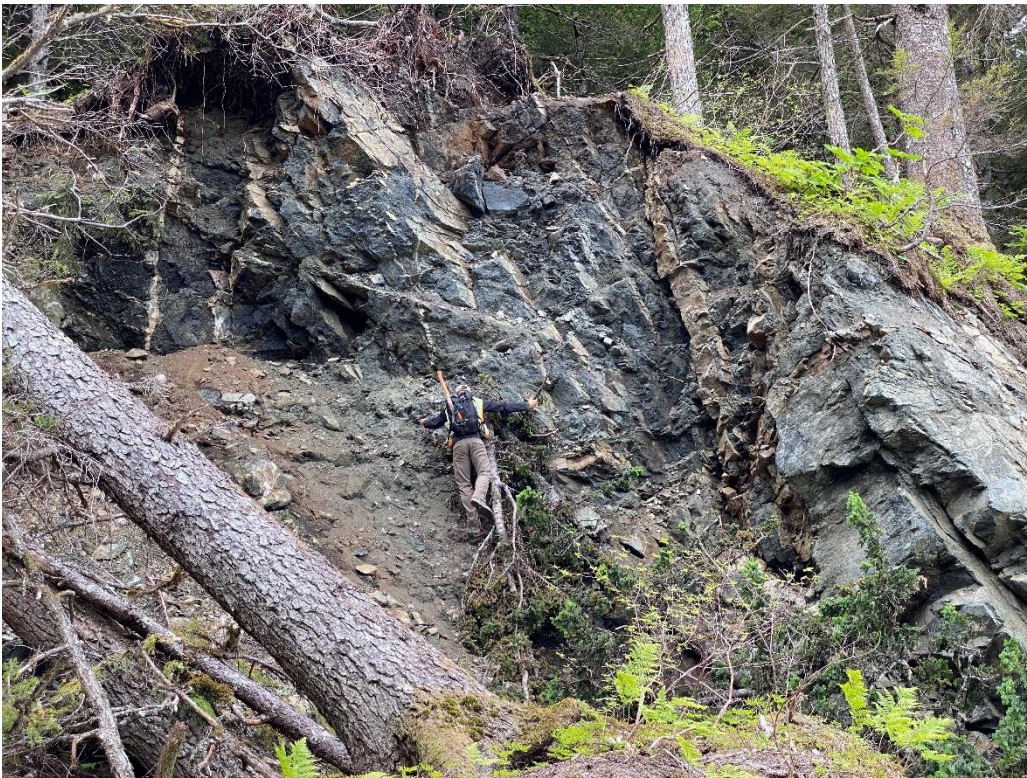
B: Rock 2 located at elevation 820-840 feet on the west headscarp of the 2020 landslide.

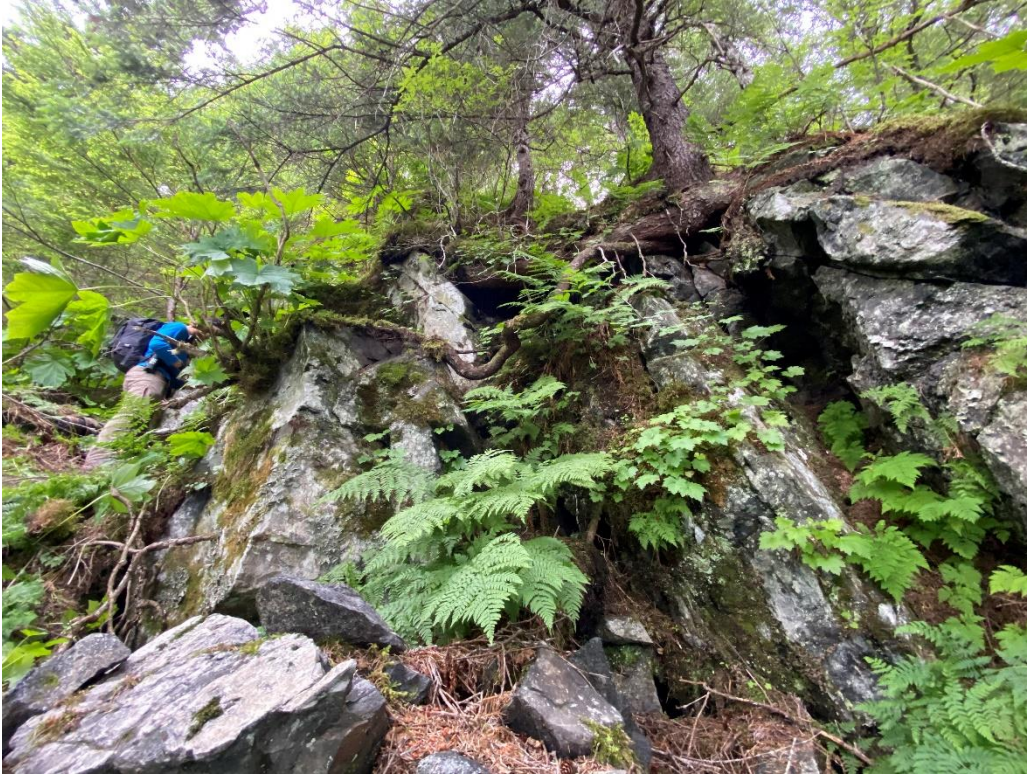
A: Rock 2 at elevation 600 feet approximately 100 feet west of the 2020 landslide.

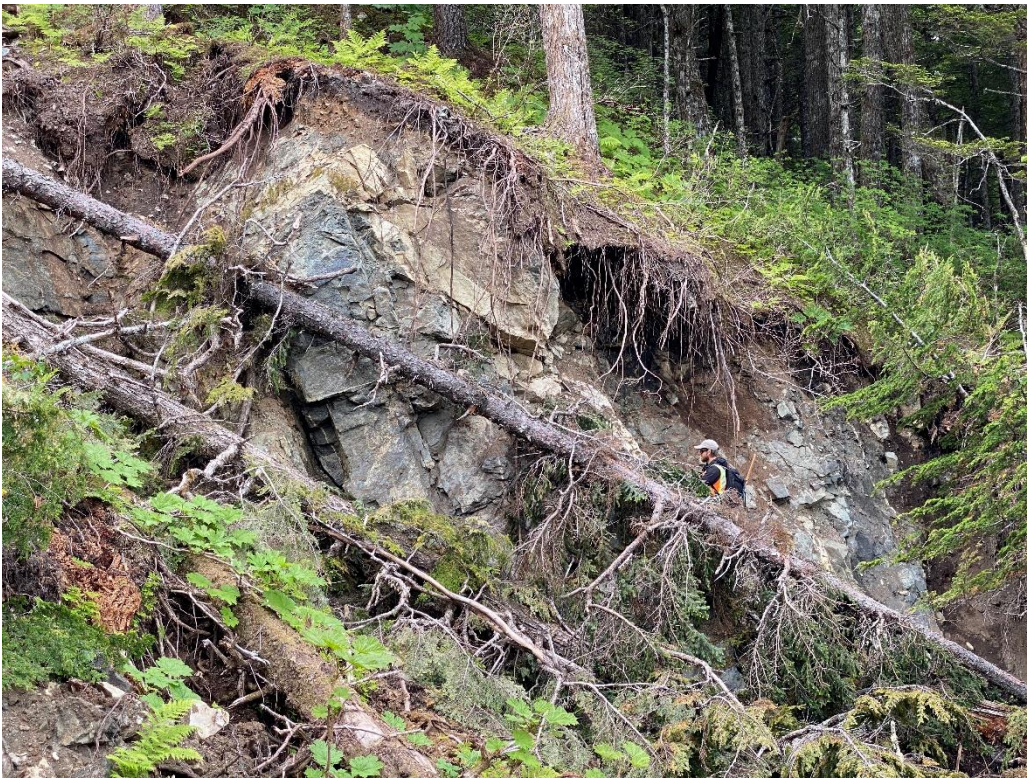
B: Rock 3 at elevation 730-750 feet on the West Slump Block, west of the Upper Rock Slump.

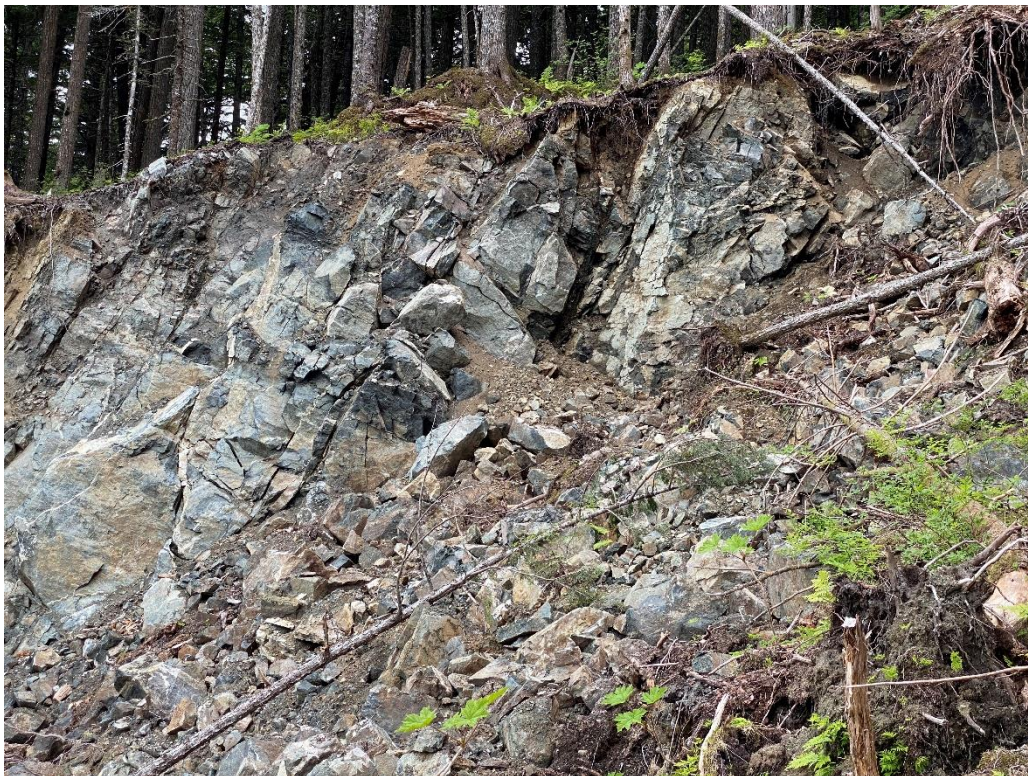
A: Rock 3 at elevation 830-840 feet on the East Slump Block, east of the Upper Rock Slump.

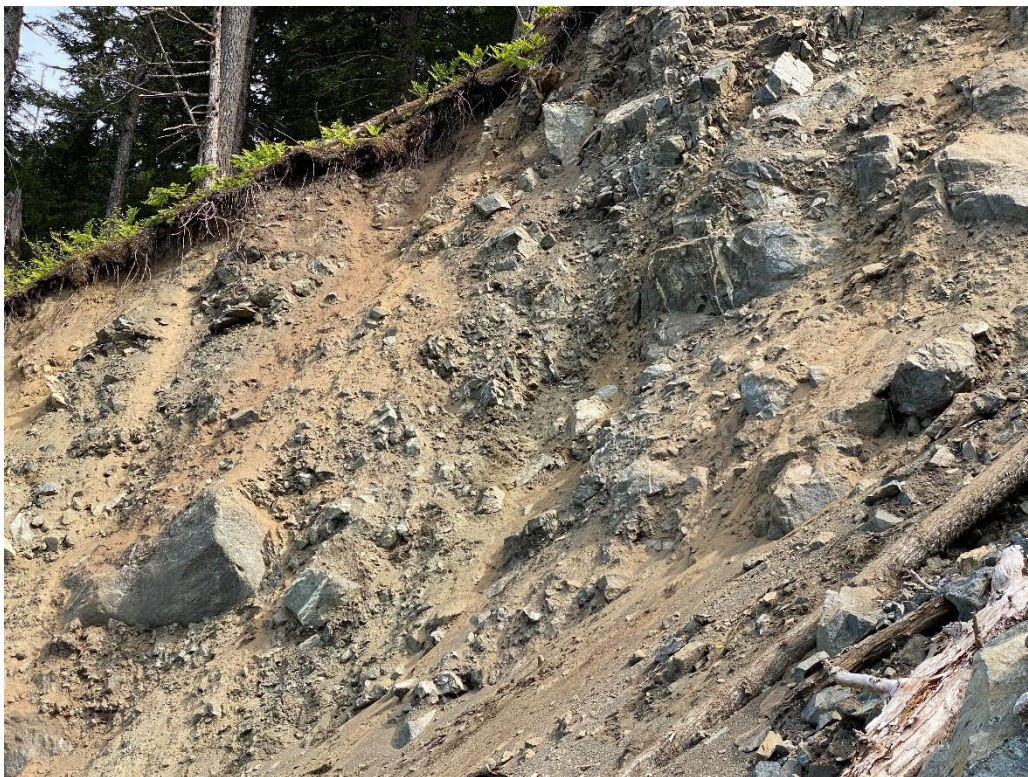
B: Colluvium 1 at elevation 650-680 on the West Soil Scarp.

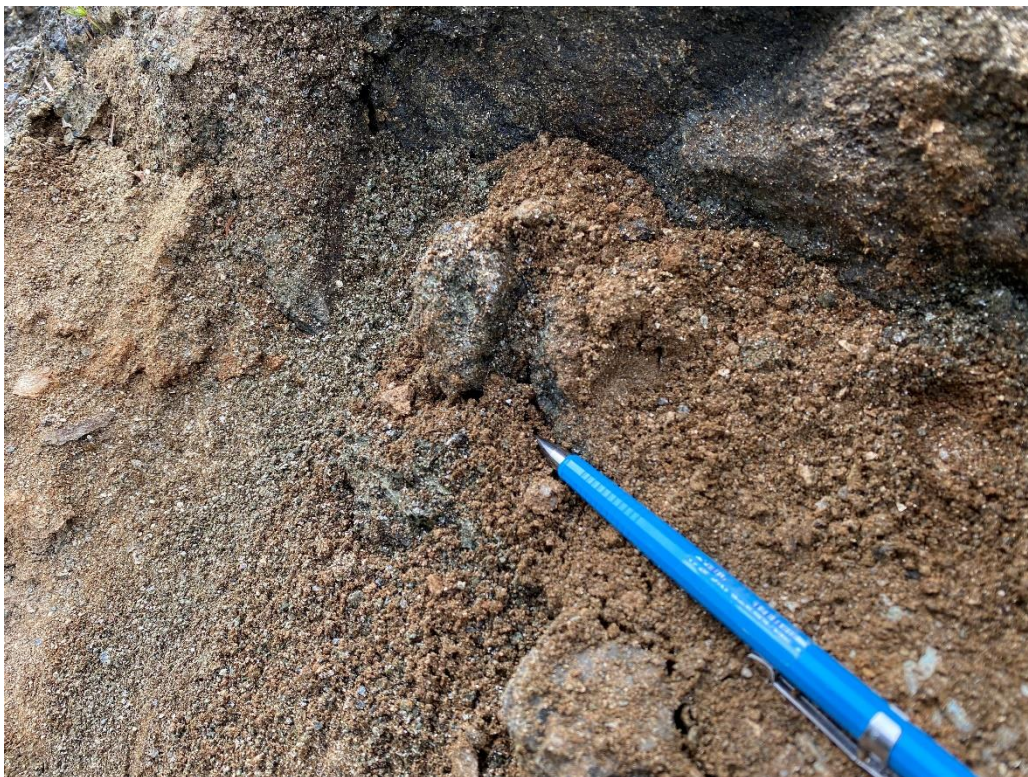
B: Colluvium 1 at elevation 620 feet on the West Soil Scarp.

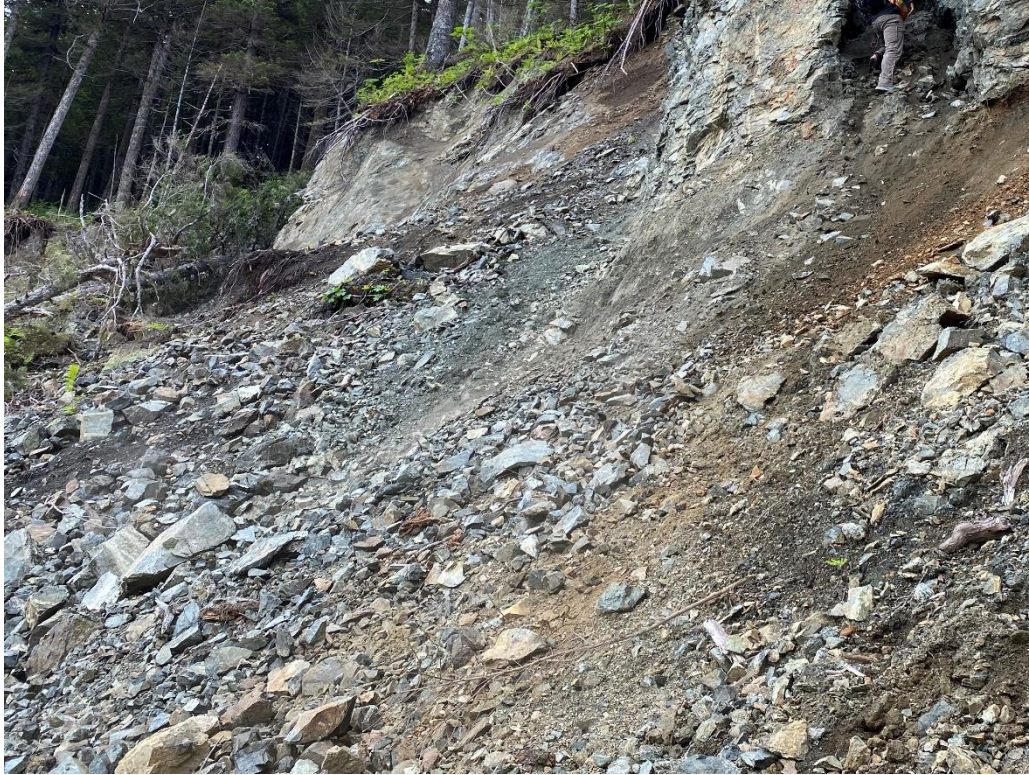
A: Colluvium 2 (newly deposited) at elevation 740-760 feet on the Upper Rock Slump of the 2020 landslide.
