Inspection and Assessment of Lutak Dock Haines, Alaska

May 2014
14-2449

**RE: Inspection and Assessment of Lutak Dock,
Haines, Alaska**

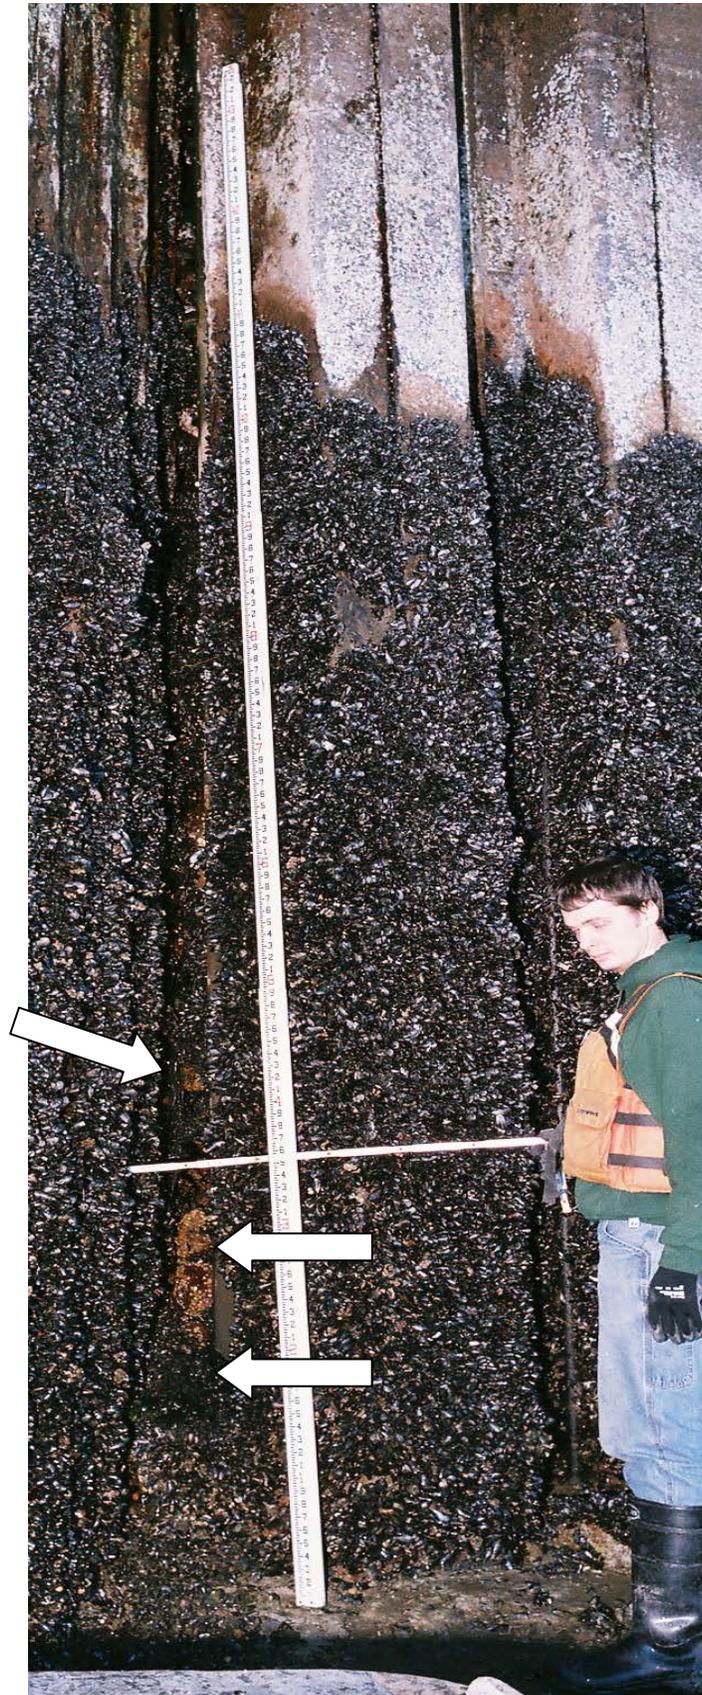
PHOTO No. 31:

Further investigation of Closure Arc No. 8.5 noted partial failure and apparent lowering of the backfill, however the level of the backfill after completion of the repair work conducted in 2008 is unknown. Refer to Photo No. 27.

Closure Arc No. 8.5 Repair, East End - Note the repaired section of the 8.5 closure arc to the right of the stadia rod and the Main Cell No. 9 on the left. The arrows indicate the gap between the main cell and the east end of the repair section. Note a cleaned portion of the steel H-pile shown on Reference Drawing S-3, Detail 8, can be seen just above the lower right arrow. The upper right arrow indicates a large (~2' dia.) rock in the backfill. No evidence of any fines or intact geotextile fabric was visible through this gap. Remnants of the geotextile fabric was found at the bottom of the gap. This condition is typical of the locations shown in the following series of Photos No. 32-36.

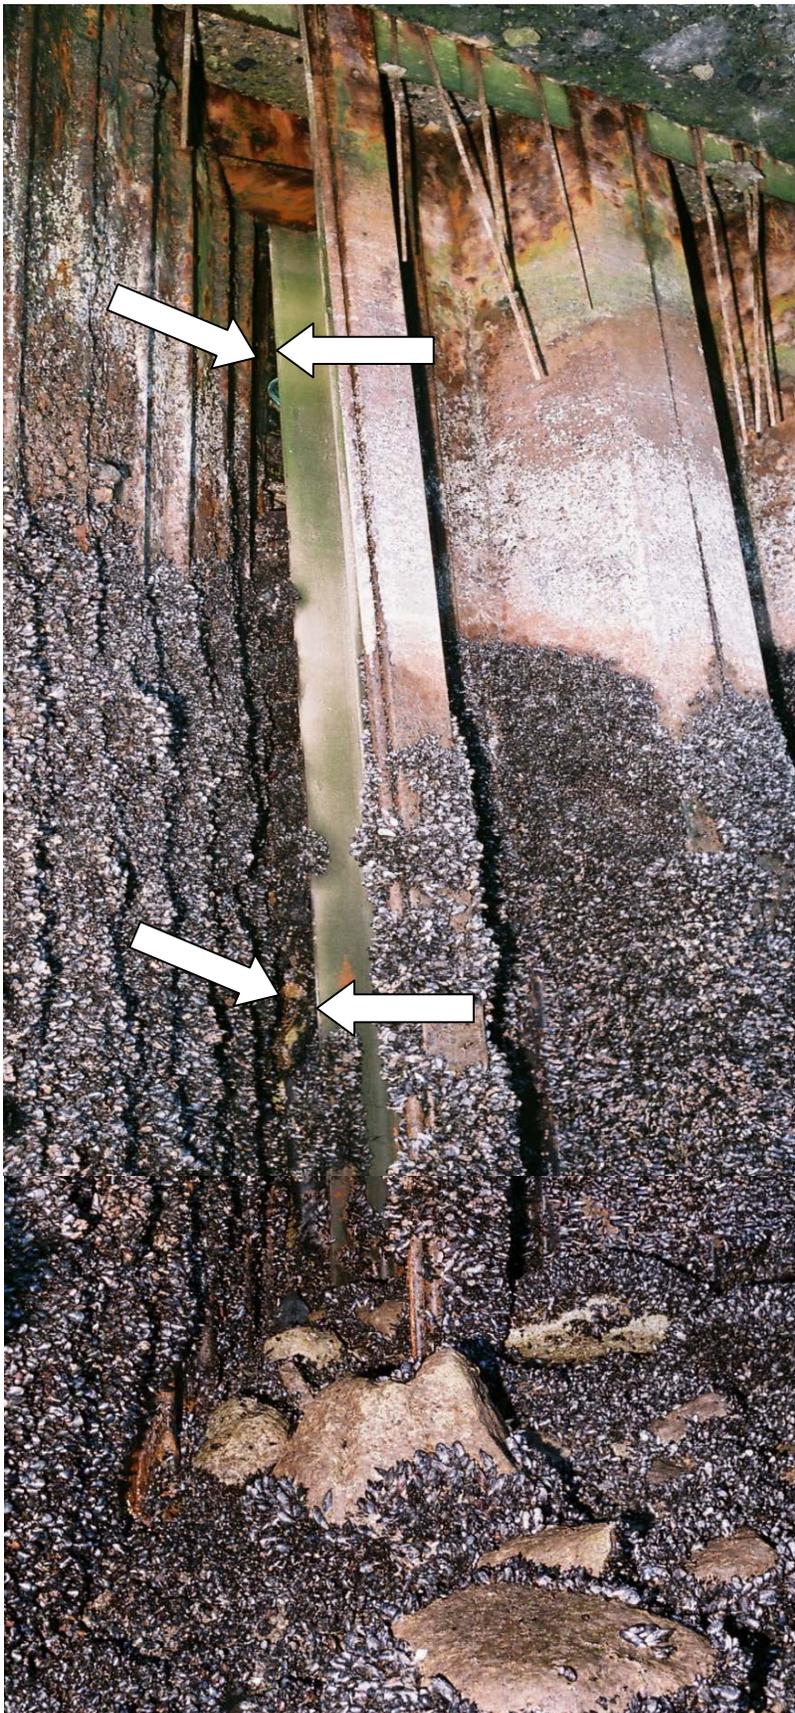
PHOTO No. 32:

Closure Arc No. 4.5 Repair,
East End - Note the gap
between the steel H-pile,
designed to terminate and
seal the end of the closure
repair, and the main cell.
No evidence of any intact
geotextile fabric or any
fines was visible through
the gap.

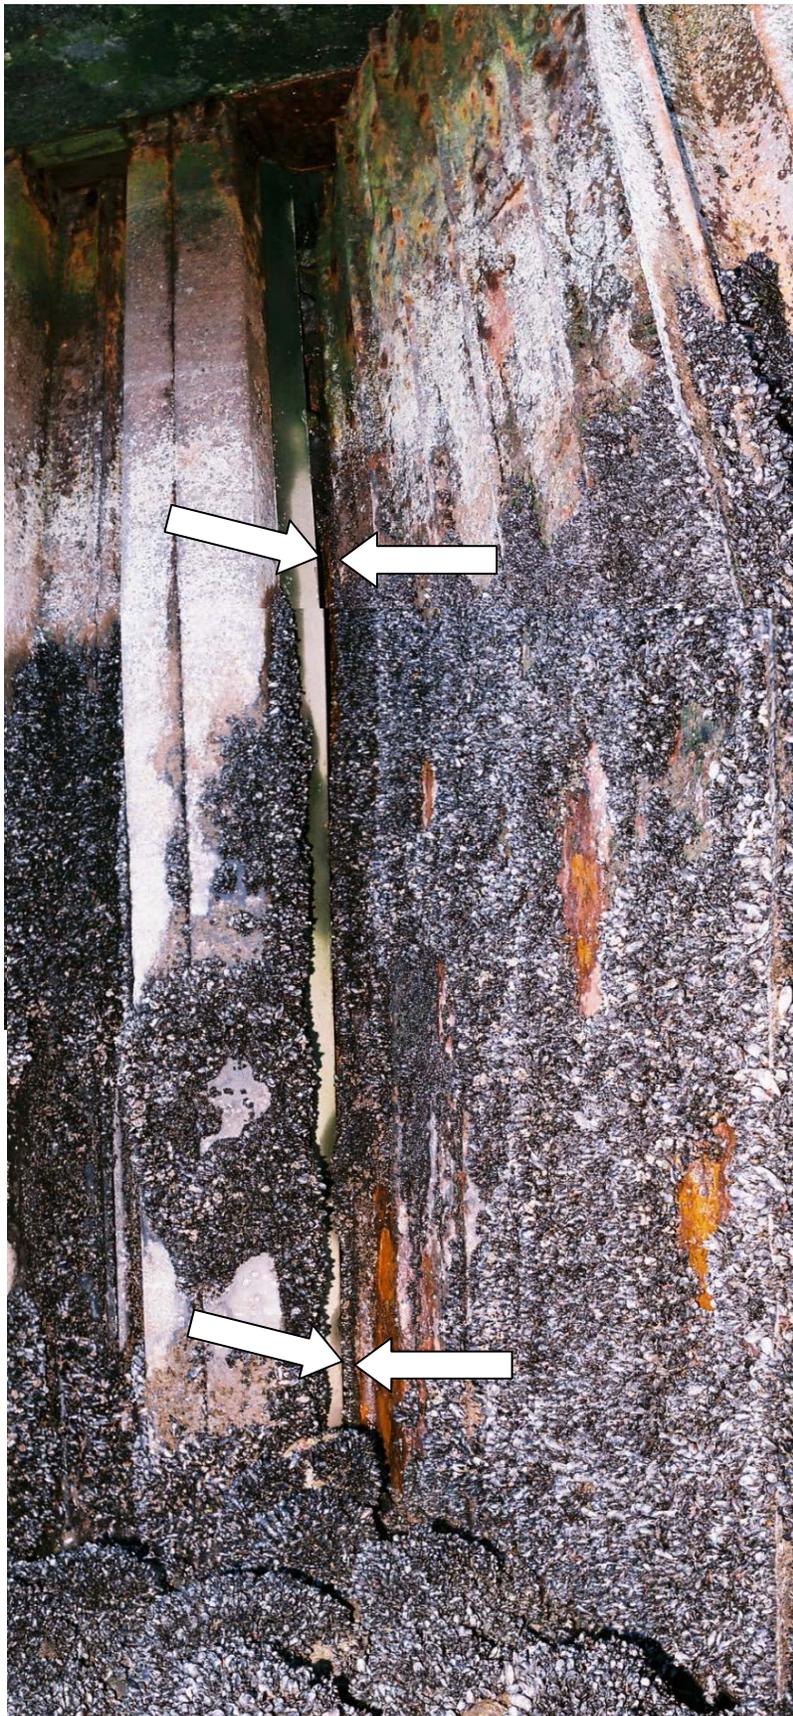
PHOTO No. 33:

Closure Arc No. 6.5 Repair,
West End - Note the gap
between the steel H-pile,
designed to terminate and
seal the end of the closure
repair, and the main cell.
No evidence of any intact
geotextile fabric or any
fines was visible through
the gap.

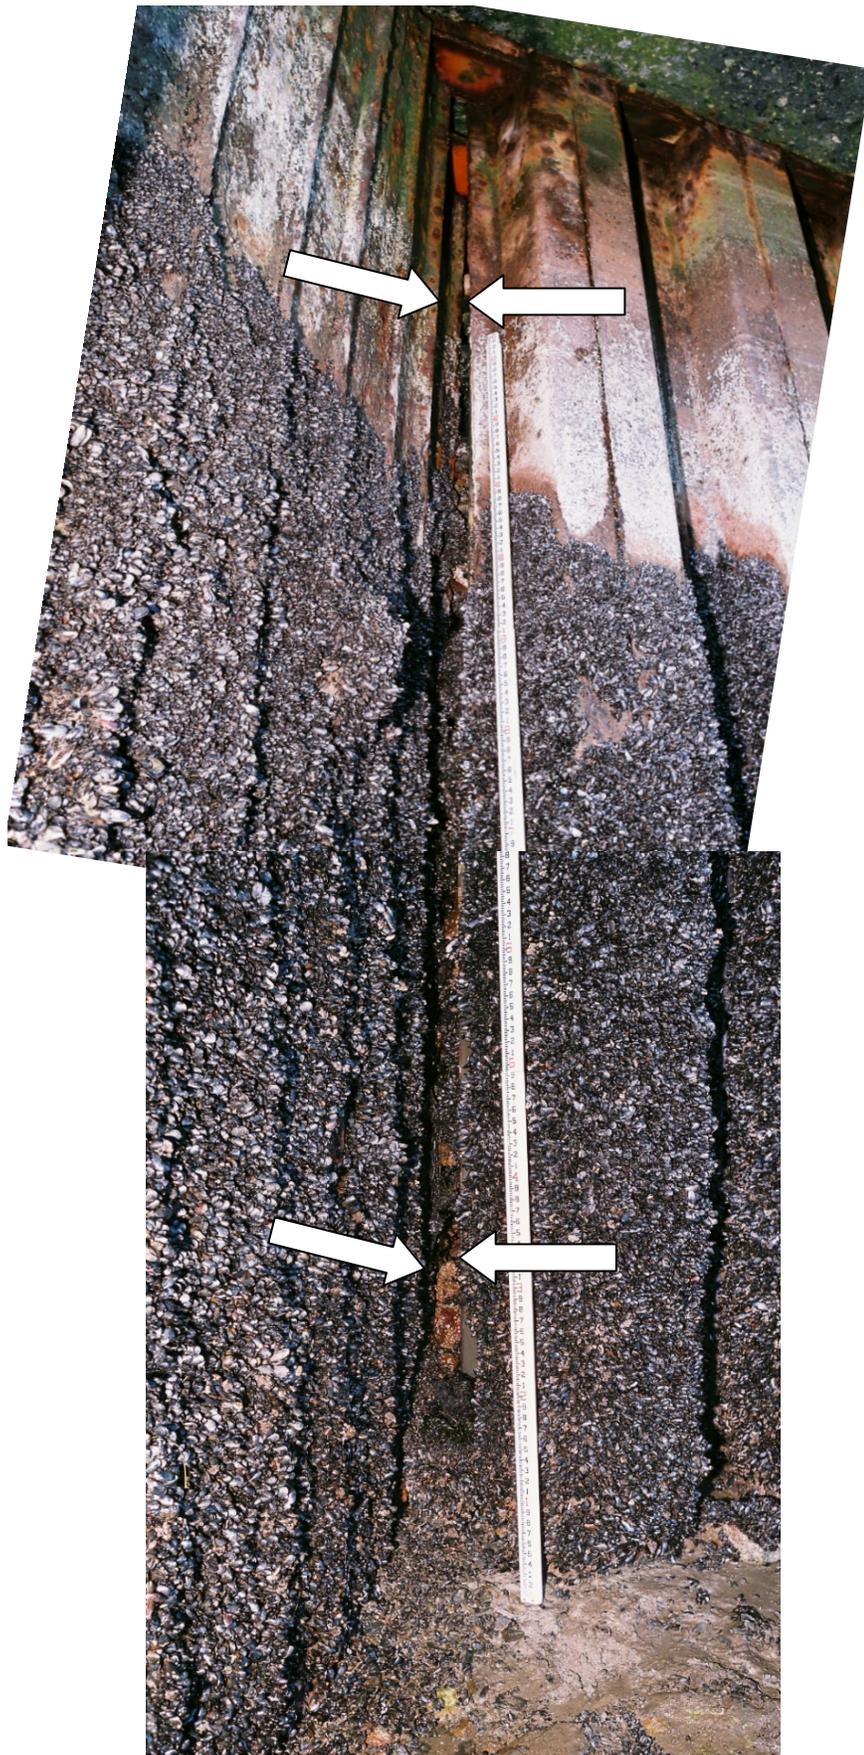
PHOTO No. 34:

Closure Arc No. 8.5 Repair, East End - Note the gap between the steel H-pile / end sheet pile and the main cell. No evidence of any intact geotextile fabric or any fines was visible through the gap. (Also shown in Photo No. 31).

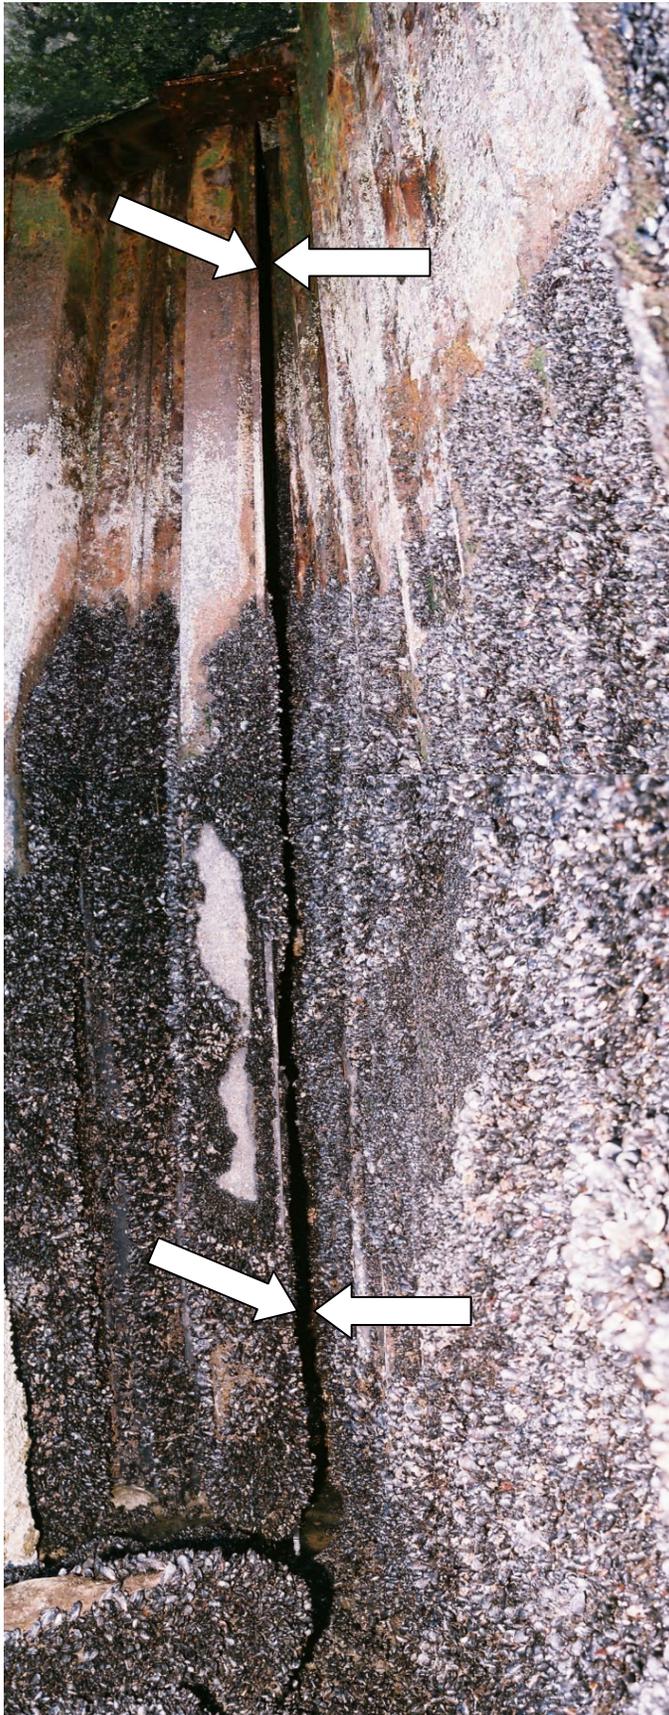
PHOTO No. 36:

Closure Arc No. 10.5
Repair, West End - Note
the gap between the last
steel pile and the main cell.
No evidence of any intact
geotextile fabric or any
fines was visible through
the gap.
