# Lutak Dock Structural Assessment

City of Haines, Alaska

OCTOBER 2014

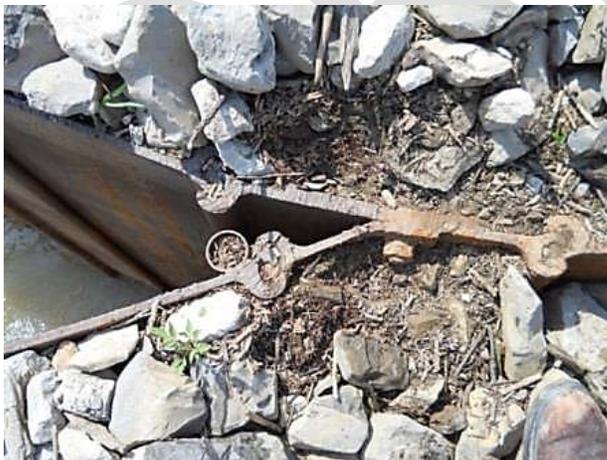
Figure 3-5. Endorsed USACE Connection Post-1965

Figure 3-5 depicts the current USACE endorsed configuration for the connections between the main cell and the closure. The geometry of the connection utilized at Lutak in 1953 (Figure 3-6) is identical to those subsequently prohibited by USACE. In 2007, PND investigated options for a private cement company to repair damage resulting from failure of an identical “tee” joint between closure arc and main cell at a structure constructed in 1964. Photographs and observations of the cement company failure are consistent with the mechanism observed by the USACE at other cellular structures.
