Condition Survey of

Chilkat Center for the Arts

May 2008

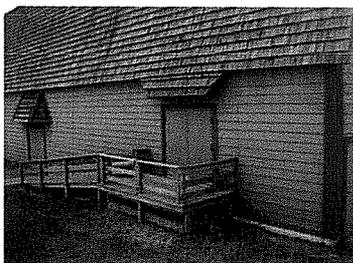
Access routes: No accessible route is provided from the main entry to the theatre. Secondary exit doors are accessible, but require bypassing the ticket area. There is no accessible route from the theatre to the stage. The stage door is served with a ramp, but it is too steep and does not meet ADAG requirements, nor are the required rails provided.

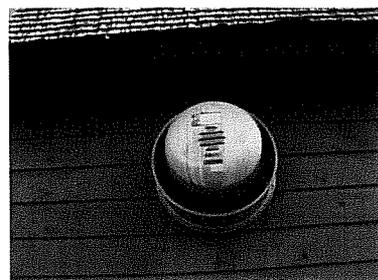
KITCHEN HOOD EXHAUST FAN

A wall mounted fan, located on the north side of the building, exhausts air from a back shelf design Type 1 exhaust hood system that covers the propane range in the kitchen plus an additional 18 inches to the side of the range. It appears that the cooking range was replaced sometime in the past with a smaller one so the hood covers a larger area that it should. The hood has grease filters but they appear to be a fabricated older type that is not very effective. The hood does not have chemical fire suppression system and the range propane system is not connected for interoperability with the exhaust air system; both serious code violations. The original plans called for an interlock of the exhaust fan with HV-3 and increased OSA damper positioning, but this feature was not functioning. The controls for HV-3 are non-functioning and there is no makeup air source for the exhaust hood other than the ventilation air supplied by HV-3 to the lobby area adjacent to the auditorium. The exhaust fan is wall mounted exhausting under a roof overhang. The fan is old and does not meet current code requirements for grease duty.

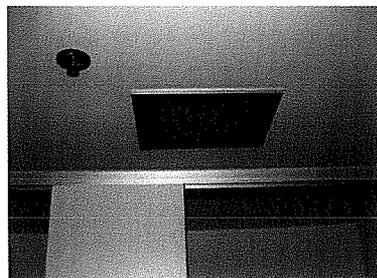
TOILET ROOM EXHAUST FAN

The exhaust ducts in the addition attic are generally long lengths of flexible duct (20 feet) with no supports that connect into a common vertical sheet metal duct to a roof cap. Long lengths of flexible duct add considerable static pressure to the exhaust system reducing the exhaust air volume the fan will produce.

Recommend replacing the flexible ductwork with sheet metal for increased exhaust air volume and efficiency.

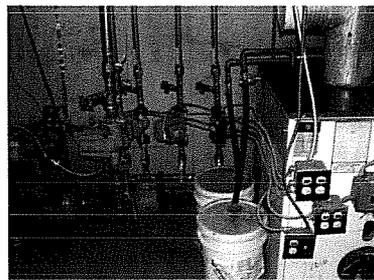
HEATING CIRCULATION PUMPS

Two boilers (Ultimate Boiler PFO 9), cast-iron sectional, were installed approximately 8 years ago during a mechanical renovation. The boilers advertise a high efficiency rating in the mid 8-0% range. It was not known or evident when the burners were last adjusted for maximum efficiency. Approximately six heating zones, each with a unitized pump at the heating plan, supplies heating water to a heating loop. Each HV fan unit also has a circulating pump within its own heating coil loop to assist with water flow. Many of the heating loops experience air blockage due to piping not pitched correctly and lack off air vent valves. Some of the heating piping is insulated, roughly 50%.

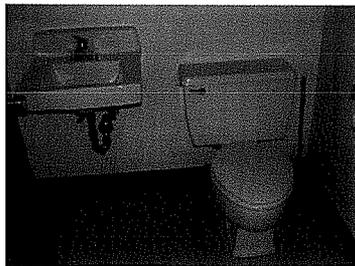
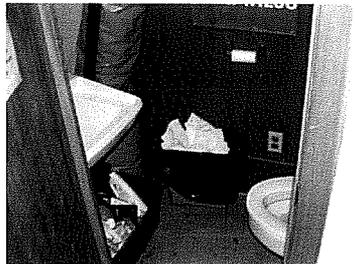
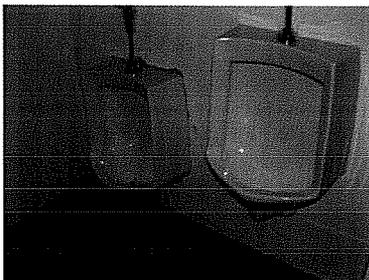
PLUMBING FIXTURES 1

The kitchen vegetable prep sink does have an air gap to the sanitary system for prevention of cross contamination and is a code violation. The plumbing fixtures are old and not a water saving type. None of the plumbing fixtures meets ADA requirements. The plumbing piping needs to be insulated for efficiency.

Item: Replace All Plumbing Fixtures. Replace the hot water tank tempering valve. Revise kitchen plumbing with new floor sink and indirect drainage of vegetable prep sink. Modify plumbing systems for ADA configuration (costs below only include the fixtures not the space renovation). Insulate all domestic water piping.

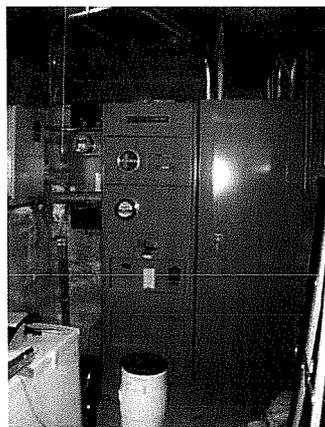
The feeder for the building is configured with conductors to a separate distribution panel located on the right side of the switchboard. This panel includes circuit breakers for panels located in the Boiler room, the Shop, and the Kitchen. Another large feeder is routed to the stage lighting panel. The remaining circuit breakers serve small, undefined loads. This panel was manufactured by Square D and the components are still manufactured. The front of the panel exposes live terminals and bus when opened. It appears to be the wrong cover for this panel and needs to be replaced for safety purposes. Access to the front of the panel is required to operate the circuit breakers. Otherwise, the panel is in good condition.

There appears to be no earth ground system for the service. No grounding electrodes were found, and no bond to the water service was apparent. A grounding system needs to be installed.

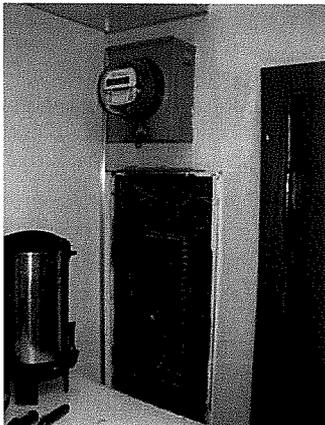
The branch circuiting primarily consists of single conductors in raceway. Most of the raceway is Electrical Metallic Tubing, EMT. There is some circuiting consisting of type NM cable (Romex type). The circuiting is in fair condition. In numerous locations, the raceway lacks adequate support, or connections have separated, compromising proper grounding paths. Many junction boxes are open with conductor terminations protruding beyond the edge of the box. Many circuits have been modified or added since the original construction. The circuit loading was not analyzed. Ground Fault Circuit Interrupters are not installed for all circuits powering receptacles in wet locations (ex. Kitchens and Restrooms) as required for safety. With renovation of spaces, the circuiting should be replaced. In some cases, it may be appropriate to retain some circuiting, however, it will require a careful survey of such circuits to define repairs and modifications if necessary. If the spaces are not renovated within two years, effort should be made to survey all of the circuits and make modifications or repairs necessary to ensure safety, as well as conformance to code.
