ADDENDUM TO THE CONTRACT

HAINES BOROUGH STREET IMPROVEMENTS – 3RD AVENUE

ADDENDUM NO.: ONE

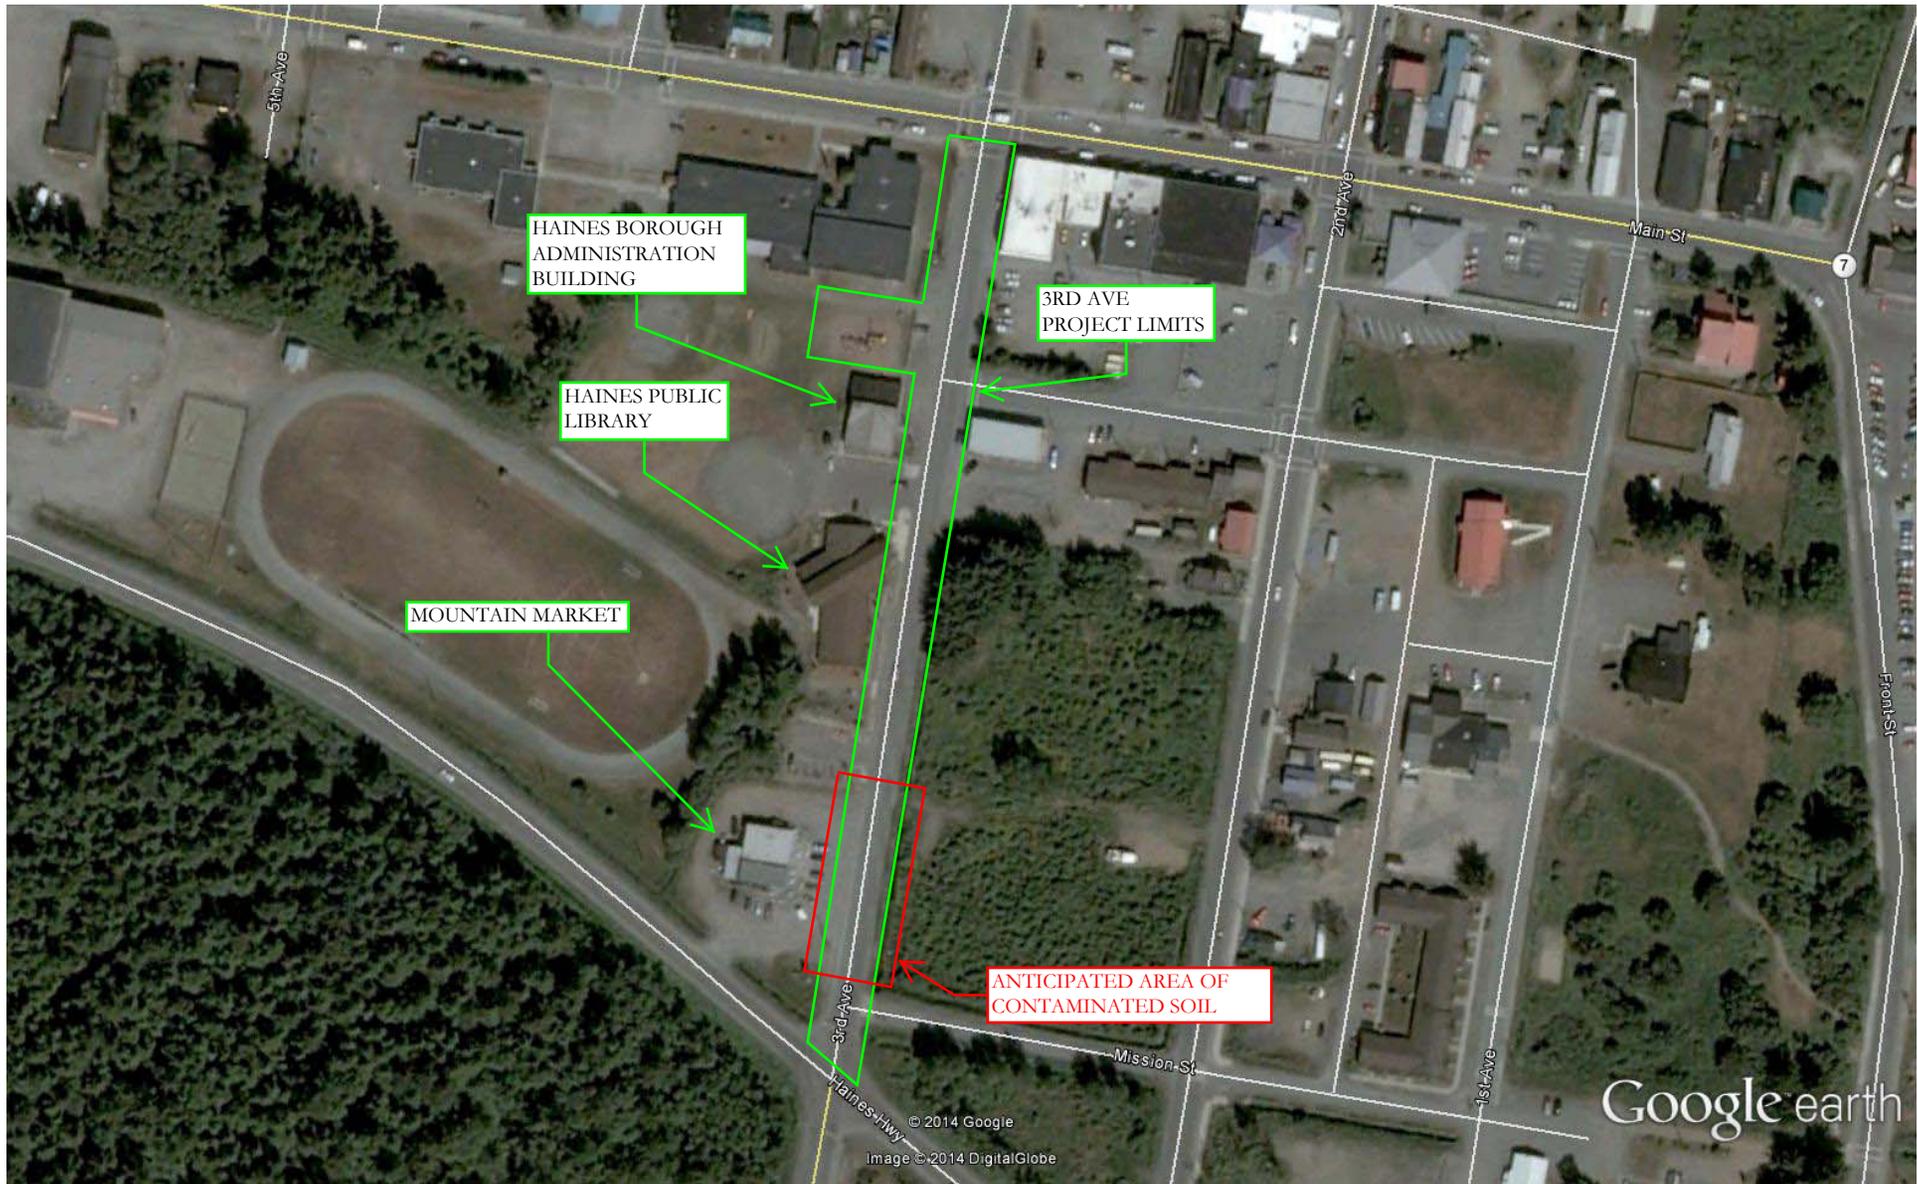
Appendix A

Project Limits/Contaminated Site

The Haines Borough (Borough) is proposing to reconstruct and improve approximately 1,000 linear feet of roadway in Haines, Alaska. The base bid project site consists of 3rd Avenue between Main Street and Haines Highway. Additive Alternate A consists of the Haines Borough Administration Building parking lot. An area at the southern end of the project site near Mountain Market has been classified as a Contaminated Site by the Alaska Department of Environmental Conservation (DEC). Per the recommendation of the DEC, PND Engineers, Inc. (PND) has developed this contingency plan in an effort to minimize delays and associated costs in the event that contaminated soils are encountered during construction of 3rd Avenue.
