**PACIFIC CORRUGATED PIPE COMPANY**

**Drawing Title**  
 Ø80"  $\frac{3}{8}$ " End Cap  
**Date** 5/20/2016 **Drawn By** WHW **Scale** NTS

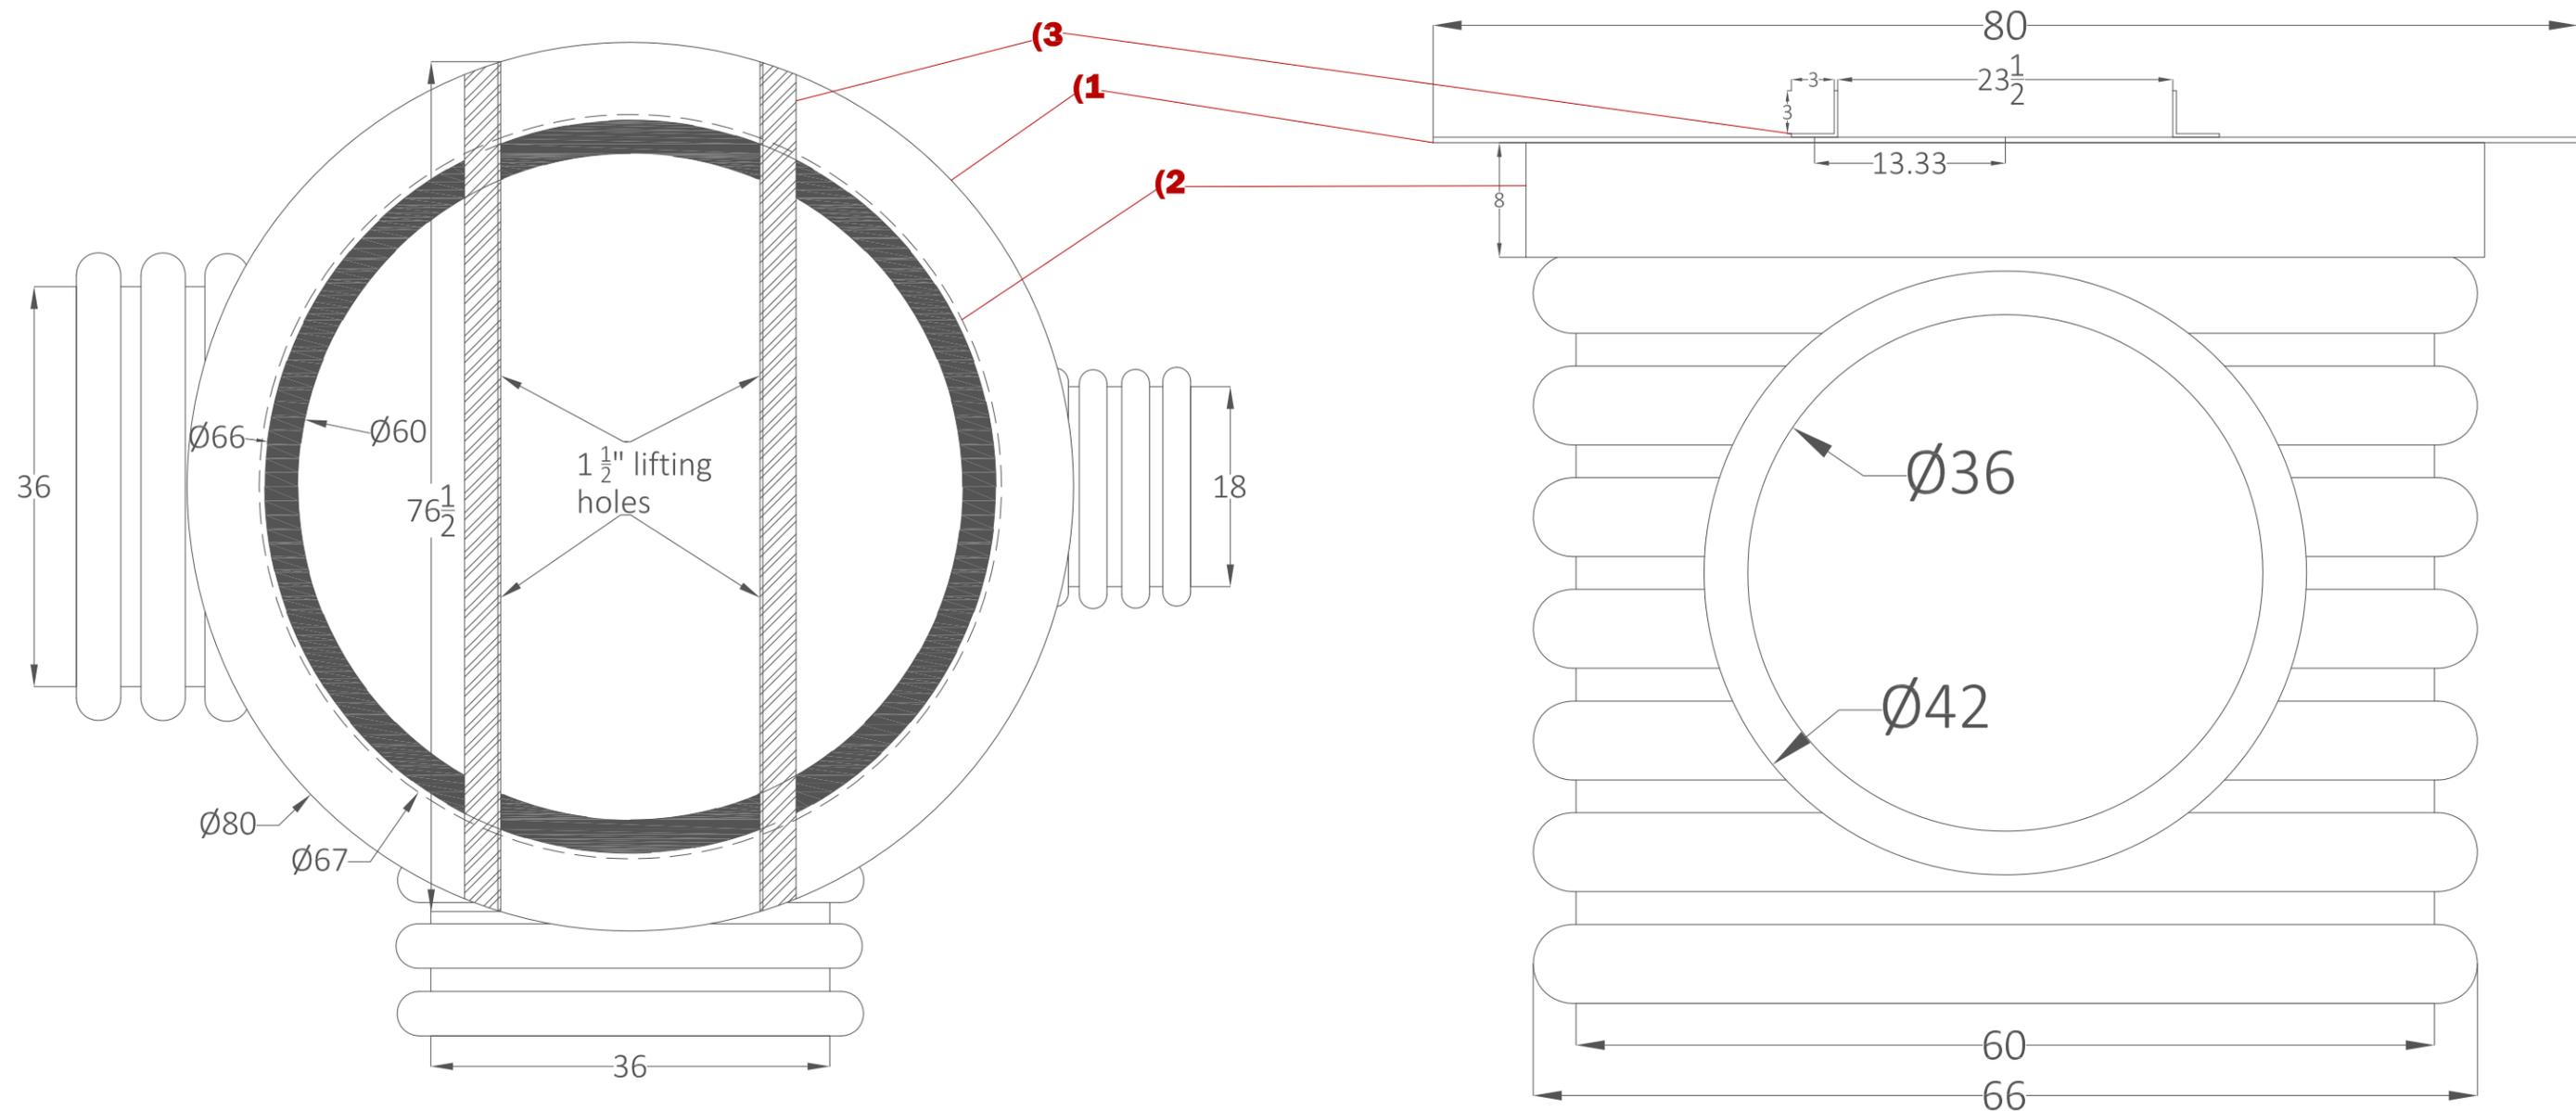
- Notes:**
- 1) PLATE: Ø80"  $\frac{3}{8}$ ", A36 Steel Plate, oversized to allow support from surrounding backfill
  - 2) SKIRT: 16ga Galvanized 8" skirt, welded to bottom of Plate
  - 3) ANGLE: 3" x 3" x  $\frac{1}{4}$ " Angle Iron, stitch welded to Plate every 6"

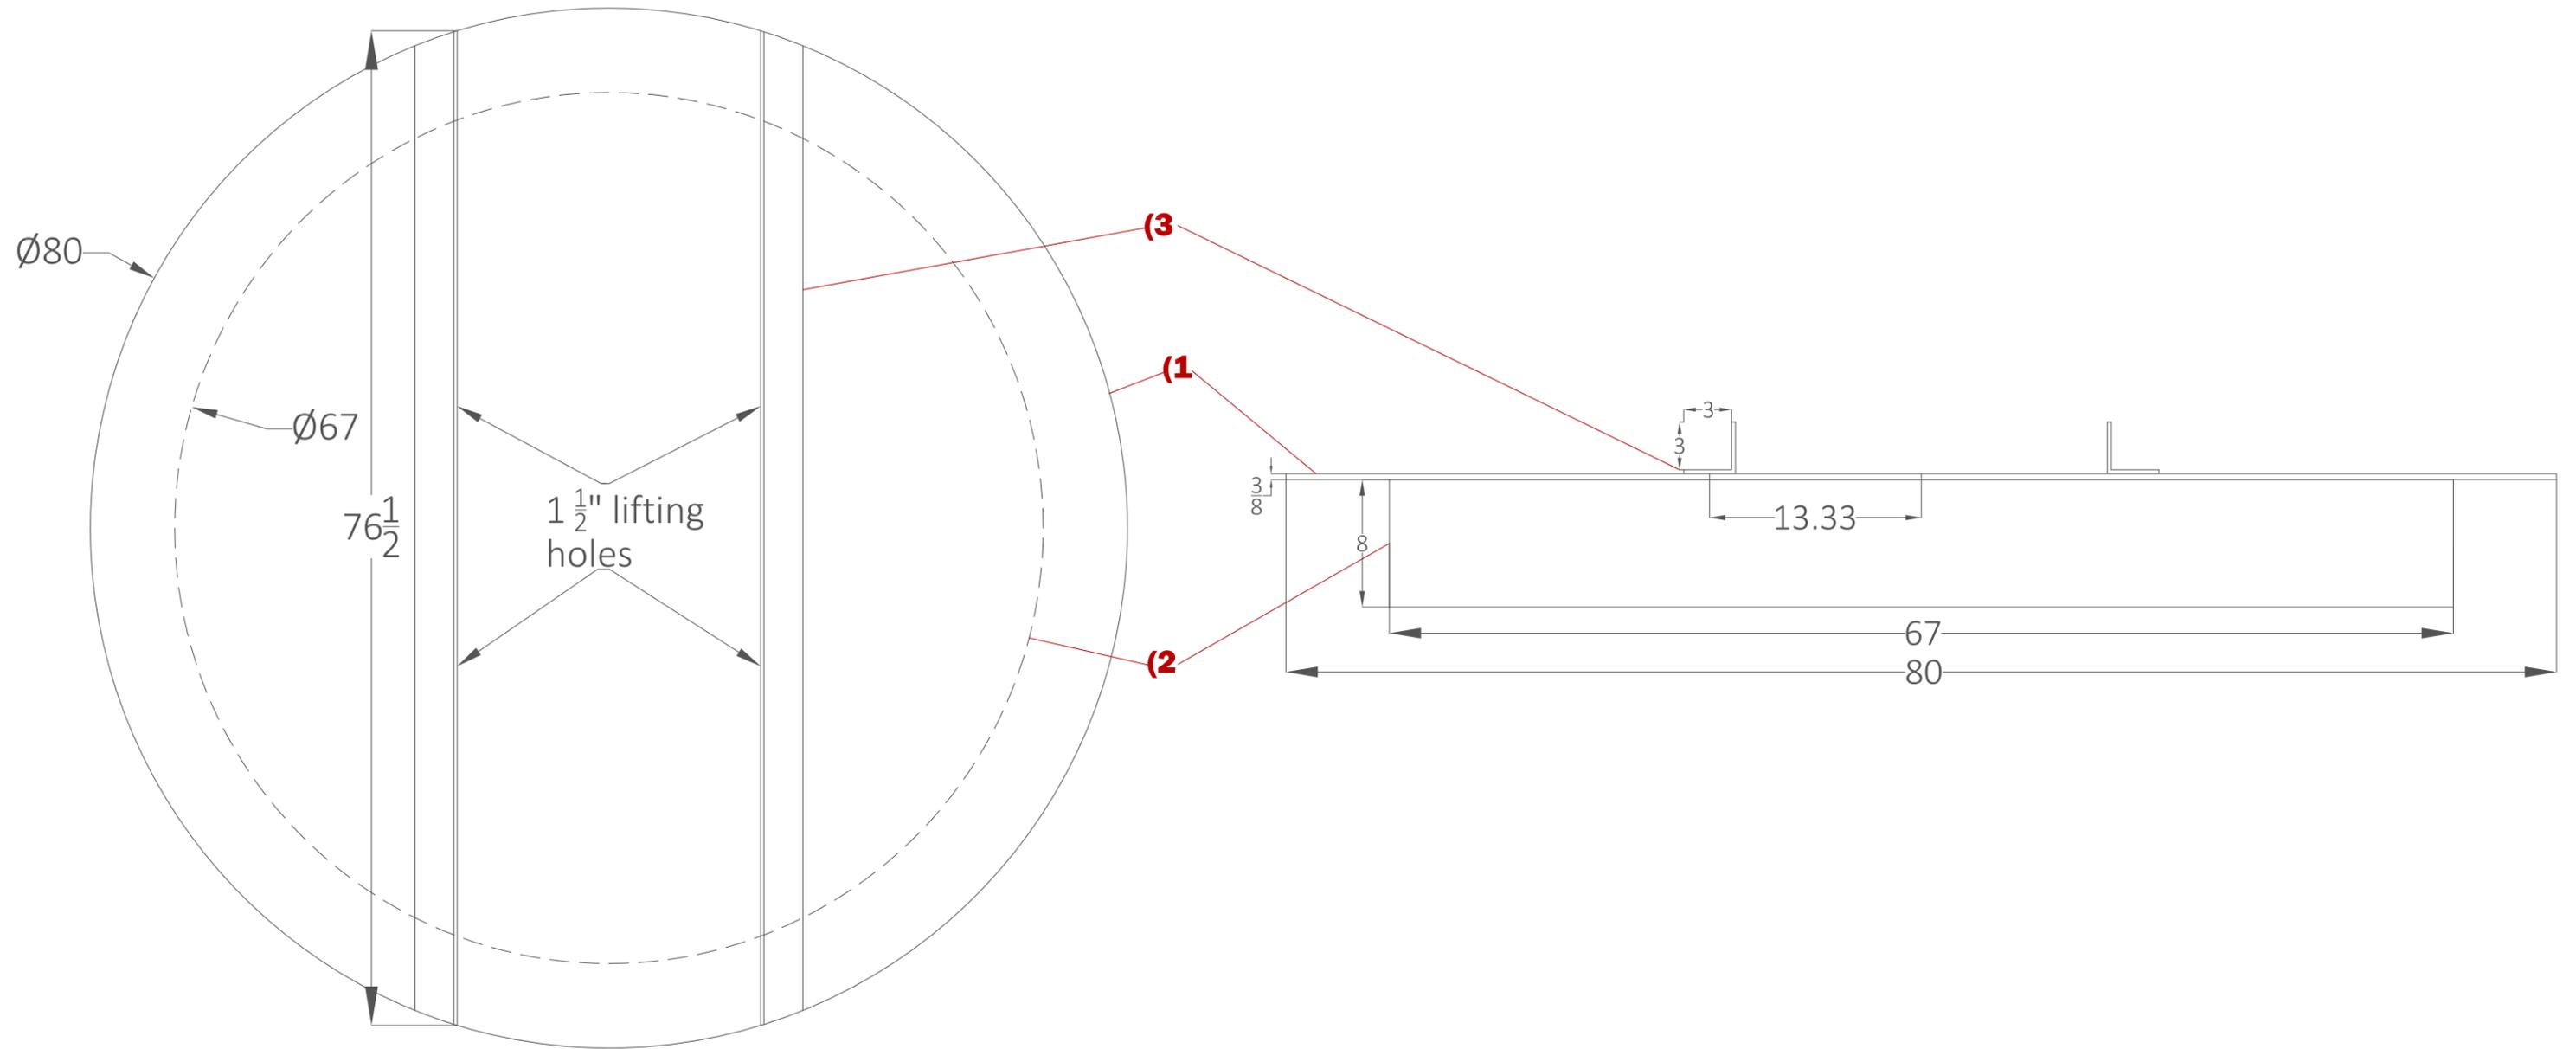
Ø80"  $\frac{3}{8}$ " End Cap

Lifting Holes In Angle

- 1) PLATE: Ø80"  $\frac{3}{8}$ ", A36 Steel Plate, oversized to allow support from surrounding backfill
- 2) SKIRT: 16ga Galvanized 8" skirt, welded to bottom of Plate
- 3) ANGLE: 3" x 3" x  $\frac{1}{4}$ " Angle Iron, stitch welded to Plate every 6"
