RE: DR-4585 PW 13 - FEMA Questions for Porcupine Road (EHP RFI)
Response to 9/20/2023 Request for Information

Completed Work, Phase I (Scope of Work Details):

Attachment A – Start/Stop GPS Points for Third-Party and Porcupine Trail Road Phase I Work

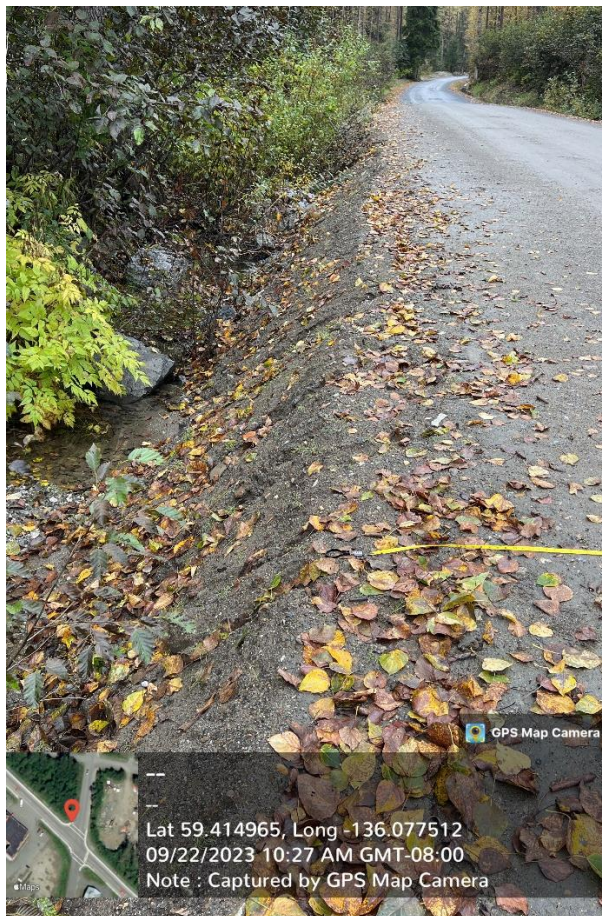
Figures C.4 (LT) and C.5 (RT) – 1:1 sloped embankment for 3’ fill at third-party work site 1 fill area. Note the toe of fill has been placed at the edge of the existing roadway, leaving the existing ditches on the left and right side of photos untouched.

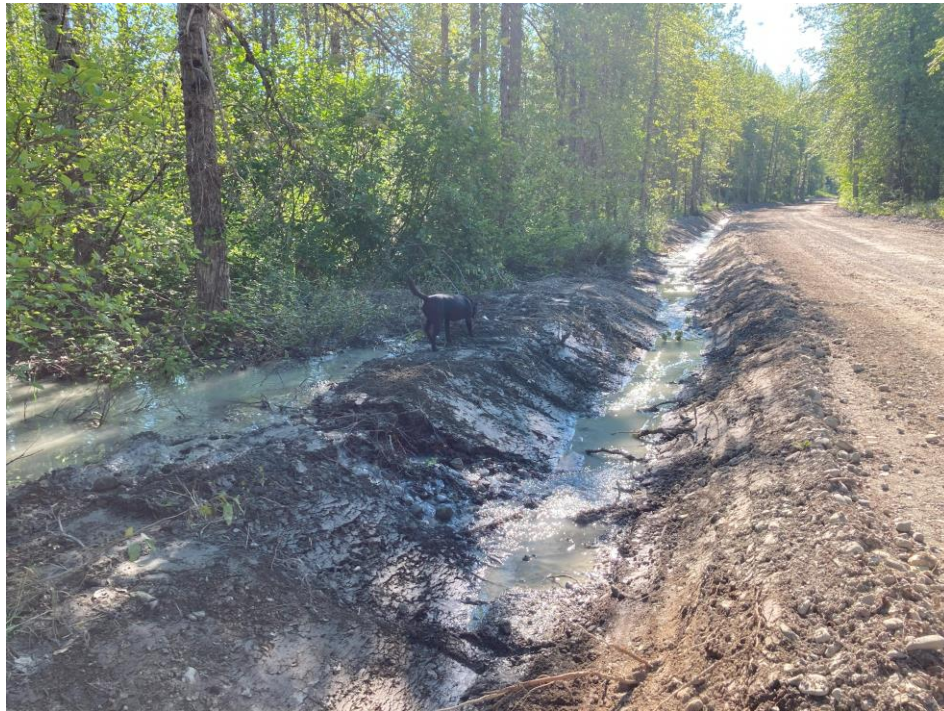
Water from the warm days

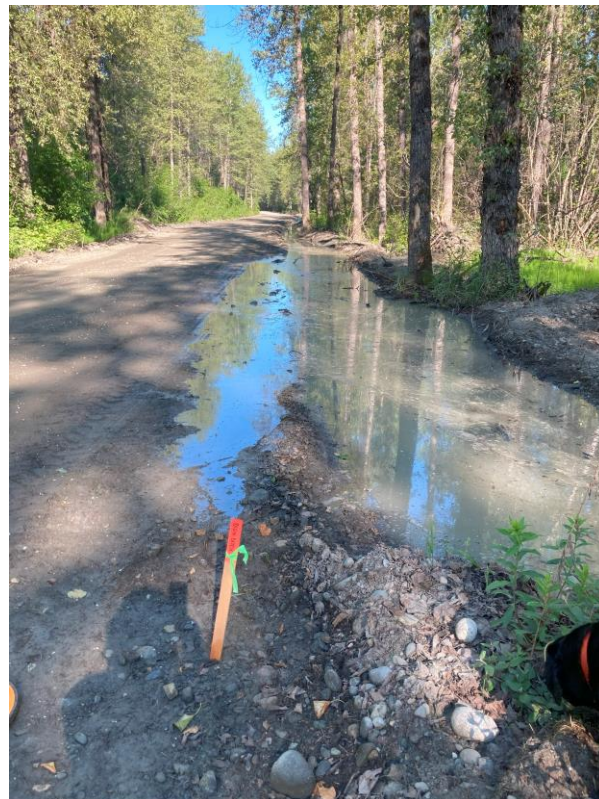
overflow

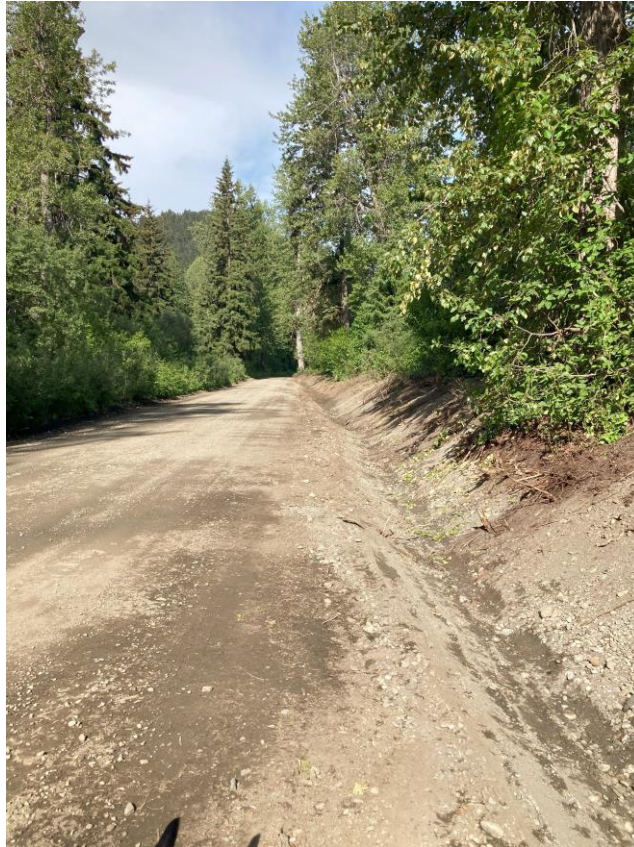
The drop in waterline, from yesterday, can be seen in ditch

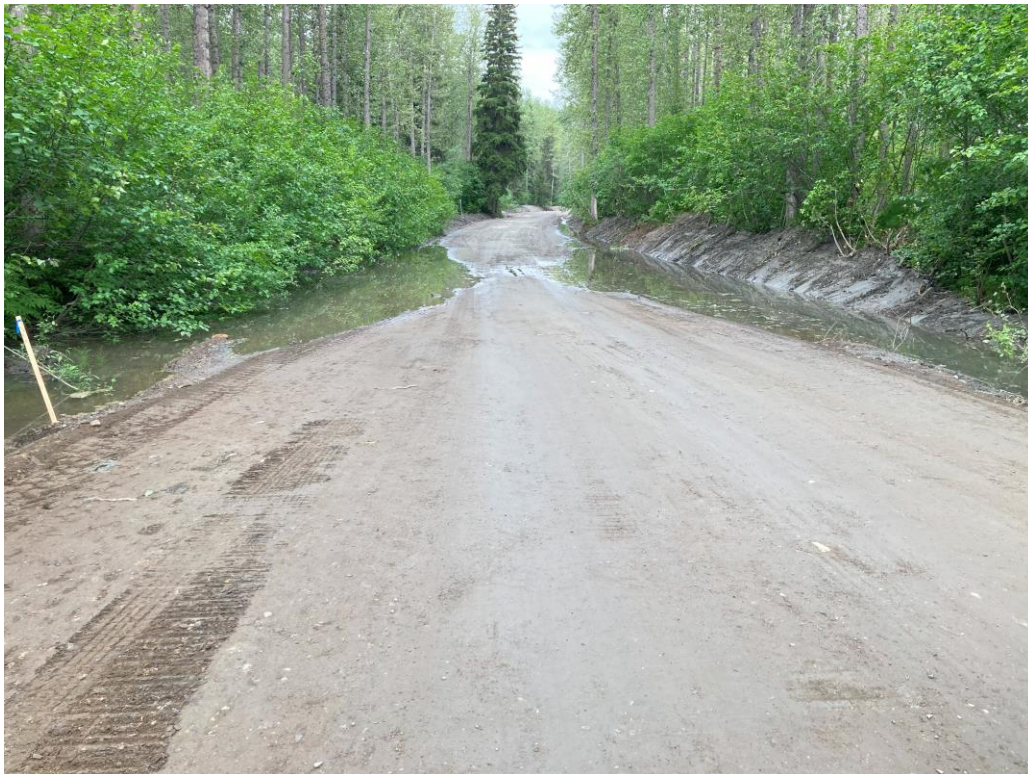
Water remains within the road 2mi. in from B□P

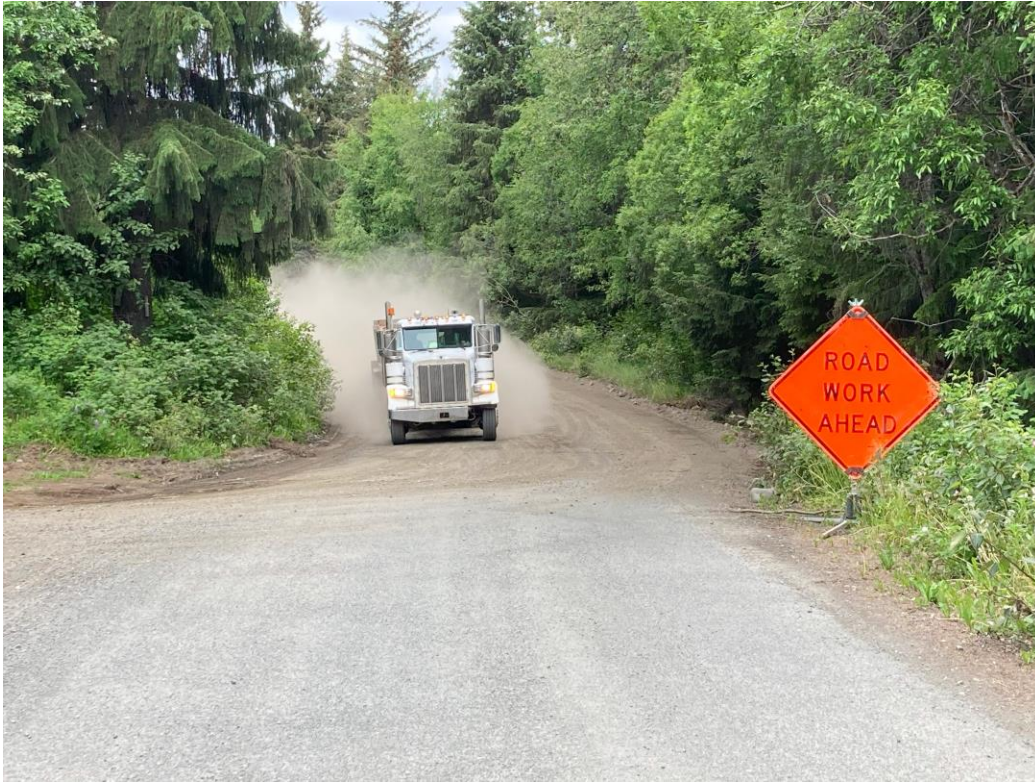
E1 haul began. Water truck needed several times

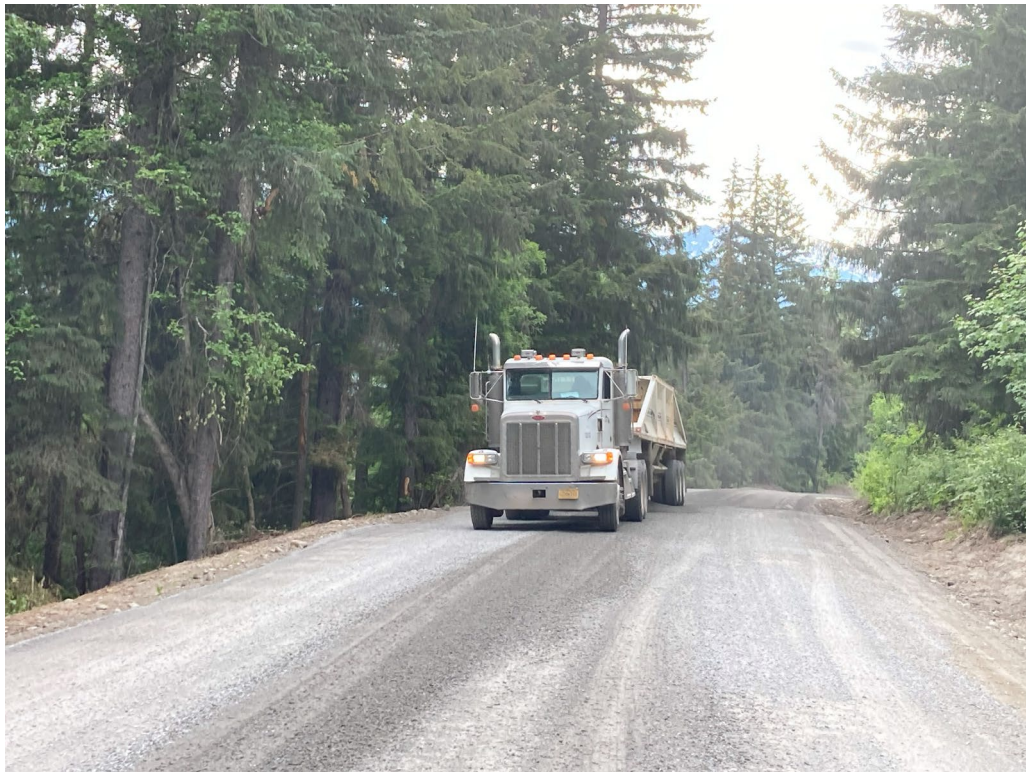
E-1 haul set back to BOP for more material

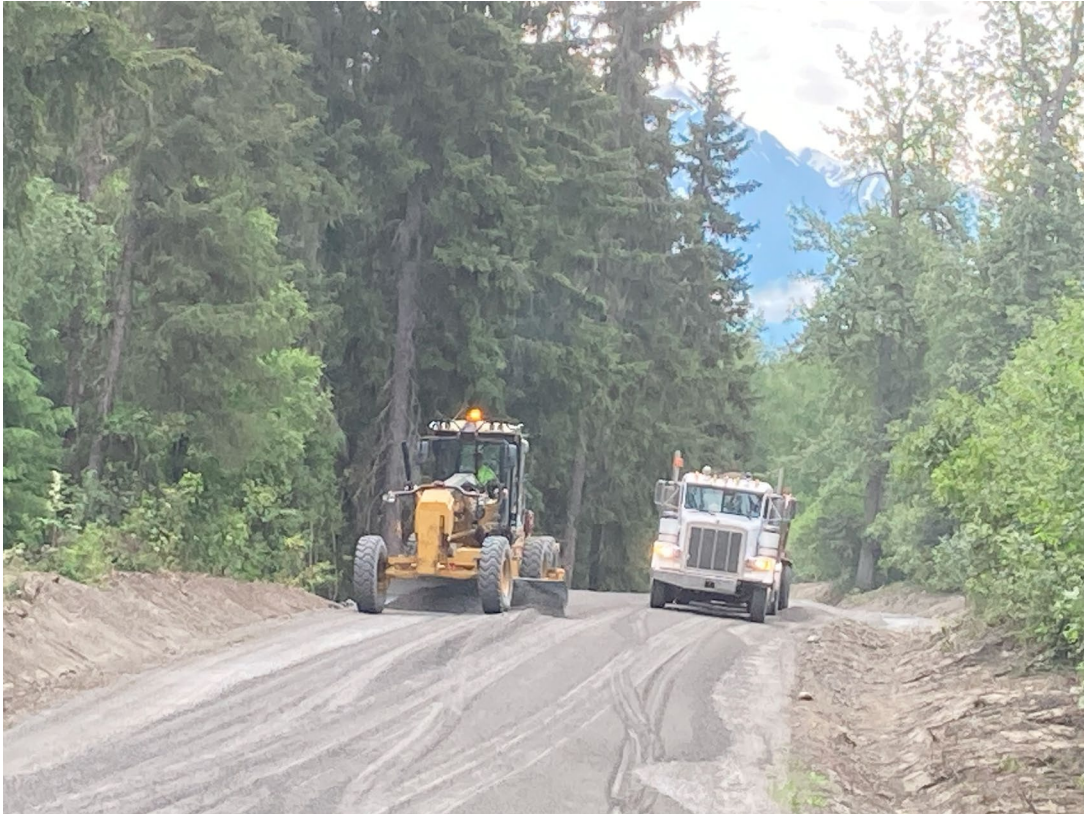
E-1 haul, 20 min. turnaround time

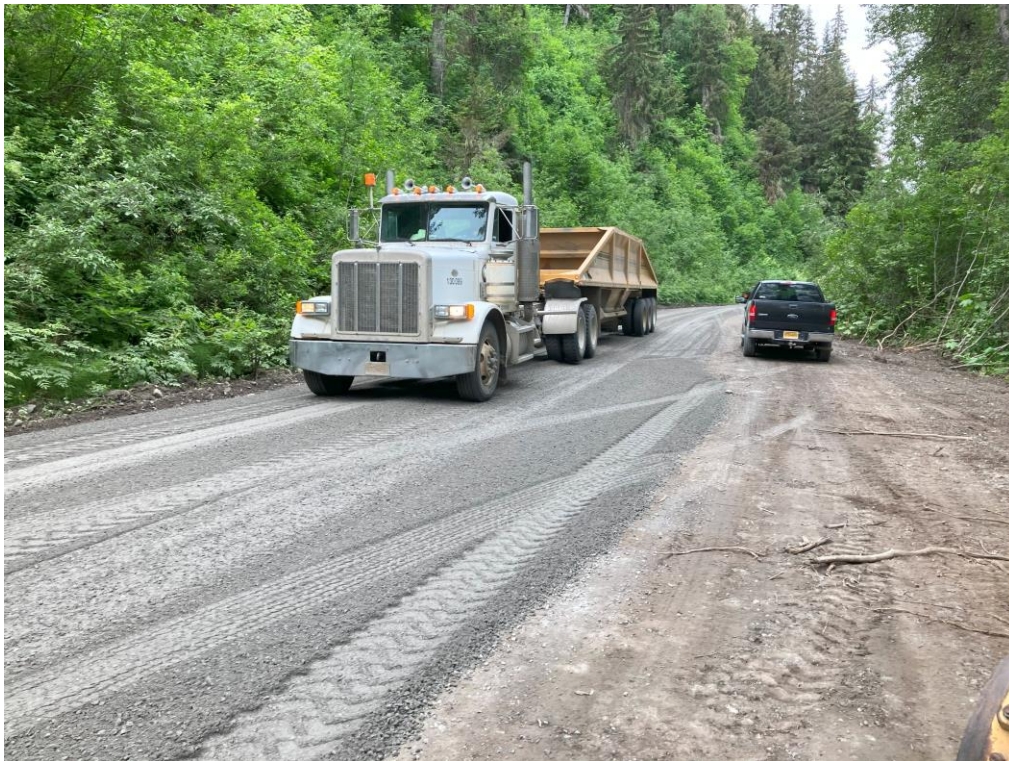
Additional material needed today around 4 miles from B□P

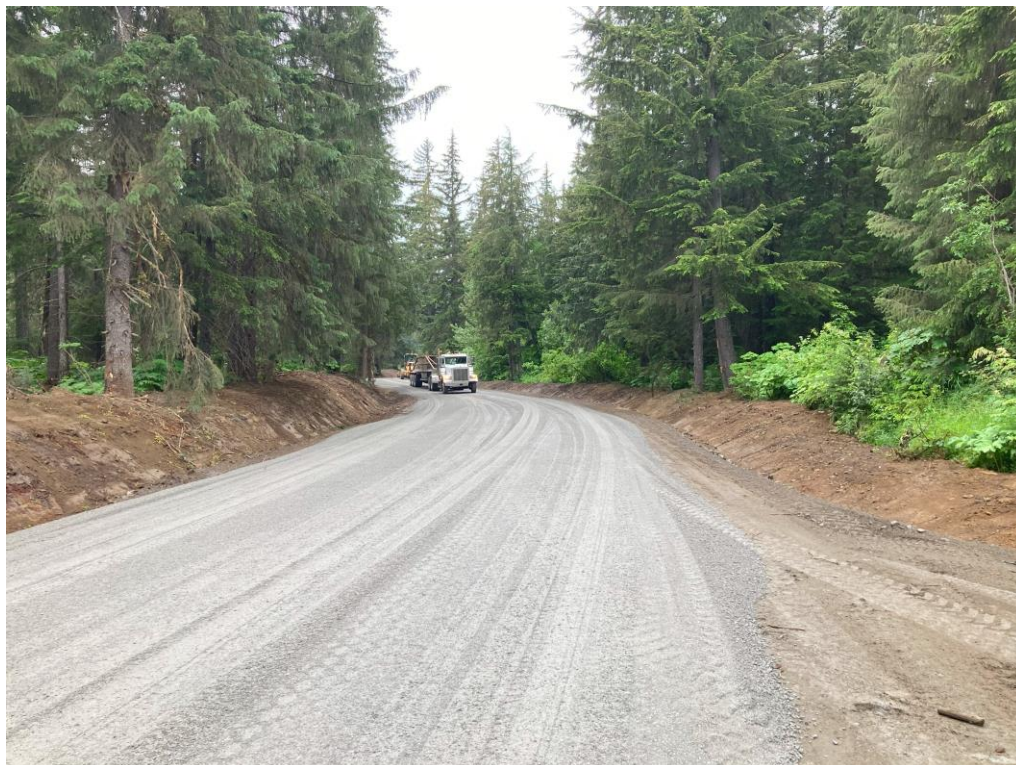
E1 haul. 30 minute turnaround

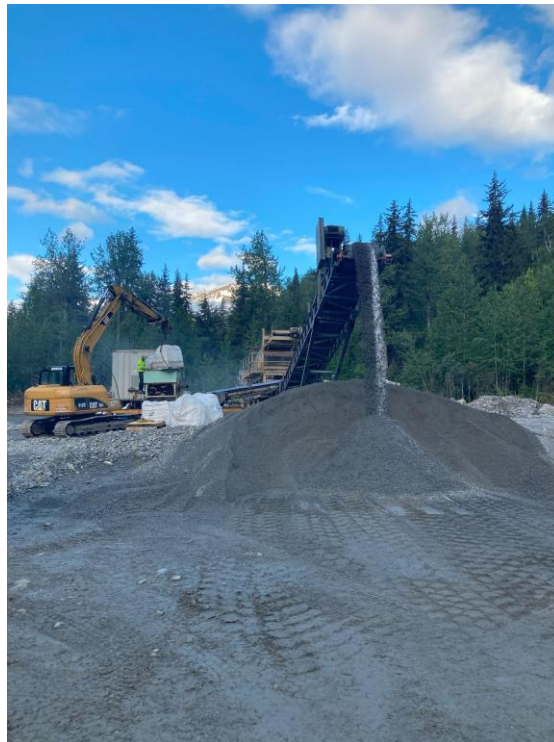
Calcium Chloride and the E material, coming off the belt

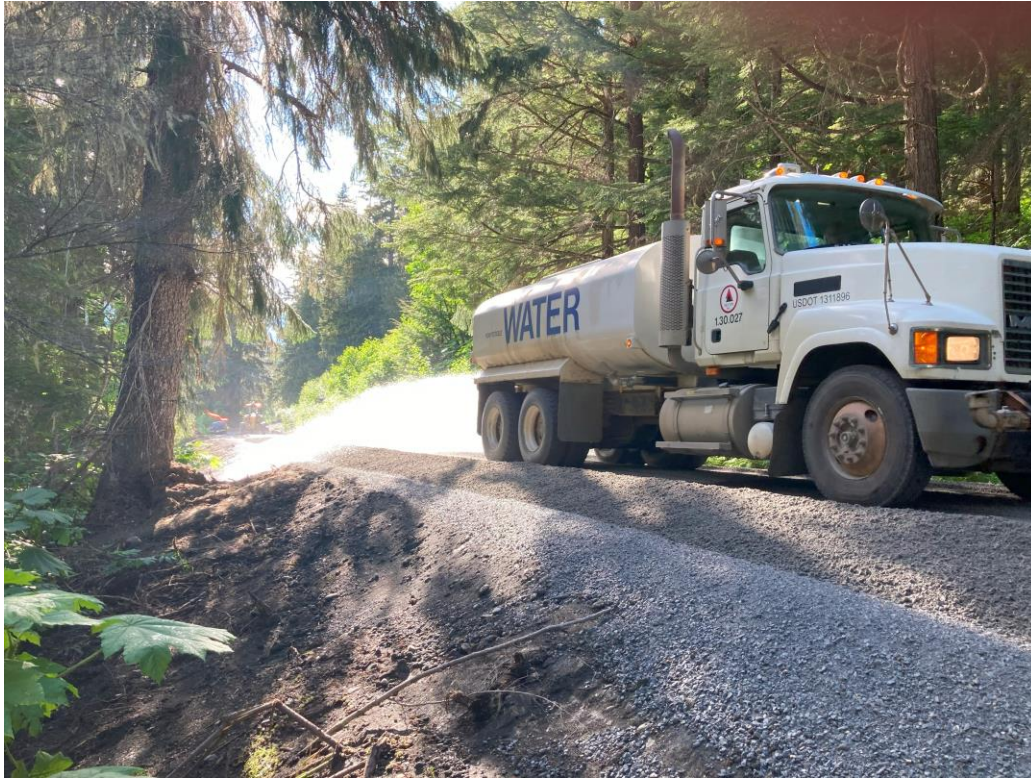
Water truck heavily waters the E1 with Calcium Chloride

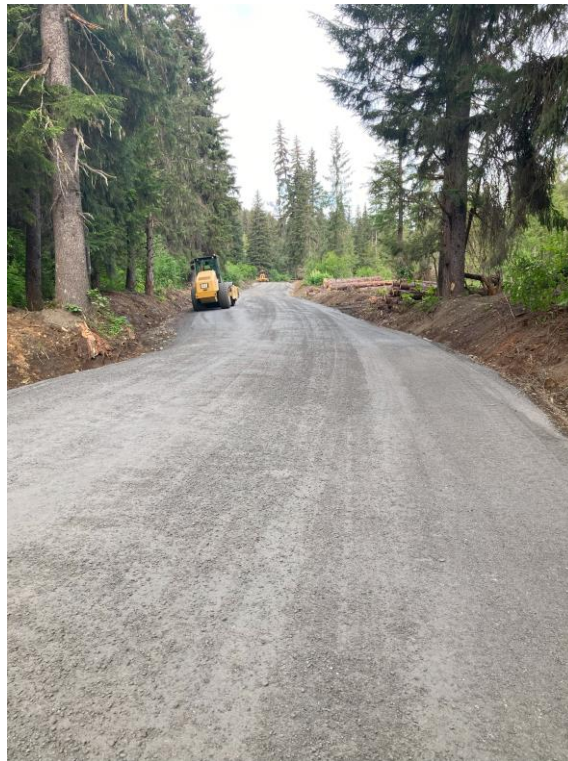
CS74B Roller at 6.5 miles from B□P

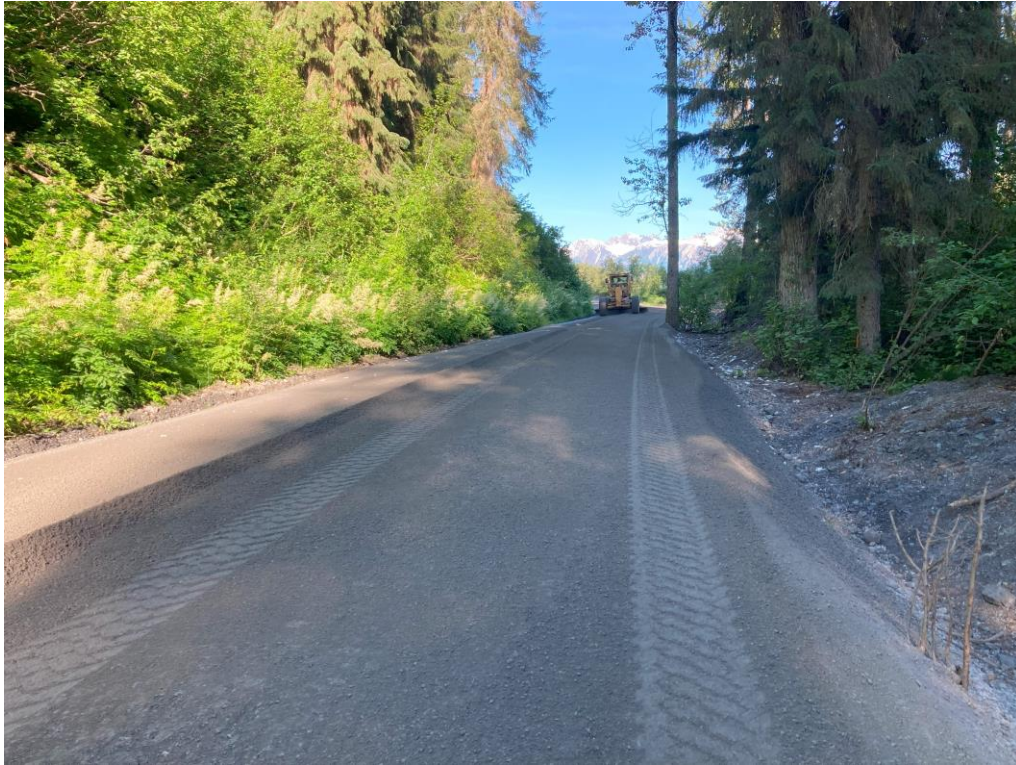
14 Grader finish blading 4.5 miles from B-P

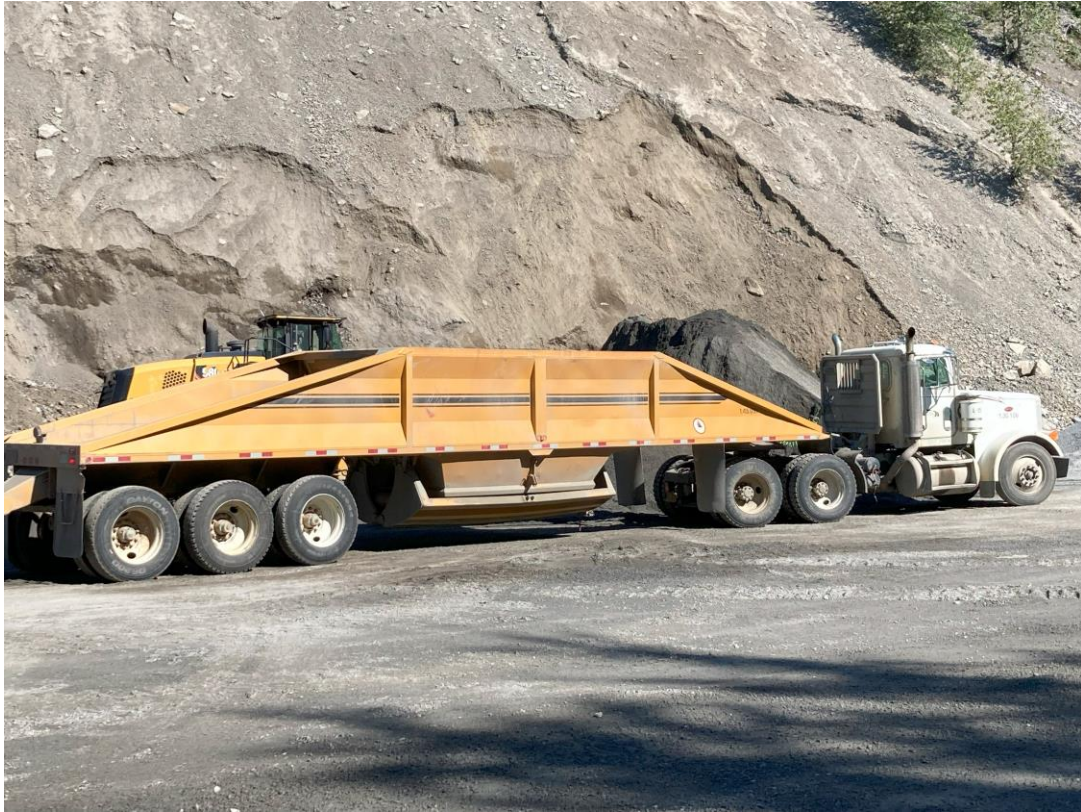
Stockpile production behind haul

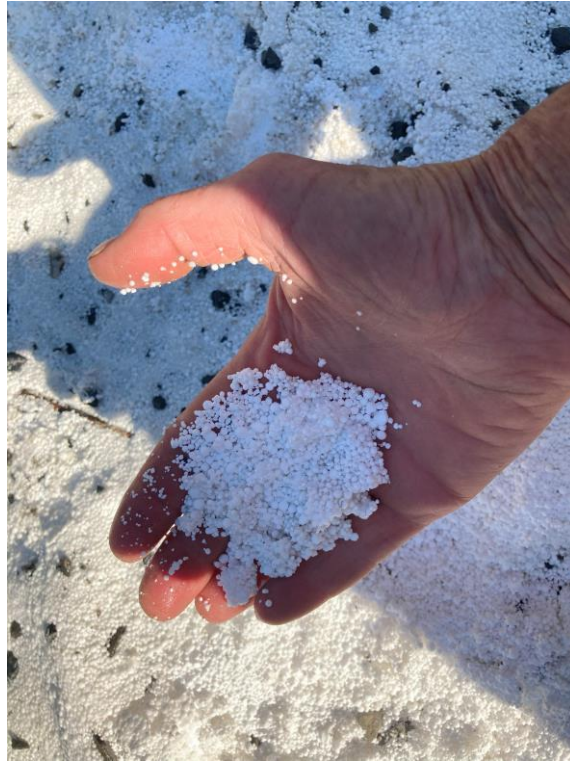
Sticky/soapy Calcium Chloride

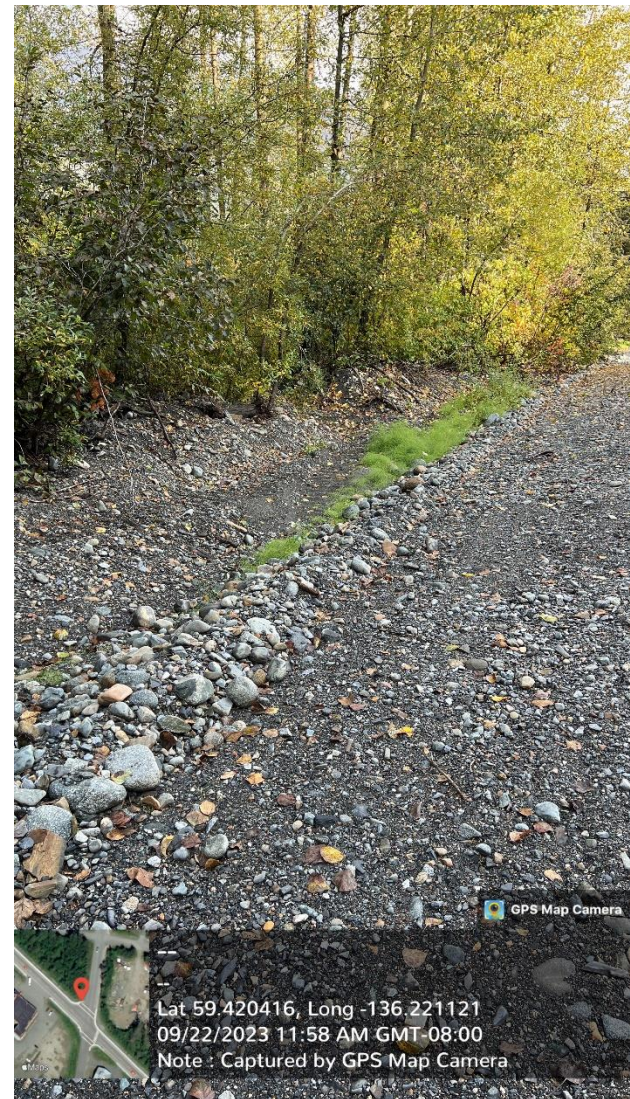
Figures F.8 (LT) and F.9 (RT) – Adjacent to and at the end of Phase I work limits, the disturbances shown here are the deposition of gravel and debris following a 2022 flood event on Porcupine Creek (which is outside our Phase I work limits). Have included photos here to clarify this is not material that was placed by Phase I or Third-Party projects.

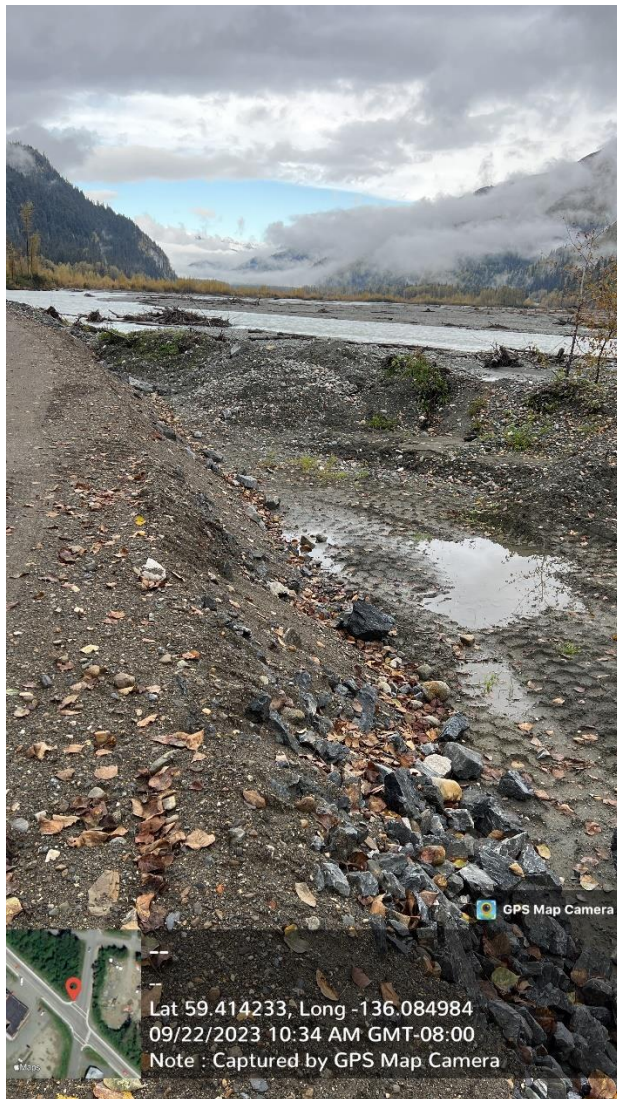
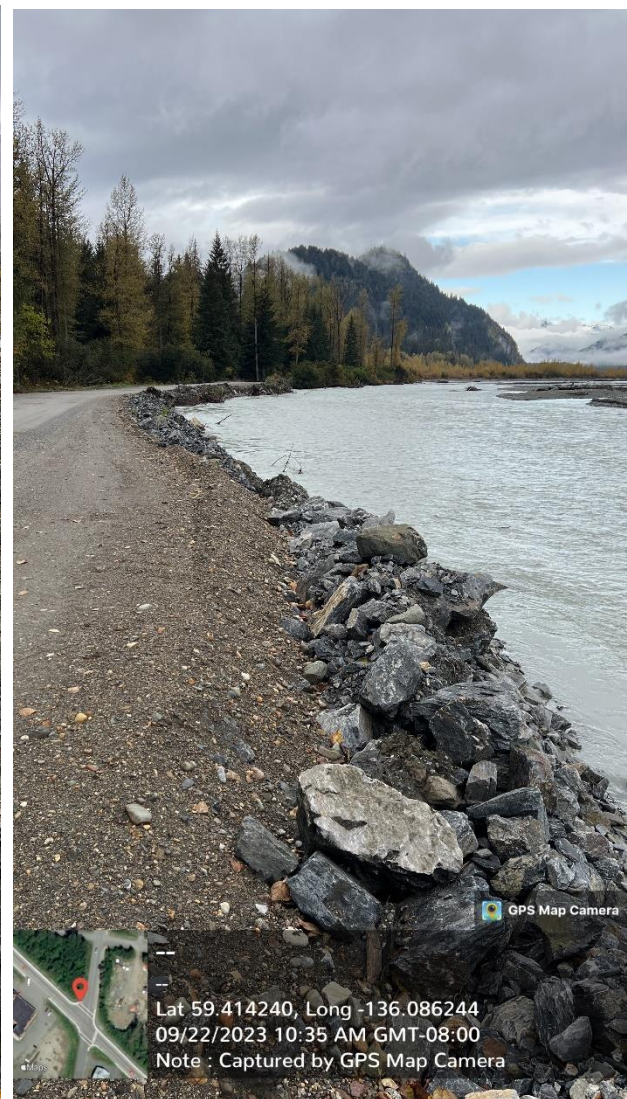
Figures H.3 (LT) and H.4 (RT) – Berms in background of photo at left, and riprap in photo at right, were placed in 2022 as described in FH22-I-0090. This is the same location as 2023 Third-Party Work Site 2. Third-party work placed 3' of road fill up against backside of riprap and berms placed in 2022. Figure H.3 on left shows elevation of existing road grade at backside of berms prior to 3' fill placement.
