# Updated Findings Report

## Beach Road Landslide, Haines, Alaska

**GEOTECHNICAL INVESTIGATION, UPDATED FINDINGS REPORT  
BEACH ROAD LANDSLIDE, HAINES, ALASKA**

March 18, 2022

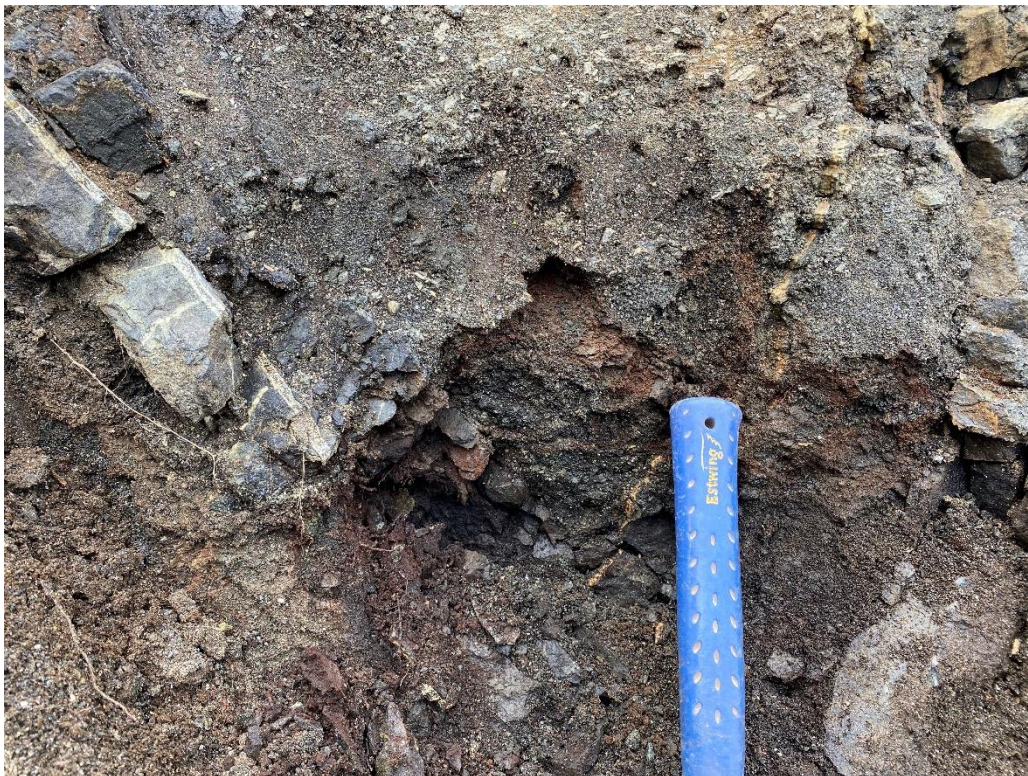
A: Colluvium 1 at elevation 640 feet on the West Soil Scarp.

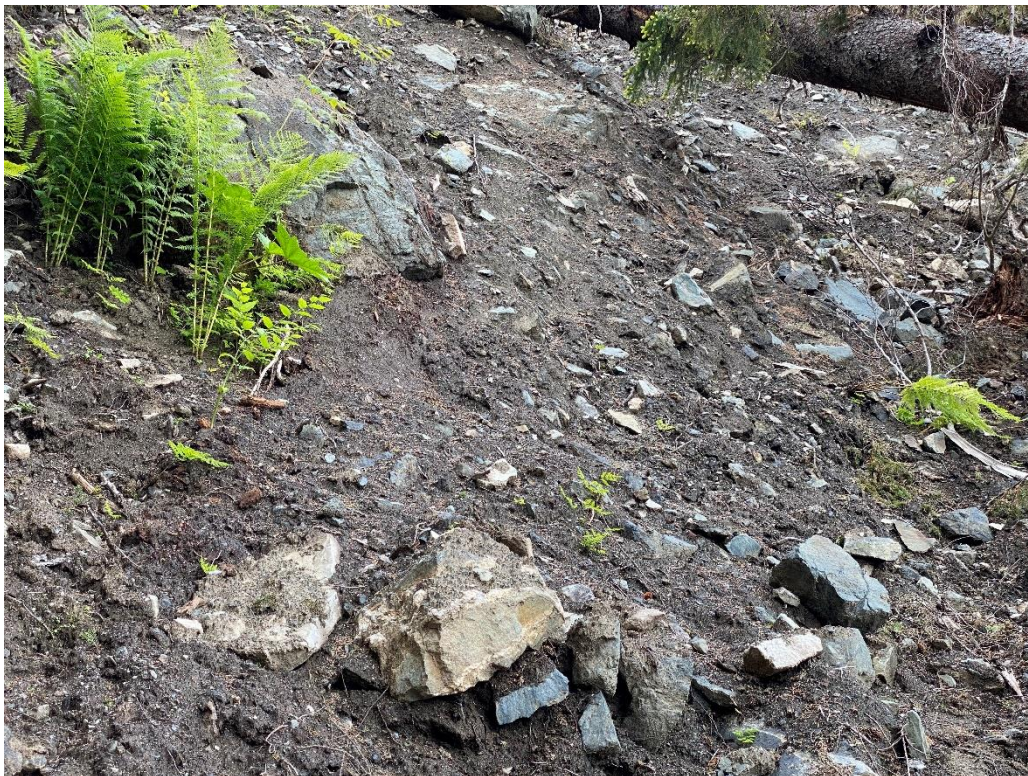
A: Colluvium 3 at elevation 460 feet East Side of Middle Boulder Field.

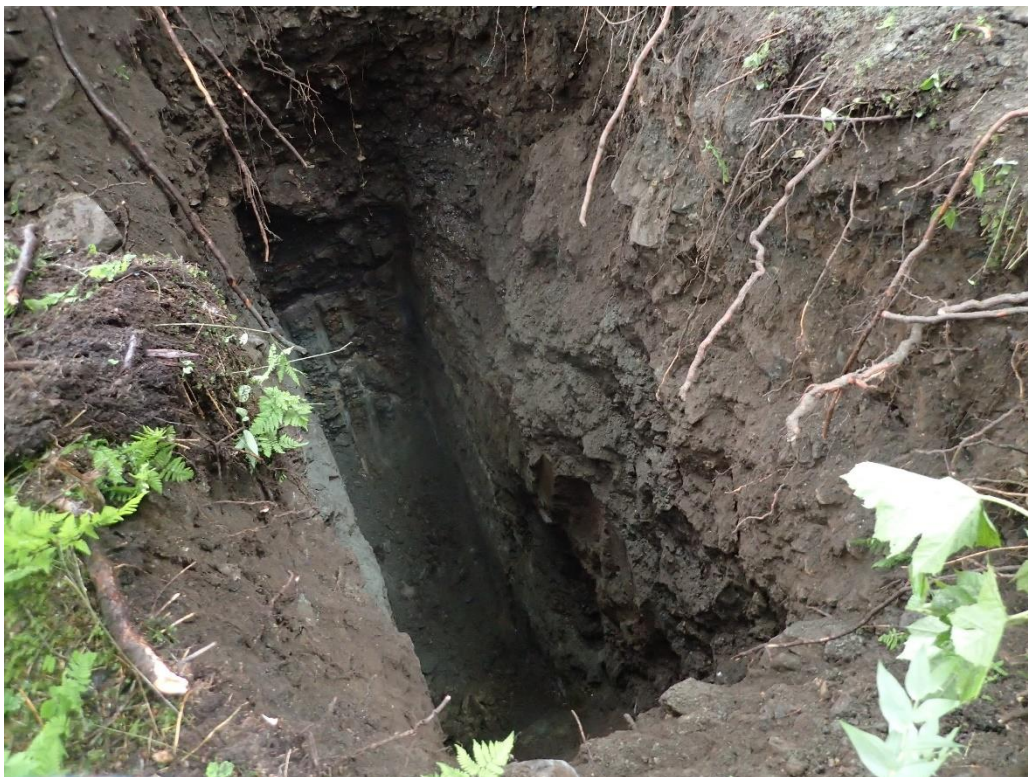
B: Colluvium 3 at Test Pit No. 27 (elevation 300 feet).

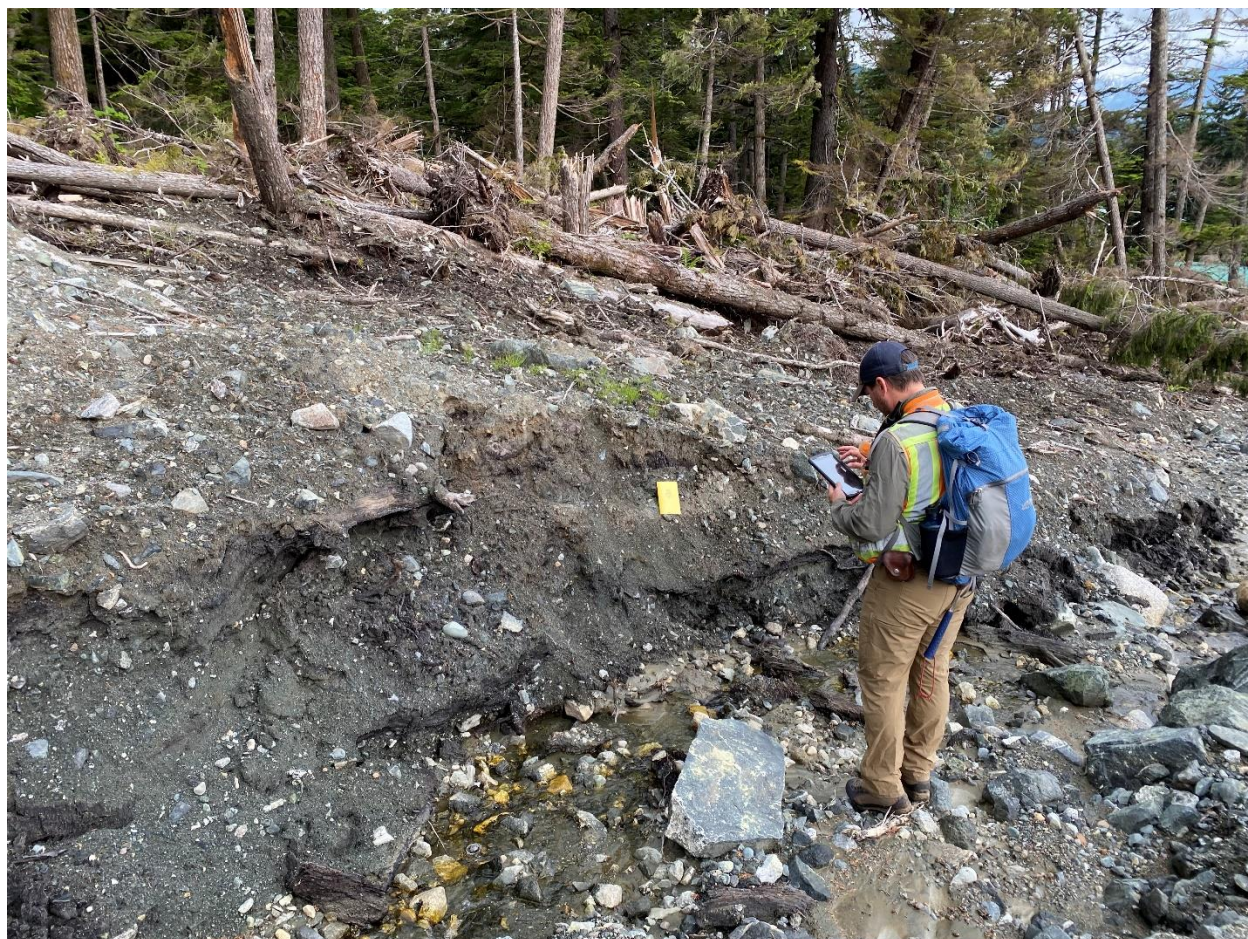
Colluvium 4 at elevation 160 feet on the west side of the Lower Debris Flow.

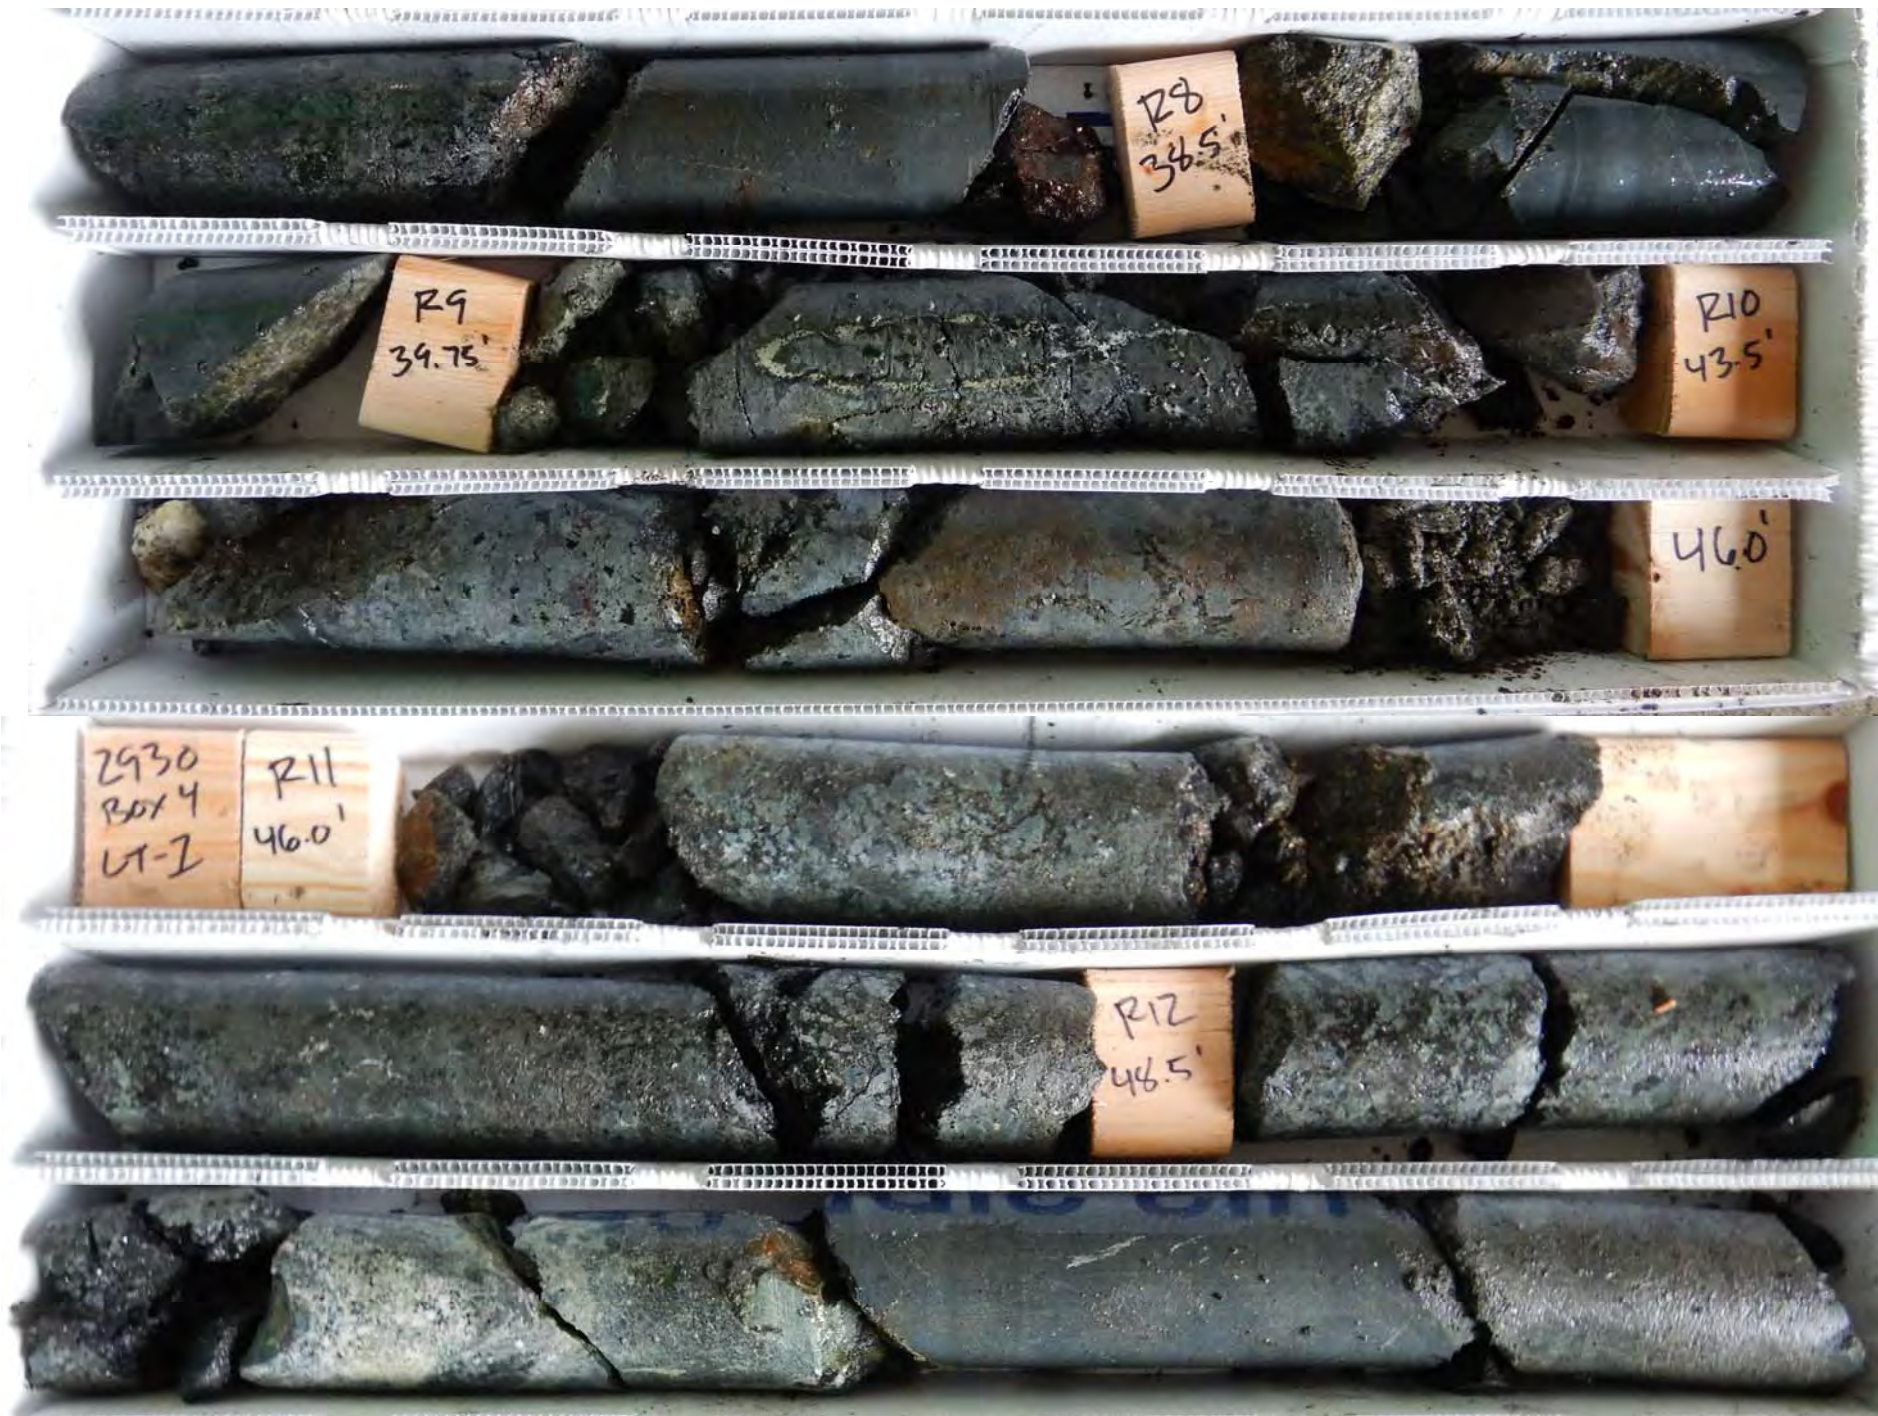
LT-1 transition  
at 50.8 ft

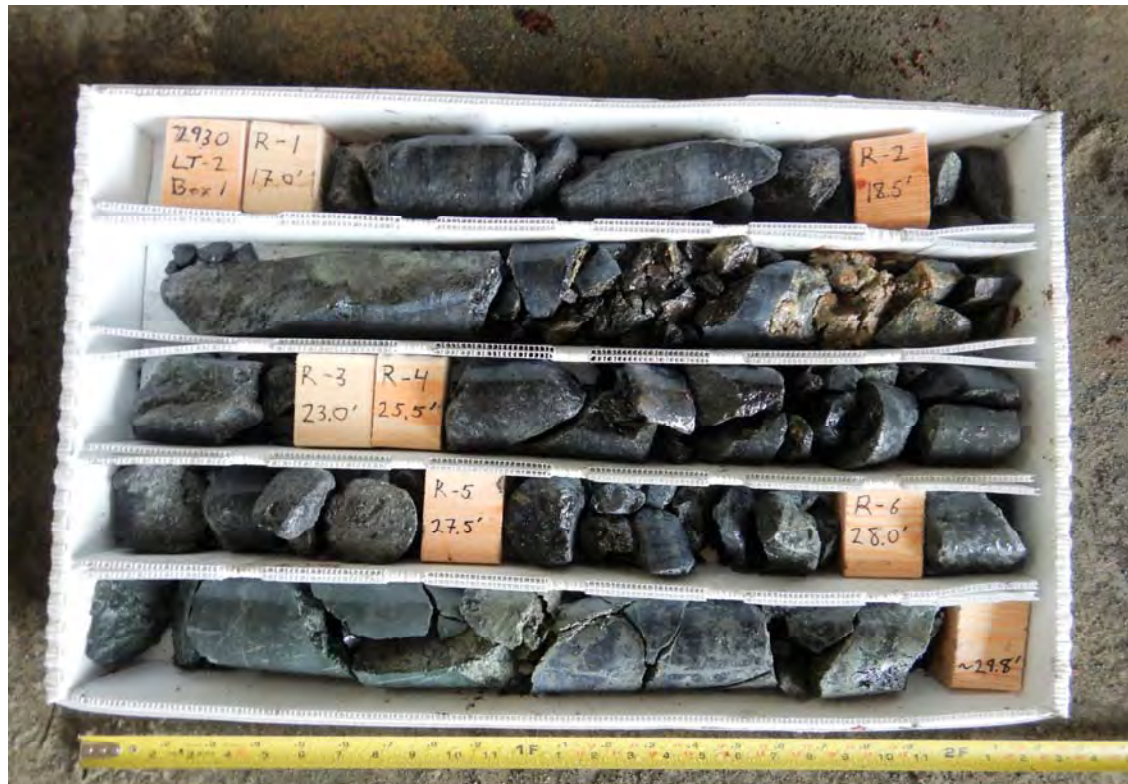
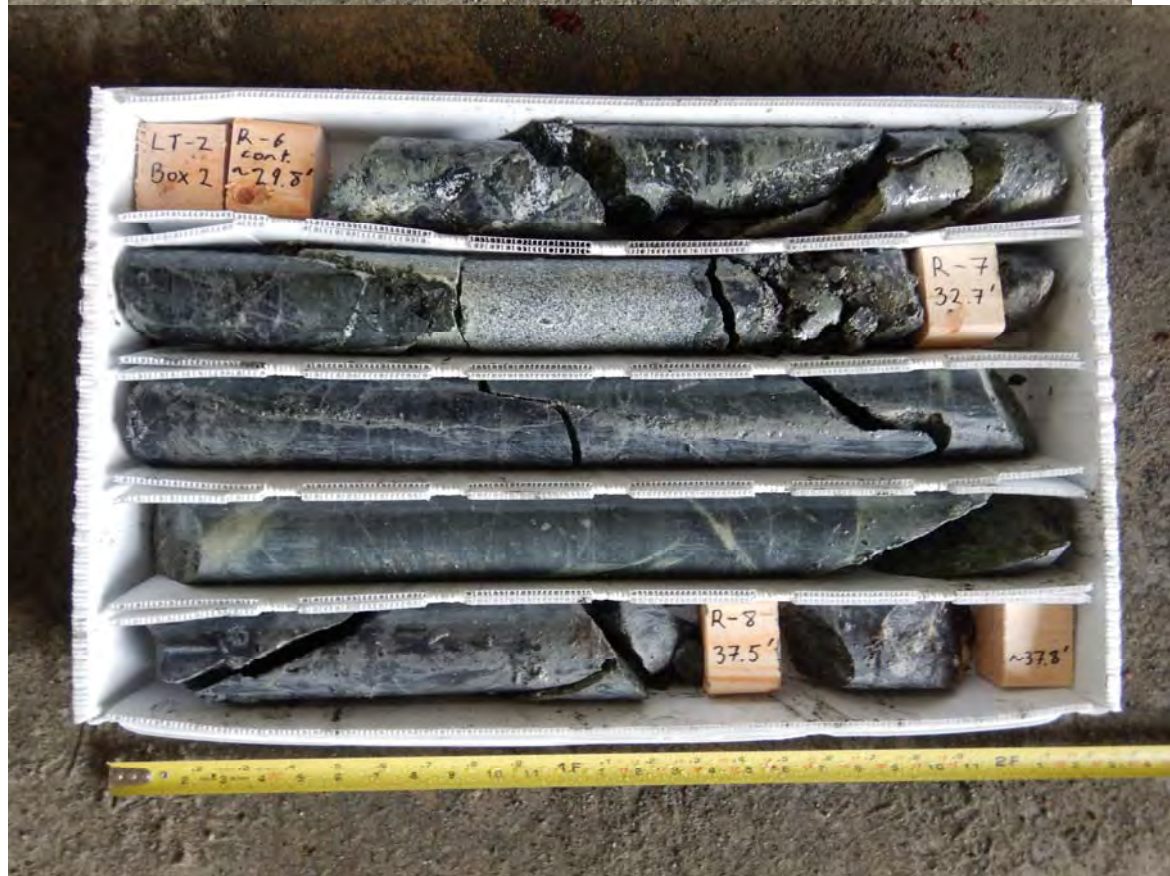
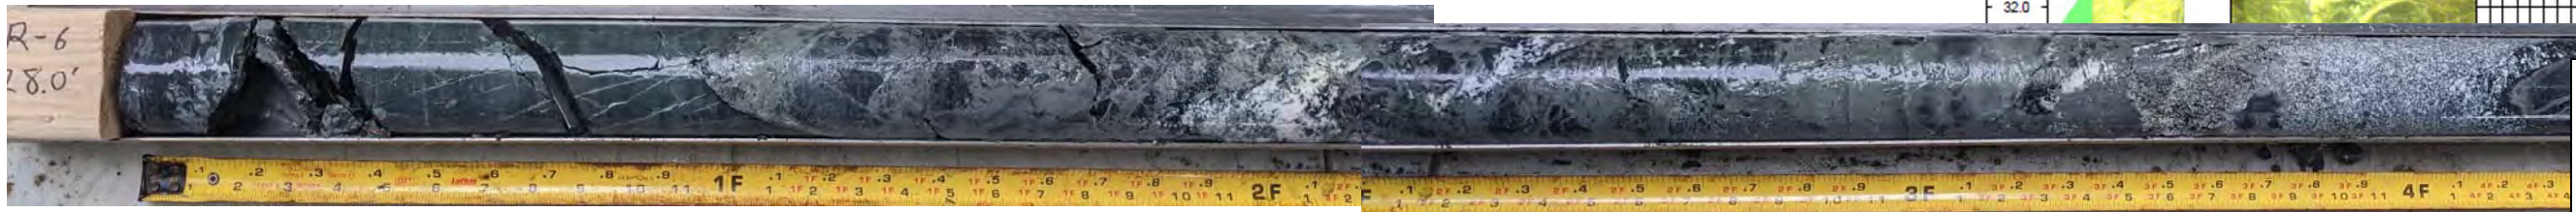
LT-2 transition at 32.8
